ARCHAEOLOGICAL EVALUATION ON THE SITE OF
THE KITCHEN OF THE MEDIEVAL GUESTHOUSE,
BUCKFAST ABBEY, DEVON

STEWART BROWN ASSOCIATES
SEPTEMBER 2013

SUMMARY

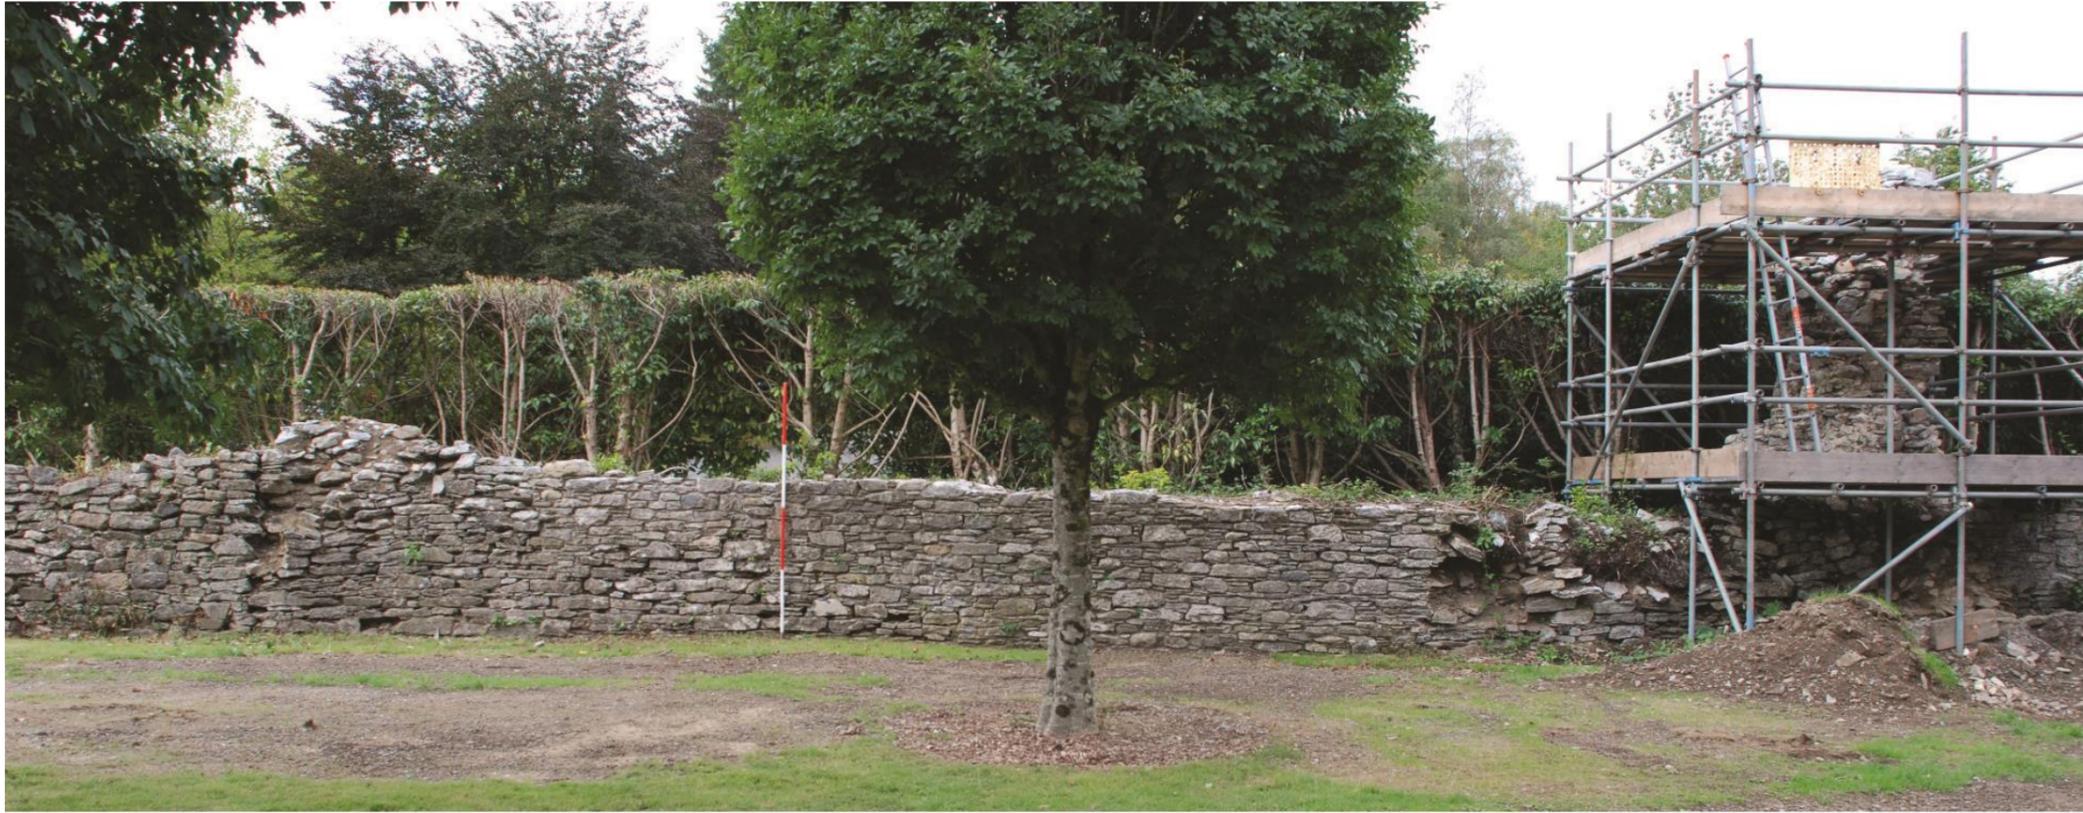
Fig. 8 Wall 33, looking west.

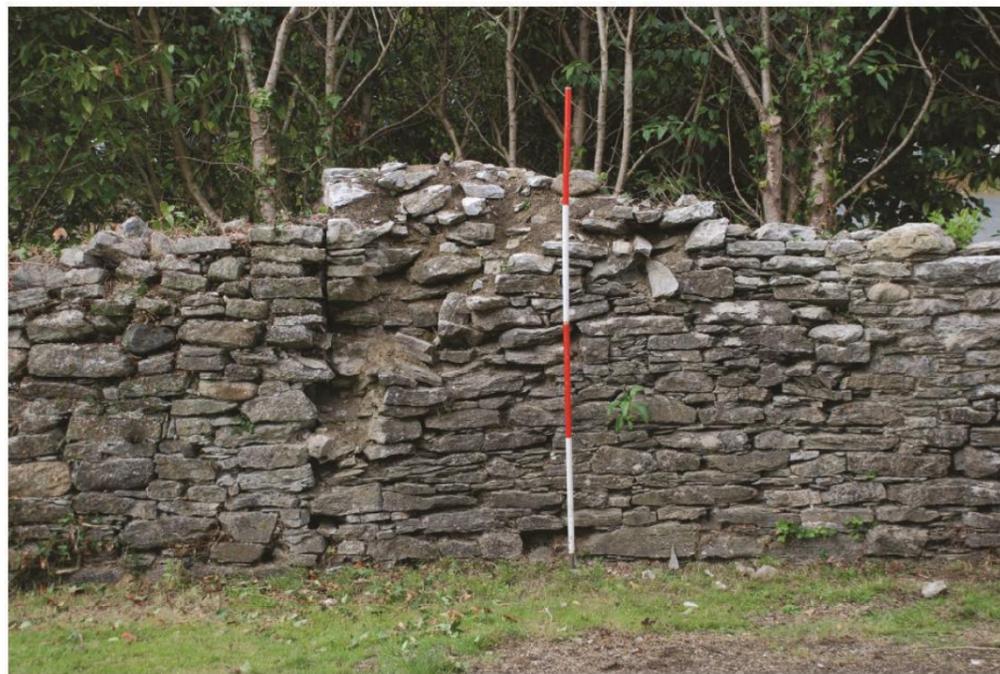
Fig. 9 Wall 33 south end, showing scar for southwest corner of the Phase 2 house and later re-facing. To the left is a 19th-century garden wall.

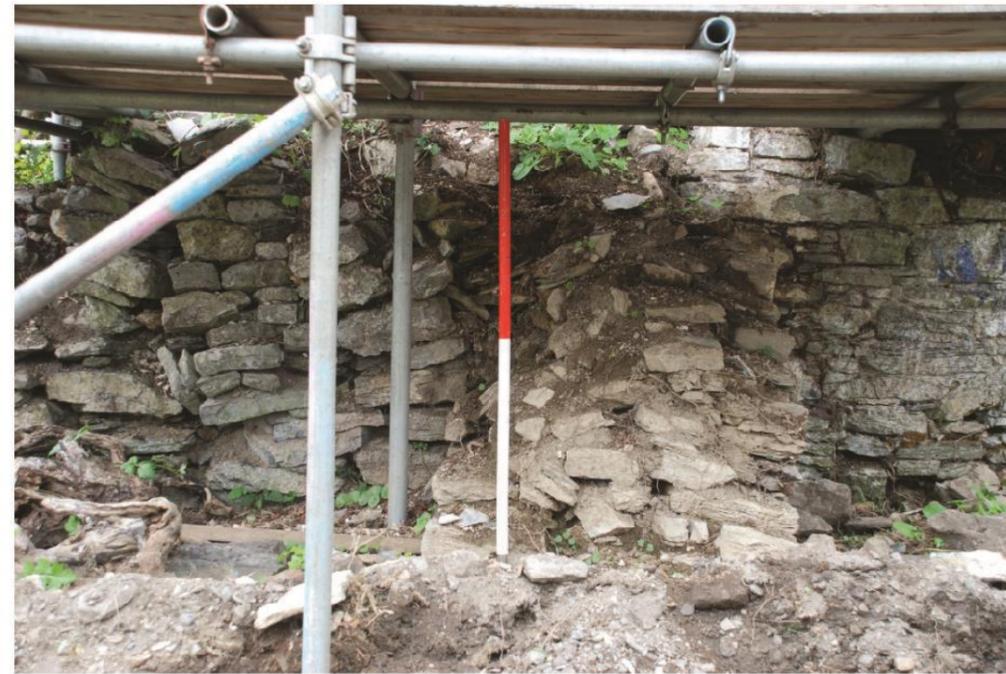
Fig. 10 Wall 33 north end showing standing remains of north-west corner of the Phase 2 house and later re-facing.

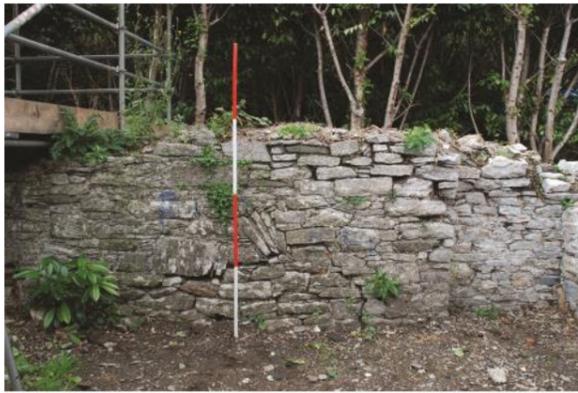
Leading northward from the northwest corner of the house was another clay-bonded wall (Figs. 1 and 2, wall 38; Figs. 11 and 12). The wall abuts the corner and was built on a different alignment from the house. It may be a little later in date, ie late 17th or 18th century. Buttress 36 crossed over its top, showing that the buttress is later than the wall. It is known from excavations in the 1980's that this wall directly overlies a late medieval wall thought to be part of the medieval guesthouse kitchen (mentioned above). The wall contains many re-used stones with white mortar adhering to them, plus two fragments from arches bonded with similar white mortar. The white mortar closely resembles that used in the nearby 14th-century guesthouse, so wall 38 would seem to incorporate stones and masonry fragments salvaged from a medieval building, probably the guesthouse kitchen. The tithe map of 1844 shows a long narrow structure standing on this part of the site (Fig. 6), so wall 38 probably once formed part of the structure's west wall. The wall contains no windows so the structure may have been a shed or store of some kind.

Fig. 11 Wall 38, looking west.

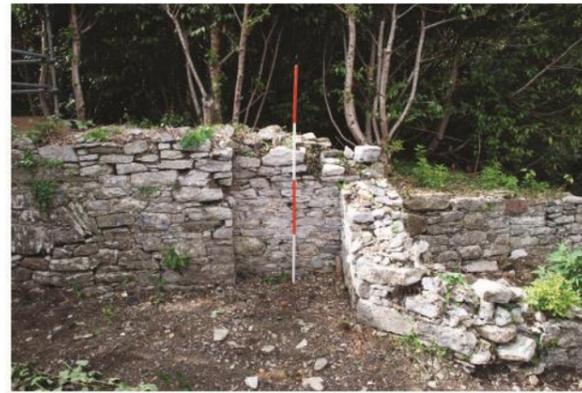
Fig. 12 Walls 38, 39, 41 and 5, looking west.

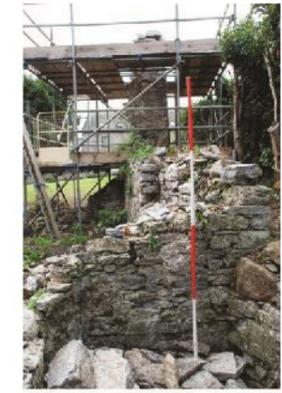
The small structure shown on the 1884 map to the north of the yard (Fig. 7 B) may have been a pigsty. Its walls (Figs. 1 and 2, walls 39, 40, 42; Fig. 14) abut walls 41 and 5 so are a little later in date.

Fig. 14 Wall 41, looking south.

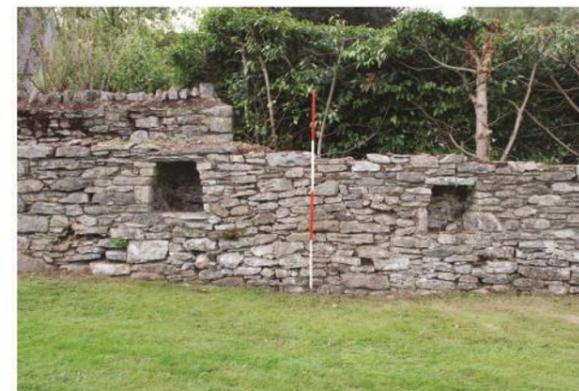
To the south of the evaluation area is a garden wall containing three bee-boles (recesses for containing wicker bee skeps; Fig. 21). The wall abuts the southwest corner of the 17th-century house and must therefore be later in date. Parts of the wall have been patched and consolidated in recent times using cement mortar. Other parts may date from the 19th century or perhaps a little earlier.

Fig. 21 19th-century garden wall to south of evaluation area showing bee boles, looking west.

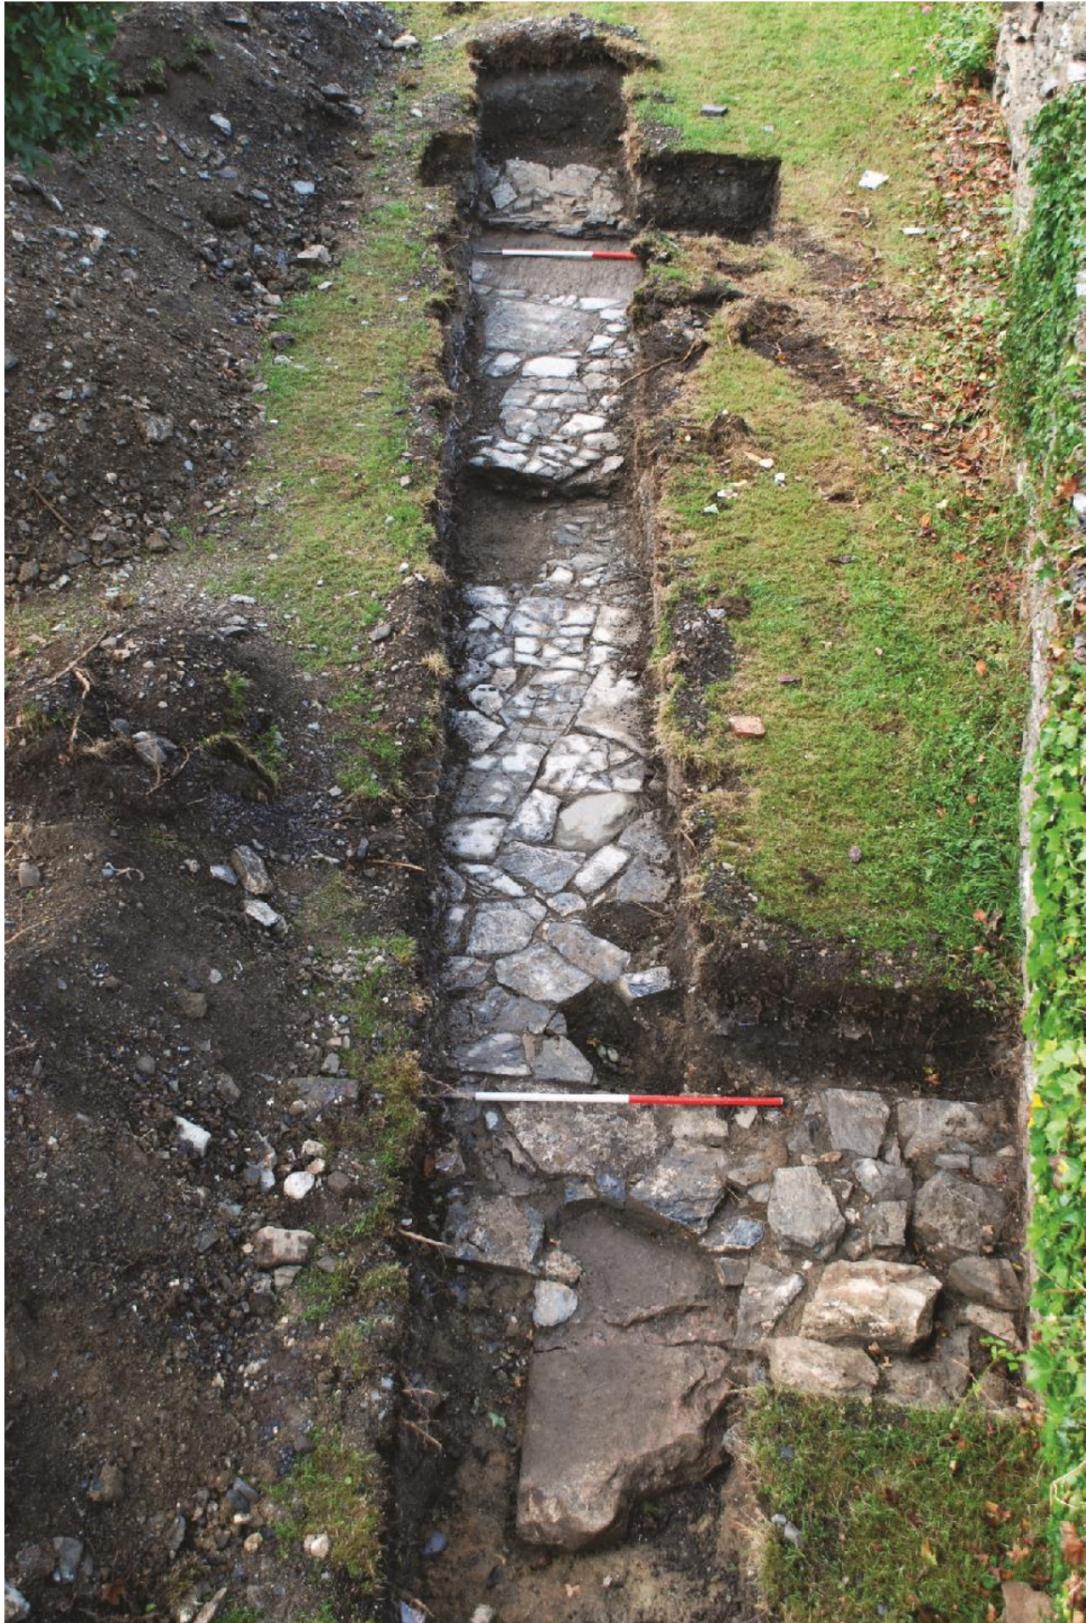
Trench 6 uncovered a stone floor made up of irregularly-shaped local limestone slabs of both large and small sizes (Fig. 1, Trench 6, 27; Figs. 25). Many of the stones are smooth and rounded on their surface owing to prolonged wear. A good number are also cracked, probably a result of tanker lorries having crossed this part of the site in the 1980's (see Phase 4 below). The floor abutted the wall footings of the house and was clearly contemporary. In a few places, stones were missing or had been dislodged by tree roots. The largest area of missing stones (28) provided an opportunity to investigate the deposits beneath the stone floor. A trial pit was opened which uncovered a series of make-up and levelling deposits, the lowest being the layer of broken roofing slates 28-5 which may date originally from around the time of the Dissolution (described in Phase 1 above). The uppermost levelling deposit, a clay layer which could be observed to extend beneath adjacent flagstones, and which therefore can be regarded as stratified immediately beneath the stone floor (28-2), produced two pottery sherds dating from the 16th or 17th century and part of a clay pipe stem of probable 17th-century date. These finds show that the stone floor very likely dates from the 17th century. There were no other floor surfaces beneath the stone floor, so the date of the floor is probably that of the house too.

Fig. 25 Stone floor 27, looking south.

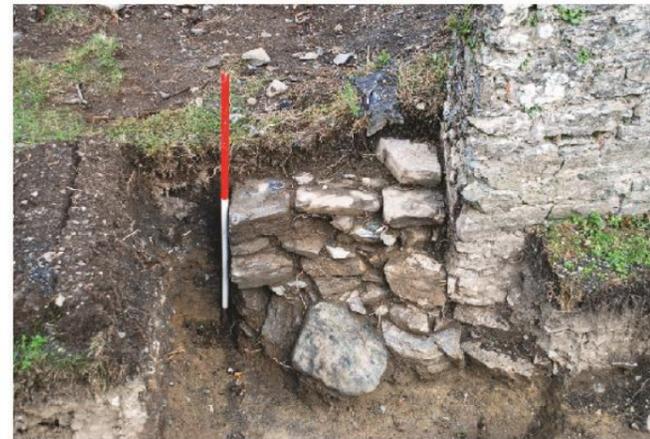
Further to the east, a wall footing for the north wall was uncovered by excavation (Fig. 1, Trench 1, 21; Fig. 22). Trench 6 uncovered parts of the building's south wall (Fig. 1, Trench 6, 25; Fig. 23) as well as a cross-wall which divided the interior into two equally sized rooms (31; Fig. 24). All the excavated wall footings were on average 0.74m wide and set in clay like the standing remains. The east wall and northeast corner of the building had been robbed of stone, leaving behind only robber-trenches (Fig. 1, Trench 1, 14 and 20).

Fig. 22 Wall footing 21, looking west.

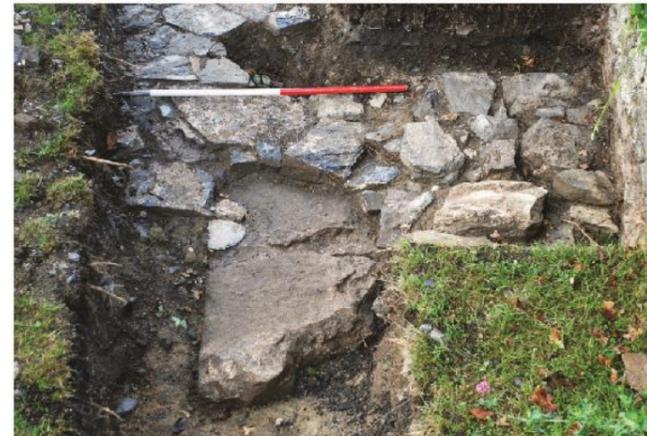
Trench 6 also located two fireplaces, one in each of the two rooms (Fig. 1 Trench 6, 24 and 32; Figs. 24 and 26). Fireplace 24 was 1.3m wide and set against the south wall closer to the southwest corner than a central position. It had a pitched slate hearth contained within a band of laid stone edging at its front and along its two cheeks. The surface of the pitched slate was burnt toward the rear of the fireplace, as were adjacent stones in the south wall, which must have served as a fireback. Fireplace 32 was set against the cross-wall 31, also further to the west than a central position. Trench 6 uncovered only its western cheek so the full width of the fireplace is uncertain. At the base of the fireplace cheek was a large stone of pink granite.

Fig. 24 Wall footing 31 and fireplace 32 (foreground), looking south.

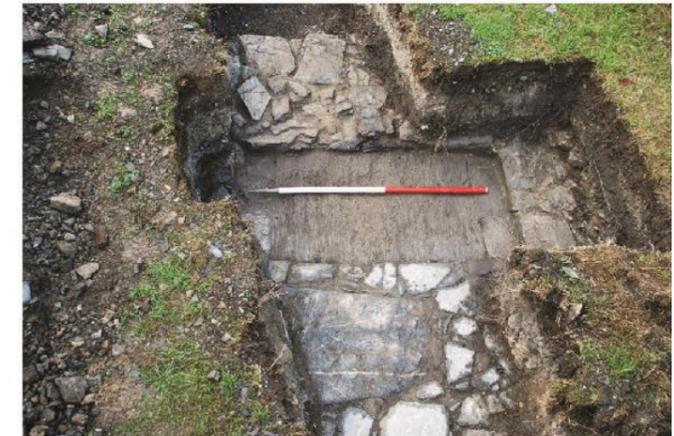
The inner edge of the stone was finely worked to a flat straight edge. The other faces of the stone were left roughly hewn apart from the bottom which was worked to a fairly flat surface so that it would sit firmly on the natural clay beneath. To the north of the fireplace and within the area which would have been occupied by its hearth, all contemporary floor surfaces had been robbed, such that late 19th-century demolition deposits of the house directly overlay natural clay (Fig. 4, section Trench 6, 52). There would almost certainly have been a stone floor like the one in the southern room, or perhaps a better quality flagstone floor. If the latter, then that might explain why the floor had been completely removed and the surviving floor left intact.

Fig. 26 Fireplace 24, looking south.
