Archaeological Historic Building Record
and Watching Brief
19 Mill Street
and Rear of 165 High Street,
PERTH
PE60

**ARCHAEOLOGICAL HISTORIC
BUILDING RECORD
AND WATCHING BRIEF,
19 MILL STREET AND REAR OF 165
HIGH STREET,
PERTH
PE60**

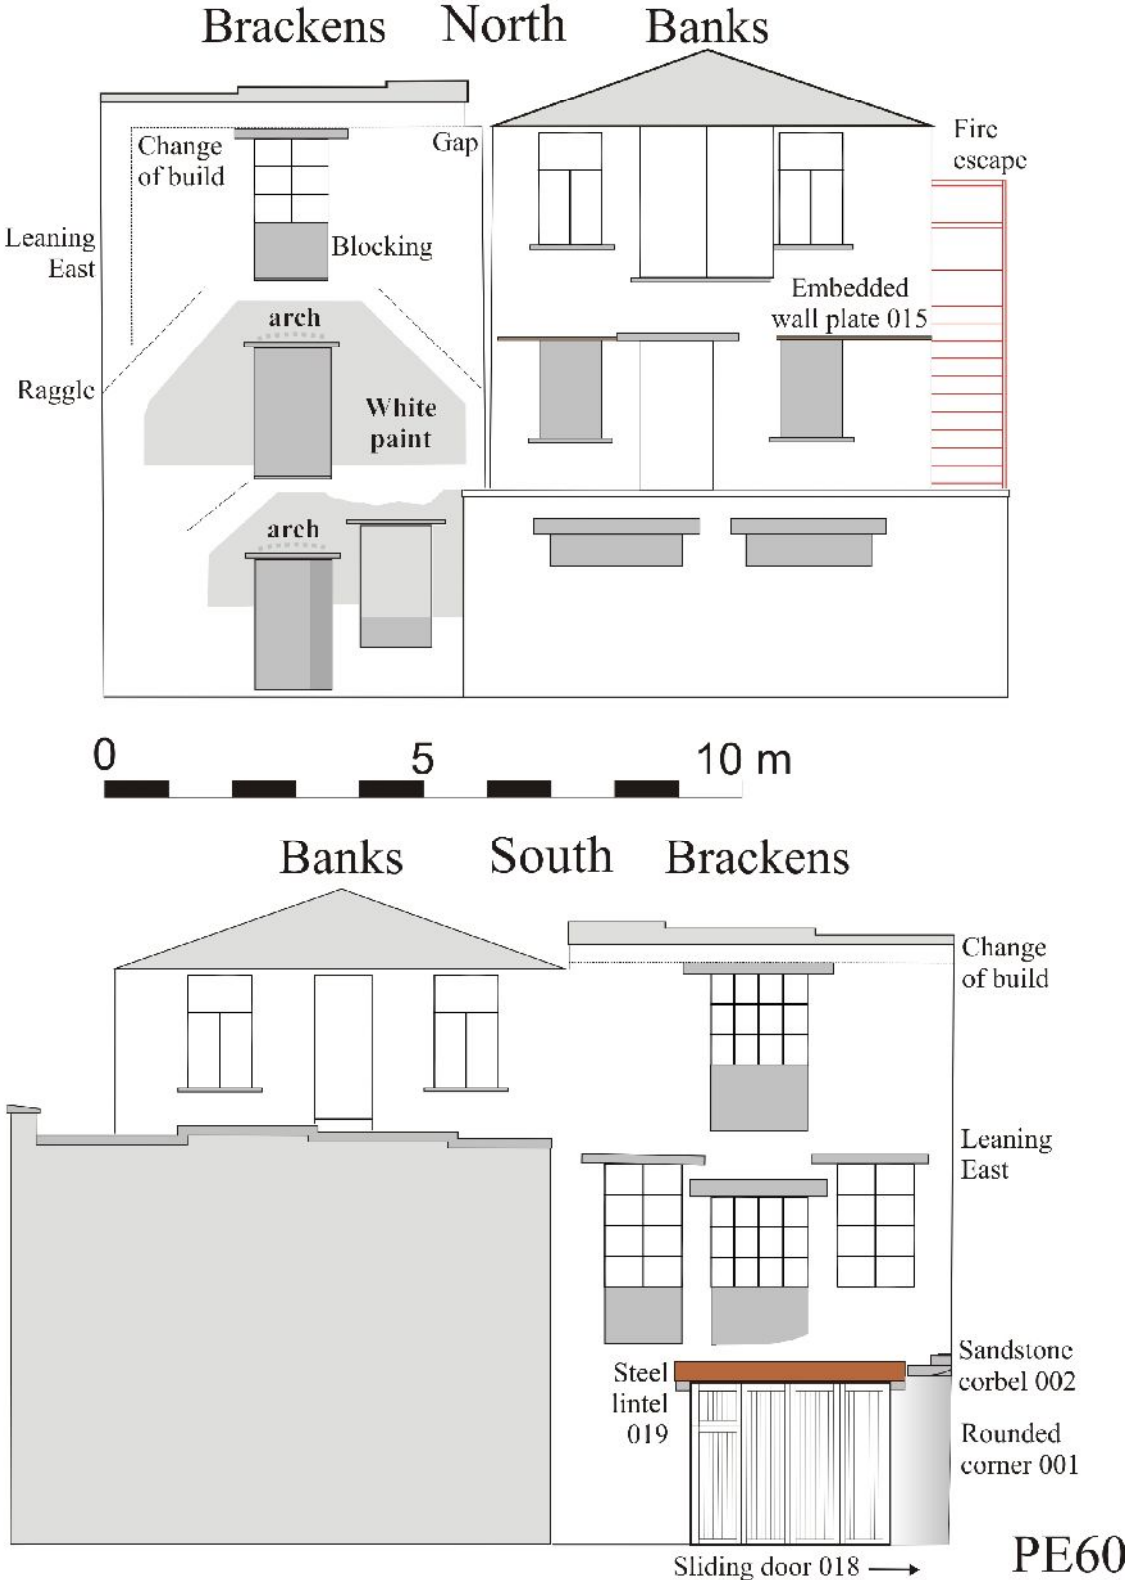
Illus 4

On the N elevation, there were several blocked doorways and windows. The central blocked windows on the ground and first floors had relieving arches above the lintels. There were also two patterns of raggles and white paint showing the positions of a single-storey and a two-storey annexe, with pitched roofs, both already demolished some time before 1983 (when the present writer first saw the building).

On the S elevation, there were central loading doors reduced to windows on the first and second floors. On the ground floor, a large vehicle entrance 018 had been inserted with a rolled steel lintel 019 made of two channel sections on edge, flanges inward to form a box section. The wooden horizontal sliding door was made of four hinged panels, sliding open eastwards round the SE corner. The westernmost panel was divided and hinged to form a pedestrian entrance opening inwards, without the need to slide the whole door open. On the ground floor, the SE corner had been built to a rounded shape 001 to improve vehicle access to the inner courtyard. This appears to be an original feature, and was built with specially shaped curved bricks. The transition to the square corner on the first and second floors was made by a sandstone corbel 002 in two parts.

19 Mill Street, Perth. North and South Elevations

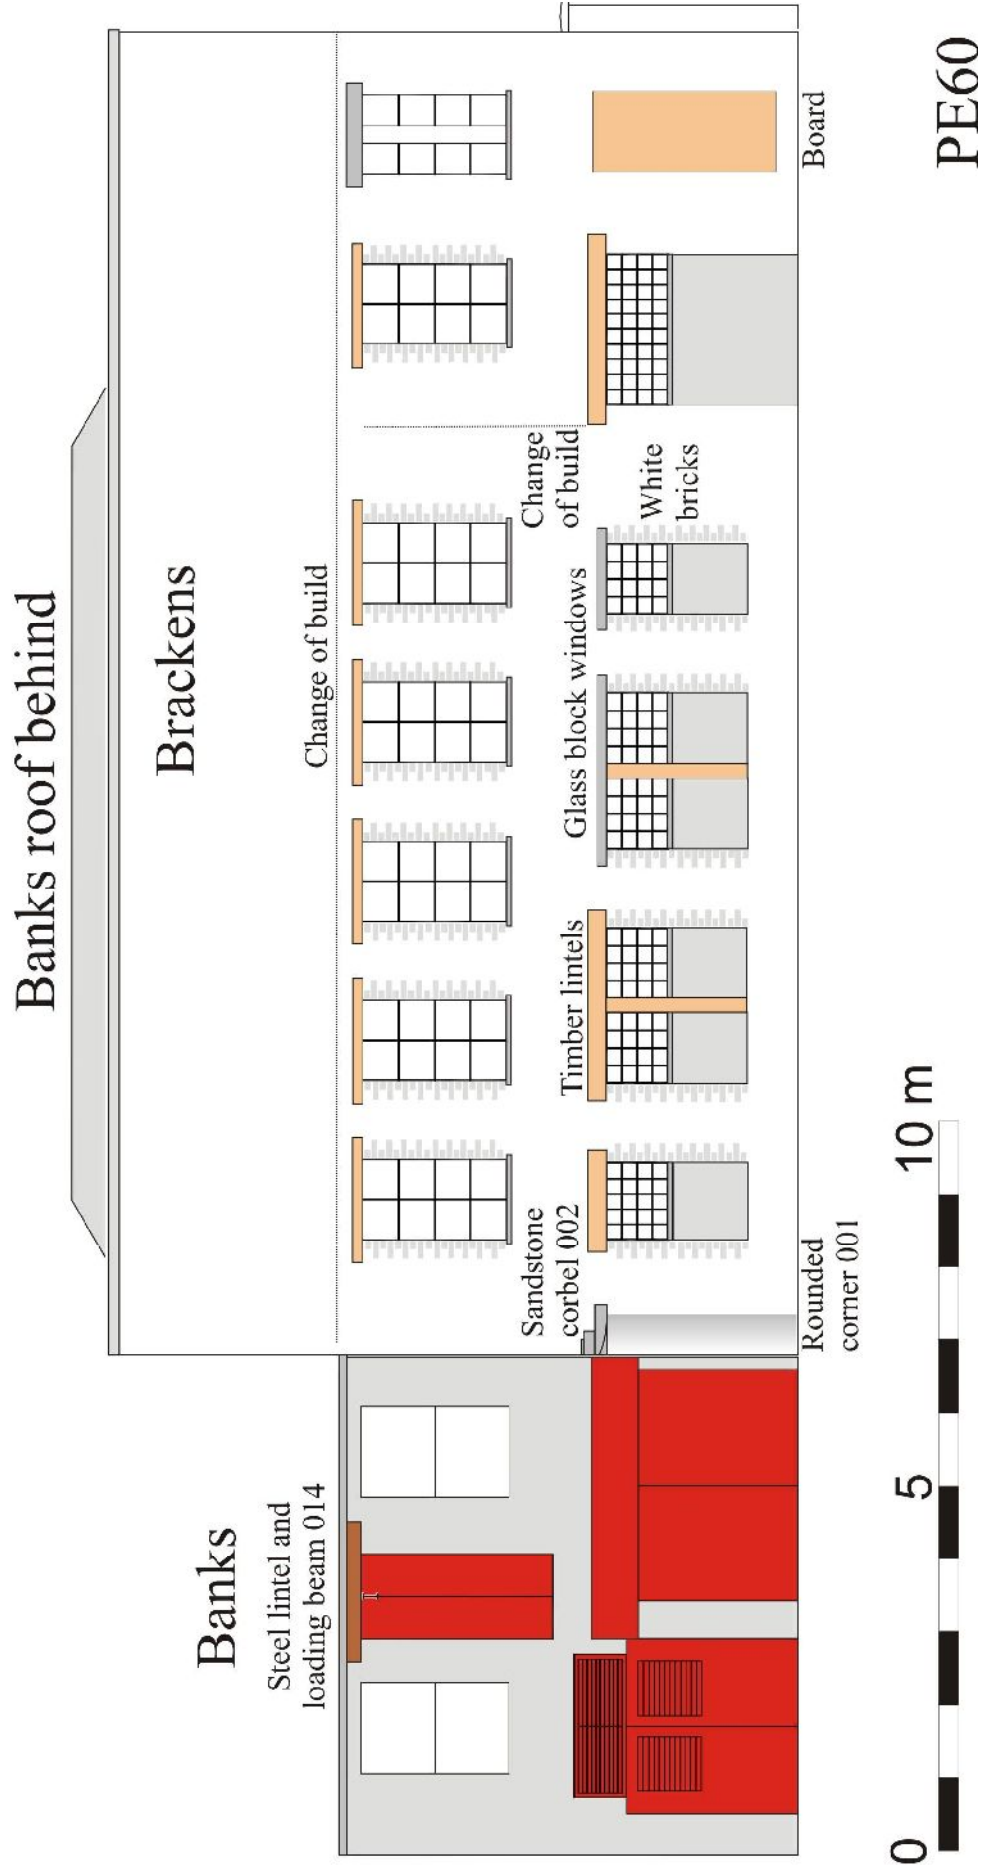
Illus 5

On the E elevation at ground-floor level there were large windows, partly reduced in brick and partly filled with glass blocks, to present a vandal-proof face to the lane on the E side of the building. Most of the windows on the ground and second floors were surrounded by white bricks, probably to improve the reflection of light to the interior. The W wall of the upper storey was blank.

19 Mill Street, Perth.
East Elevation

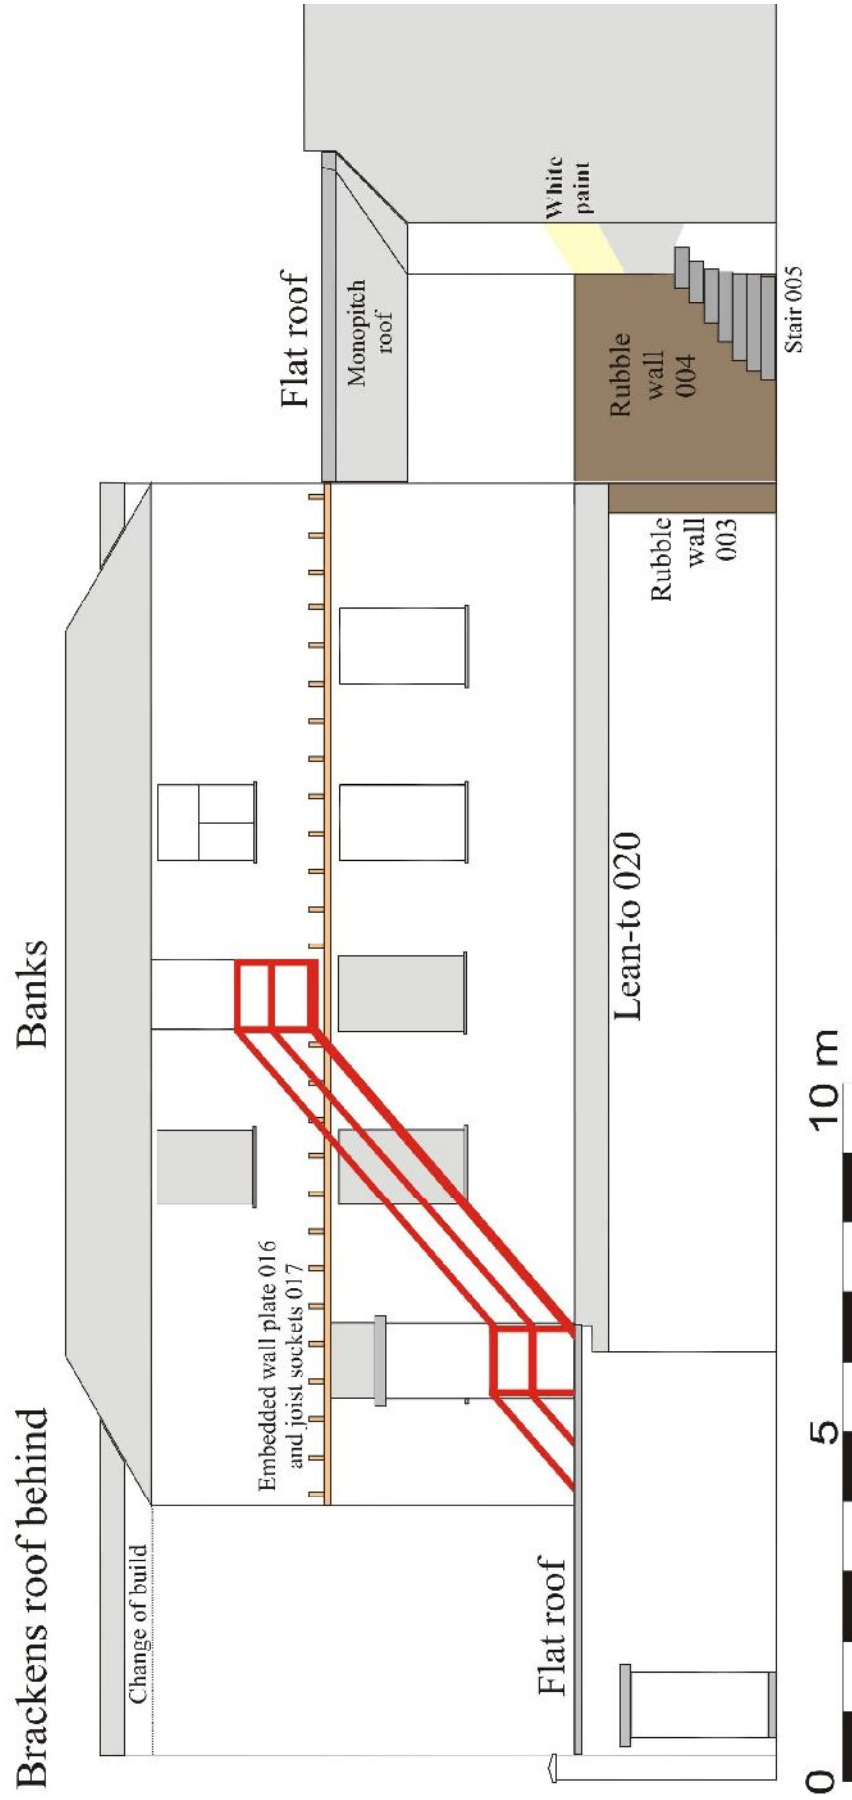
Illus 6

19 Mill Street, Perth.
West Elevation

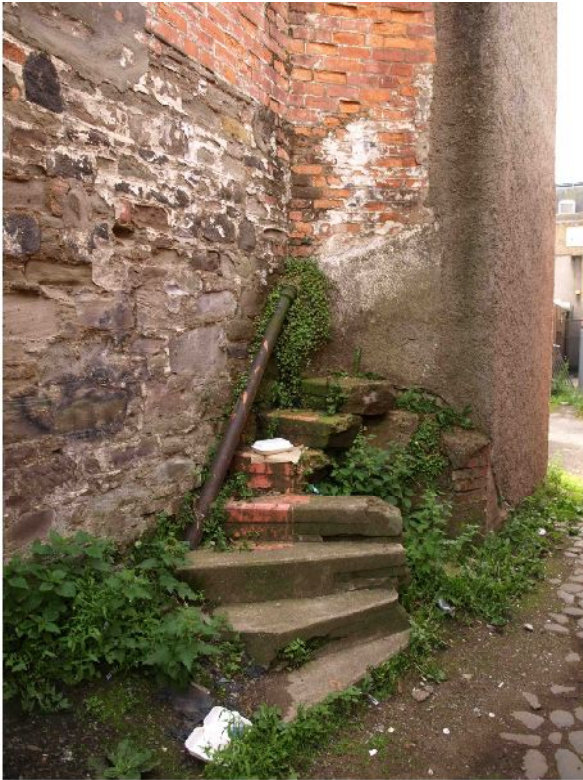
To the S was a two-storey annexe with a mostly flat timber roof. Part of this annexe was actually earlier than the rest of the building. On the W side, externally, was an inset bay with sandstone and whin rubble walls 003 and 004 and the base 005 of a sandstone turnpike stair. These features were of 19th or perhaps 18th-century appearance. Internally, in the same location, at the W end of the S room of the annexe, there was a cast-iron fireplace 009 of 19th-century appearance set against a brick chimney.

Illus 7 W side of Banks.
Stair 005 and rubble wall 004.

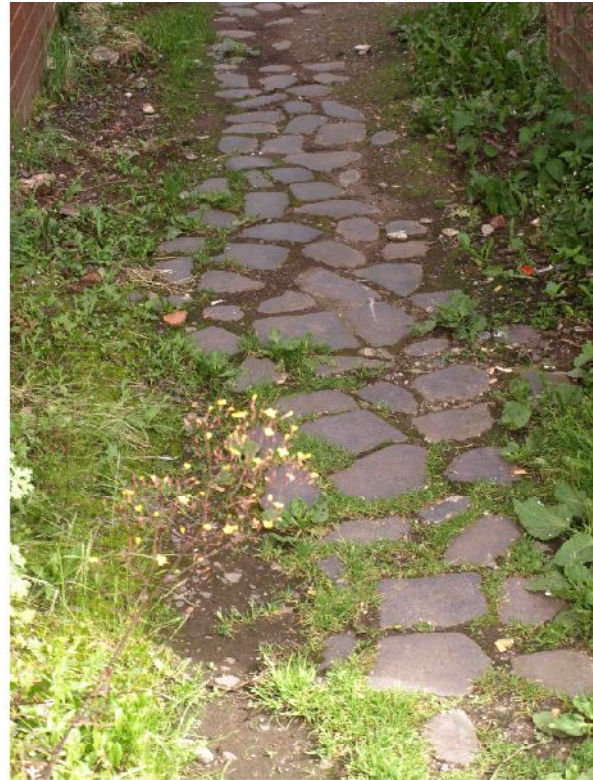
On the W side of the building was a disused footpath or vennel, paved with irregular, very dark whinstone blocks. These may have been whin setts re-used and laid flat on their sides.

Also of interest were rectangular whin or granite cassie setts, observed in the SW outer corner of the Banks building footprint. These cassies were also visible prior to the demolition and appear to have been contemporary with a turnpike stair 005 formerly located on the W side of the building near the SW corner which predated the construction of Banks but had been incorporated within the Banks building. Cassies could also be observed near the entrance of the site below the worn tarmac.

Illus 8 Whin setts on W side of Banks.

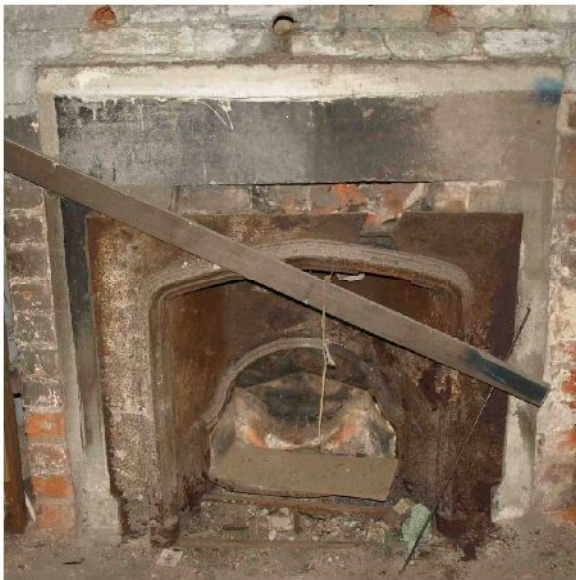
Illus 9 Banks, interior.
Cast-iron fireplace 009.

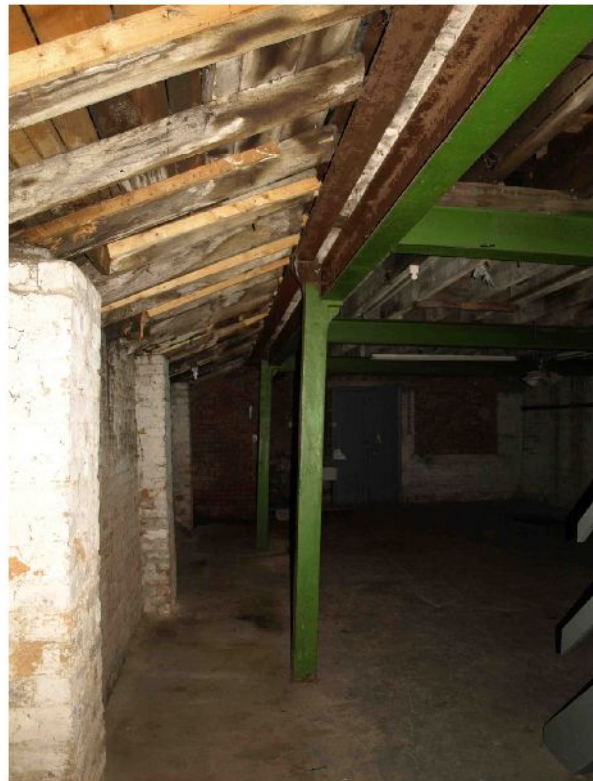
A very curious feature was that on the ground floor of the central block, the entire W wall had been removed at ground level and supported on a structure of rolled steel joists 010 and square-section cast-iron columns 011, all painted green, and of mid-20th century appearance. The effect of this was to join up the ground floor with the lean-to structure 020 to the W. The external W wall of the lean-to extension was reinforced with internal buttresses, but was very flimsy, leaning and bowing markedly to the W. It is very surprising that such a difficult and expensive piece of engineering work was undertaken merely to gain an extra metre or two of width on the ground floor.

Illus 9 Banks interior. Green-painted cast-iron columns 011, rolled steel joists 010, replace W wall. Lean-to roof on W.

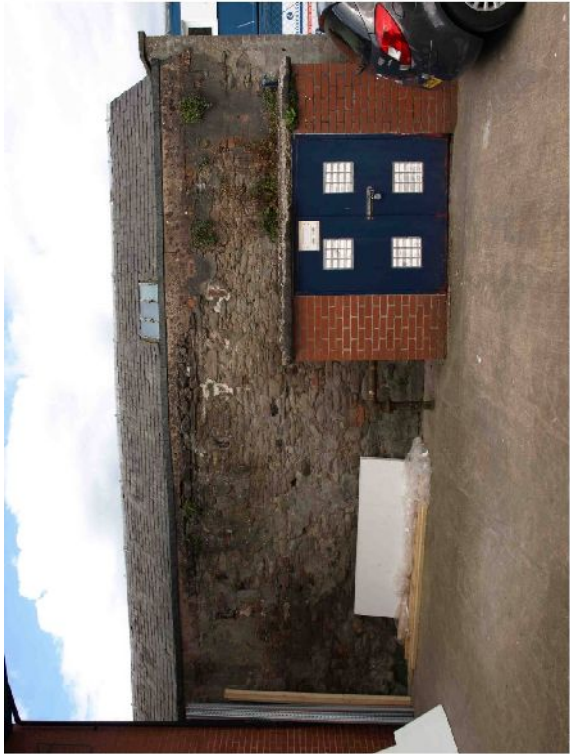
Directly to the east was boundary wall 007, built of small green sandstone random rubble. This was structurally separate from the building, and was likely to be much older. Before the addition of the concrete brick skin, it probably formed the E side of the building, but was latterly mostly masked by an internal brick wall, except at the N end, where it was still visible. On its external, E face, there is a line of putlog holes where the roof timbers of a lean-to structure were once inserted. After the demolition of the building, the W side of wall 007 was exposed for its full length of 25.07m. It was 2.95-3.10m in height, 0.35m in thickness and topped with modern bricks. Against the wall's W face were piers of ashlar blocks (each block measured 0.50 x 0.35m and 0.33m in height), which had previously divided the building into 10 bays, probably for stabling, each roughly 2.50m wide. For recording purposes the bays were numbered 1-10 and measured from the N end of the site.

Illus 12 Watsons. E face of wall 007, with putlog holes for lean-to roof.

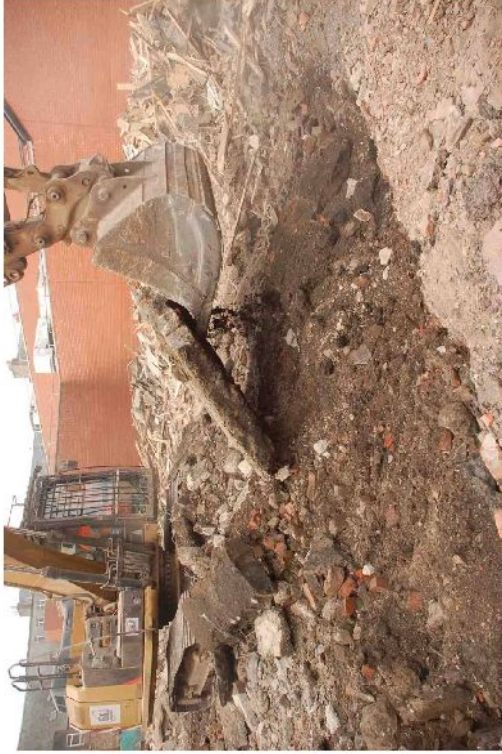
Illus 14 Concrete stripping in progress, Banks and Brackens.

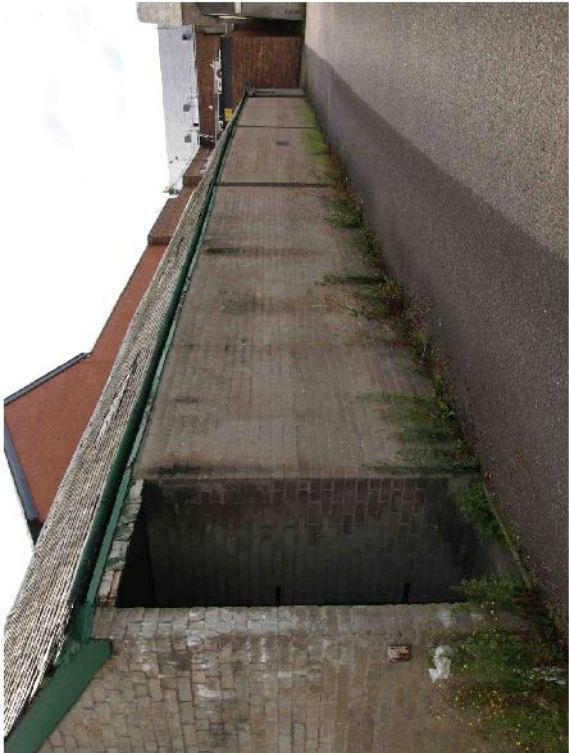
Illus 11 Watsons, view SE.

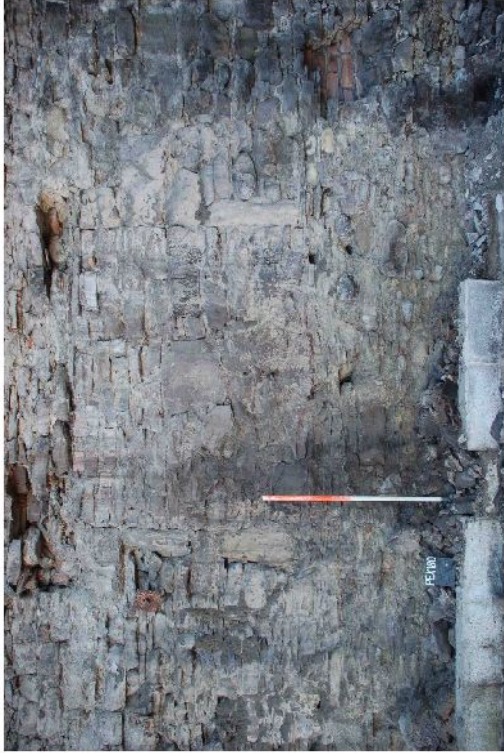
Several blocked windows (ctxs 027, 030 and 032) were visible, some with traces of timber lintels above (ctx 026), and also iron bolts and washers (ctx 031) where structures had been attached one side of the wall or another. Wall 007 was very unstable and fragile, bonded with mid brown friable mortar, and was demolished after recording (see Appendix 1 Contexts Register for details of features in this wall).

Illus 13 Watsons. W face of Wall 007. Blocked opening 032, with imprint of timber lintel above and iron bolt and washer 031.
