Archaeological Watching Brief  
West Mains of Huntingtower  
Perth  
HR02

*The watching brief took place on 16<sup>th</sup> March 2020, and was commissioned by Scottish and Southern Electricity Networks.*

Scottish and Southern Electricity Networks commissioned Alder Archaeology to undertake an archaeological watching brief on the replacement of a faulty 11 Kv underground power line at West Mains of Huntingtower, on the western outskirts of Perth. The work area is within a Scheduled Monument SM3630, including Roman and Prehistoric crop mark features, and is centred on NGR NO 0734 2485.

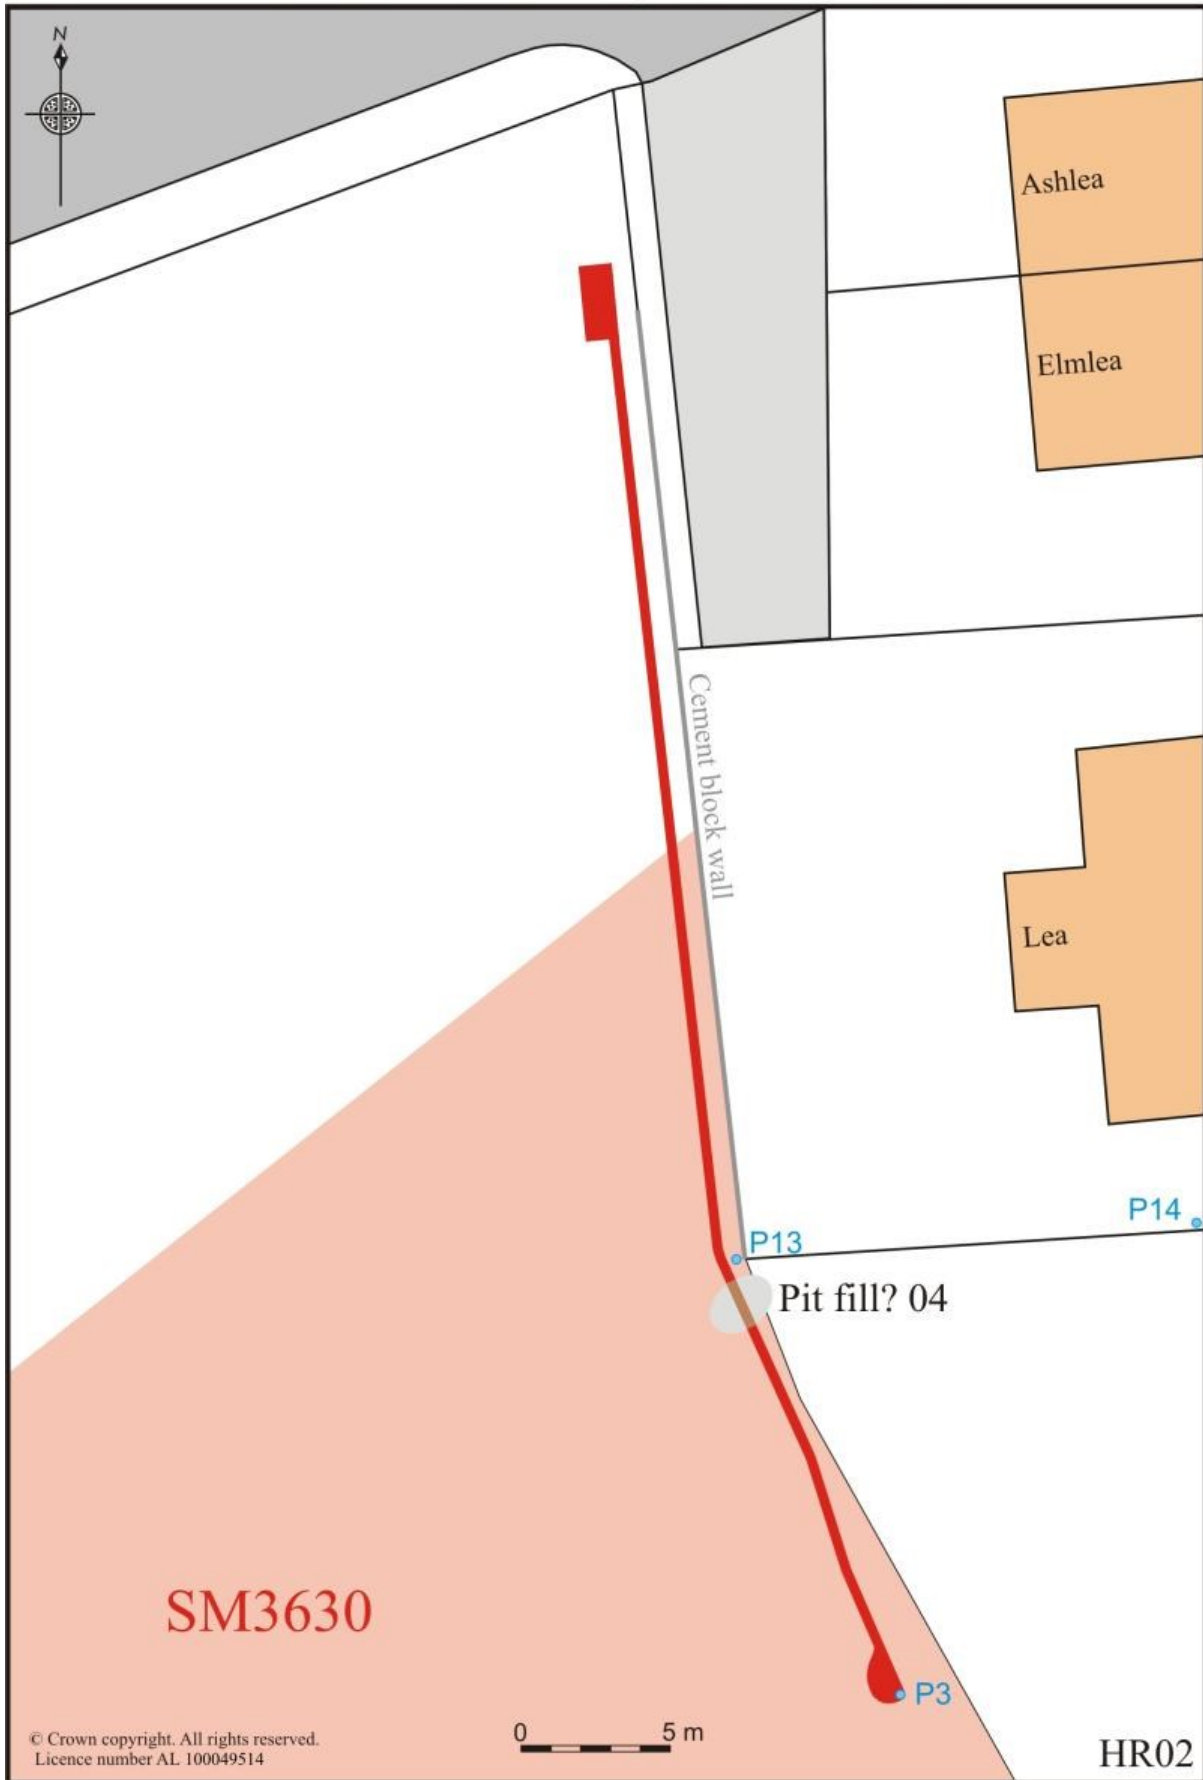
Illus 3 West Mains of Huntingtower, Trench Plan

Under these layers was the failed electricity supply cable. When this was removed, clean yellow natural gravel 03 became visible in the trench base, about 1 m down. This gravel was interrupted by a stretch of fine brown silty loam 04, appearing 2.3 m S of the bend in the E boundary, and continuing N for about 1.8 m. Natural gravel (numbered 05) then resumed, at 0.5 m S of the bend, and continued uninterrupted, all the way to the N end of the cable trench.

The new cable was manually laid in the bottom of the old trench, and marked with yellow tape prior to backfilling. The pit at the N end was left open to give access so that the old and new cables could be cut to length and connected together, after completion of necessary safety checks and documentation. No further excavation was required, so the watching brief was ended at this point.

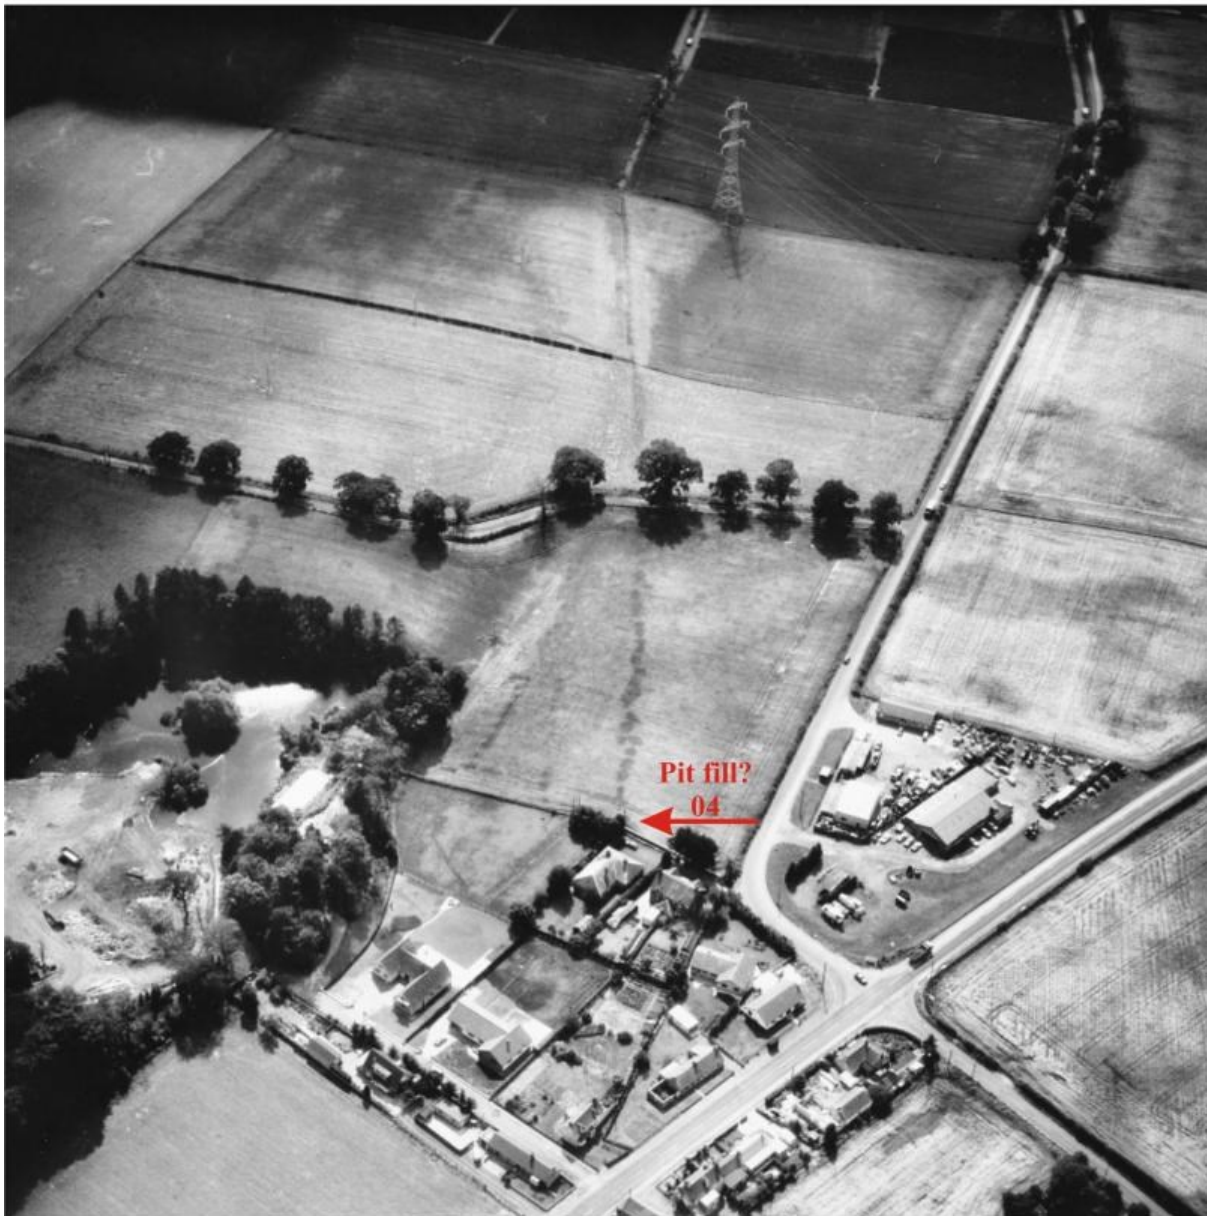
Illus 4 West Mains of Huntingtower, Aerial Photograph looking WSW

Presumed Roman pit alignments. Location of pit fill? 04 hidden by trees.  
Historic Environment Scotland Aerial Photograph Collection SC0170623

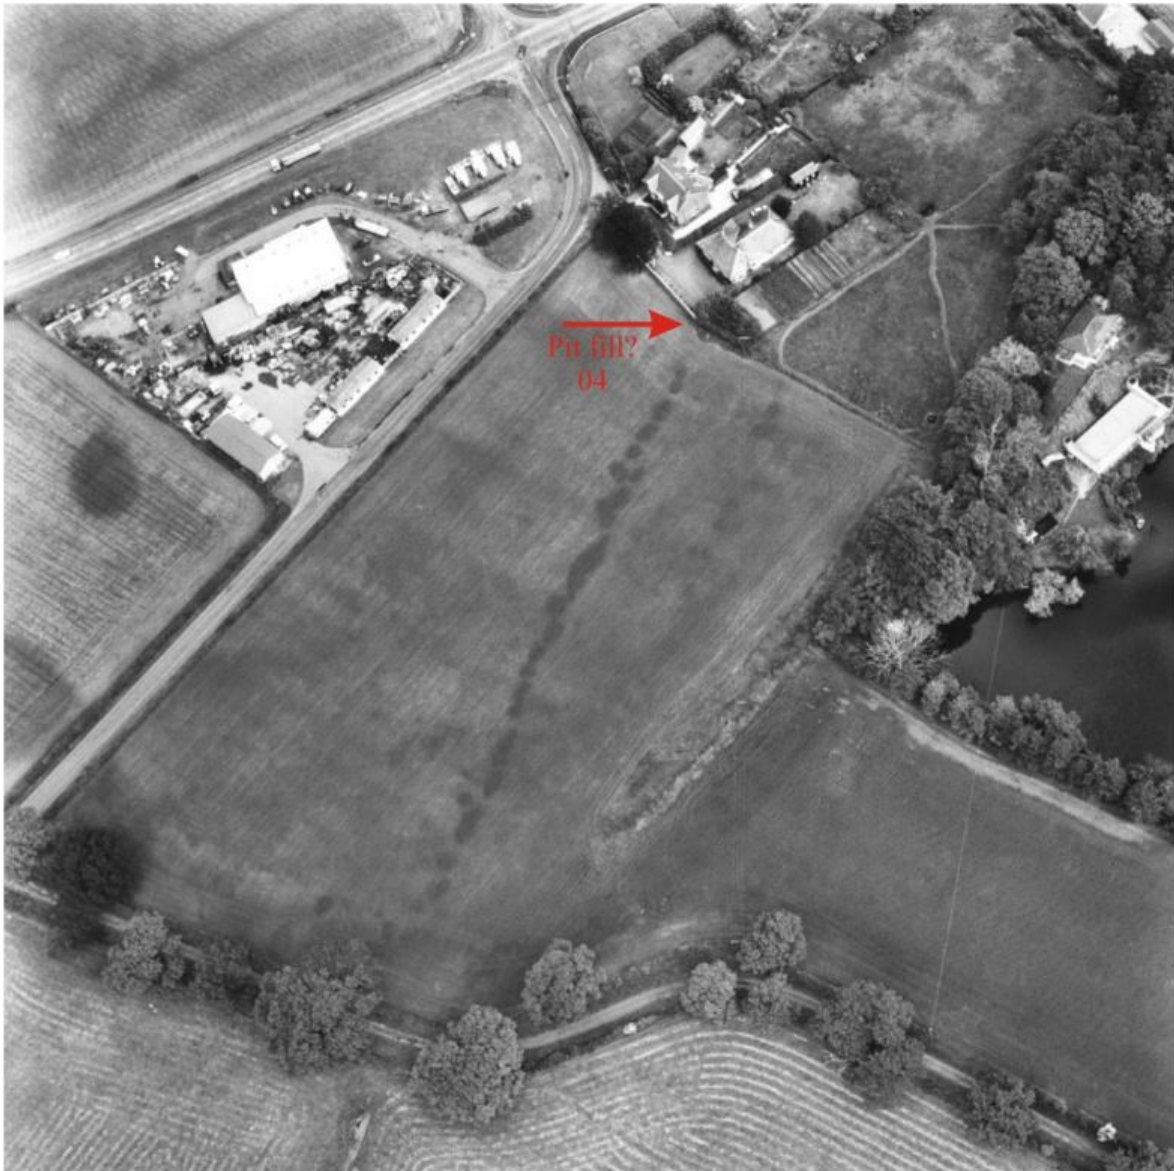
**Illus 5 West Mains of Huntingtower, Aerial Photograph looking ENE**

Presumed Roman pit alignments. Location of pit fill? 04 obscured by mud or vegetation.  
Historic Environment Scotland Aerial Photograph Collection SC0170736

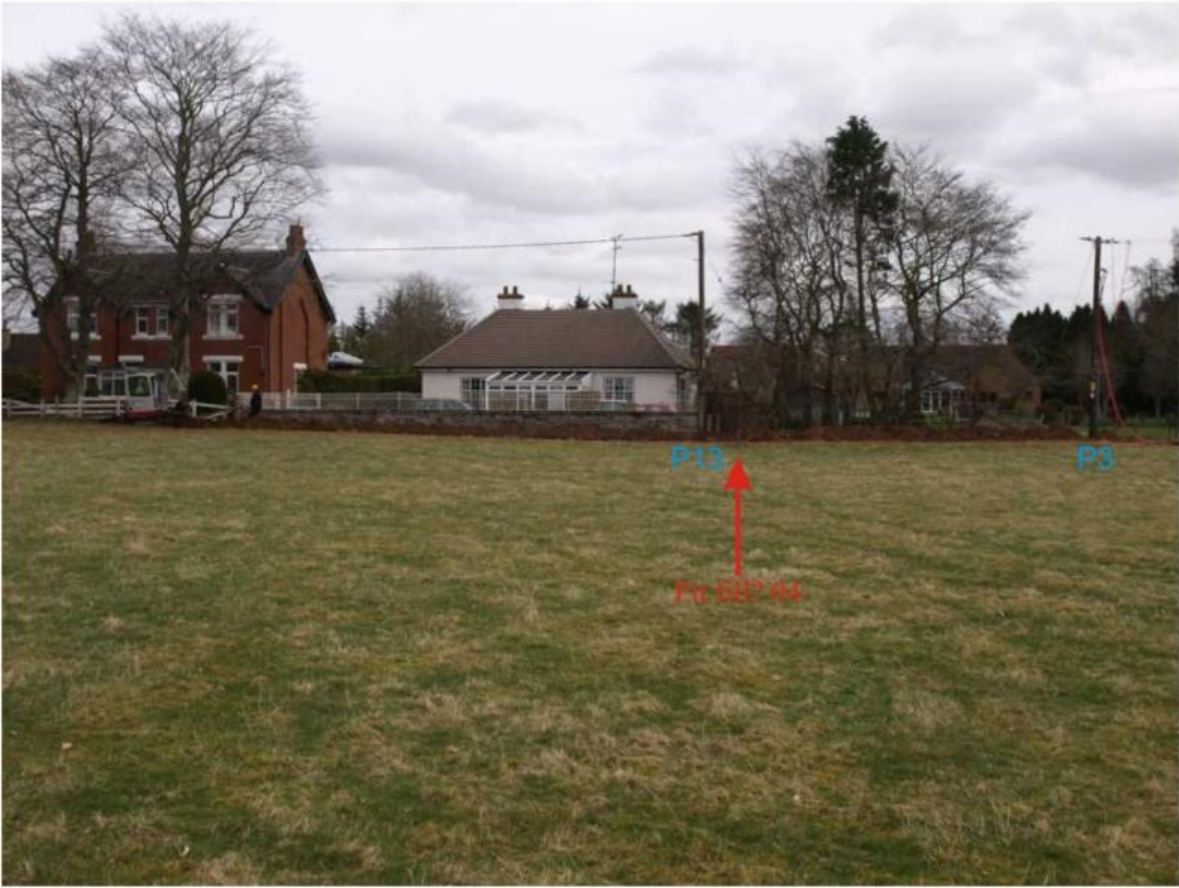
The silty loam 04 was very obviously the fill of a feature cut into the natural gravel 03 and 05, about 1.8 m across N – S. Comparison with aerial photographs shows that it lines up well with the presumed Roman gravel-pits along the N edge of the Roman road, and may be identical with an uncertain smudge at the very E end of the pit alignment, in the shadow of the hedgerow and partly masked by surface changes in vegetation and soil.

6 General view E. Location of ?pit fill 04.

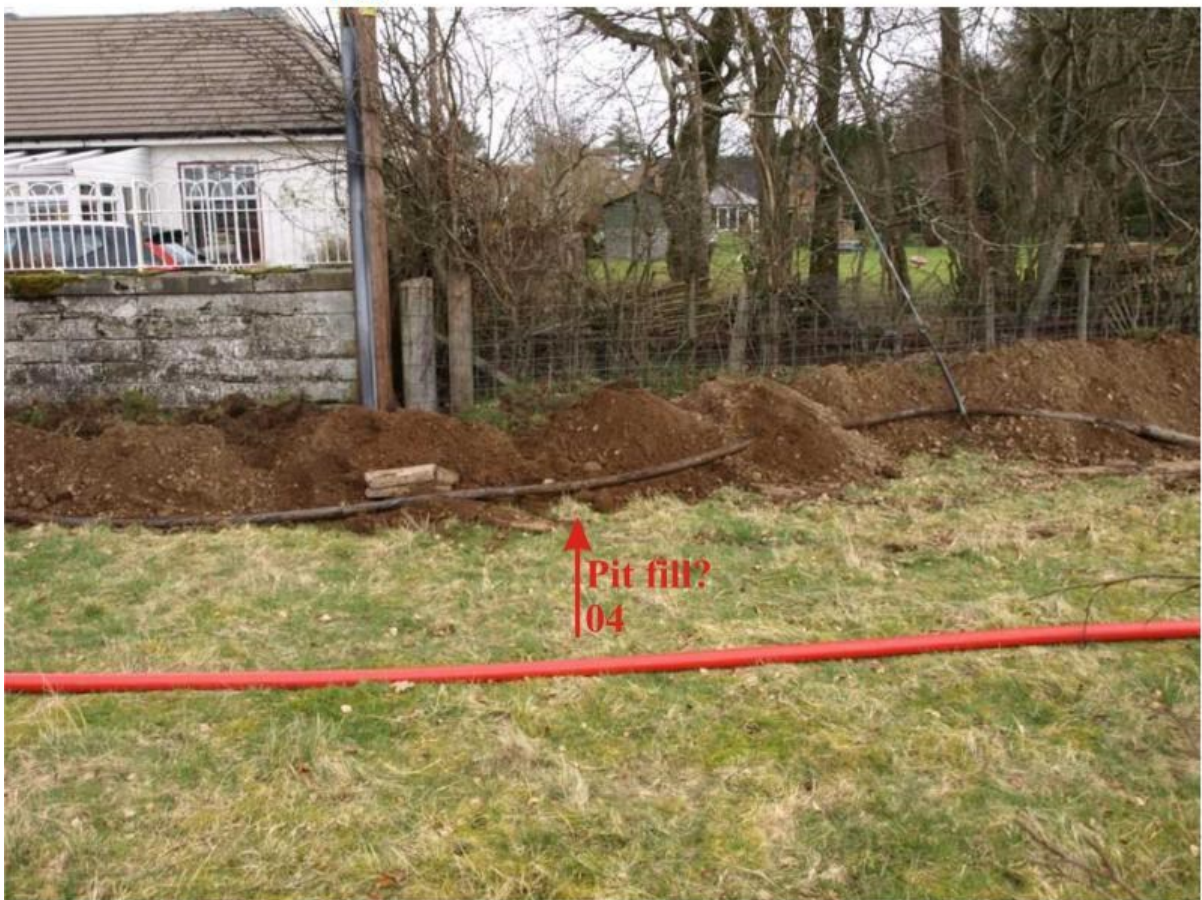
These changes were measured in on the trench bottom, and photographed with difficulty, but can also be clearly seen in photographs of the spoil heap along the W side of the trench. The change in the colour and texture of the upcast material is quite

obvious. Only the top surface of the loam 04 was cleaned off as the trench was bottomed. Although this area was watched closely and the spoil heap carefully examined, no artefacts were seen.

9 Detail, E. Brown pit fill 04 visible in upcast, compared with gravel on either side.
