**A1 DISHFORTH TO
NORTH OF LEEMING IMPROVEMENTS
CULTURAL HERITAGE
INITIAL ASSESSMENT OF THE BUILT HERITAGE**

Date	Originator	Checked	Approved	Status
January 1995	S Haigh (AWP)	E Dennison (AWP)	G Barton (AWP)	Final

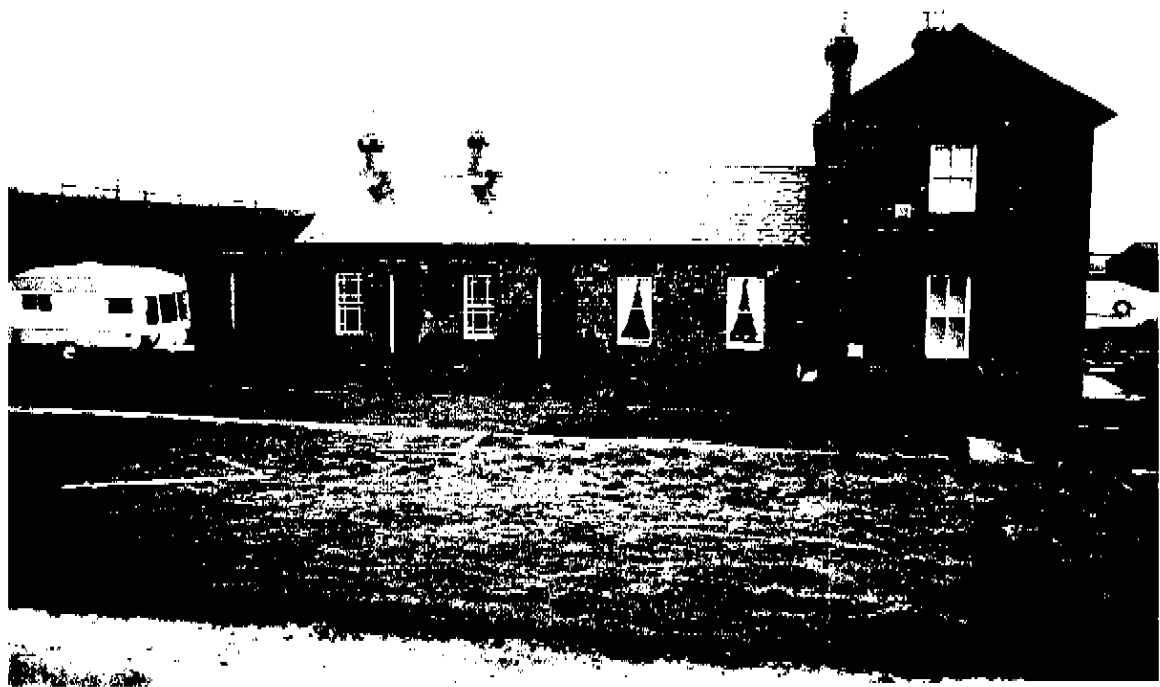
- 3.1.3 The remaining buildings are of architectural and historic interest because of their relatively intact condition; there appears to have been little external alteration since the railway closed. There have also been relatively few internal changes, the most obvious of which is perhaps the extension of residential accommodation into the former administrative buildings.

- 3.1.21 The buildings at Sinderby Station clearly represent the remains of the mid 19th century railway station, and to a lesser extent the coal depot. They have survived closure since 1962 and the subsequent removal of the railway, and remain largely intact.

Plate 1: Site 3/15 Sinderby Station from the east.

- 5.2 The initial assessment indicates that a number of the buildings in this complex are of some architectural and historic interest. Their significance can be confirmed as being of district importance. While they are not of sufficient quality and importance to merit physical preservation, it is recommended that all the buildings in the complex are subject to more detailed architectural recording and historical research, prior to demolition.

- 5.3 It is envisaged that the recording work would involve the production of measured ground floor plans of the three buildings, together with elevation drawings of the main station buildings and the house. A detailed photographic record would also be produced to complement the architectural description. Further documentary research is also recommended, which might bring to light otherwise unknown details of the complex to complement the architectural recording.

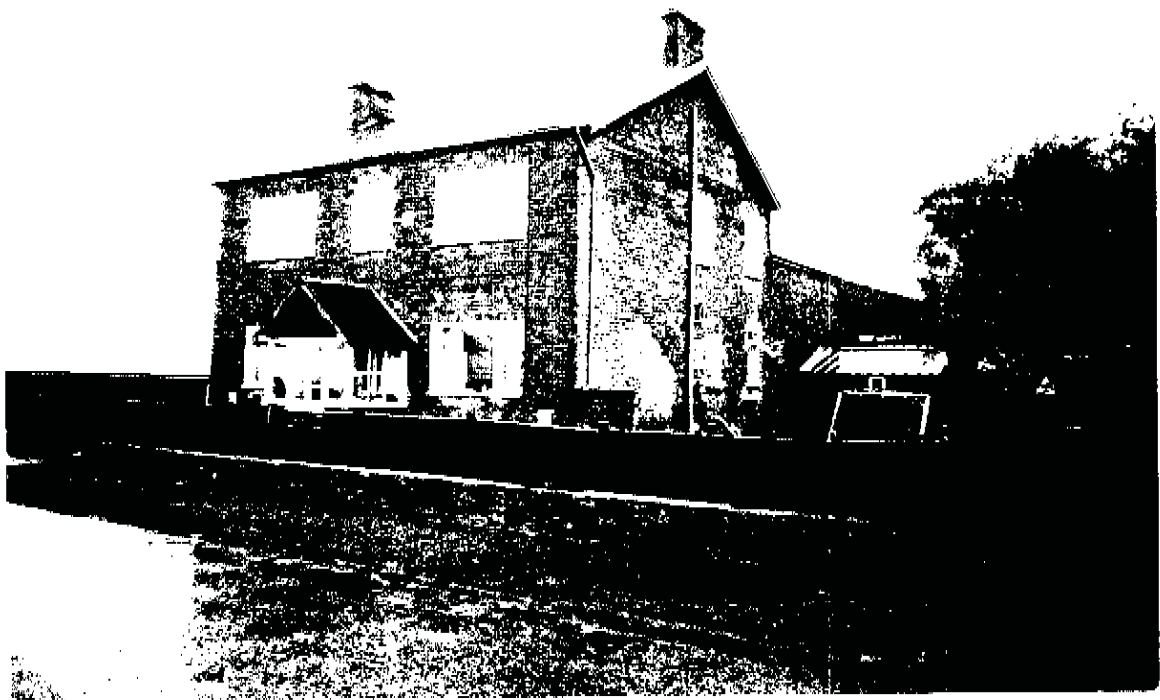
Plate 2: Site 3/23 Roxby House from the east.

- 5.5 The initial assessment indicates that a number of buildings in this complex are of some architectural and historic interest. As a whole, the significance of the group can be confirmed as being of district importance. While they are not of sufficient quality and importance to merit physical preservation, it is recommended that the buildings are subject to more detailed architectural recording, prior to demolition.

- 5.6 At this stage, it is envisaged that this work would involve the production of measured ground plans of the house and the historic elements of the agricultural buildings. Elevation drawings of the latter only would also be carried out. Additionally, drawn records of further significant details, including any re-used roof timbers, would be made as required, together with a detailed photographic record of the complex. Further documentary research is also recommended, which might bring to light otherwise unknown details of the complex to complement the architectural recording.

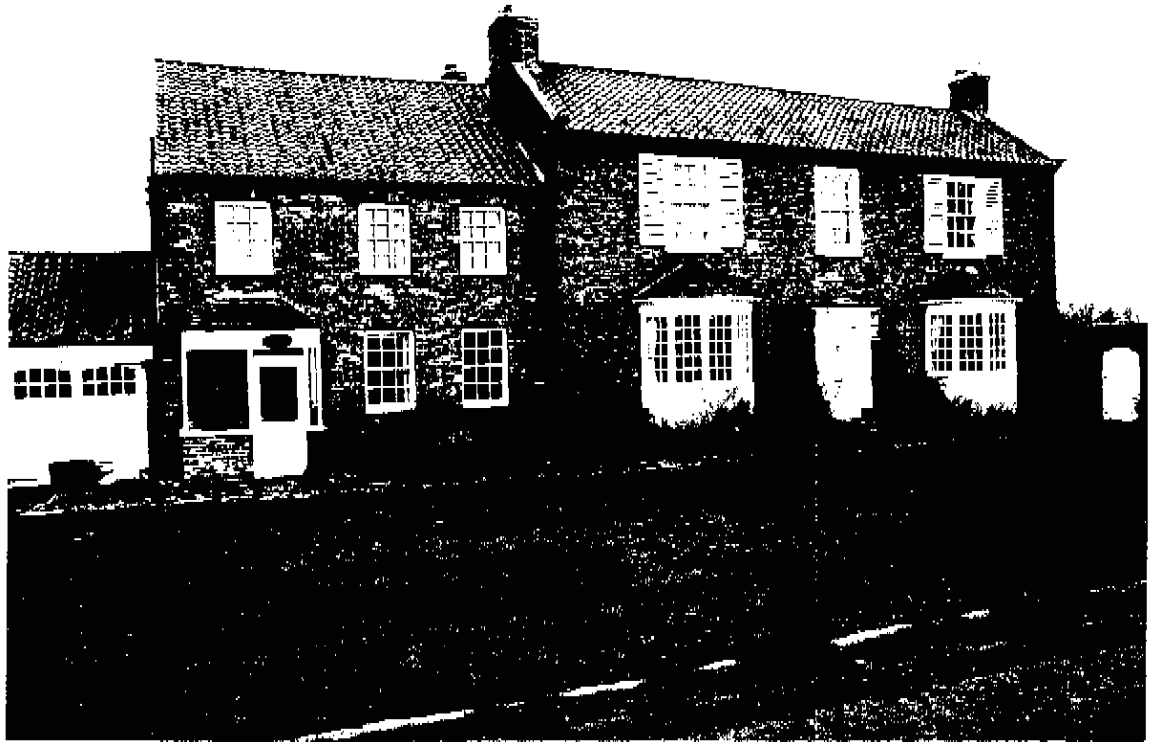
- 3.3.2 As its name suggests, Georgian House almost certainly dates from the mid 18th century and is a medium-sized house of some quality. It is of double depth with a central stairhall plan, with a symmetrical facade to the west. It is believed that this was once used as a coaching inn (M Trehwitt, pers comm), and on Tuke's 1787 map of Yorkshire, the 1839 Burneston tithe map and the OS 1856 6" map (sheet 86), it is named as "New Inn". Until the issue of the revised List of Buildings of Special Architectural or Historic Interest on 30.08.88, this building was listed as Grade 3. It was unoccupied at the time of the assessment.

Plate 3: Site 4/07 New Inn Farmhouse and Georgian House from the west.

- 5.9 The initial assessment indicates that a number of the buildings in this complex are of some architectural and historic interest. Their significance can be confirmed as being of district importance. While they are not of sufficient quality and importance to merit physical preservation, it is recommended that seven buildings in the complex are subject to more detailed architectural recording, prior to demolition.

- 5.10 At this stage, it is envisaged that, for the six agricultural buildings in this complex, this recording work would involve the production of measured ground floor plans. External elevation drawings would also be produced of the threshing barn, stable block and cowshed. Section drawings of these three buildings, together with records of any further significant details would be carried out as required. A detailed photographic record would also complement the architectural description. Further documentary research is also recommended, which might bring to light otherwise unknown details of the complex to complement the architectural recording.

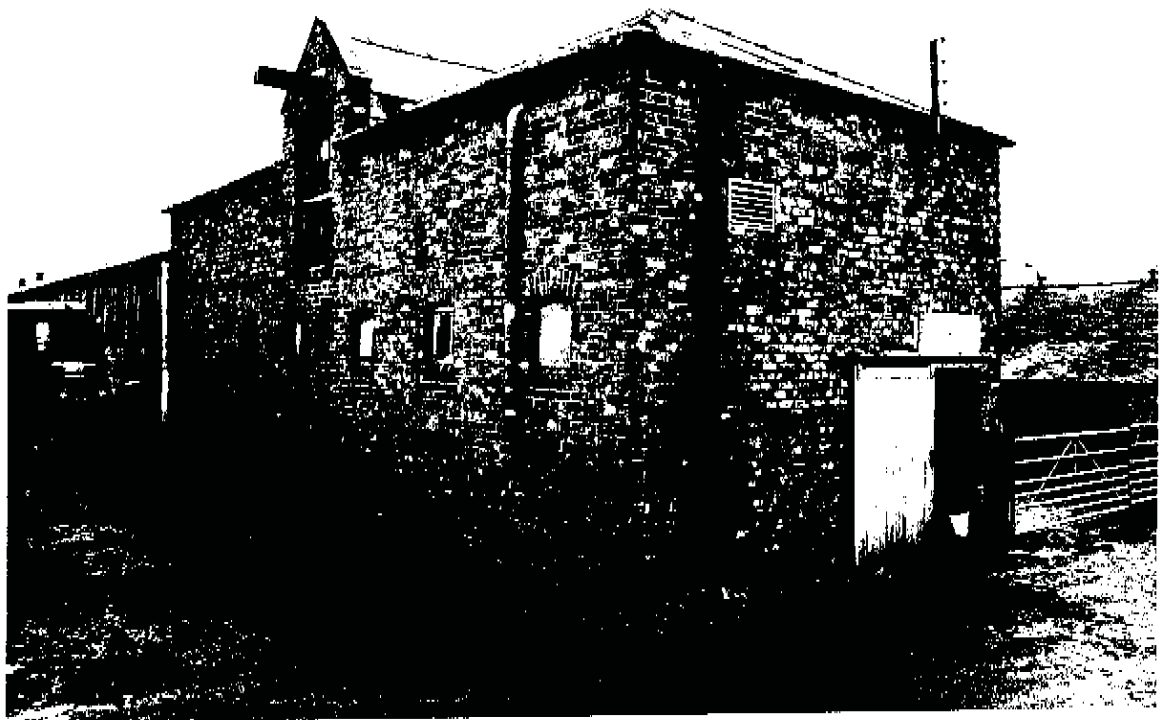
Plate 4: Site 4/07 Former stable block (building "D") at New Inn Farm, from the south.

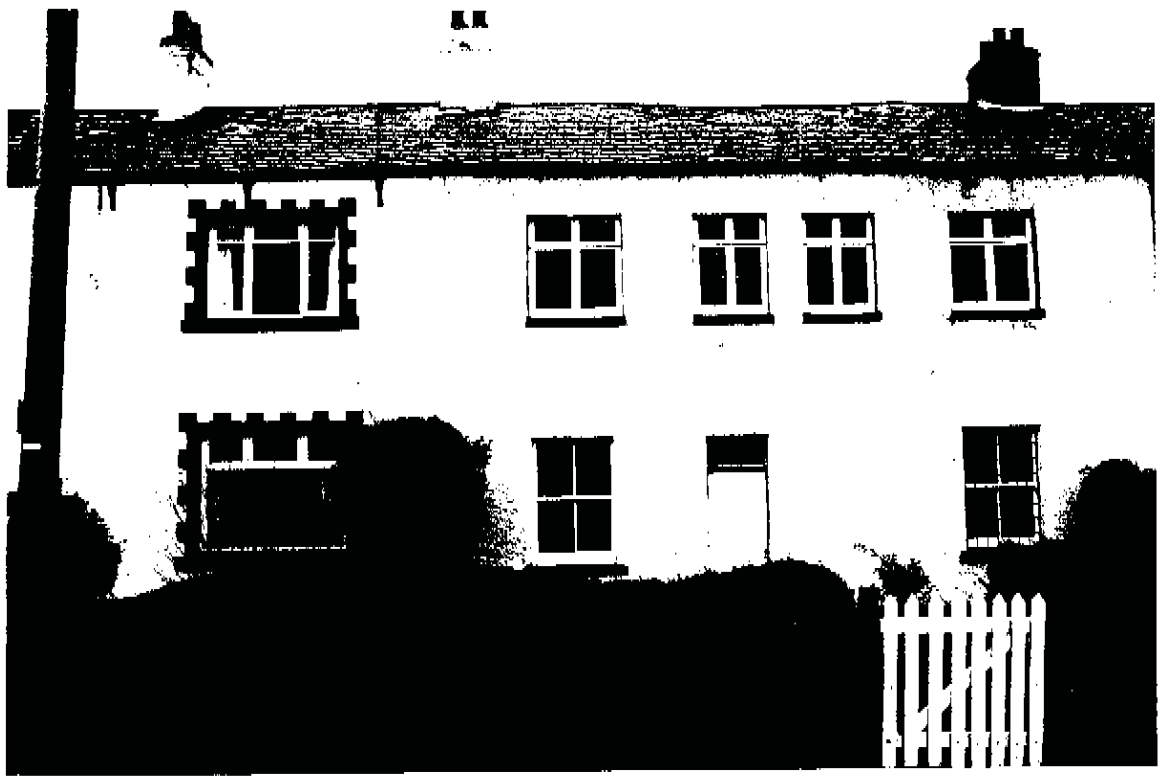
- 3.4.7 The original layout of the ground floor of the cottages within the terrace appears to have included a continuous dividing wall running the length of the terrace, located approximately two thirds of the way into the building; to the rear of this was a space utilised for kitchens and containing the stairs to the first floor. No features of interest were noted in those front rooms that were inspected, which have all had the fireplaces removed or blocked. There is no cellar.

Plate 5: Site 4/08 Hope Town Terrace (central part) from the west.

- 5.14 The assessment of this complex carried out to date indicates that it is of some architectural and historic interest; this significance can be confirmed as being of district importance. While it is not of sufficient quality and importance to merit physical preservation, it is recommended that the terrace is subject to more detailed architectural recording, prior to demolition.

- 5.15 At this stage, it is envisaged that this work would involve the production of measured ground and first floor plans and an elevation drawing of the west wall. One or more section drawings across the terrace, possibly showing the roof structure, and drawn records of any further significant details would be carried out as required and as access permits. Detailed drawings of a number of fittings including door furniture would also be made, as well as a detailed photographic record. It should be noted that those elements of the complex which have not been assessed due to access restrictions may contain features of greater significance, requiring more intensive recording.

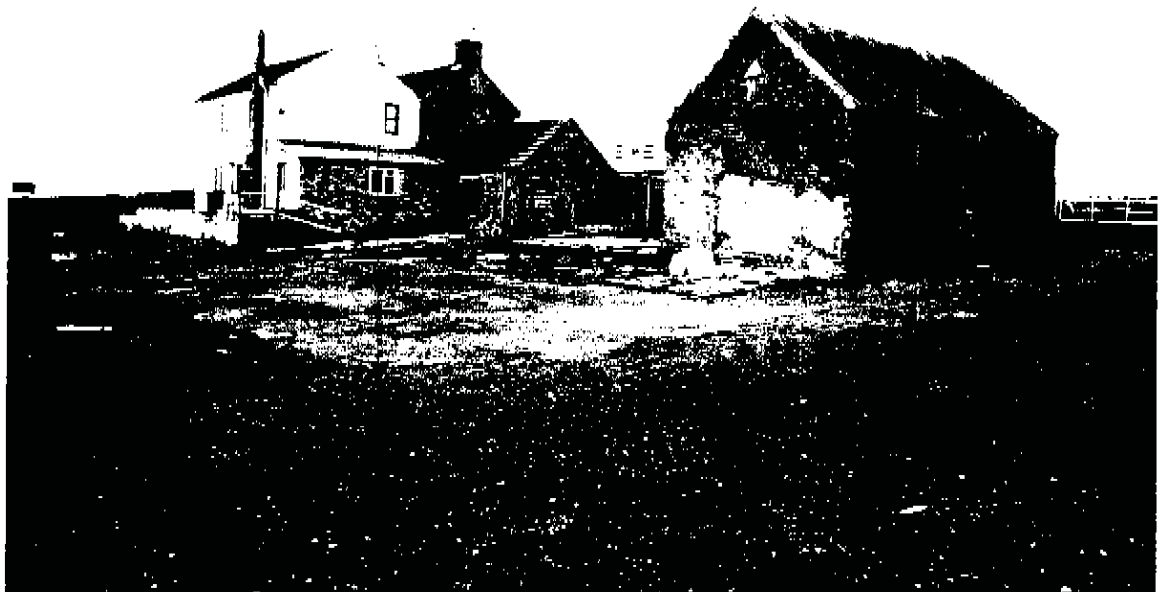
Plate 6: Site 4/20 Street House and outbuildings from the north.

- 5.19 It is recommended that limited recording is carried out, being confined to the production of ground floor plans of the house and outbuildings, and further photographic recording. Further documentary research is also recommended, which might bring to light otherwise unknown details of the complex to complement the architectural recording.

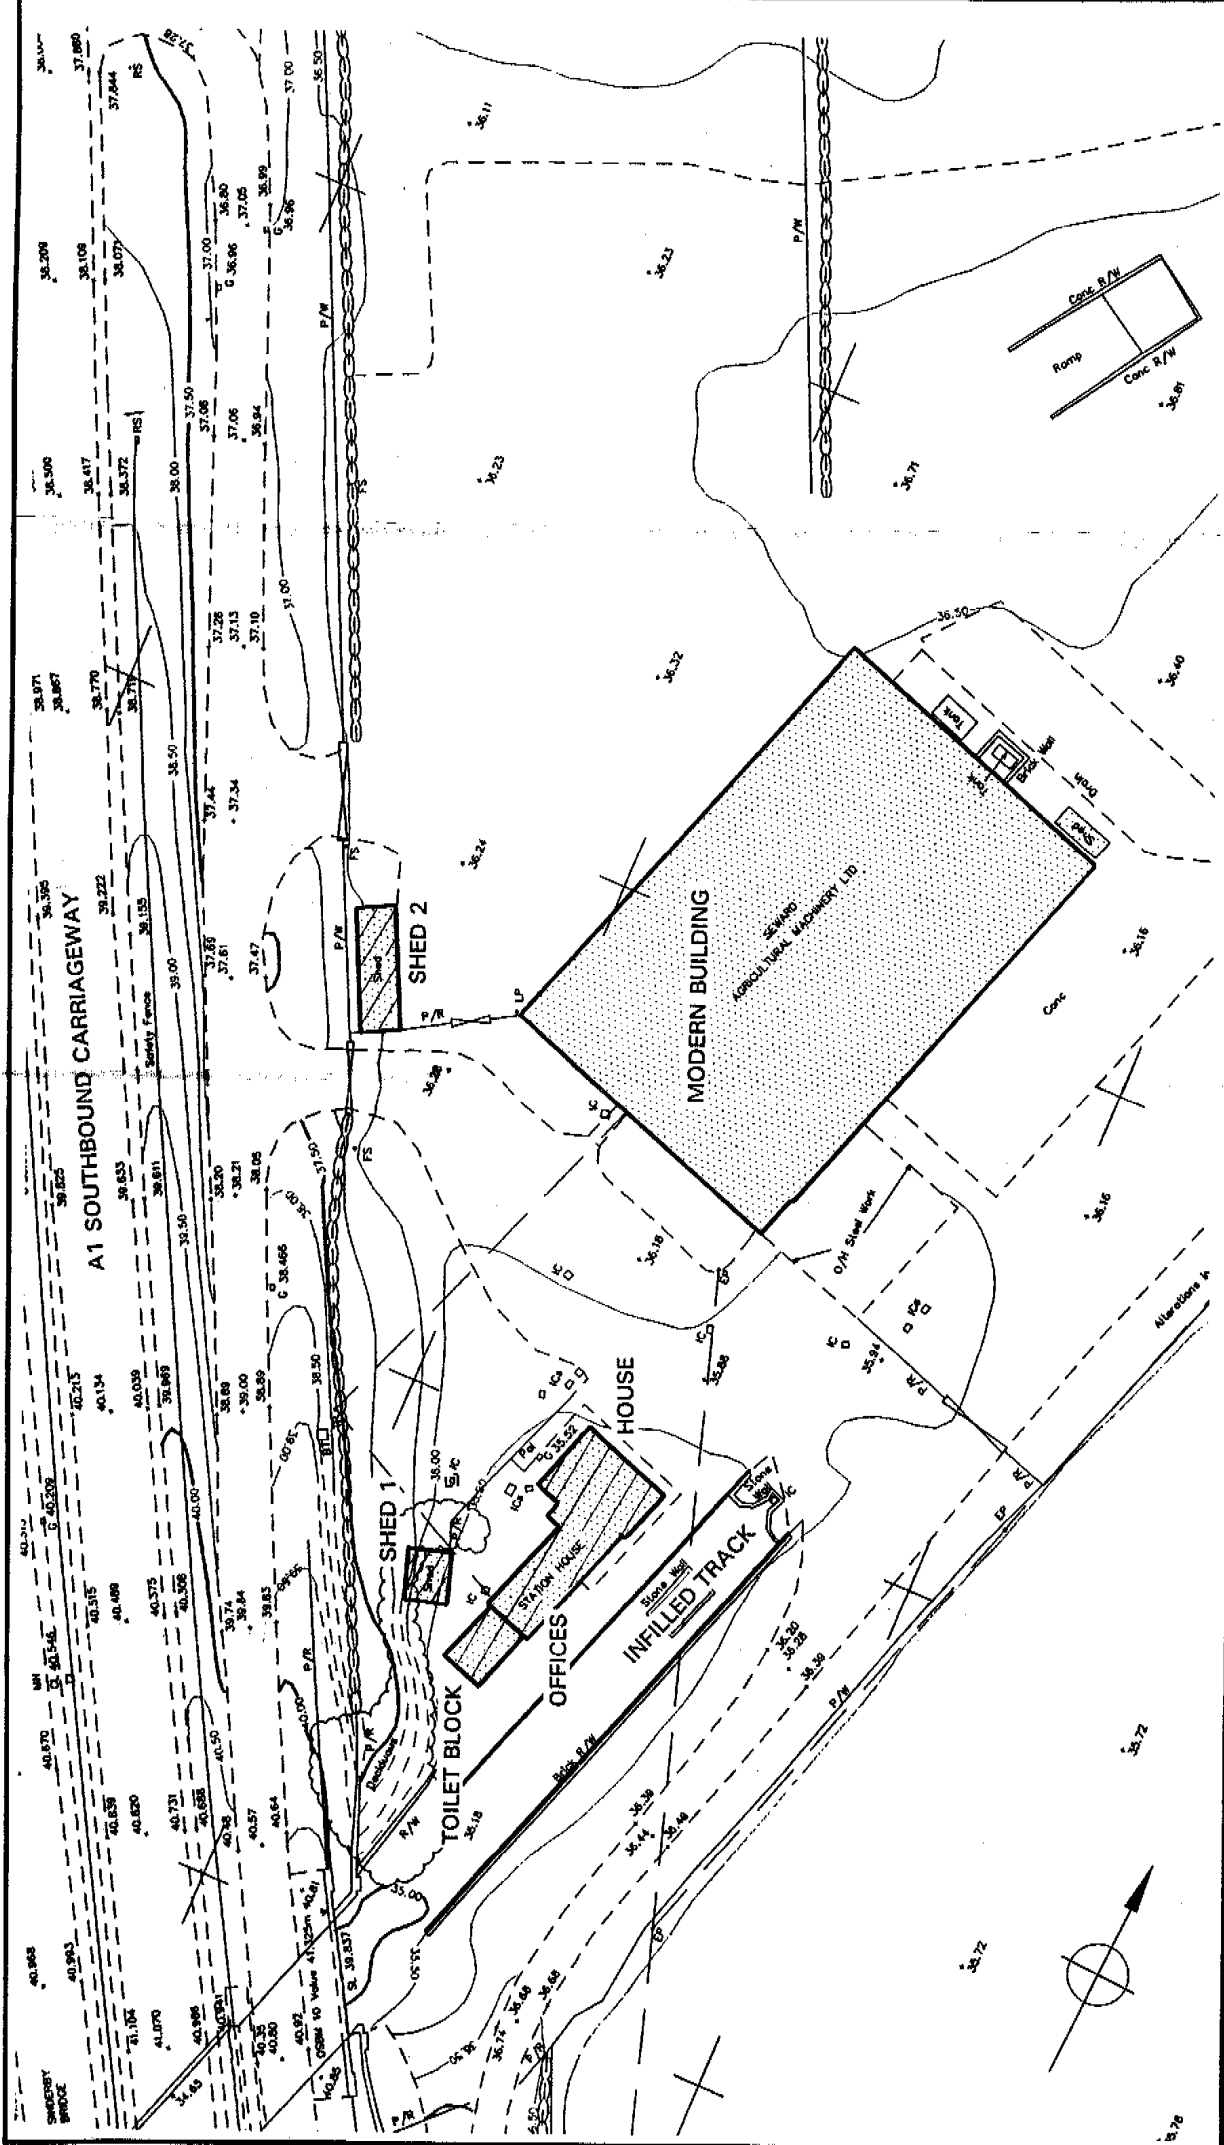
PROJECT	INITIAL ASSESSMENT OF THE BUILT HERITAGE		
	FIGURE	SITE 3/15 SINDERBY STATION	NUMBER
DRAWN	ED	CHECKED	SH
SCALE	1:500	DATE	1/95
			2

- 3.1.17 A detached outhouse lies across the rear yard to the west of the station buildings (shed 1 on figure 2). This is of two cells, dating from different times. The structure is brick built, of rougher bricks than the other buildings of the complex, although also of English Garden Wall bond, and with pantile roof. It therefore appears to be somewhat vernacular, unlike the station buildings.

- 3.1.19 The second outbuilding (shed 2 on figure 2) lies some 50m to the north. It is a single storey brick-built shed, with pantile roof, aligned north-south. The only openings are found in the east elevation, and are all doorways leading into separate cells. The interior of the building was not inspected. The location of this building at the end of the "coal depot" as marked on the 19th century map (OS 25" 1892 sheet 86(15)) suggests it was associated with this part of the station complex.
