INDEX DATA	RPS INFORMATION
Scheme Title Culvert A41 Access.	Details Archaeological Survey.
Road Number A41	Date
Contractor Oxford Archaeological Unit	
County Buckinghamshire.	
OS Reference SP 71.	
Single sided <input checked="" type="checkbox"/>	
Double sided	
A3 Q	
Colour 0

THE CALVERT A41 ACCESS, BUCKINGHAMSHIRE, AN ARCHAEOLOGICAL SURVEY

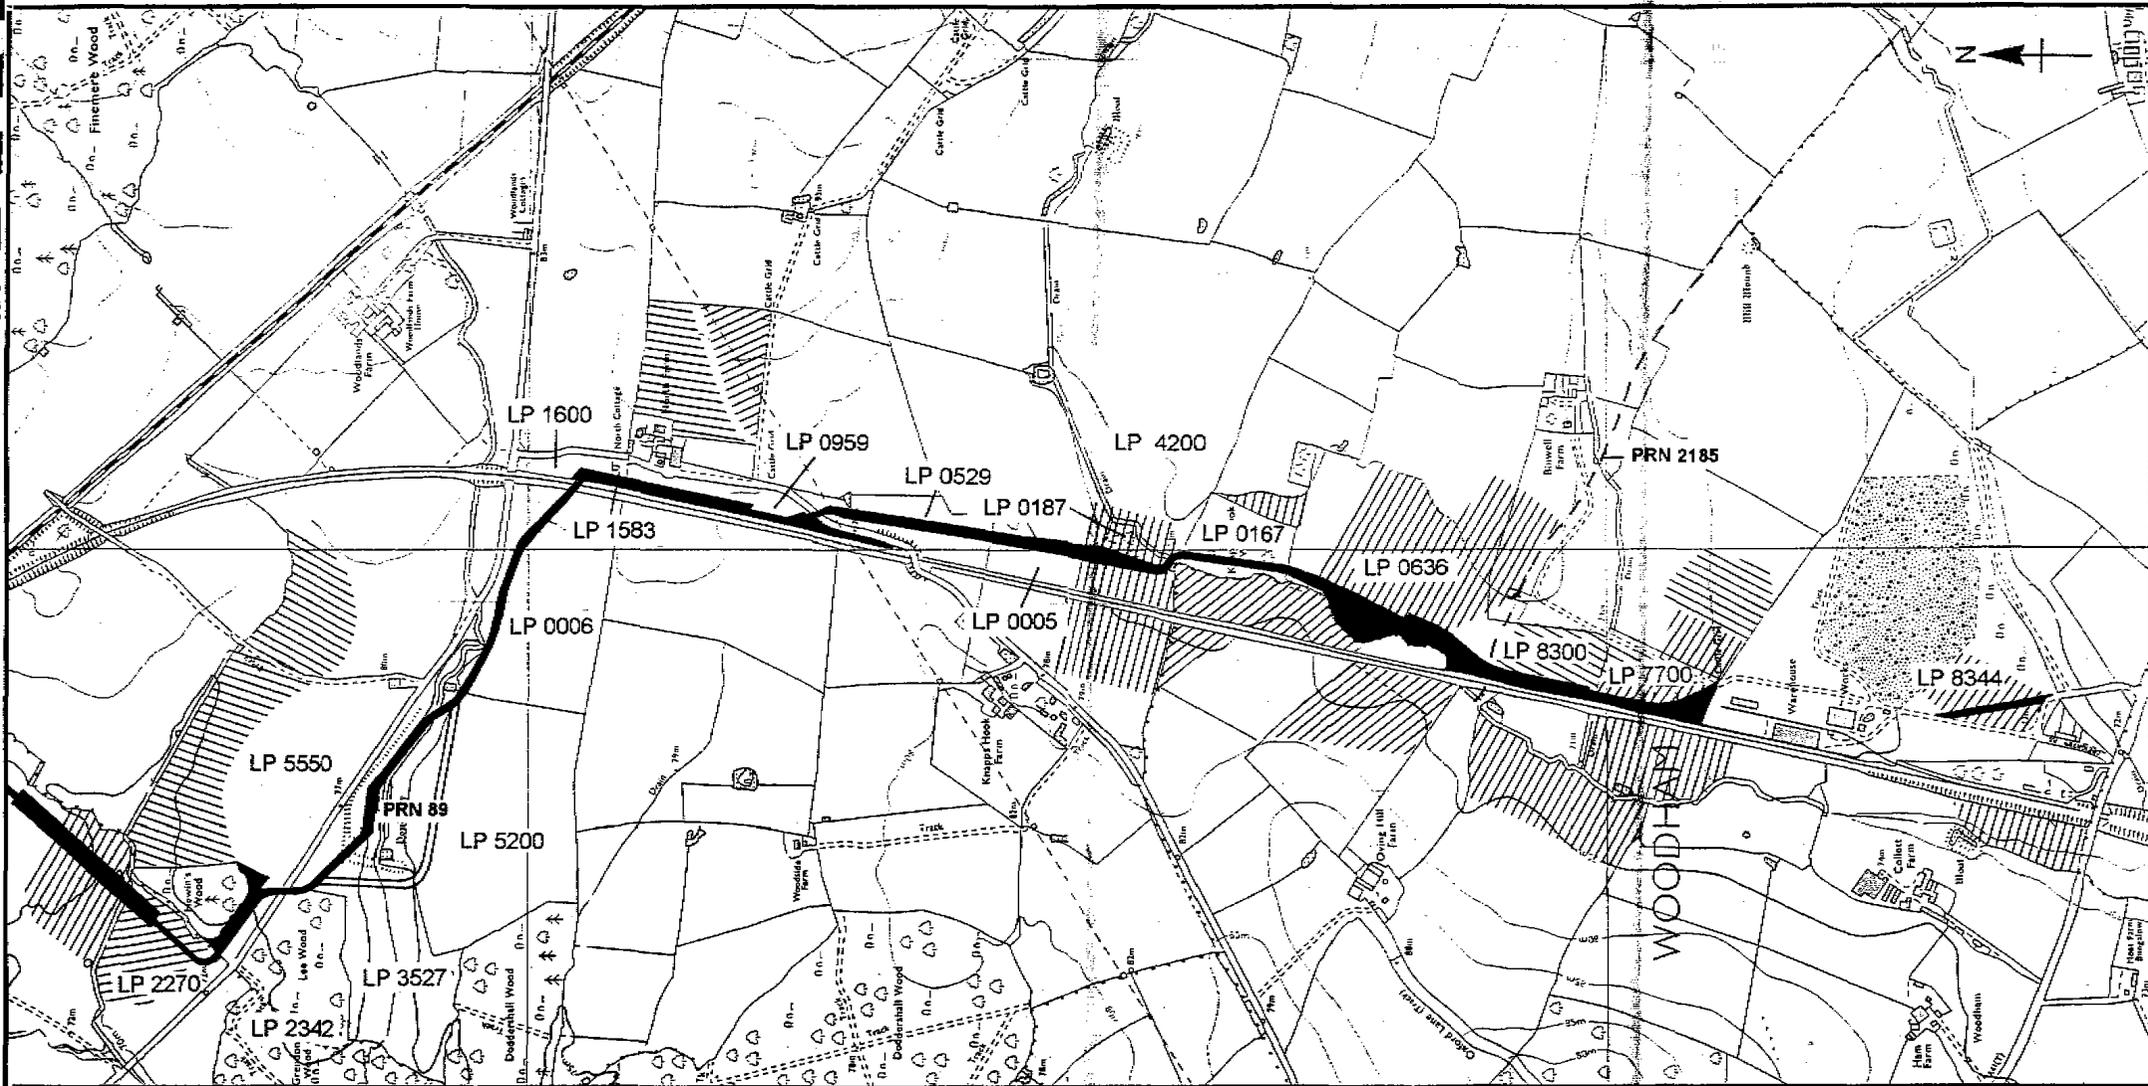
figure 1

The southern and central parts of the route of the projected road run through a medieval and post-medieval landscape of considerable interest. The relatively high degree of survival of this landscape, at least until quite recently, means that there is very little evidence for the archaeology of earlier periods in the area as a whole, and no pre-medieval sites are known in the immediate vicinity of the new road.

Between the A41 and North Farm the road initially follows part of an existing access, cutting a corner through field 8344 in which ridge and furrow can be seen from aerial photographs, and then runs close to the railway line through more ridge and furrow fields. W of Binwell Farm the route cuts the line of a probable medieval and post-medieval road or trackway, Binwell Lane (PRN 2185) which approaches Binwell Farm from the SE through Waddesdon and Westcott parishes and continues to the WNW. This may be the 'ancient public bridle road' referred to in an award of 1766 (VCH 1927, 108) and known as the London Road. Its probable line in the vicinity of Binwell Farm is followed for some distance by the boundary between Woodham and Quainton parishes. This road presumably ran WNW at least as far as Oving Hill Farm, but the SMR map shows no continuation W of the railway line.

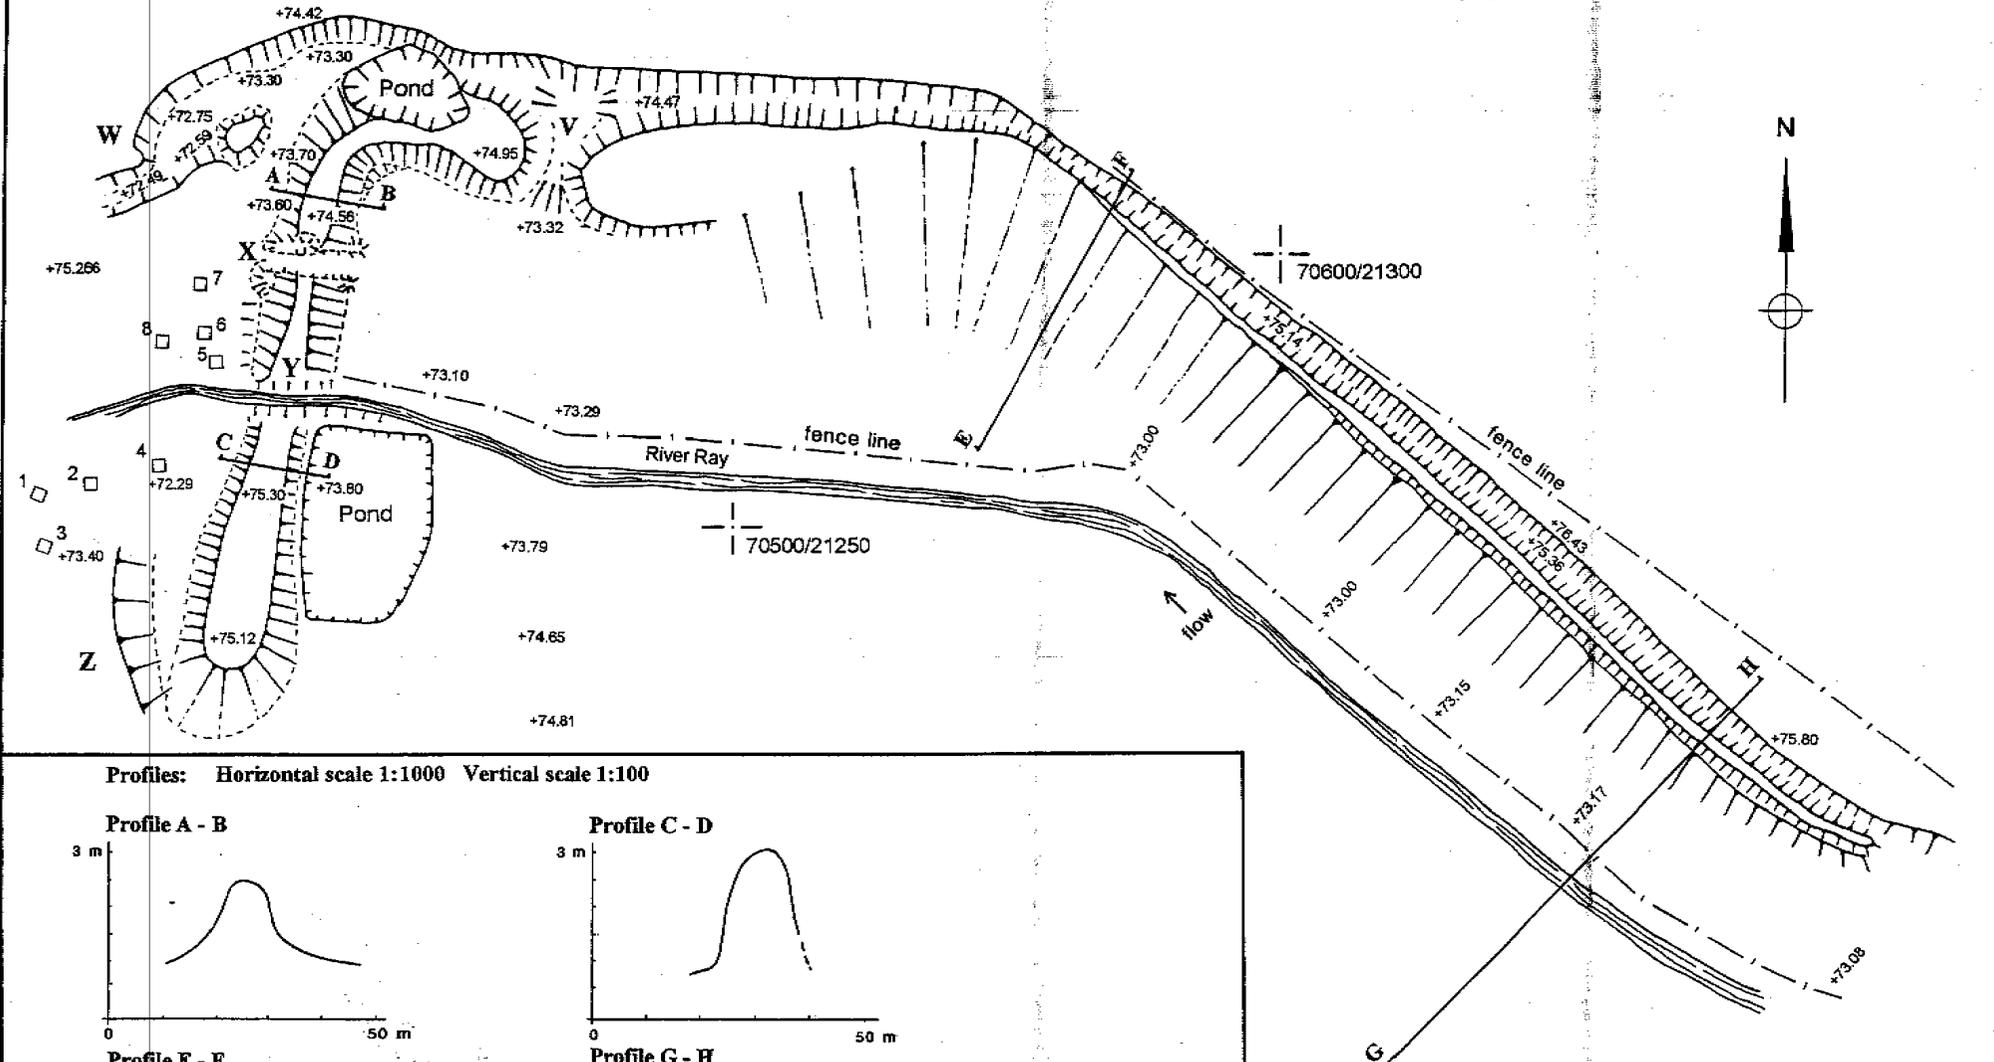
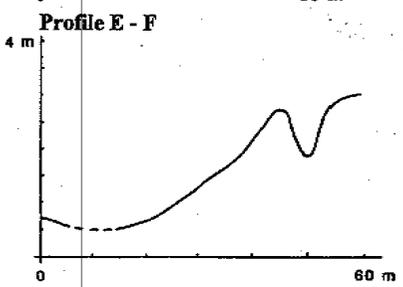
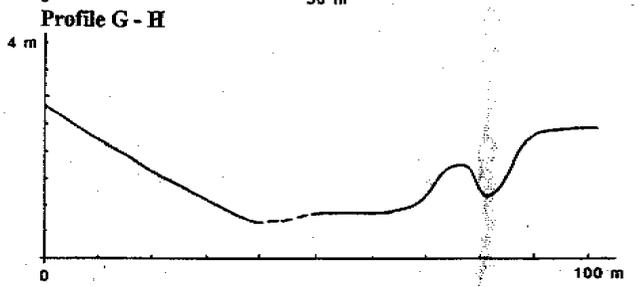
figure 2

The plan of the earthworks is presented in Fig. 2. The principal features are the N-S aligned dam at the W end of the complex and the channel which runs along the N edge of the pond. The dam is described first, then the channel.

The dam is situated to take advantage of the natural contours of the valley of the River Ray. The N side of the valley is steeper than the S, which only rises gently. The S end of the dam is quite wide and shallow. To the W of the S end a noticeable hollow (Z on plan) probably represents a pit from which clay was excavated for the dam. E of the S end of the dam is a large pond which is currently in use for fishing on an organised basis. The appearance of the pond has consequently been altered in recent times to accommodate this use.

The dam is cut (at point Y on Fig. 2) by the present course of the River Ray. A little to the N of this point is a further cut (point X on Fig. 2) where a breach has been made in recent times with a tractor. Small mounds of earth at each end of the breach and on both N and S sides represent surplus earth derived from this operation. The sides of the breach are steep and are not yet covered in vegetation. N of the breach the dam turns through a rounded right angle to the E. On the outside of this corner is another, small pond of irregular shape. Its origin clearly postdates the use of the dam and may be of relatively recent date. The pond also encroaches in part on the line of the channel to the N.

To the E of the small pond is a substantial opening in the N arm of the dam (point V on Fig. 2). This cannot have been the original end of the dam because in its present form it would have provided a direct inlet into the pond from the channel. It is assumed that the opening must have been made after the Pond Bay went out of use, though it appears to be of some antiquity. The extent to which the dam continued to the E is unclear. Within a distance some 20-30 m E of the gap the natural contour of the valley was adequate to contain water and the dam structure certainly did not extend further E than this point. It is possible that the dam originally terminated close to point V. In the process of creating the gap it would have been easier to remove the end of the dam itself than to cut through the natural ground.

The earthworks forming this pond are generally in good condition. If at all possible, damage to the monument should be avoided, and it is desirable that this should be done by routing the proposed road away from the earthworks. This would include keeping the road as far away as possible from the W face of the dam, for two reasons; firstly to maintain the integrity of the monument in its landscape and secondly to avoid impacting on the location of a possible mill building which, despite the findings above, might still be found in the area W of the dam. This is, however, a lesser priority than avoiding the direct impact of road on earthworks.

If the road were to pass through the Pond Bay it would have to be constructed at ground level on a geotextile. Nevertheless, it is difficult to see how the road could be successfully carried through the bottom of the Pond Bay and out of its NW corner without causing damage to the earthworks. This is because the profiles of the banks in the NW corner of the pond are quite steep (any route which passes across the main W dam is quite out of the question, for the same reason). The problem is not particularly helped by the steepness of the N side of the valley immediately beyond the earthworks. Consideration needs to be given not only to the process of putting the roadway in place, but also to its removal at the end of its useful life. For this reason the original proposal, whereby the road was routed through the extreme NW corner, is not desirable since in the process of removal of dumped material from this point it is almost certain that damage would be caused to the earthworks. Moreover, this route would require road material to be dumped on both sides of the dam, the crest of which would be an exposed point and likely to suffer degradation. The visual impact of this route upon the monument would be particularly unfortunate.

A better, but by no means ideal, option would be to utilise the gap in the N side of the dam/bank, probably of relatively recent date, which occurs some 30 m E of the NW corner of the dam. For this route to be effective would involve dumping of road material (over geotextile) within the existing gap and up its sides, and within the channel to the N of it. One advantage of this scheme is that the N side of the channel at this point is cut out of the natural slope of the valley, so the infill would be placed against solid ground rather than a principally artificial earthwork. Engineering problems, in terms of gradients and turning circles, may be encountered with this suggestion, however. Nevertheless, from an archaeological point of view, this solution is preferable to the route which passes through the extreme NW corner of the dam.
