**Church Street, Carlby**

**Archaeological Watching Brief**

**Anglian Water Services Ltd**

**LAS Report No. 363**

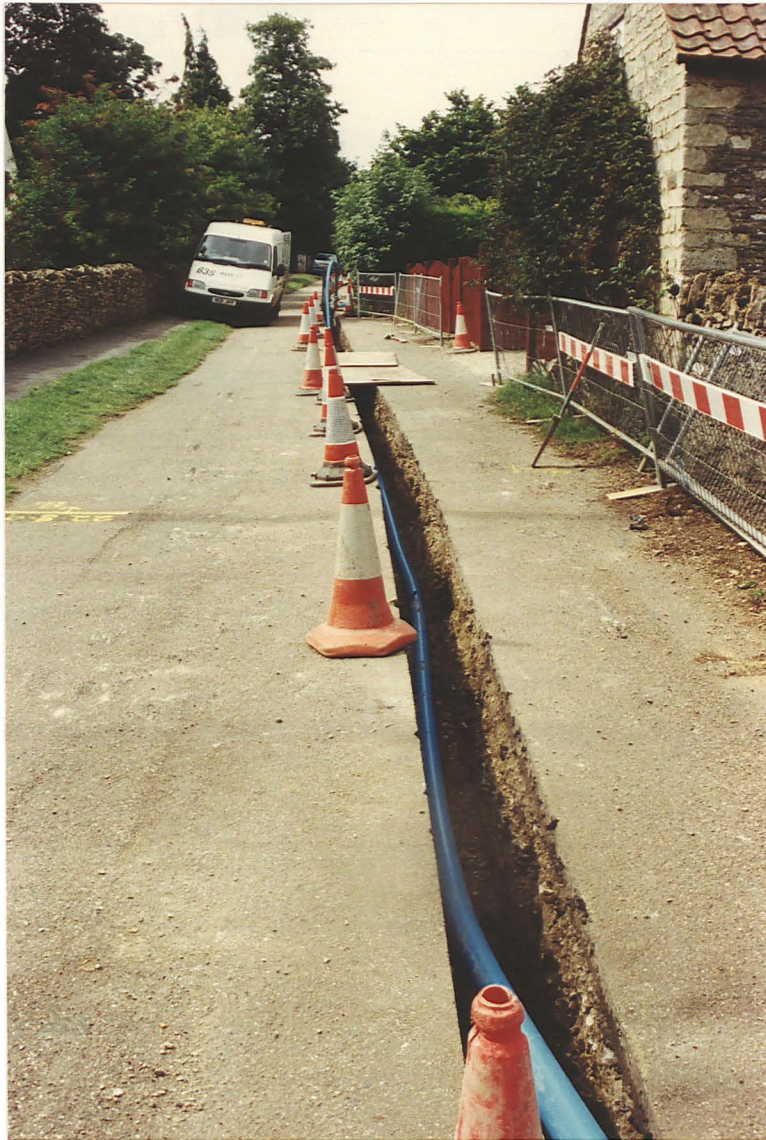
To the south of Blacksmith's Cottage the trench cut through a mixed deposit of clay and stone **2**, dissimilar to the modern sewer trench backfill seen to the south and west (Pls. 1 and 2). It was unclear whether it represented accumulation layers or fill of a ditch. No dating material was seen.

**PI. 1** Position of the pipe trench in Church Street, Carlby (looking SW; Blacksmith's Cottage is behind the red fence).

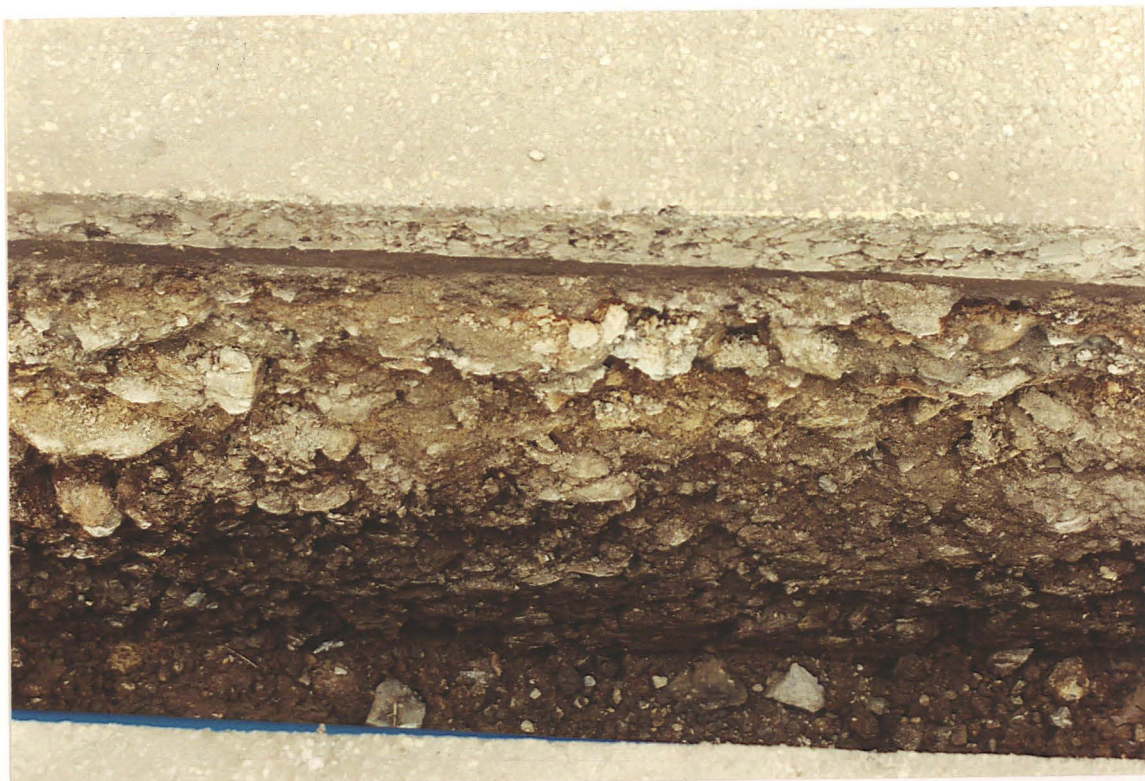
**PI. 2** Mixed clay and rock 2 in a feature of unknown date or purpose. The upper layers are road foundation material.

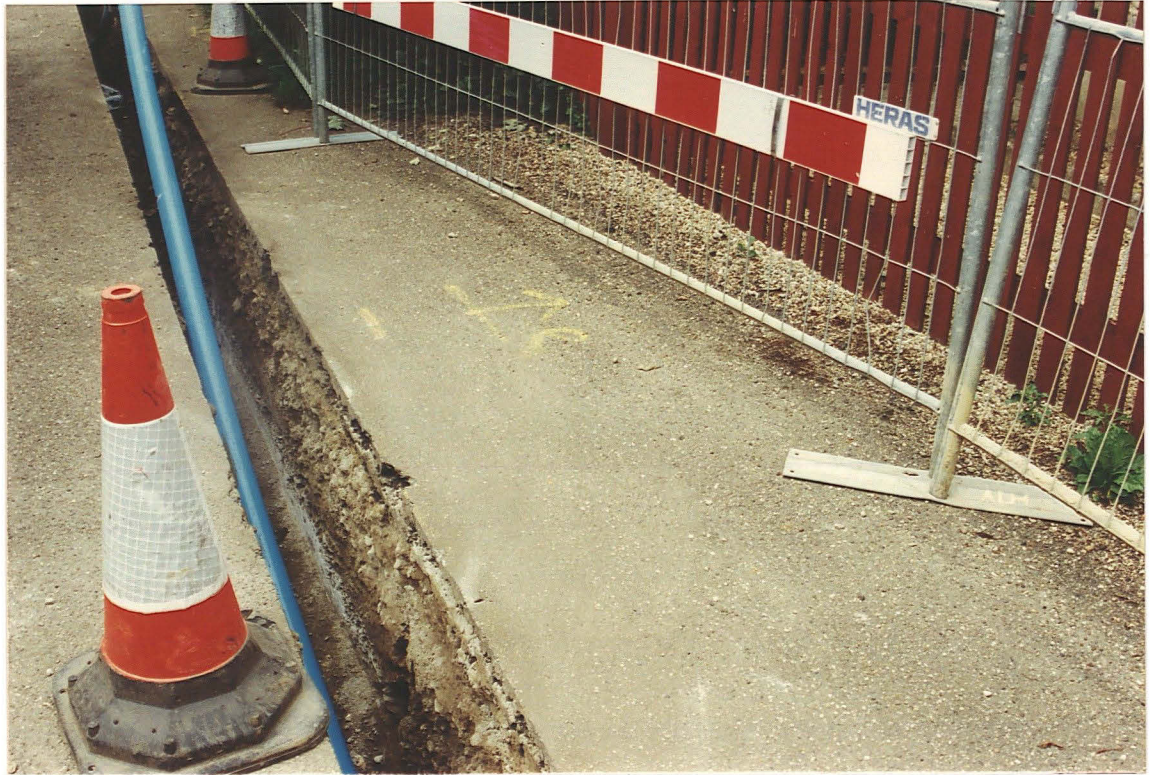
The southern wall of Blacksmith's Cottage coincided with a thin NW-SE aligned band of solid rock **3**, which interrupted the mixed clay and stone for a distance of about 2.5m (Pls. 3 and 4). One possible interpretation is that the ground beside it had been quarried to a depth of about 0.7m below ground level and that the band represented a ridge between workings; there was no other evidence to support this hypothesis. Another interpretation is that the stone had survived beneath a bank or path between two linear features such as ditches, but the evidence of modern plot boundaries is unhelpful. The feature could simply represent a band of resistant rock, with the ground either side deliberately made up to flatten the road surface in the medieval or post-medieval period.

**Pl. 3** Position of bedrock ridge 3 in base of trench, in front of Blacksmith's Cottage (looking west).

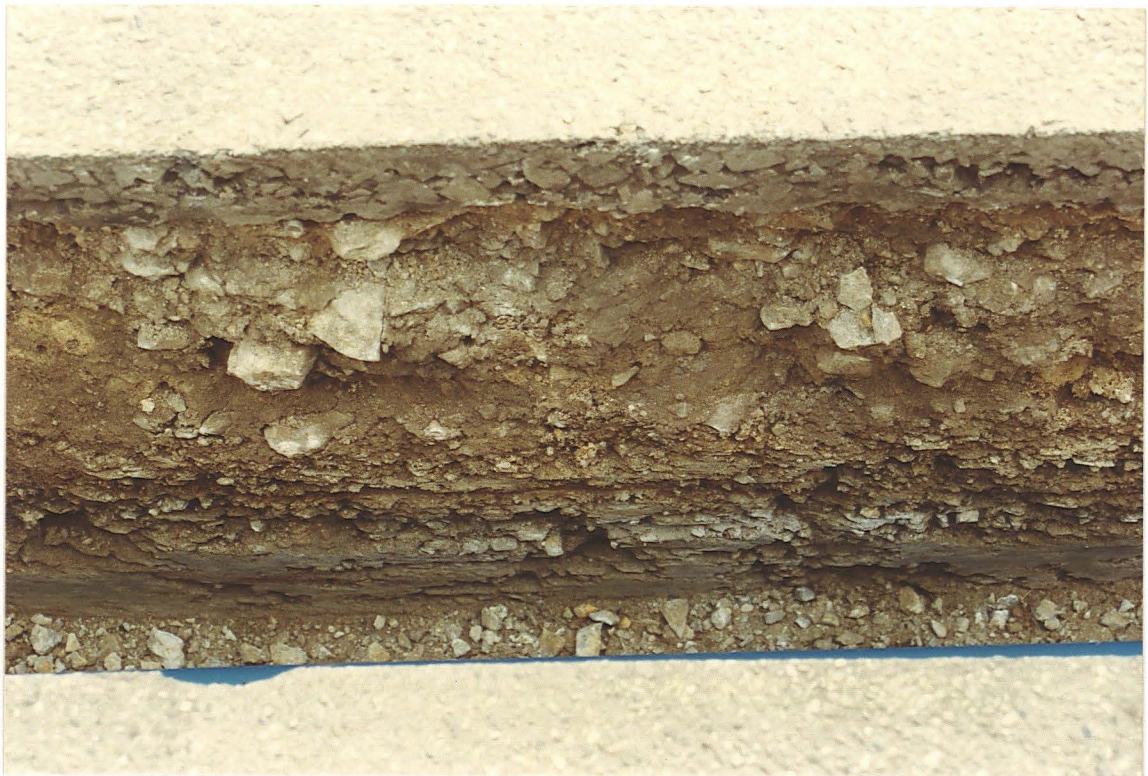
**Pl. 4** Bedrock and natural horizontal strata 3 at trench base.

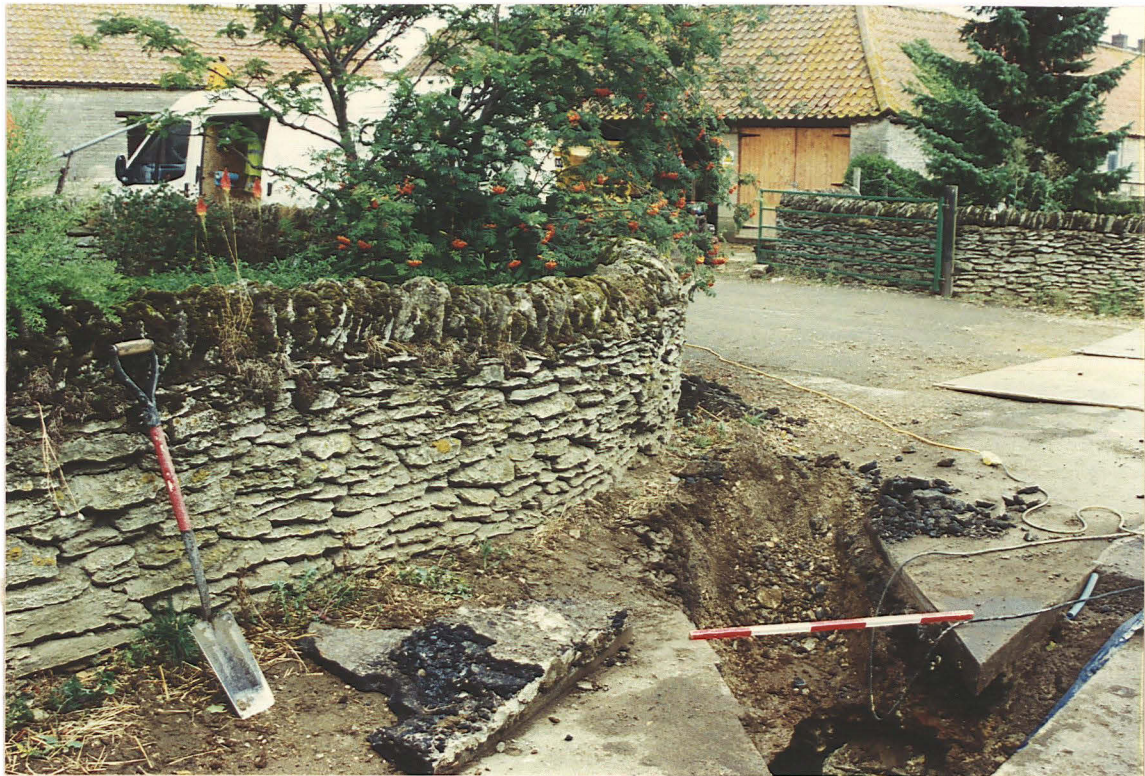
Beyond the monitored area, the upper part of a broad stone-lined well 5 was revealed in the western side of the entrance to Poplars Farm, High Street partly extending beneath the modern road (Pls. 5 and 6). Its stone cover had been supported on a steel acrow, and it has now been backfilled for safety reasons.

Pl. 5 Location of post-medieval well 5 in High Street, in front of the entrance to Poplars Farm (looking NE, scale 1m).

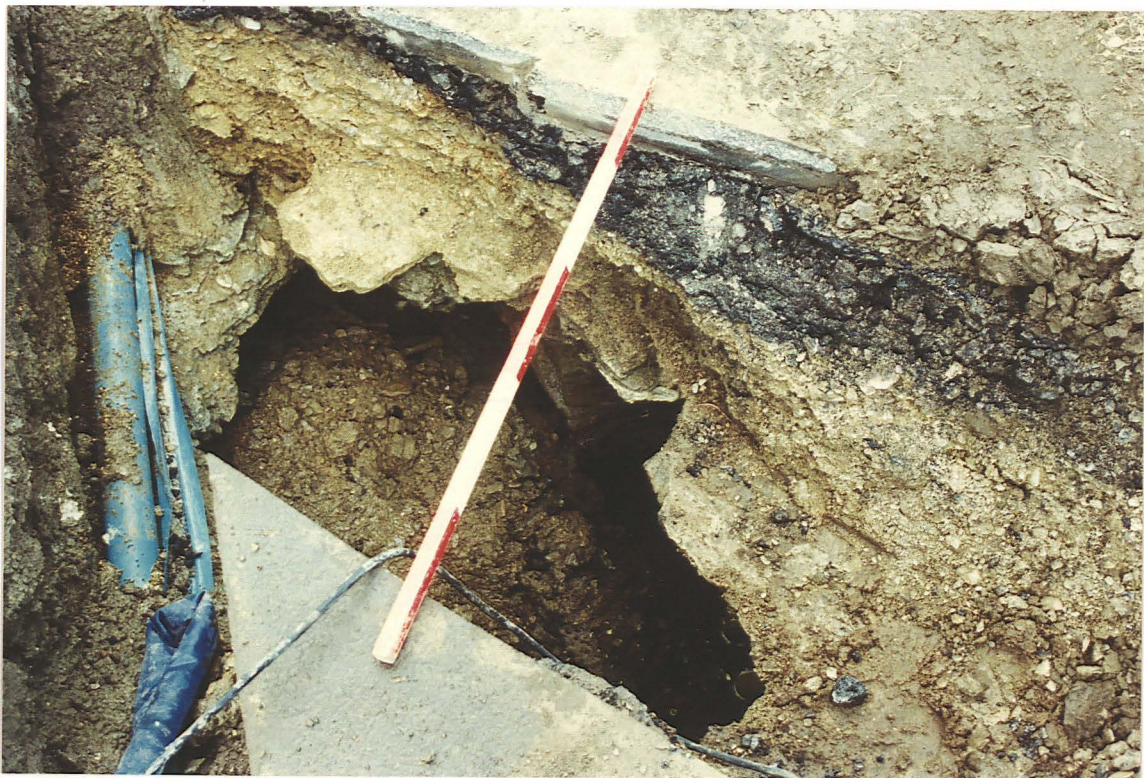
Pl. 6 Part of the capped well 5 revealed beneath High Street (scale 1m).
