Allington Sub Zone

Dry Doddington Replacement Mains

Archaeological Watching Brief

LAS Report No. 417

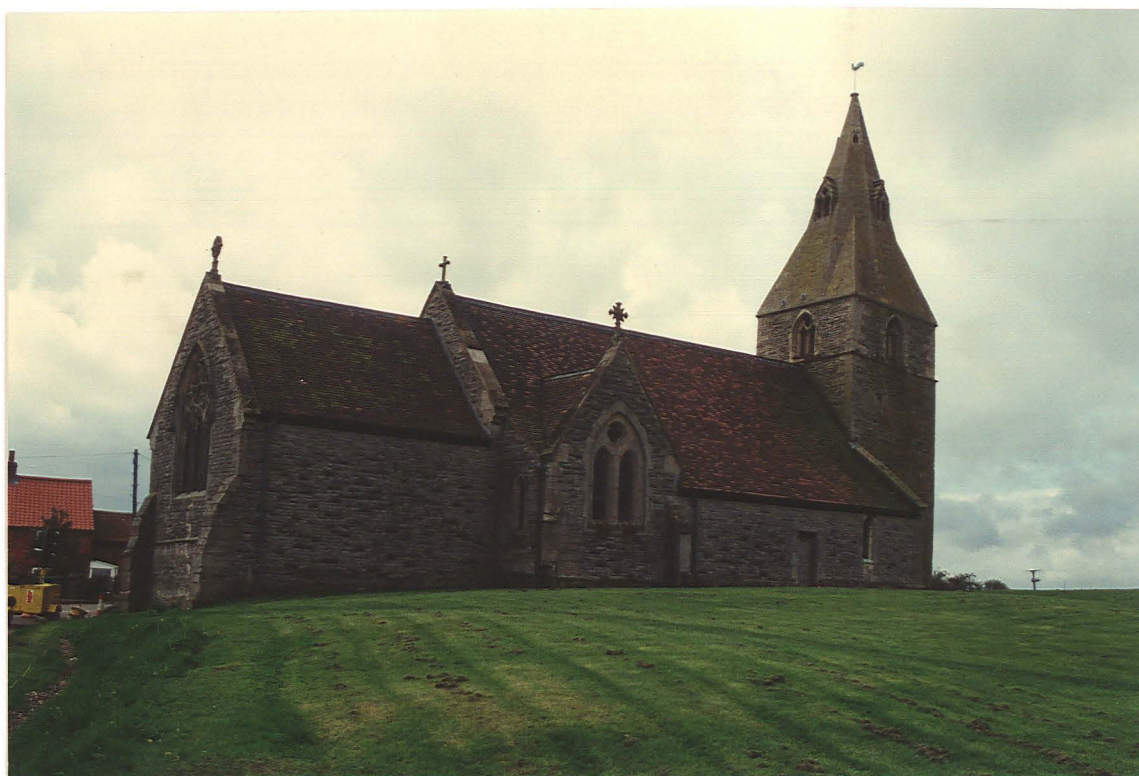
Close to the medieval church, which stands on a raised site, there was the potential for medieval settlement remains and possibly burials (Pl. 1).

Pl. 1 St. James' Church, Dry Doddington (looking south). Trench 1 was sited at the front left of the photograph, at the base of the slope.

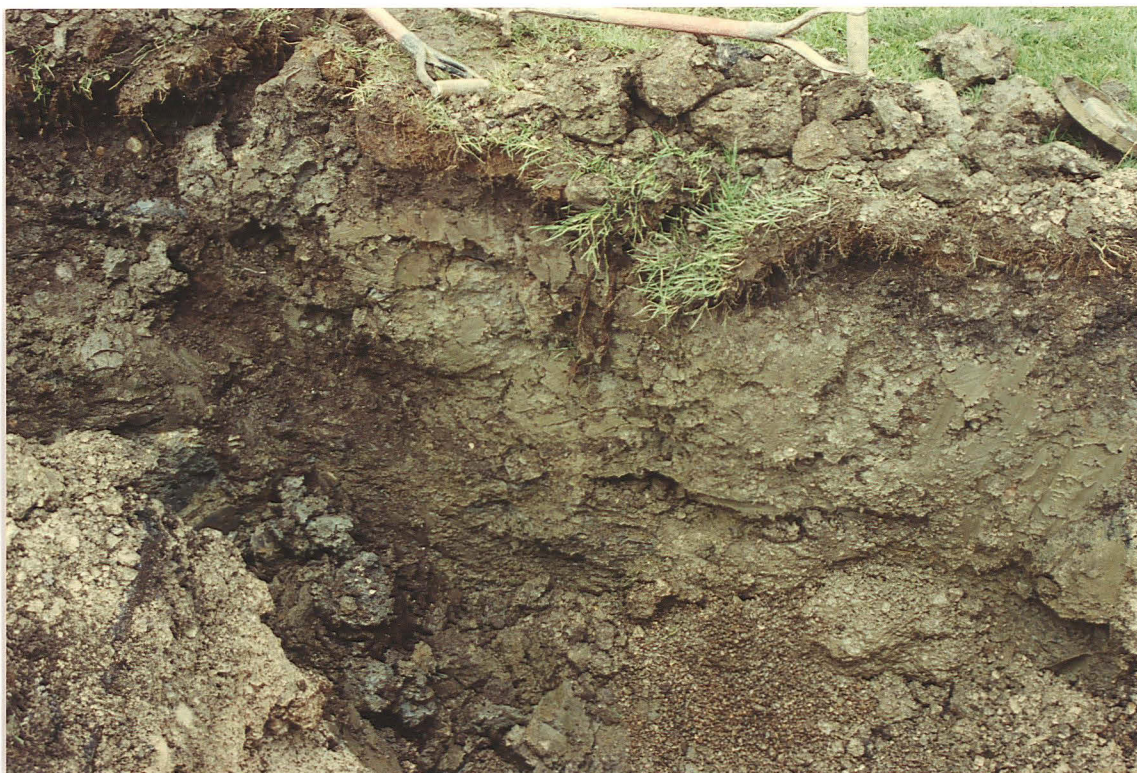
1. A single trench was opened in the roadside verge to the NE of St. James' Church in order to connect two existing pipes. Most of the trench cut through the backfill of the two existing pipe trenches, and the fill of an adjacent telephone cable duct. Where deposits had not been disturbed, the topsoil was about 0.3m thick, above a mixed yellow/brown clay with pebbles (Pl. 2). Shaley rock was encountered 0.85m below the surface.

No archaeological remains were found. The watching brief found that the monitored ground had been considerably disturbed in the past when existing services had been installed.

Pl. 2 Clay deposits and backfill of earlier service trenches, in the western side of Trench 1.
