## **Branston Mains Relay**

**Branston and Washingborough Replacement Mains**

## **Archaeological Watching Brief**

**LAS Report No. 418**

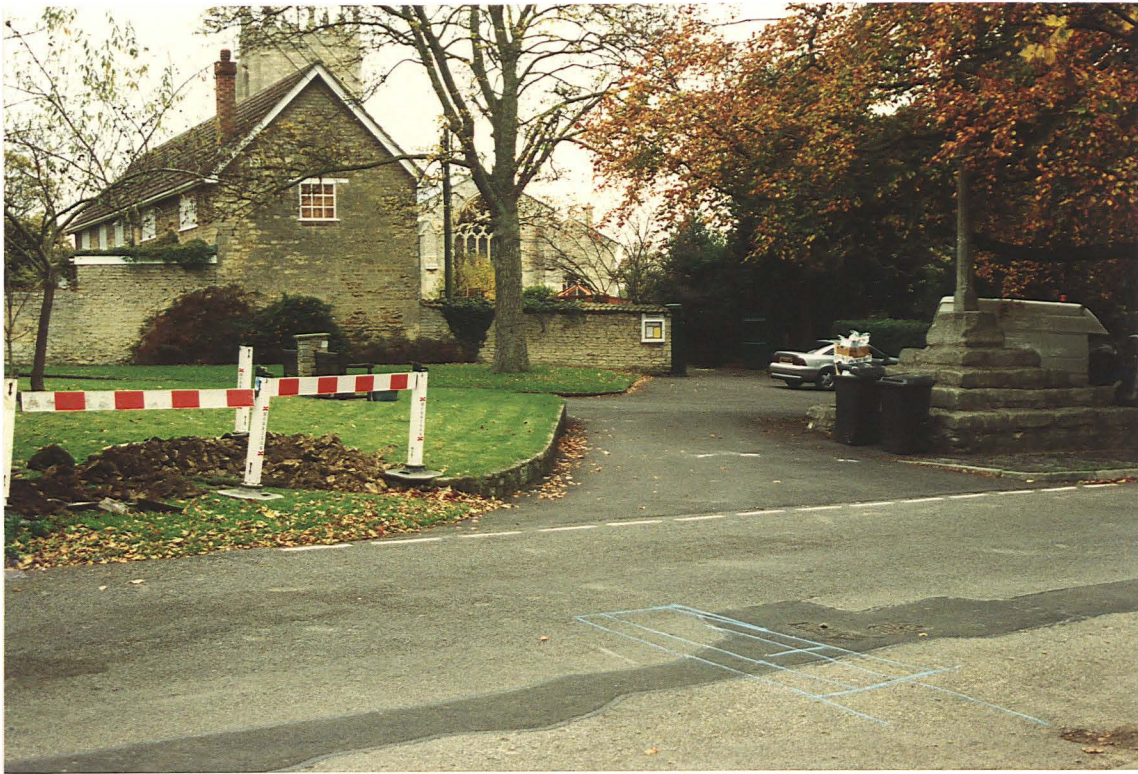
6b. A connection was made between the trench in High Street and the properties to the south and west of the cross. A narrow open trench was excavated across the grassed area south of the cross, cutting through stone rubble but no recognisable archaeological features (Pls. 19 and 20).

Pl. 19 Location of trench 6a, in the verge beside High Street, Washingborough (looking west).

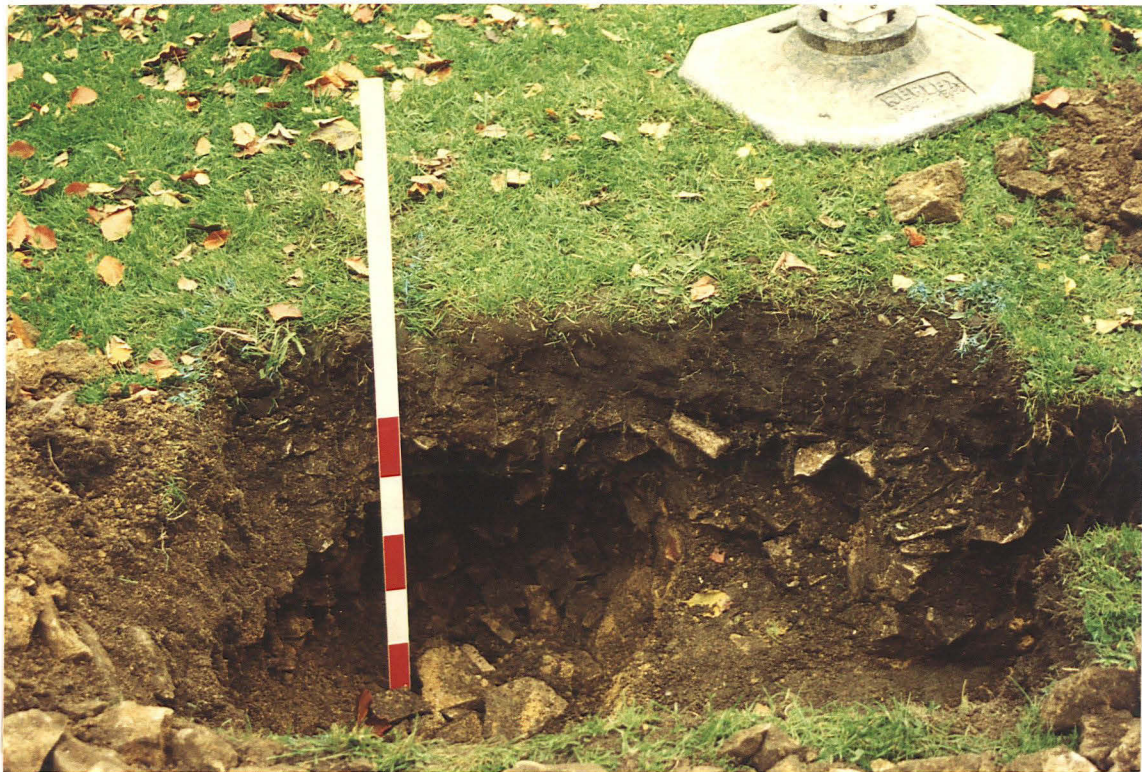
Pl. 20 Limestone rubble in trench 6a, close to the Washingborough medieval cross base (scale 1m).

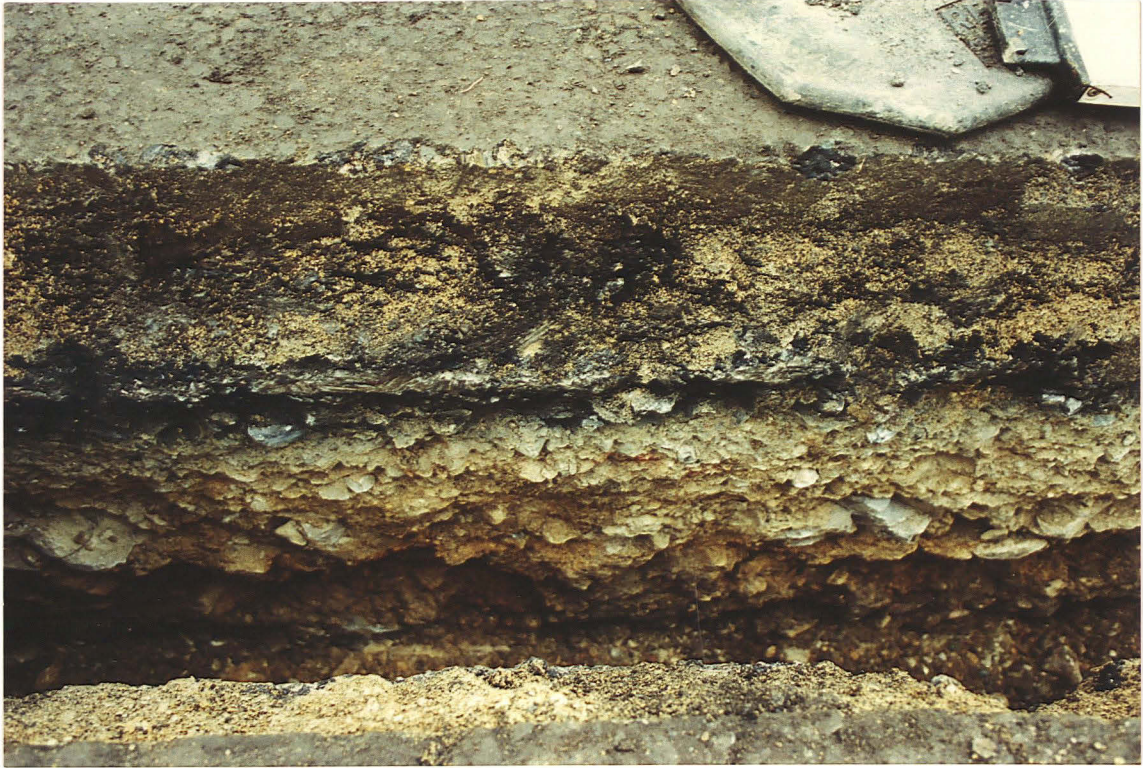
**4c.** Less peat was evident within the trench base to the west of No. 6, but it was unclear if this was because of firmer ground or thicker road foundation rubble (Pls. 16 and 17).

Pl. 17 Road foundation deposits at 4c.

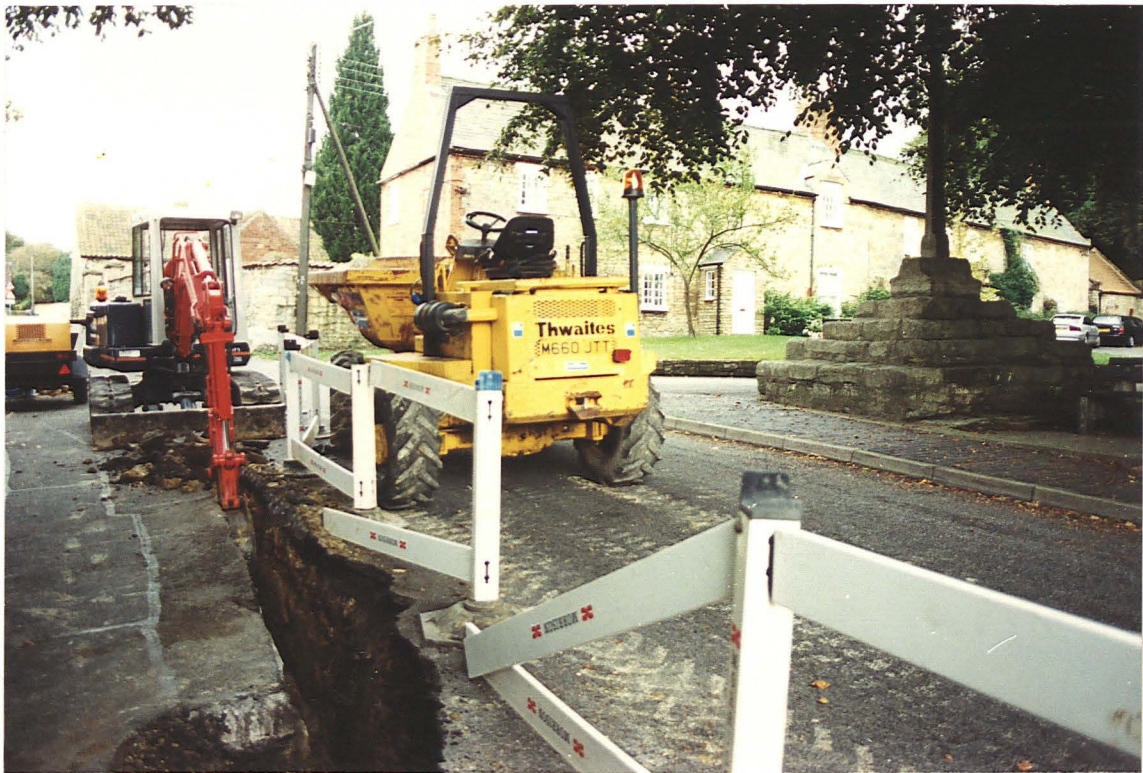
**6a.** On the east side of High Street, opposite the cross, the trench was excavated alongside existing backfilled service trenches (Pl. 18). Where a small area of less recently disturbed ground was visible, a layer of limestone rubble (which may have been a post-medieval road surface) was seen under the modern road bedding. Beneath the rubble was light brown clay.

Pl. 18 Trenching at 6a, opposite the medieval cross base, High Street, Washingborough (looking south).

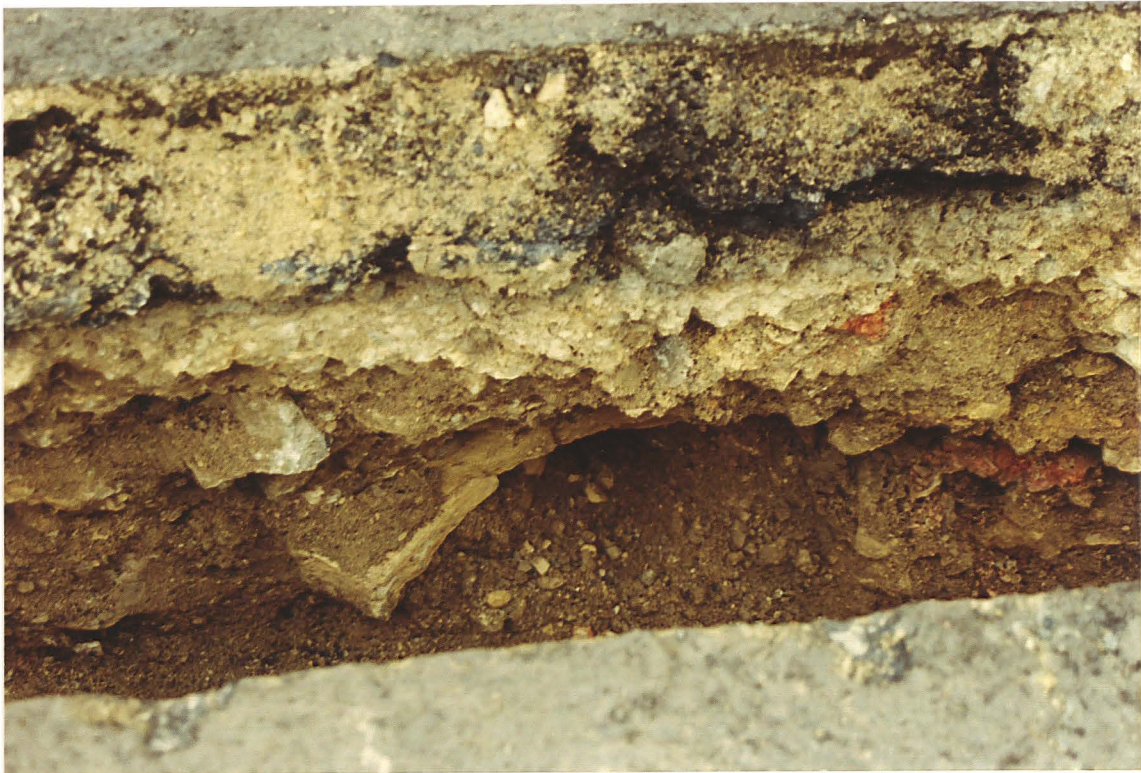
**4b.** On the north side of Main Road in front of No. 6, the trench cut across some form of stone culvert beneath the main road (Pls. 12 and 13). It was difficult to establish its shape as the machine had dislodged the stones, but it appeared to have had a broad curving cover resting on a wall of stone rubble (Pls. 14 and 15). No. 6 has a date stone inscribed 1863, and the culvert could either have drained its site before it was developed, or have been built with the house. The presence of brick rubble in the hardcore around the culvert implies that the culvert is probably no earlier than the eighteenth century, and it is possible that the brick rubble and culvert were laid together as part of an extensive road improvement which raised the road surface by about 0.5m.

Pl. 15 Remains of stone culvert 4b, looking north.

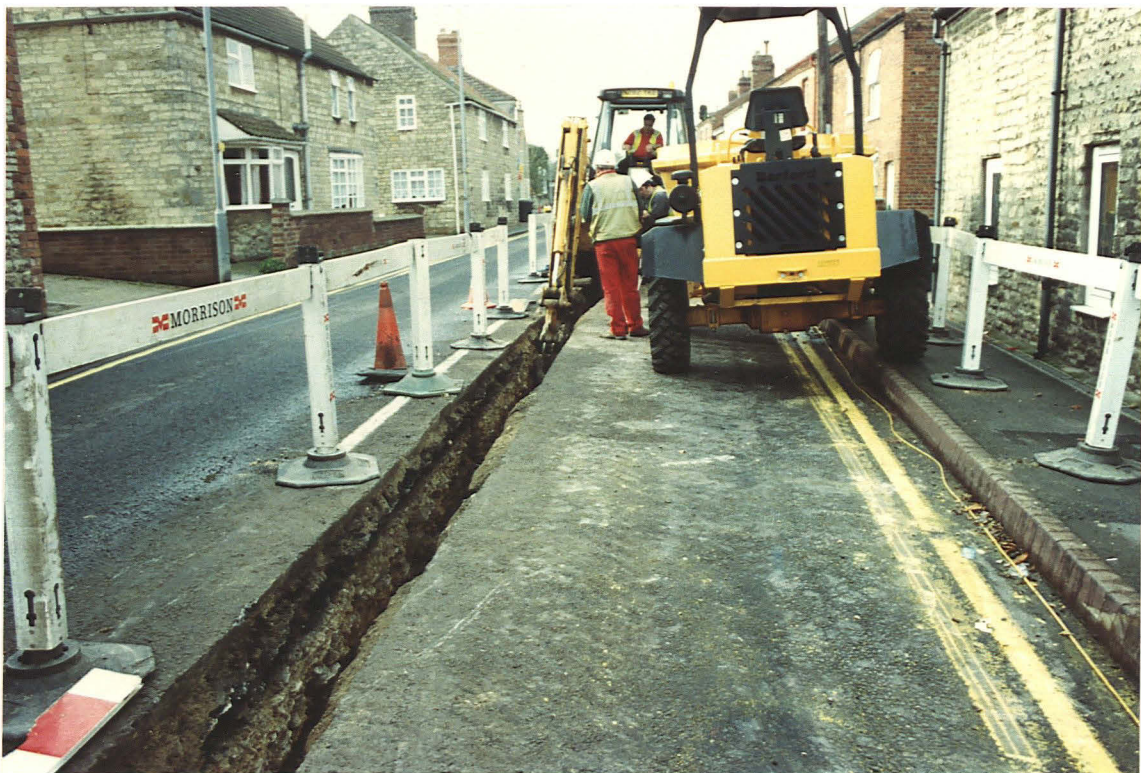
Pl. 16 Location of 4c, Main Road, Washingborough (looking west).

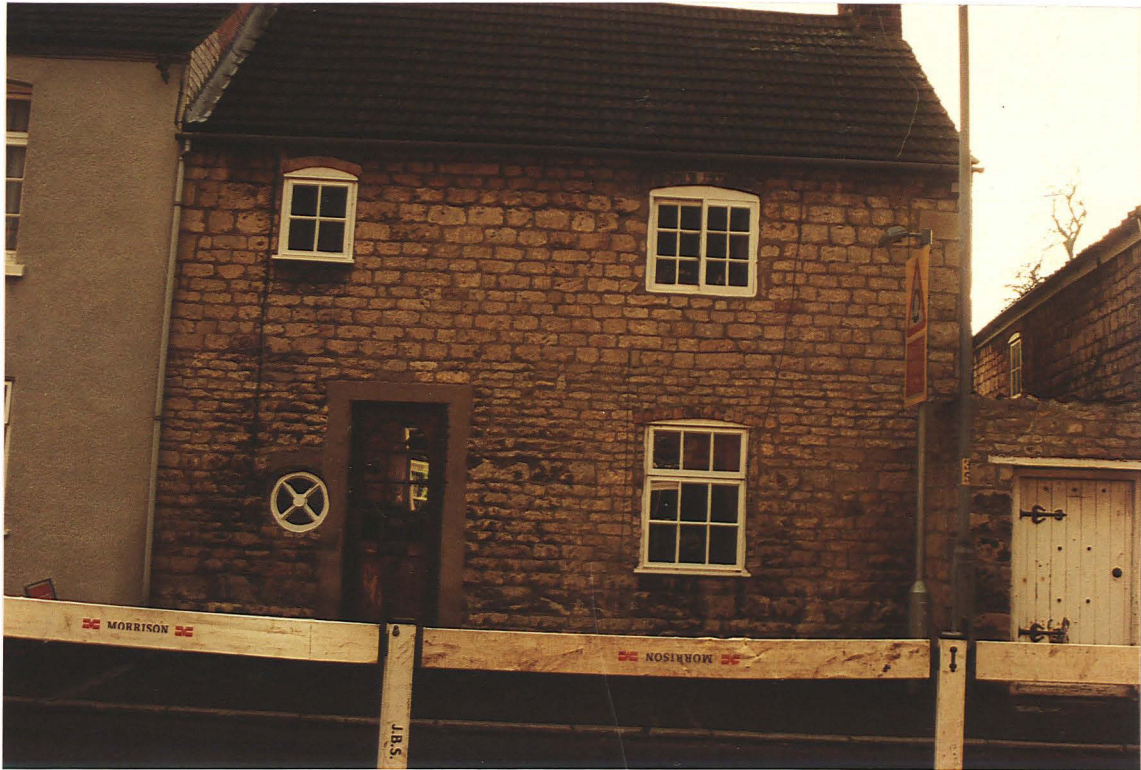
Pl. 13 The stone culvert 4b was aligned towards No. 6, Main Road (looking north).

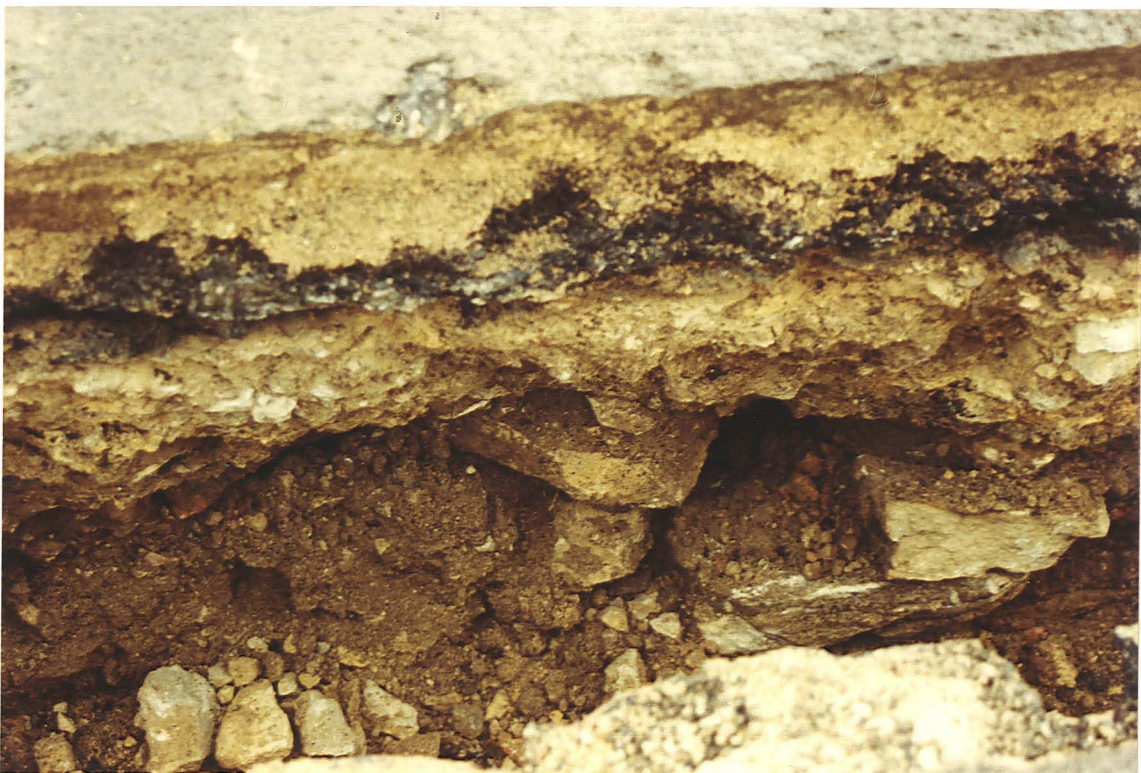
Pl. 14 Remains of stone culvert 4b, looking south.

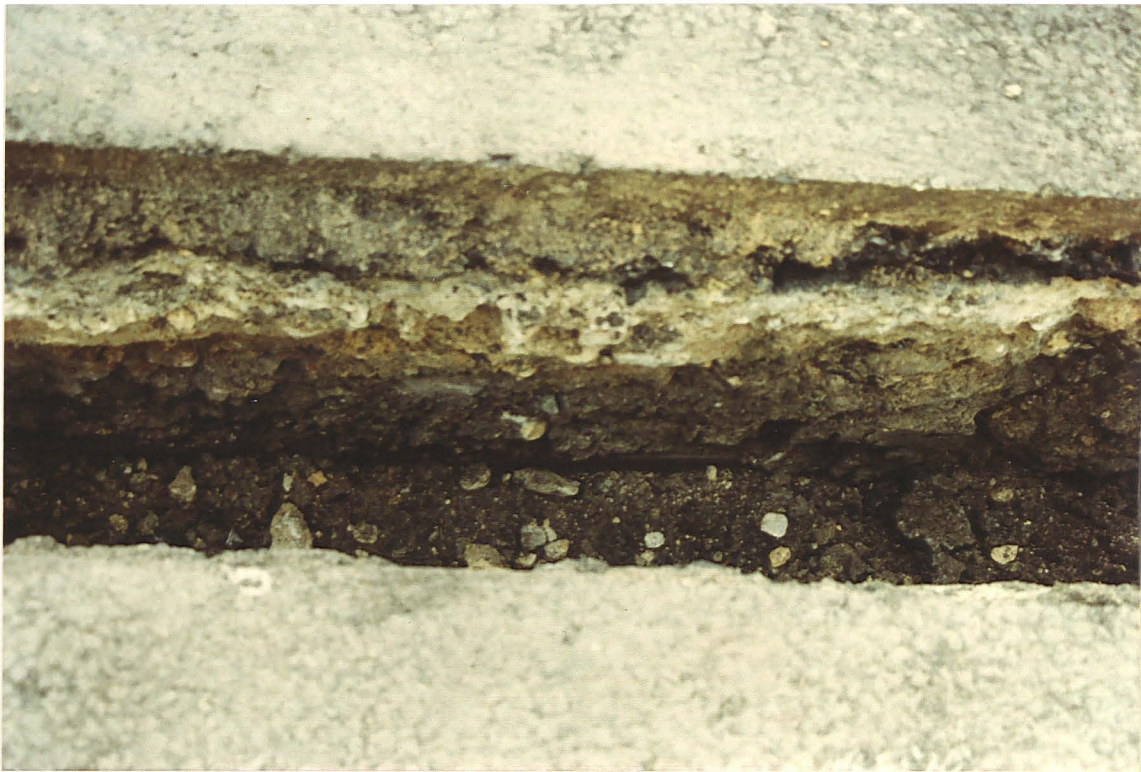
**4a.** West of High Street, the trench was laid close to the centre of Main Road (Pl. 9). The tarmac surface here was particularly thick, covering an equally thick layer of crushed limestone and limestone rubble (Pl. 10). The limestone layer was not of uniform thickness, and sealed a dark brown silty soil which was interpreted as a peat deposit (Pl. 11). The road has been constructed on peat, and considerable thicknesses of rubble have been needed to produce a solid foundation. As this road skirts the edge of the historic settlement core (which is on the higher ground to the south), it could represent a late medieval or post-medieval 'bypass'. Drainage of this part of the fen was very late, in about the late eighteenth century or early nineteenth century. The road was certainly

Pl. 11 Thinner road foundation over peat at 4a.

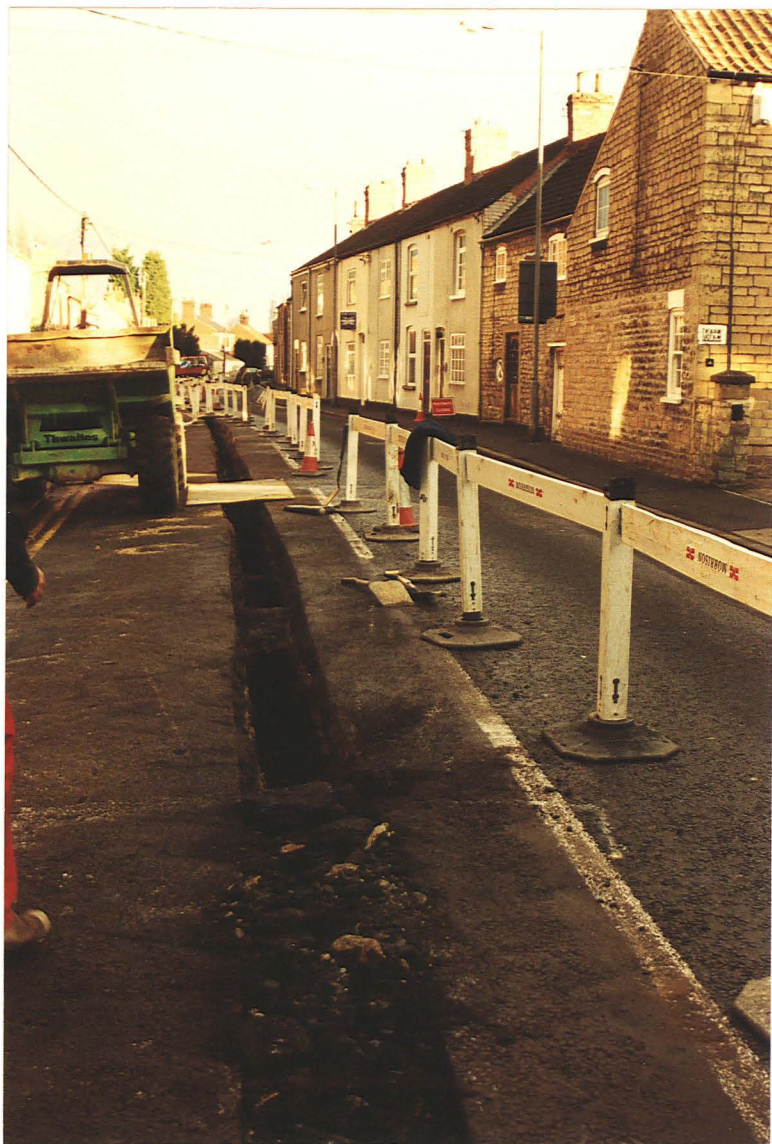
Pl. 12 Location of 4b, Main Road, Washingborough (looking east).

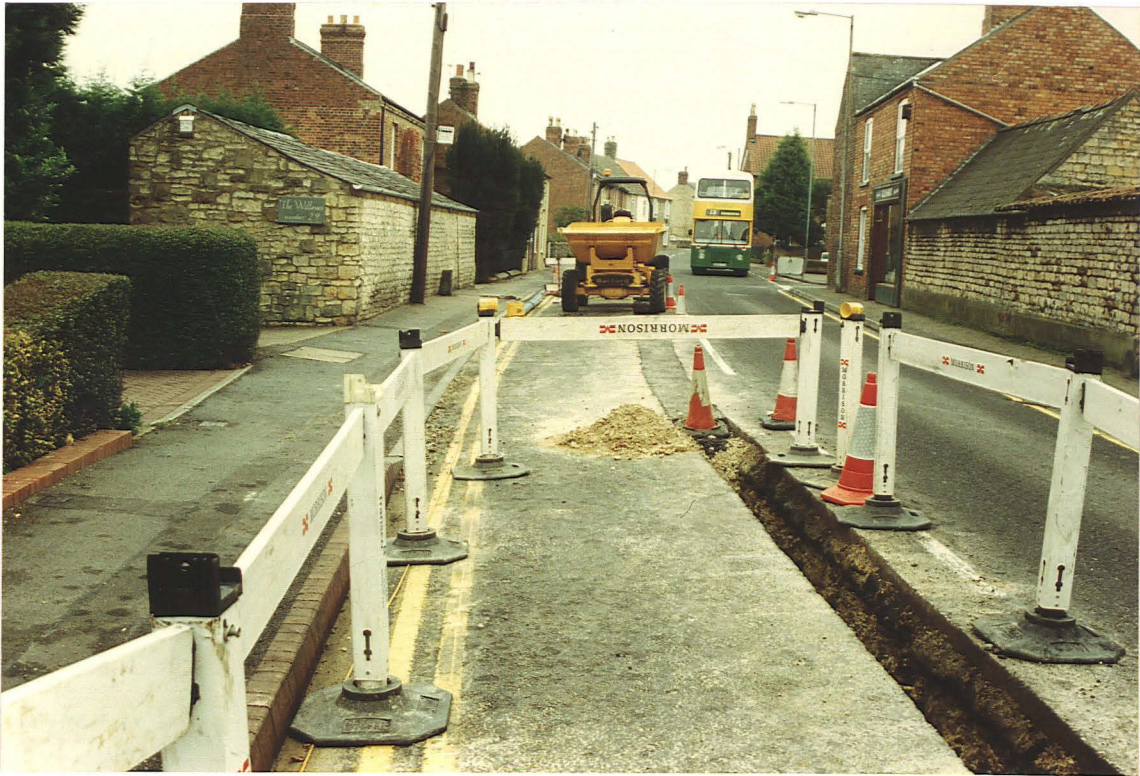
Pl. 9 Location of 4a, Main Road, Washingborough (looking east, with High Street to the right).

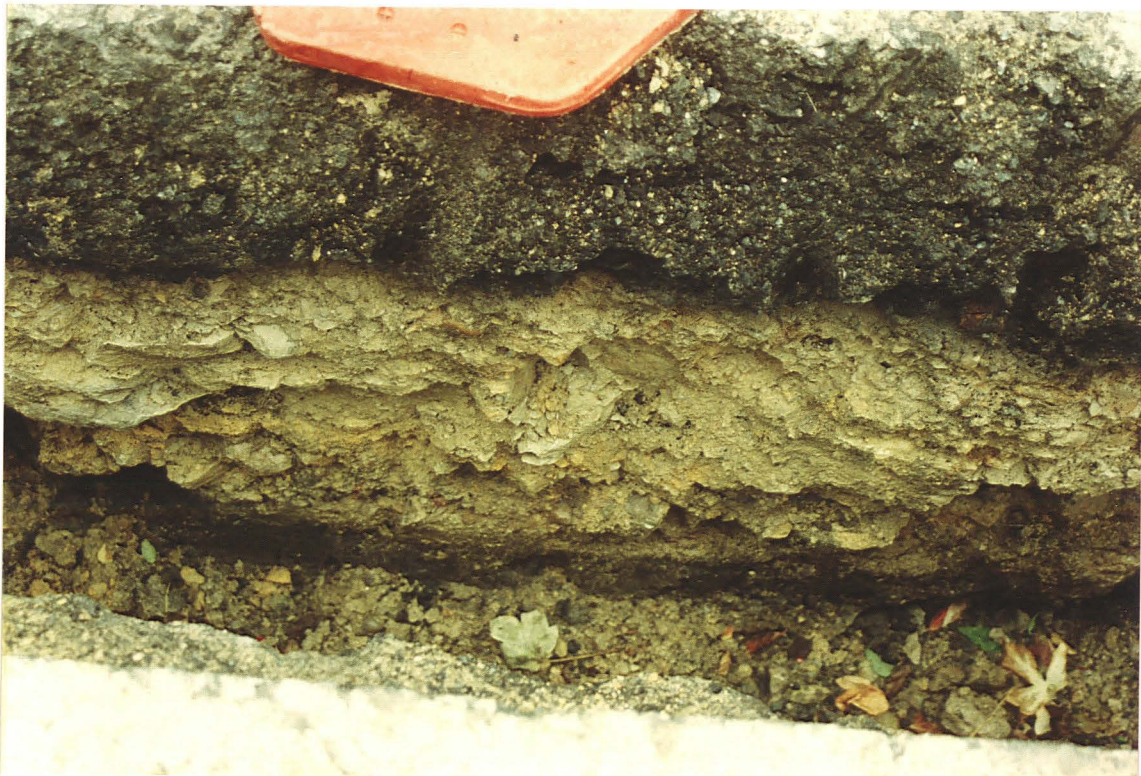
Pl. 10 Thick limestone rubble road foundation at 4a, overlying peaty material at the trench base.

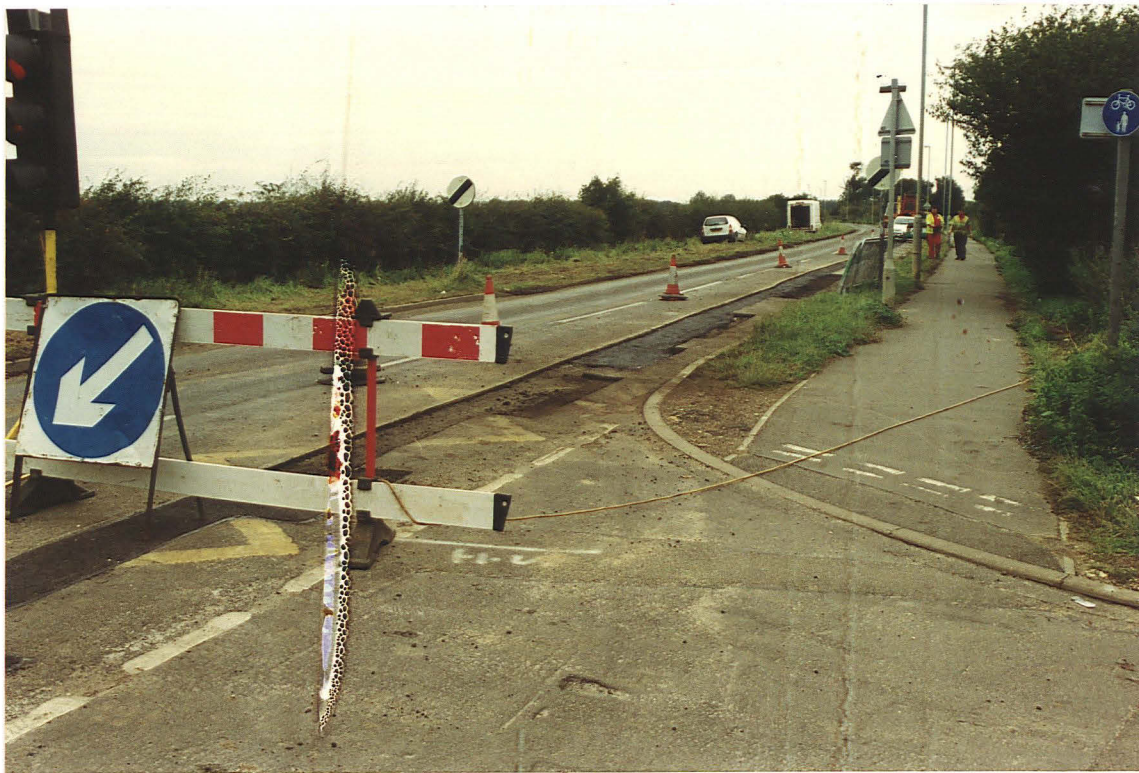
**3.** In Station Road, immediately north of Branston Community College, the road is raised relative to the fields to either side, as is the track to Grange Barn (Pl. 7). Within the road, the trench exposed 0.3m of tarmac over 0.2m of limestone rubble. A 0.15m thick, mixed layer of clay and rubble beneath this covered a red/brown loam (Pl. 8). It is probable that much of the visible material has been introduced to create a raised road across a depression. The original ground level may have been close to the trench base (1.05m deep), and any archaeological features present here may not have been disturbed by this scheme.

Pl. 7 Location of the monitored trench 3, Station Road, Branston (looking north from the college entrance).

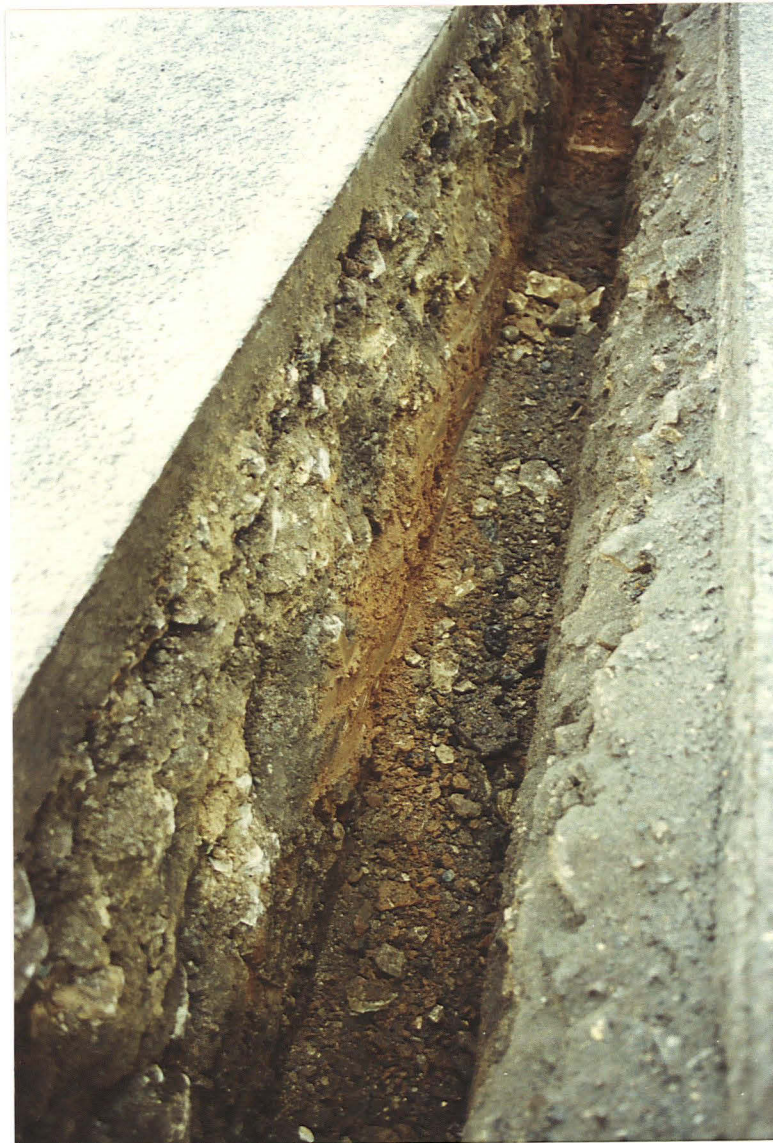
Pl. 8 Thick layer of limestone road foundation at 3, with light brown buried soil at the trench base.

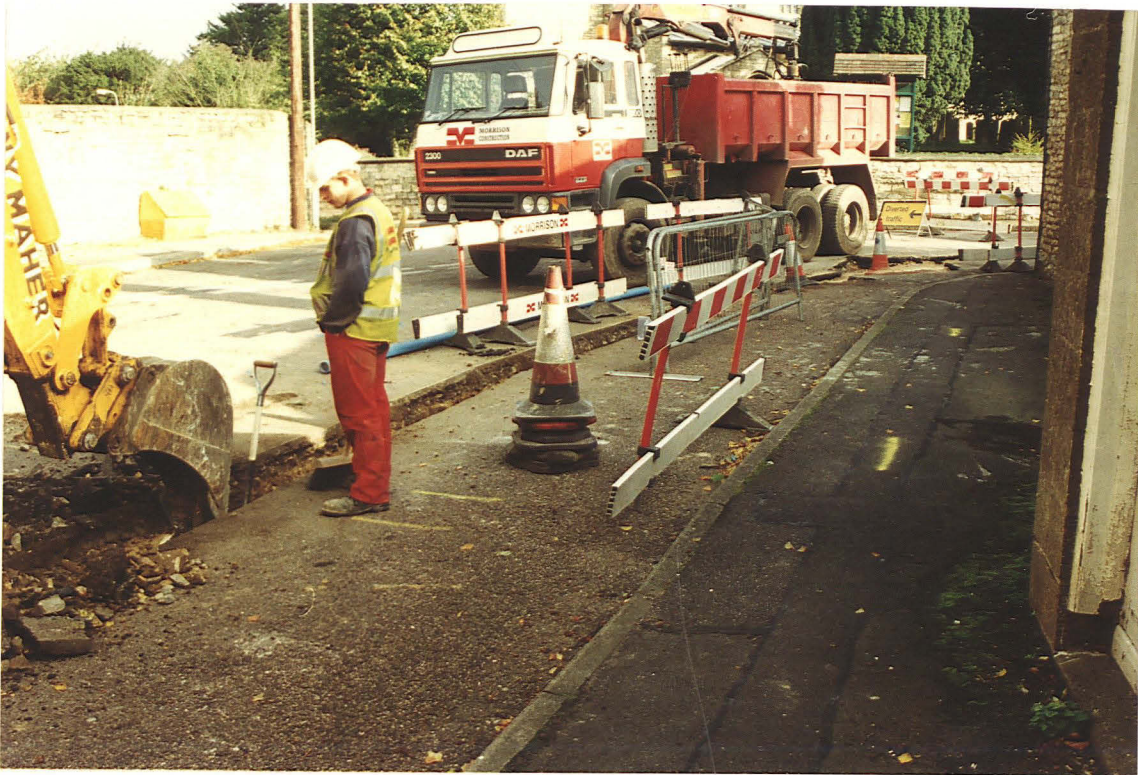
This feature was interpreted as a backfilled watercourse or broad ditch. The road here is at about 39m OD, in a depression between higher ground at the church to the north, and the junction with Hall Lane to the south. It was noted that the feature shared a common alignment with the boundary wall of the Hainton House property to the SW of the church (Pls. 5 and 6). The boundary wall forms one side of a narrow lane which leads to Rectory Lane.

Pl. 5 Location of 2d, looking NW along its alignment. Hainton House lies beyond the wall to the left, with the church in the centre, top.

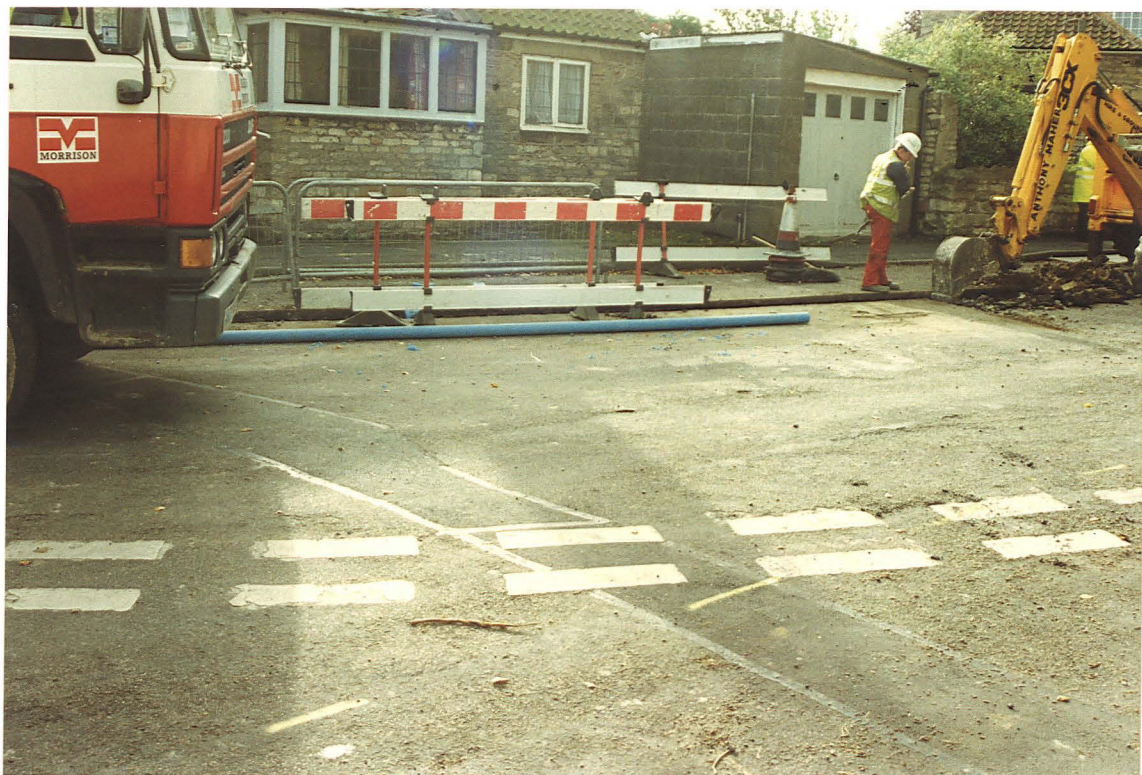
Pl. 6 Location of 2d, looking SE along its alignment.

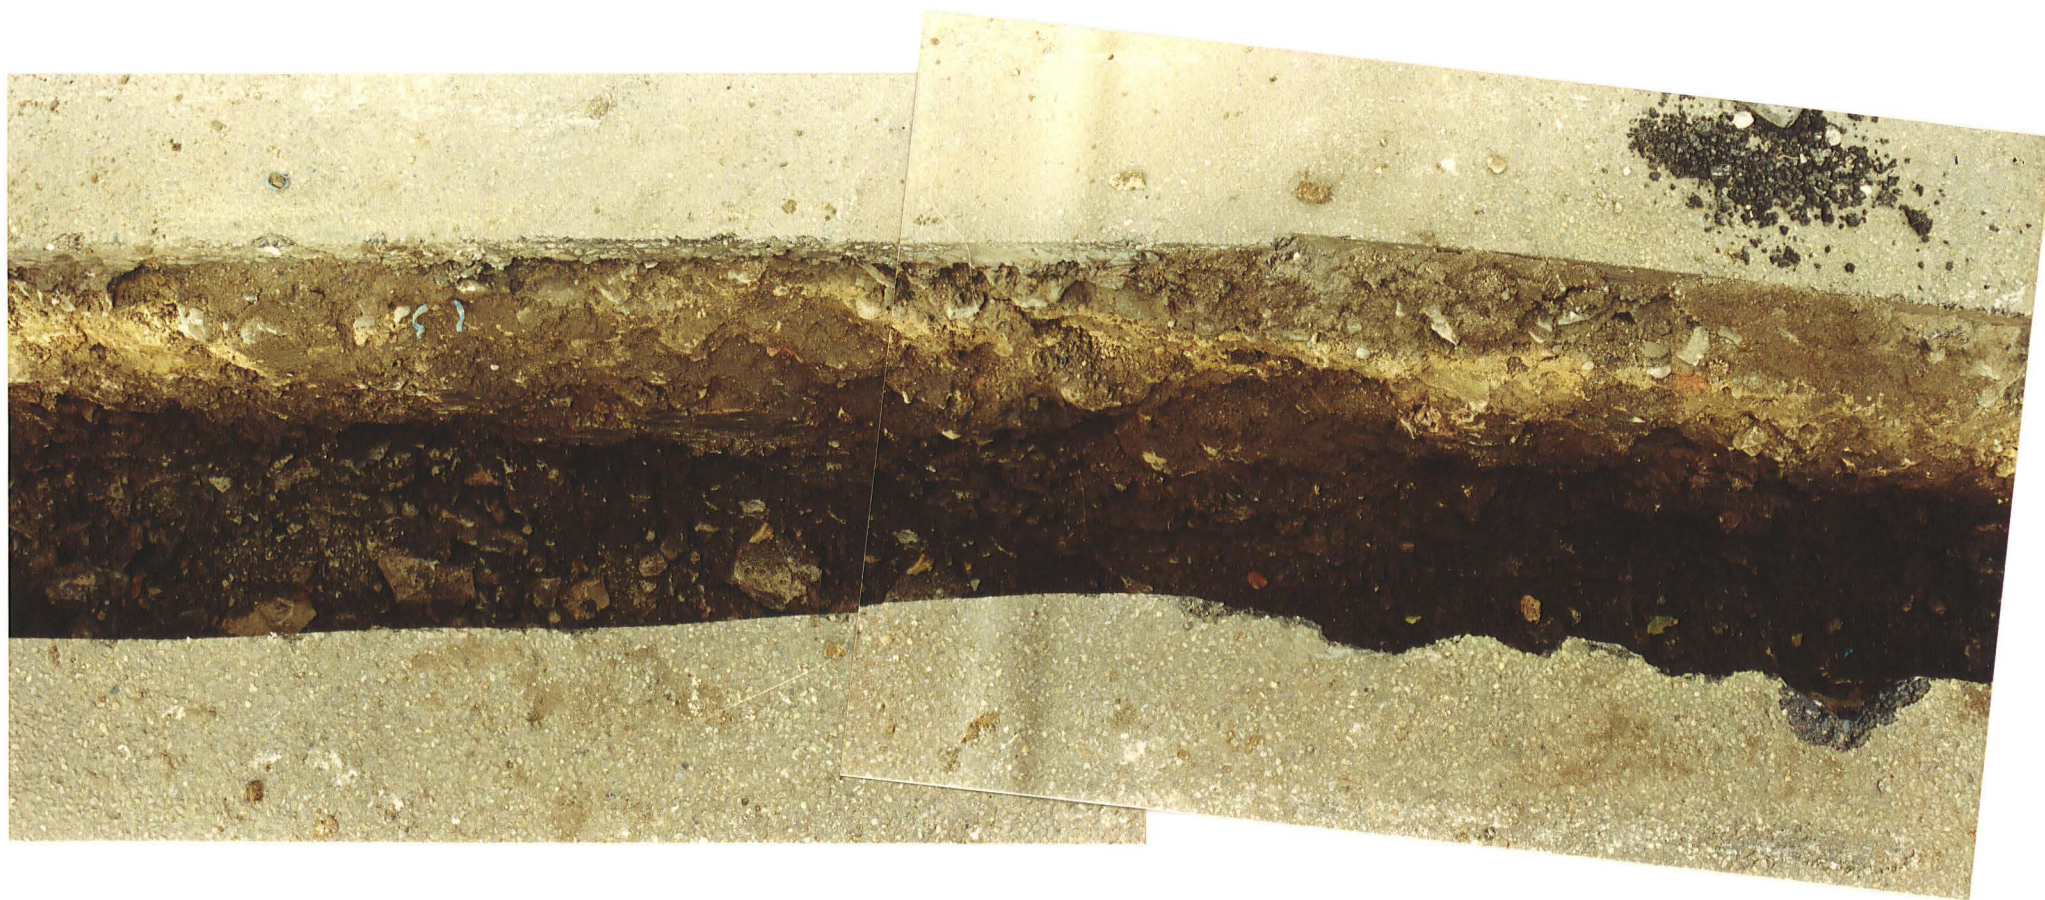
**2d.** From **2c**, the ground had been disturbed to a depth lower than the trench base (0.9m below the surface) by a 14m wide feature, apparently aligned NW-SE or north-south (Pl. 2). The sides seemed to be steeply sloping (Pl. 3). The fill contained a high proportion of dark brown clay loam, with some limestone rubble, but nothing dateable was seen other than brick and tile fragments in the top fill (Pl. 4).

Pl. 4 Dark soil fill of 2d.

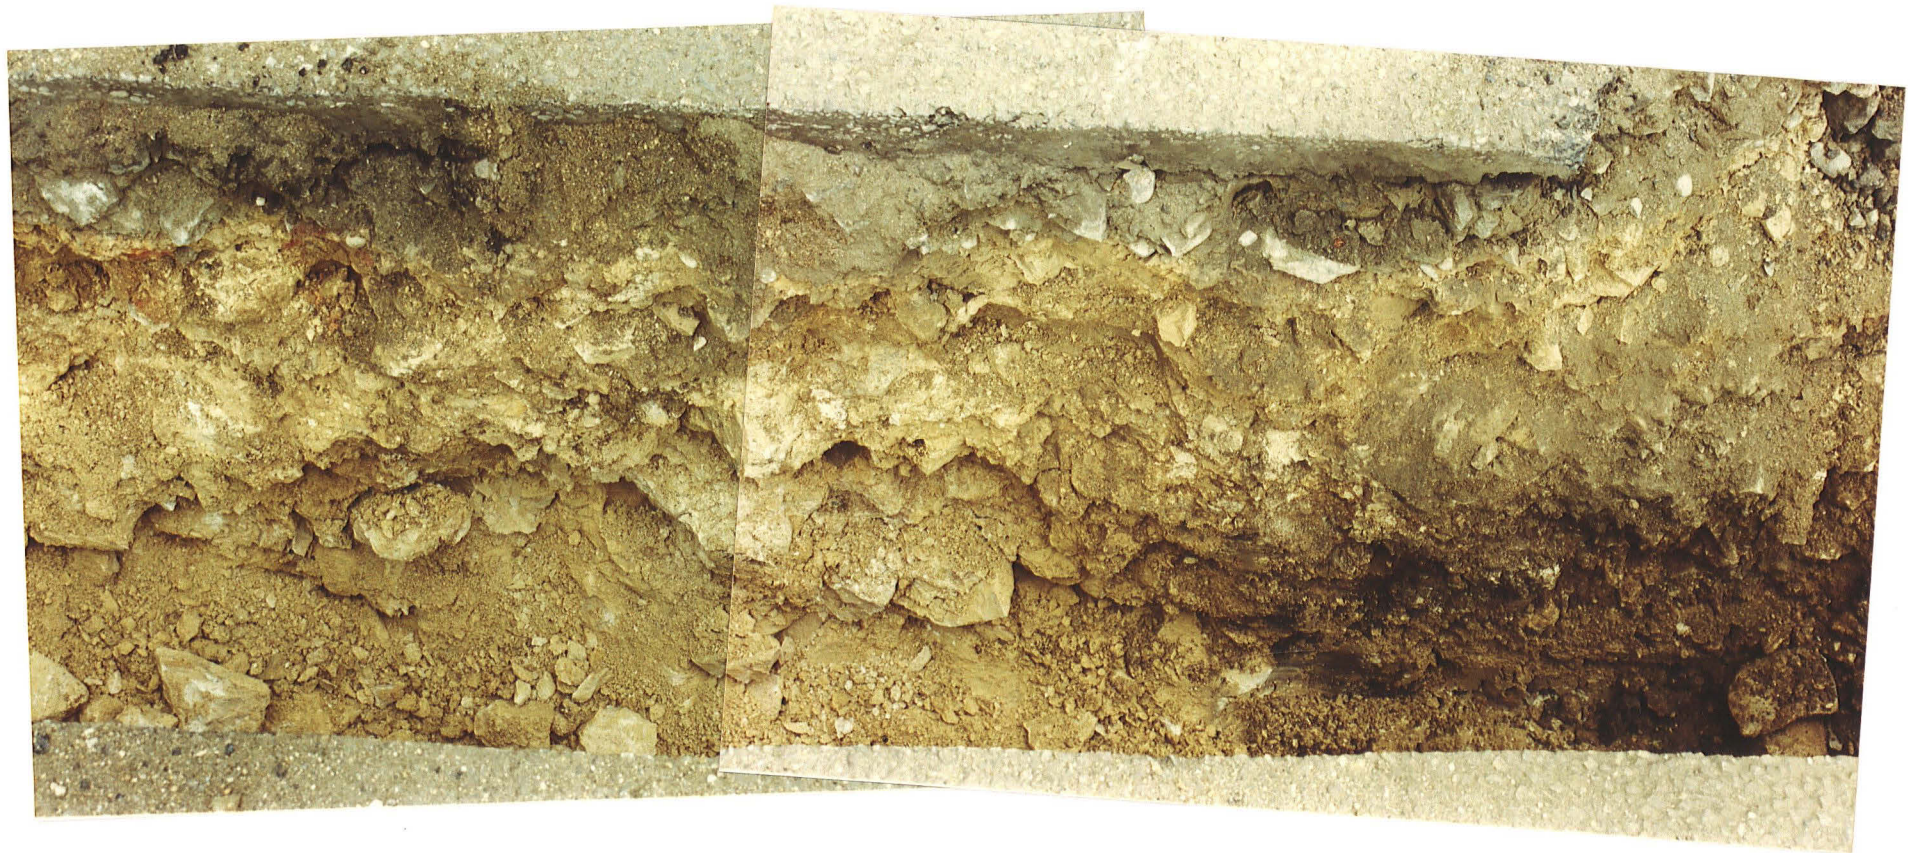
**Pl. 3** Detail of the southern edge of the broad feature 2d, Church Road, Branston. The dark fill is to the right, with apparently undisturbed bedrock to the left.

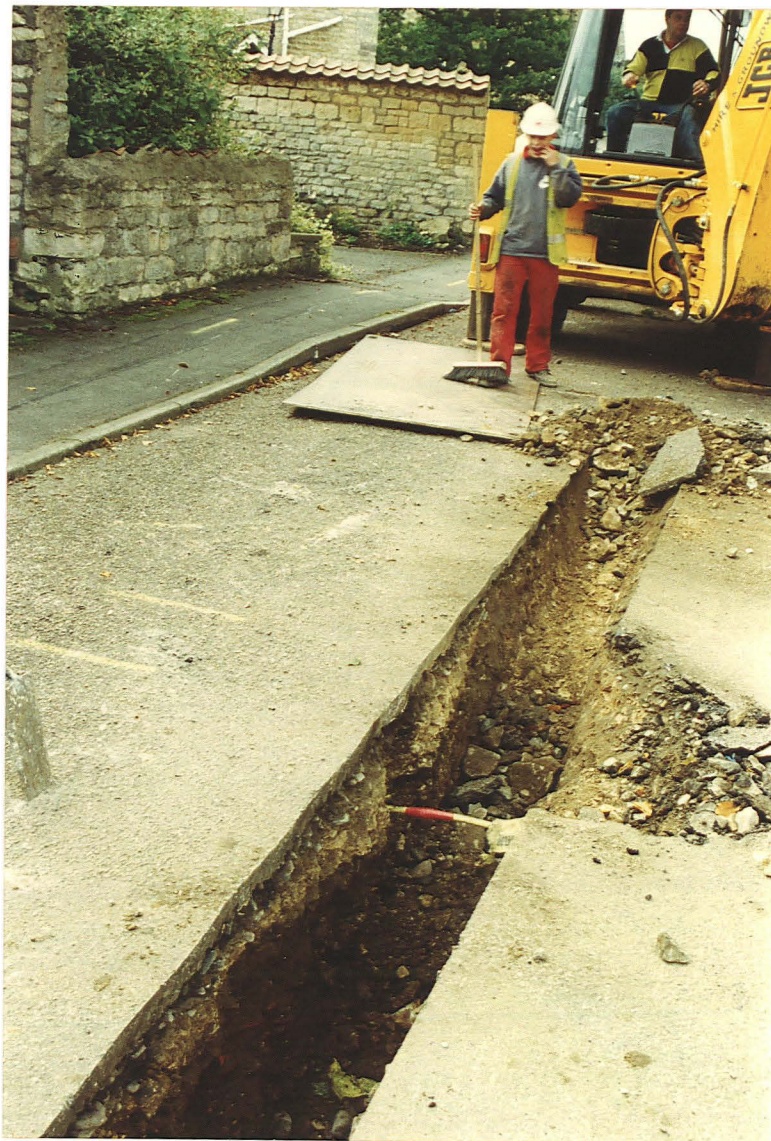
PI. 2 Limestone in the trench end marking the southern edge of the broad feature 2d, Church Road, Branston.

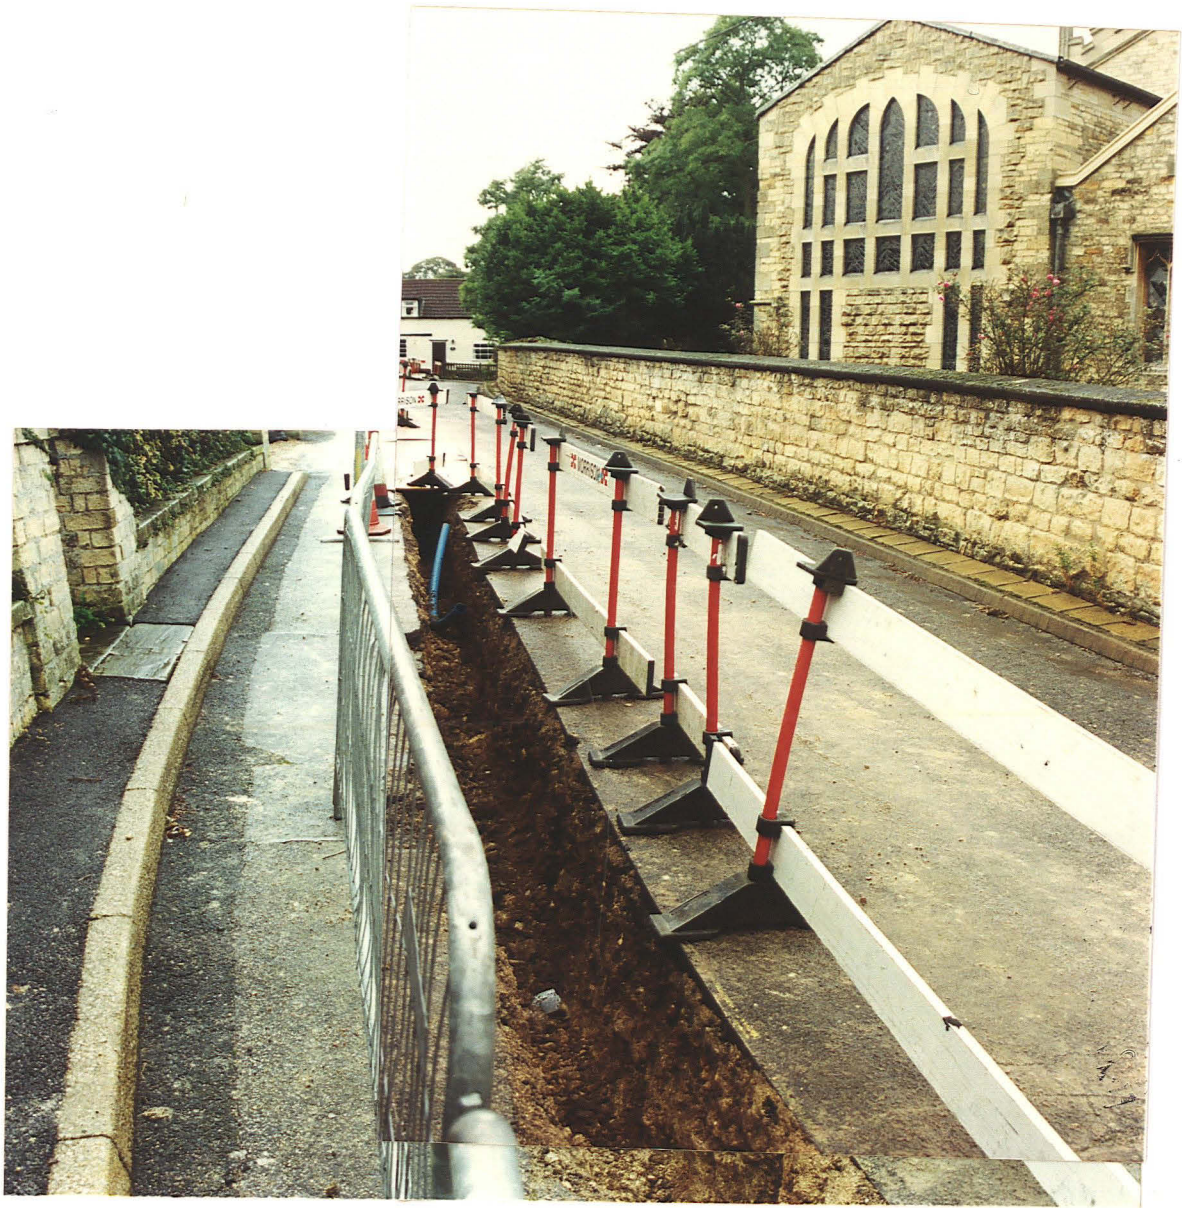
**2a.** Alongside the NE edge of the churchyard, the trench cut through very mixed deposits of soil and limestone rubble, which extended beneath the trench base (PI. 1). The material was not uniform, and may have been the fill of a large feature or of several intercutting features, possibly stone quarries. There is a small possibility that the disturbed material was more recent, and filled a broad existing service trench.

Pl. 1 Disturbed deposits 2a, possibly from backfilled stone quarries, in the trench face opposite All Saints' Church, Branston (looking SW).
