**Church Farmhouse, Church End
North Somercotes, Lincs.**

Archaeological Watching Brief

LAS Report No. 488

December 2000

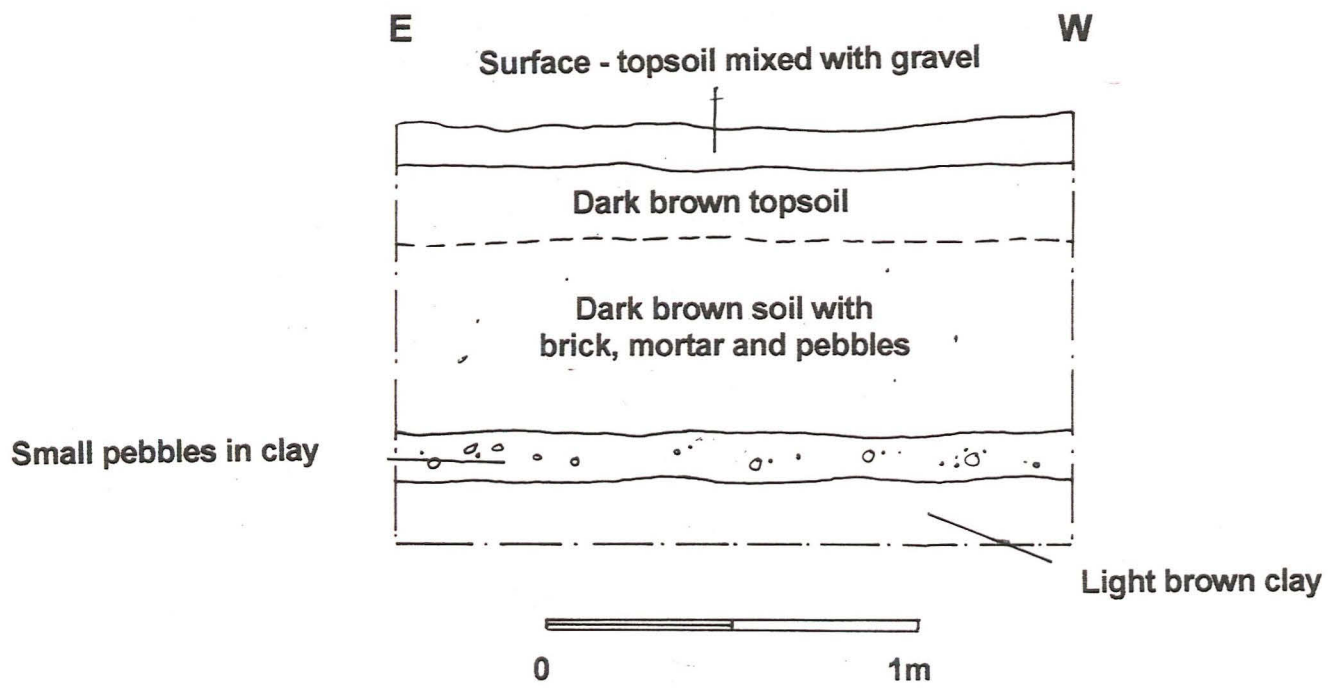
The foundation trench next to the road was cut through a backfilled service trench containing an alkathene water pipe (Pl. 6), and through the foundations of the demolished outbuilding running north-south. The 0.3m thick topsoil layer sealed a 0.5m thick layer of dark brown clay loam, which contained brick rubble, mortar, and infrequent rounded pebbles. The layer may represent a construction or demolition layer. Beneath it was a 0.1m thick band of clay containing numerous small rounded pebbles, which could be the remnants of a yard surface or possibly road metalling along the frontage. At the trench base was light brown clay (Fig. 3; Pl. 7).

Fig. 3 Sequence of deposits found in foundation trench adjacent to the road. Scale 1:20 (M. McDaid, after Field)

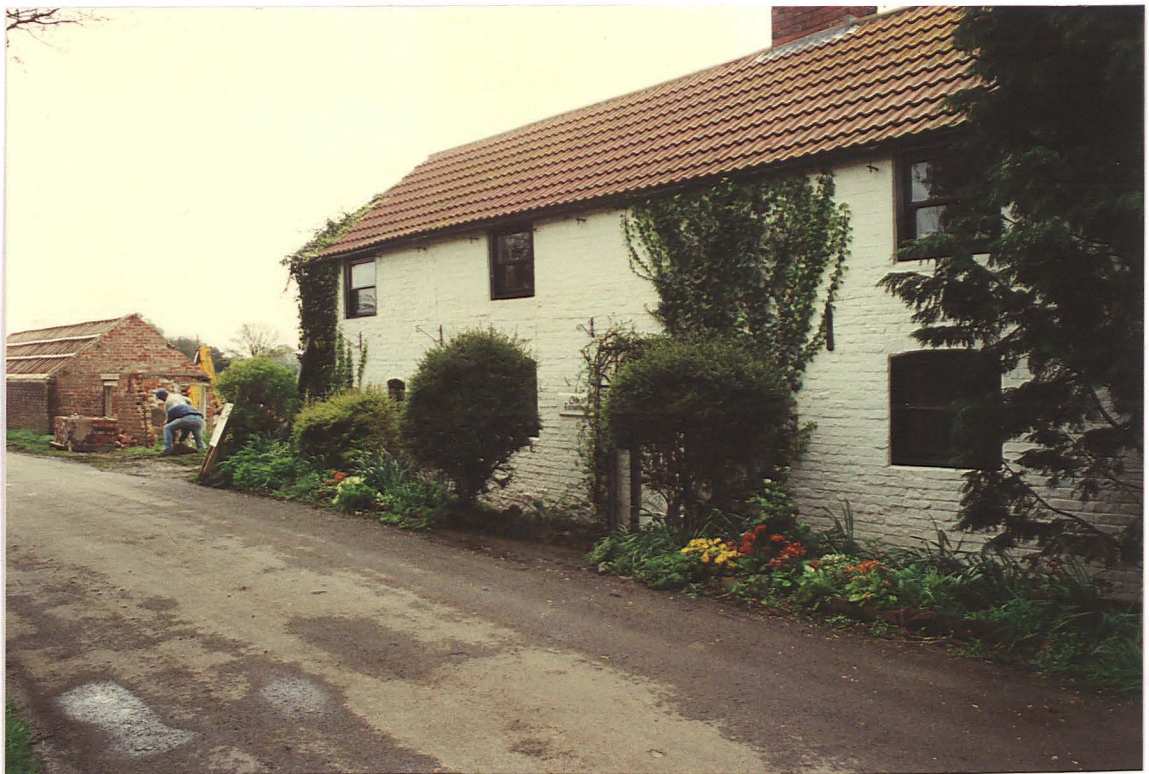
Church Farmhouse appears to have originally been a single storey brick building, with a central chimney stack and front entrance which was subsequently extended eastwards (Pls. 2 and 3). The building has a modern pantile roof and looks as if it has been raised by half a storey. An air photograph of the early 1960s (possibly 1962) in the possession of Mr and Mrs Drewett shows that much of this work has been carried out since then. The chimney has also been rebuilt.

Pl. 2 Church Farmhouse North Somercotes, front elevation looking south-east

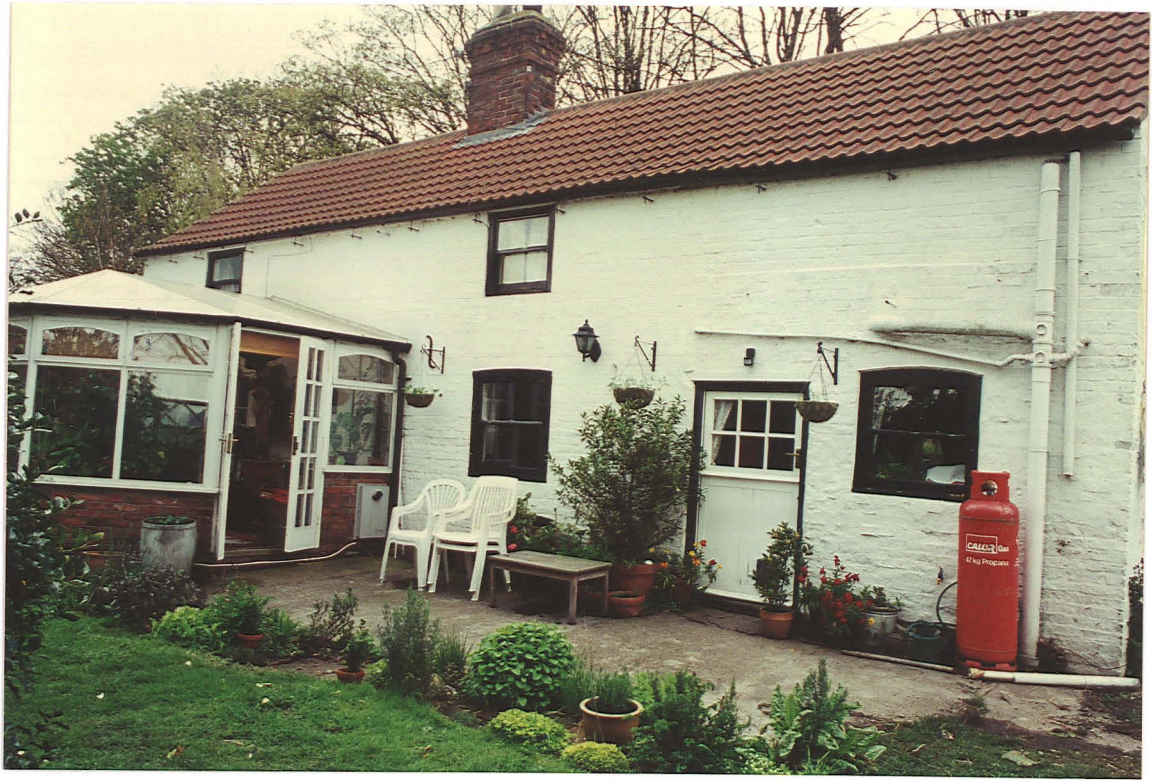
Pl. 3 Church Farmhouse North Somercotes, rear elevation looking north

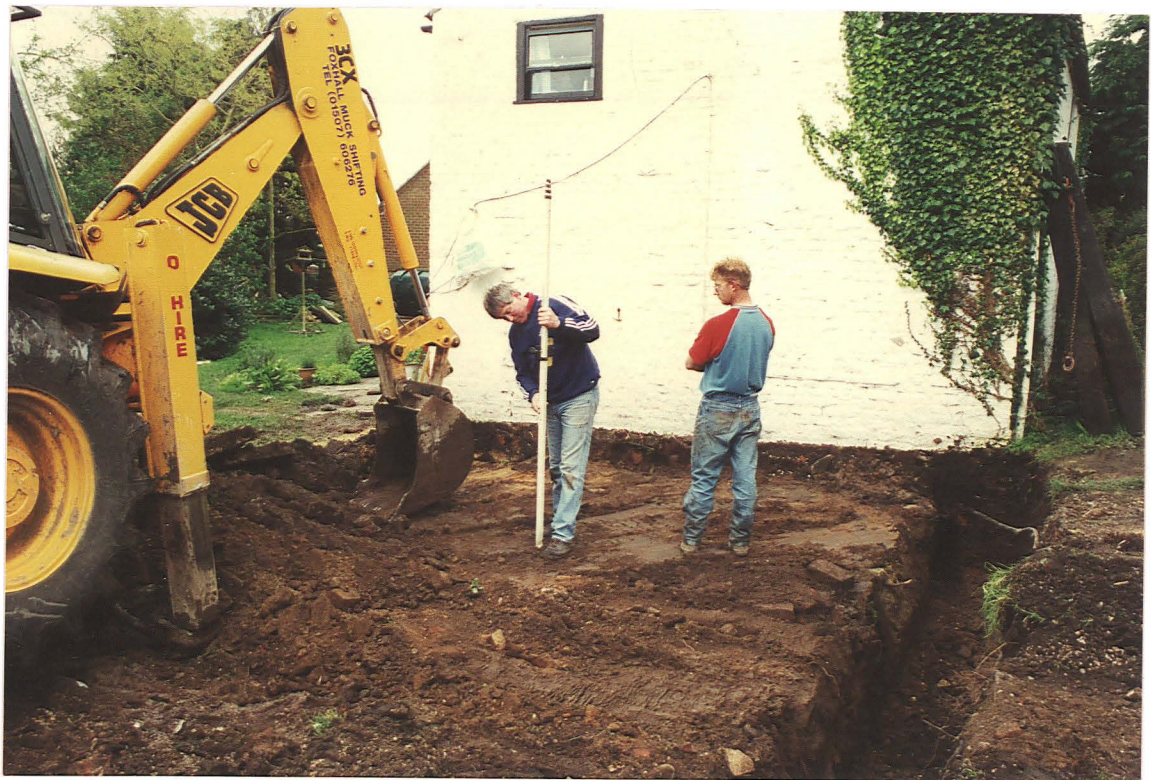
Within the 5m x 7.5m footprint of the new extension, the ground was lowered by 0.2m. The foundation trenches were excavated to a depth of 1m, through disturbed ground exposing boulder clay 0.8m below present ground levels (Pls 4 and 5).

At the western end of the new extension, the base of the brick foundations for the cottage were exposed 0.4m below the modern surface (Pl. 4).

Pl. 4 Topsoil clearance in progress, looking west

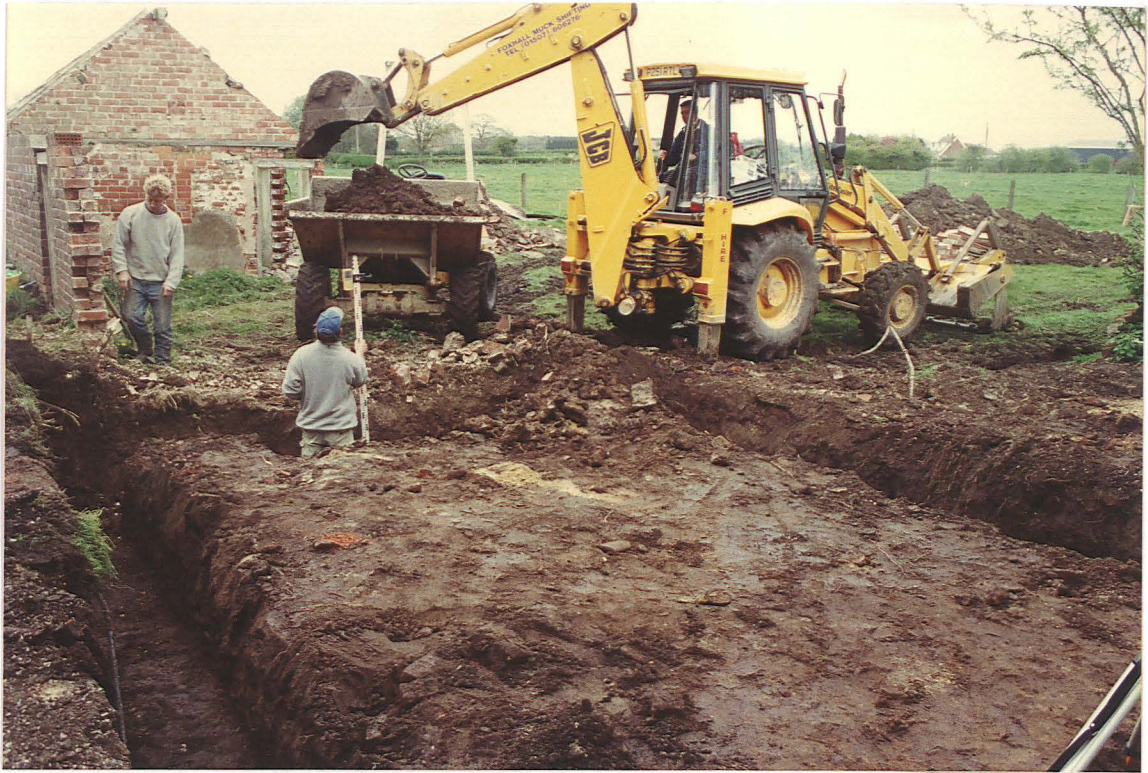
Pl. 5 Excavation of foundations looking east

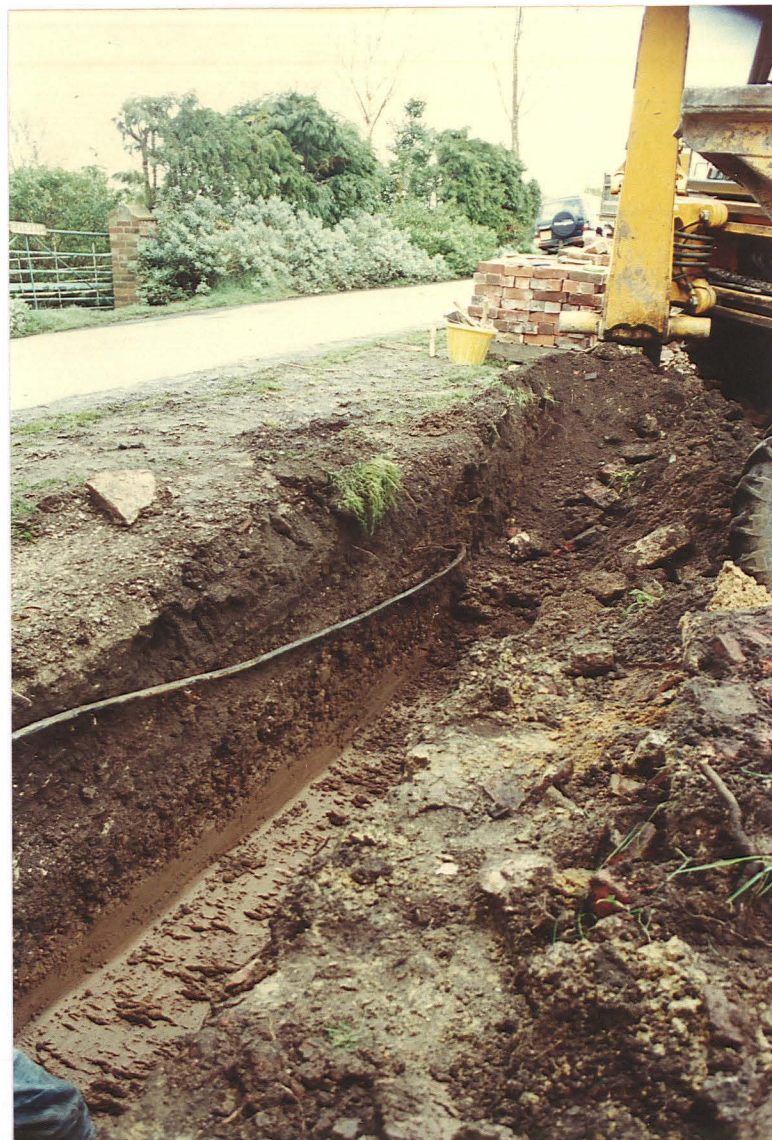
Pl. 6 Foundation trench with water pipe along road frontage, looking east

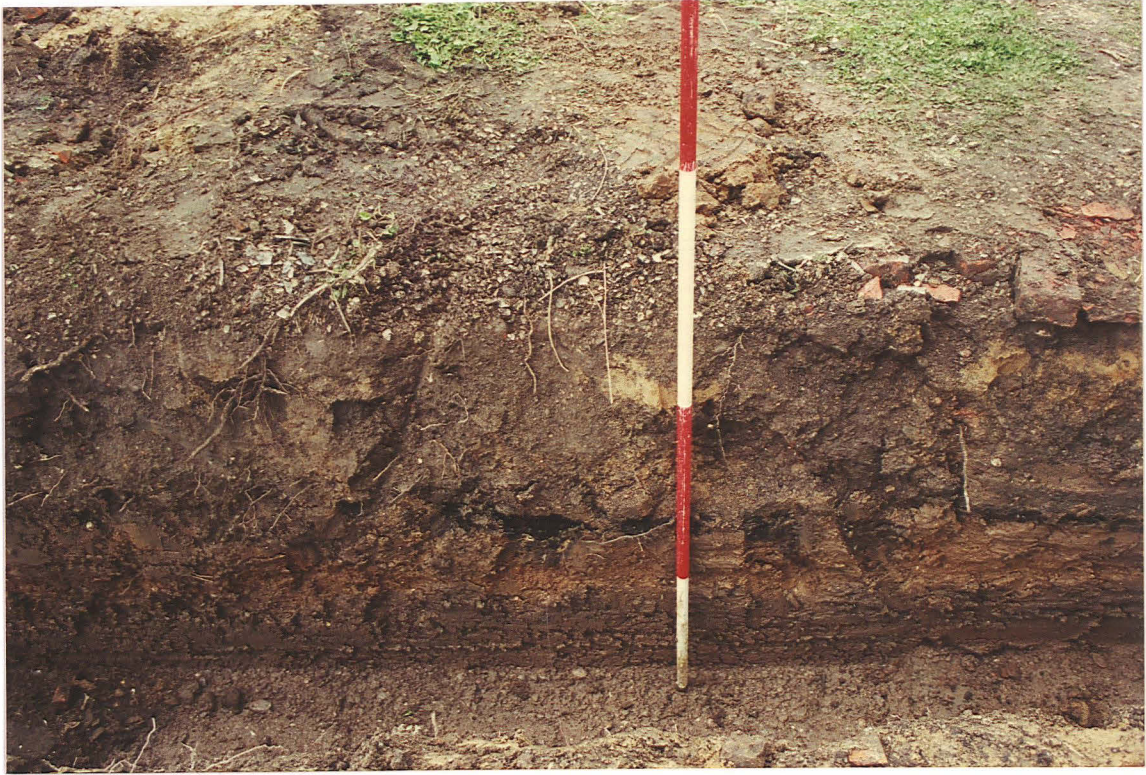
Pl. 7 General sequence of deposits in foundation trench along road frontage

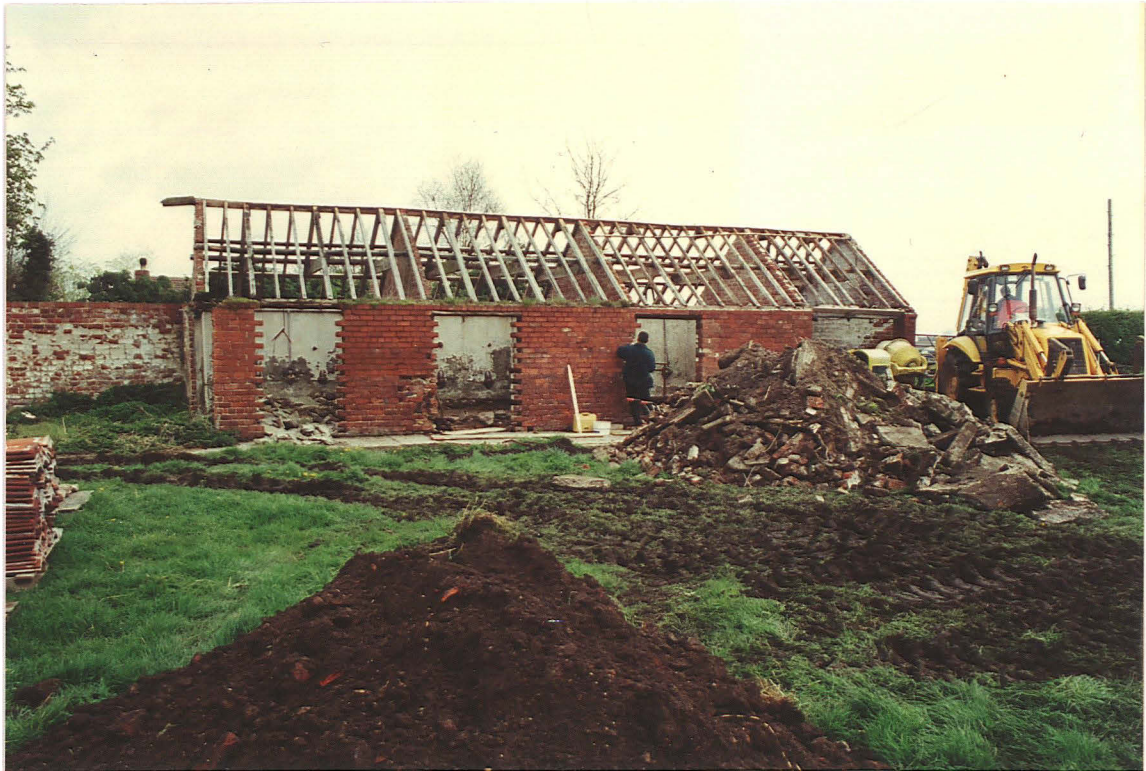
The watching brief provided an opportunity to inspect the former cattle shed. This was being converted to provide a studio, garden store and garage (Pl. 8). A timber brace and cross frame, together with three wattles, from a mud and stud building was exposed in the external face of the western wall (Pls. 9 and 10).

Pl. 8 The cattle shed east of the extension

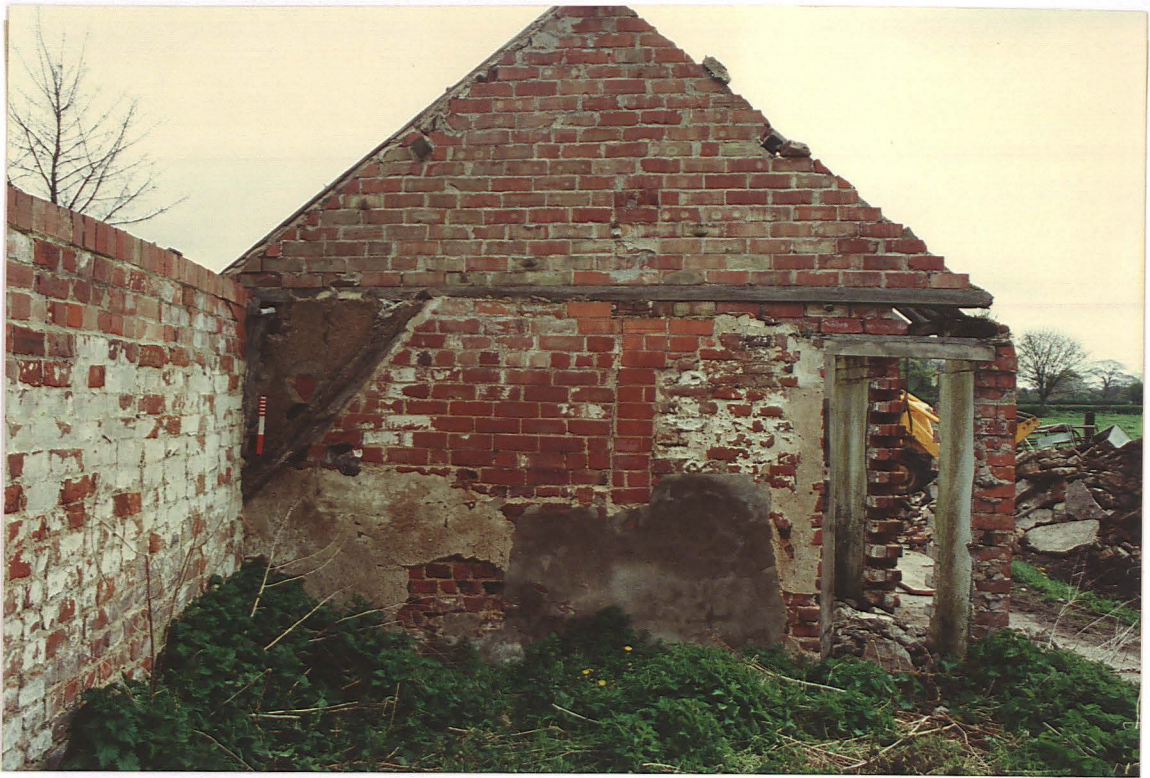
The brace spanned a point 1.165m across and 1.05m high. The corner post was at least 0.2m square in cross – section, the brace being 0.14m across. Just visible through holes in the mud was a horizontal rail 0.15m above the bottom of the brace (at the top of the solid red 10cm zone on the scale in Pl. 10). The opposite face of the wall was obscured by brickwork and rendering so the rail and other features could not be seen. The wattles had diameters of about 500mm, and one contained a visible nail. The surrounding mud fabric was rich in straw content and had been repaired with brick and tile fragments. There was no evidence that any other part of the mud and stud building remained, although there is some suggestion in the brickwork that a central post had been replaced with bricks (Pl. 9).

The presence of the rail on the east face of the wall indicates that this was an internal elevation and that the building continued eastwards. Whether the visible west facing elevation was the end of the building or an internal cross wall is unclear.

Pl. 9 Cross wall at west end of cattle shed showing remains of mud and stud wall

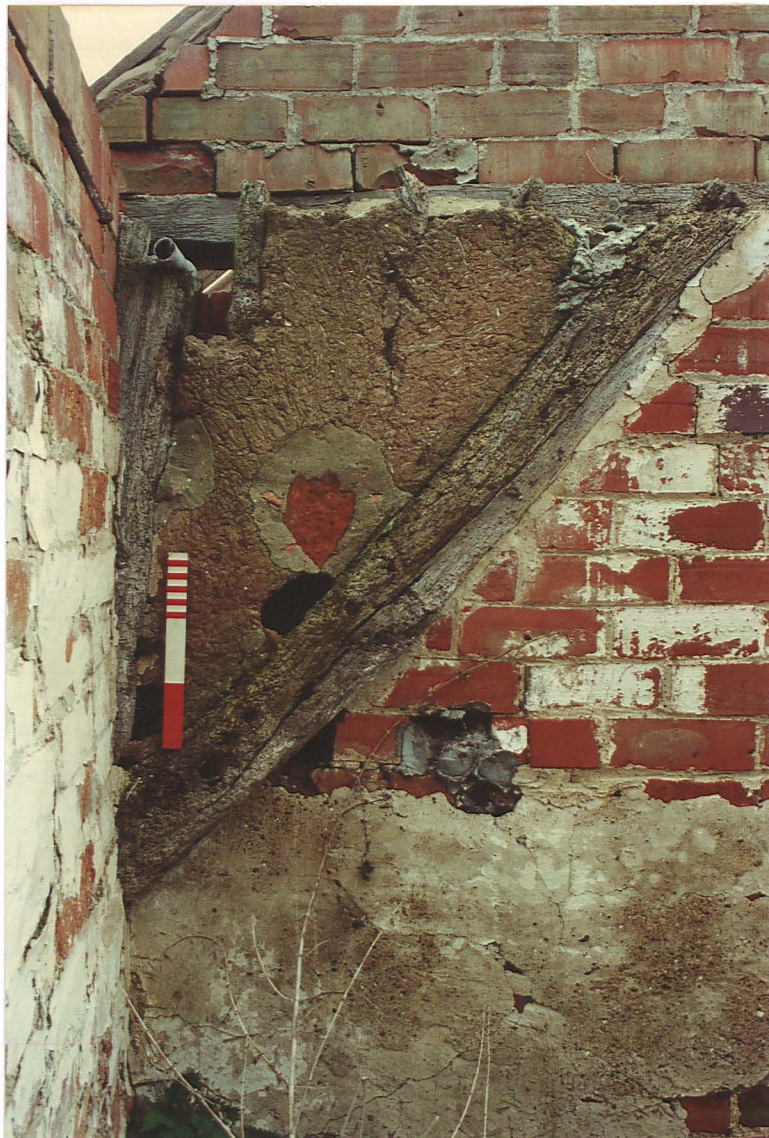
Pl. 10 Close up of brace and cross frame fragment belonging to a mud and stud building

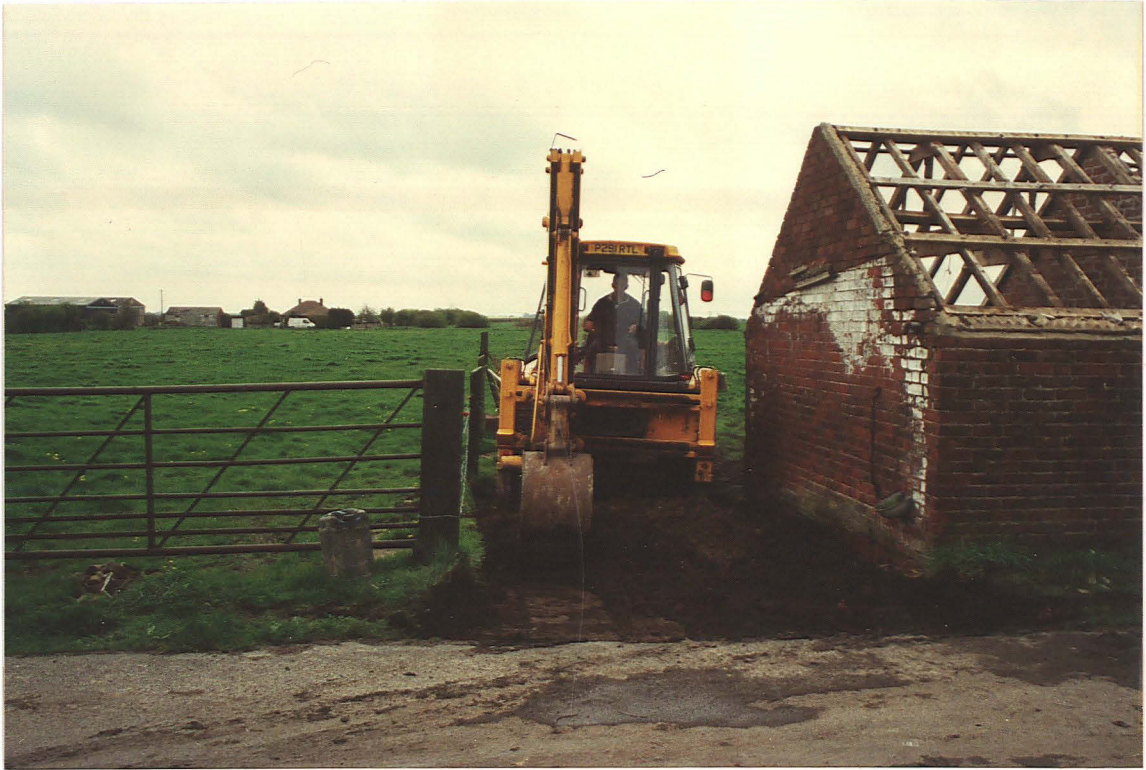
Topsoil removal of the garage access to the east of the existing cattle shed failed to identify any archaeological remains (Pl. 11).

Pl. 11 Clearance of access to east of cattle shed
