Osgodby cum Kirkby S101A Sewerage Scheme, Lincs Earthwork Survey and Evaluation Trenches NGR: TF 0700 9300 (centre) Site Code: OSS 02 LCNCC Accn No.: 2002.88

Report

for Anglian Water Services Ltd

LAS Report 572 February 2002

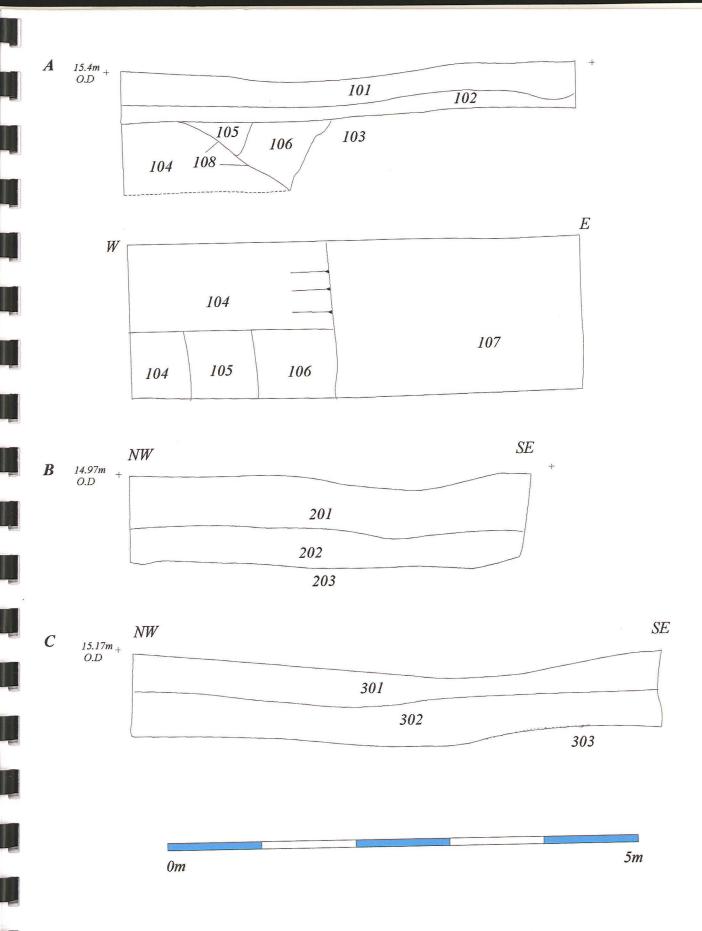
Fig 4. A) Trench 1, plan and section. B) Trench 2, plan and section. C) Trench 3, section.

Beneath the subsoil was a single feature (103) which extended beyond the section and was dug into a yellow grey firm clay natural (107). It was excavated to a maximum depth of 1.5m below the surface and was at least 2m wide. Its primary fill was an orange grey mottled clay (104) with a possible recut (108) on its eastern side which was much narrower and filled with a mid grey mottle clay (106) and a yellow brown clay (105) (PI. 19).

The feature did not precisely line up with the depression visible on the surface but was the most likely cause of it. The very clayey nature of the fills suggest that the channel was for drainage although the sharp cuts suggests the form of a plough furrow. No dating evidence was recovered.

Trench 2 was 10m to the north west of Trench 1 and excavated across a linear earthwork orientated approximately east-west. It was 1m deep with 0.60m of topsoil (201) over 0.40m of subsoil (202) onto a firm yellow grey clay (203) (PI. 20, wrongly labelled Trench1). No archaeological explanation for the earthwork was found although a variation in the natural clay possibly relates to a water channel.

Trench 3 was excavated through a much more amorphous earthwork to the northwest. The earthwork itself appeared to be linear but lost some of its coherence when it entered the area of investigation. The topsoil (301) was approximately 0.50m deep and overlay 0.30m of subsoil (302) onto a yellow grey natural (303). There was a slight depression in the natural which seemed to correspond with the overlying earthwork (PI. 21). Again it seems likely that the depression was a water channel and or alterations to line of the stream.

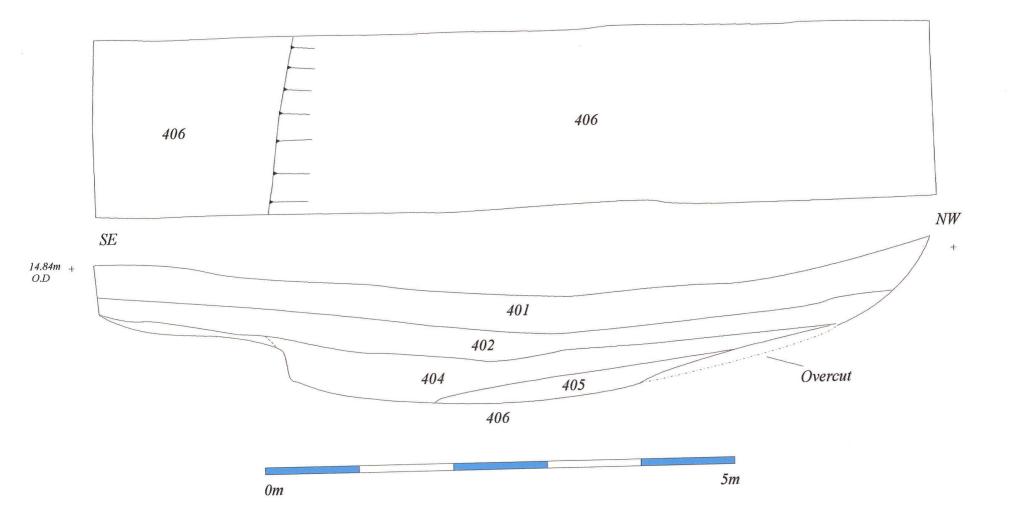
Fig. 5 Trench 4 plan and section.

Trench 4 was positioned to investigate an elongated horseshoe like feature to the west of Trench 3. It was 10m long and 2m wide. The topsoil (401) was 0.40m deep, overlying a 0.30m deep mid reddish brown subsoil (402). Below the subsoil was a cut (403), 6m wide, which corresponded with the earthwork. The fills were 404, a mid grey brown clay, 405 a mid red orange brown sand and 406 mid yellow/grey firm clay (Pl. 22). The feature had a sloping north side and a much steeper south side. There were no finds and the ditch was probably for drainage.

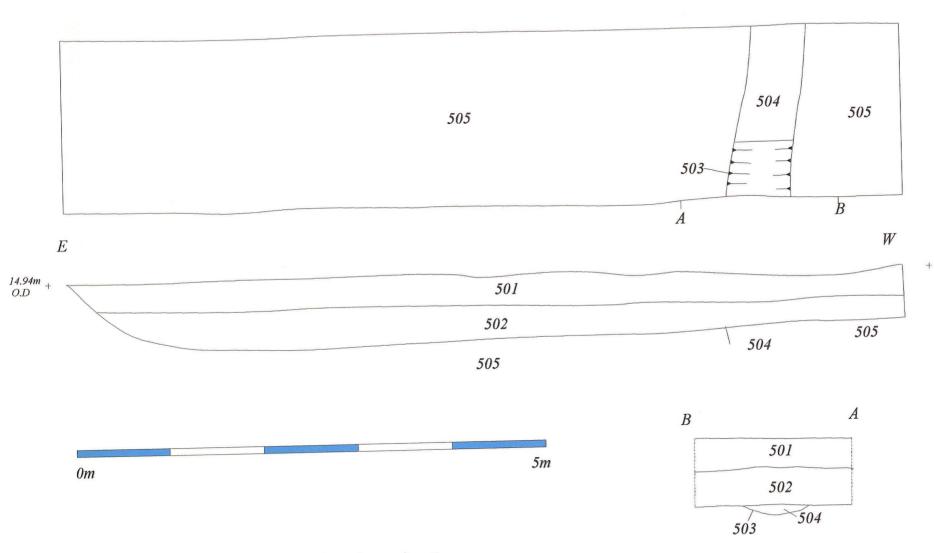
Fig 6. Trench 5, plan and section

Trench 5 was excavated over a slight plateau on the western part of the site, it measured 9m in length and 1.6m wide. It was excavated through 0.35m of topsoil (501) and 0.4m of subsoil (502) onto yellow grey firm clay (505) (Pl. 23). Cut through this clay was a narrow gully (503) 0.7m wide and 0.11m deep, containing a dark grey/brown silty clay (504) (Pl. 24).

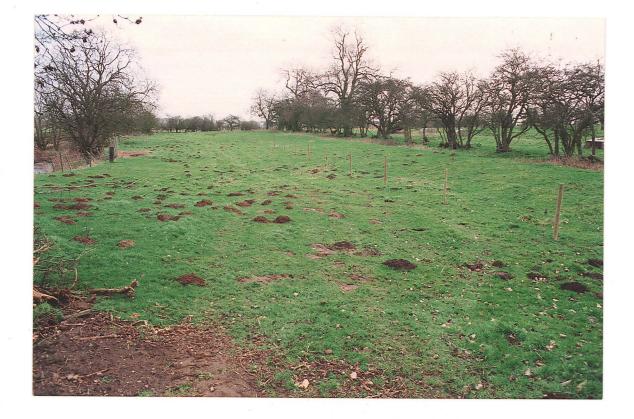
This narrow field immediately east of the bridge on Osgodby Rd is bounded to the south by a line of trees with a ditch on their north side. The ground drops slightly towards to the stream which forms the northern boundary, with a slight rise in the ground next to the stream bank, probably created by dredging of the channel (Pl. 1). In the SE corner of the field, where the boundaries of three fields meet, a deep channel runs north to join the stream (Pl. 2).

Pl. 1 Field 1 View looking east from road showing slight fall in ground level along line of easement posts.

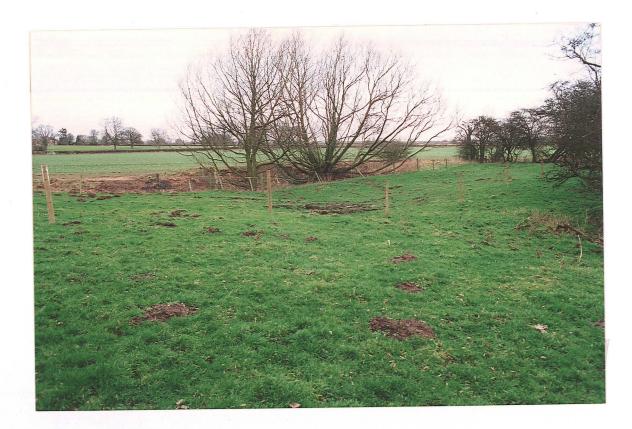
Pl. 2 Field 1. Depression at east end of field, probable former drainage channel running towards stream.

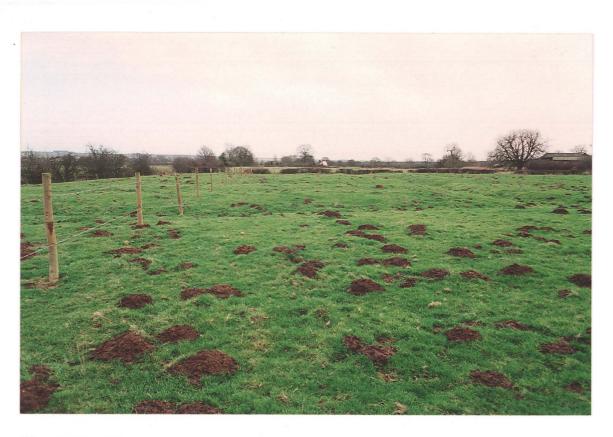
In the north-west corner of the field there appears to have been slippage into the stream along the north boundary. A series of four, possibly five, parallel channels run north towards the stream and are connected to an east-west channel. They don't quite reach the field boundary probably because the edge is masked by dredging along the stream edge (PIs 3 and 4). Two of the channels continue south, beyond the east-west channel. At the east end of Field 2 is a deeper channel which runs east and turns north towards the stream. It is perhaps a recut of channels belonging to the system immediately to the west (PI. 5). These are the most pronounced features along the pipeline route.

- PI. 3 Field 2 . View looking east showing regular drainage ditches.
- PI. 4 Field 2. View of western channel looking north

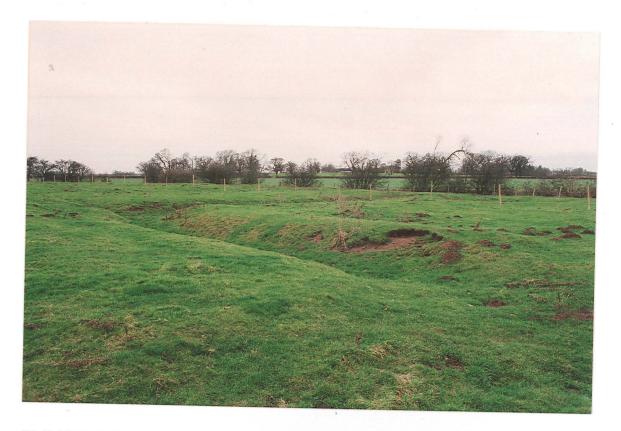
PI. 5 Field 2. Deep channel at east end of field running west then north, feeding into stream at hedge boundary.

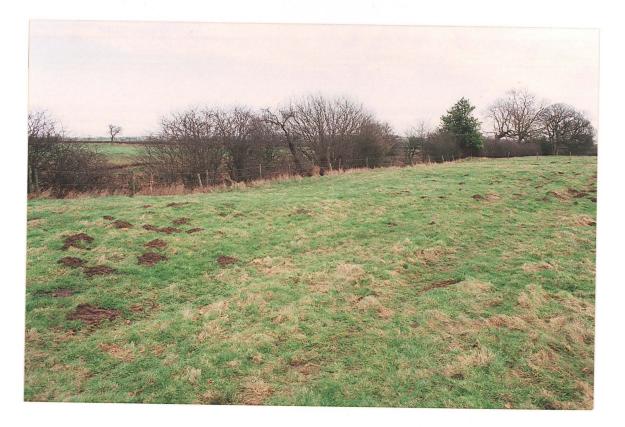
Pl. 6 Field 3a . Depression along hedgeline

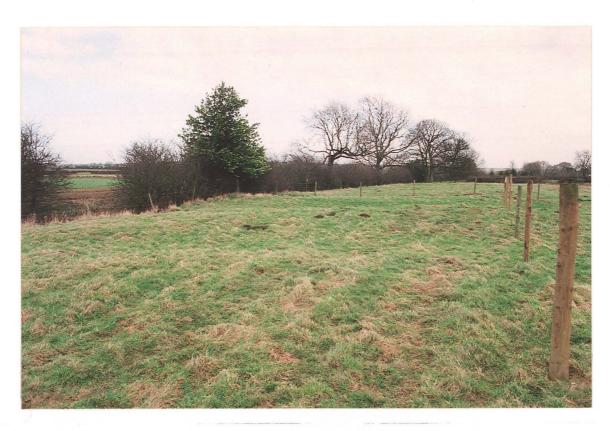
- PI. 7 Field 3a. Shallow oval depressions at east end of field, looking east.
- Pl. 8 Fields 3a and b. Shallow earthworks, looking east.

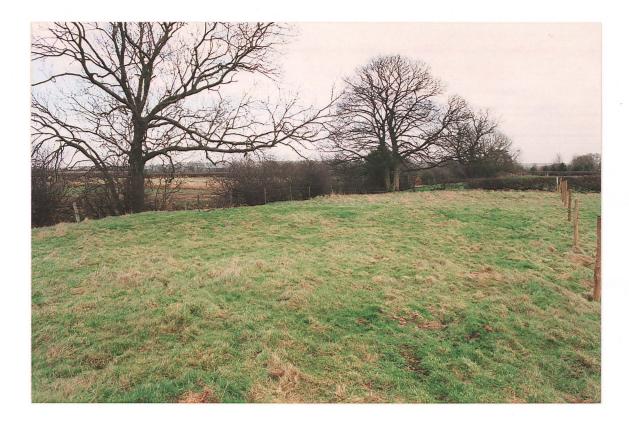
PI. 9 Field 3b.Earthworks at east end of field, looking east.

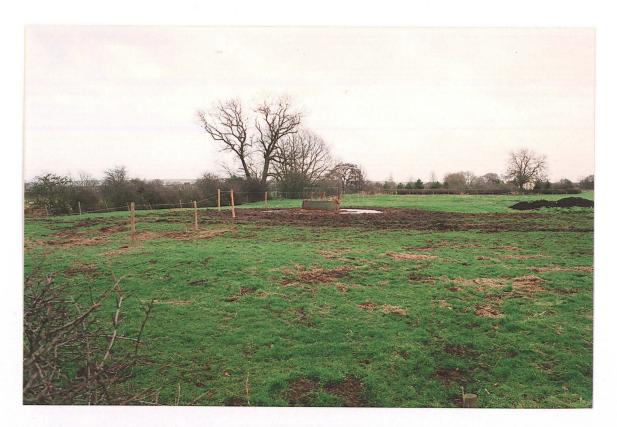
The channel observed in Fields 3a and 3b continues east into Field 4, running south of an animal feeding trough set in a shallow scoop at west end of the field (Pl. 10). It turns north and feeds into the stream through a deep channel with a bank on its east side (Trench 3 was dug across this feature, see below). A second shallower channel to the west (Pls 11-13) (Trench 4 was dug across this feature, see below). The channel enters the stream at a point along the bank where there has been extensive erosion. There are further areas of slippage along the bank and in the north-east corner of the field, next to the stream a shallow curving channel runs diagonally into the hedge (Pl. 14).

Pl. 10 Field 4 General view looking east with cattle trough in foreground

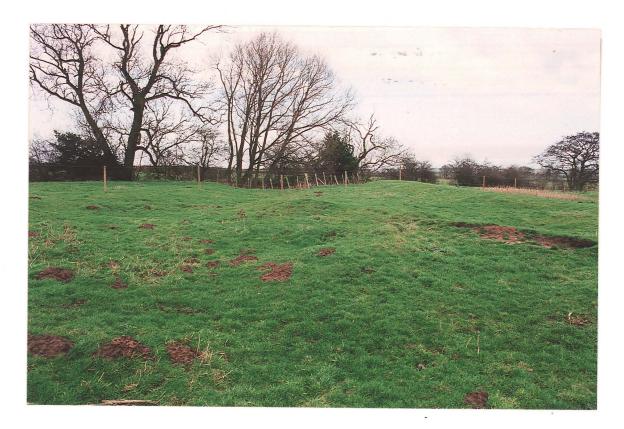
Pl. 13 Field 4. Bank adjacent to drainage channels. Looking north

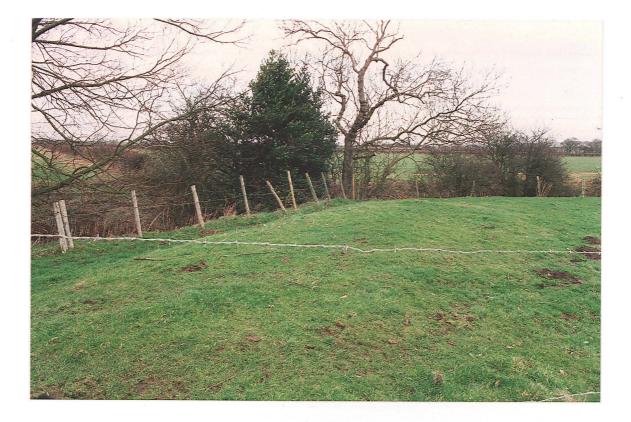
Pl. 14 Field 4. Channel in northeast corner of field

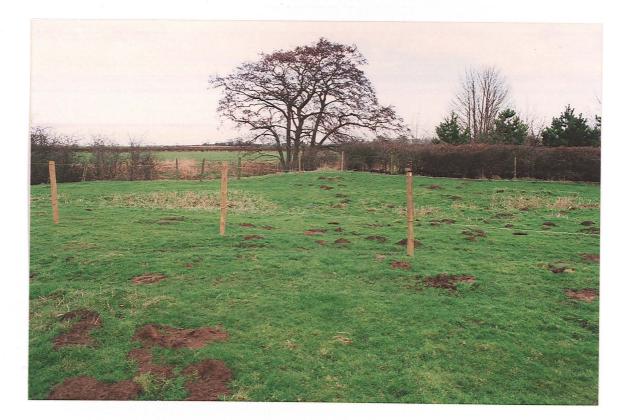
At east end of field are two distinct straight narrow gullies one aligned NNE-SSW (Pl. 15) and

- Pl. 15 Field 4. Narrow straight channel looking east
- PI. 16 Field 4. Undulations running north-south, possible ridge and furrow

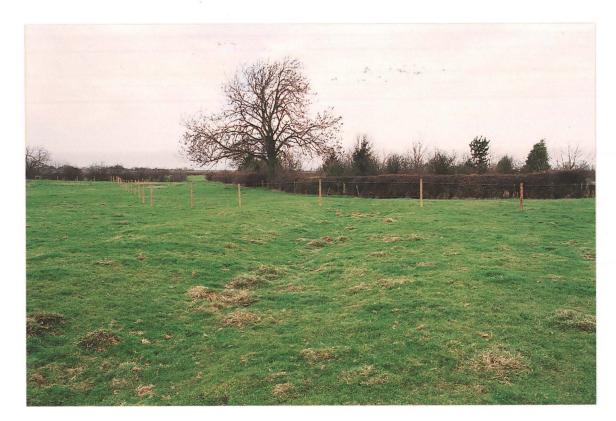
This field is currently under cultivation. Only shallow undulations are evident in the field (PI. 17).

- P. 17 Field 5. General view looking east along pipeline easement
- PI. 18 Trench 1 looking east

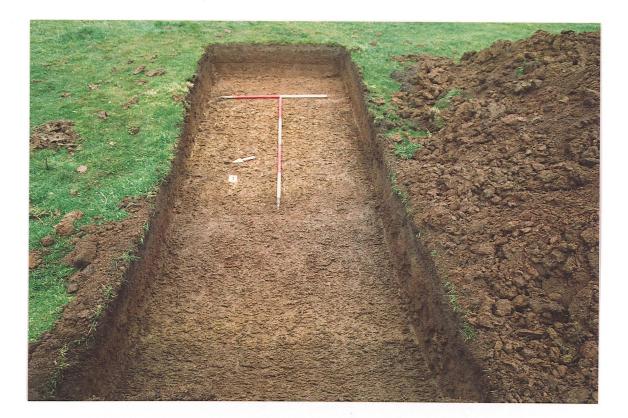
- PI. 19 Feature 103 looking north
- Pl. 20 Trench 2 looking south east

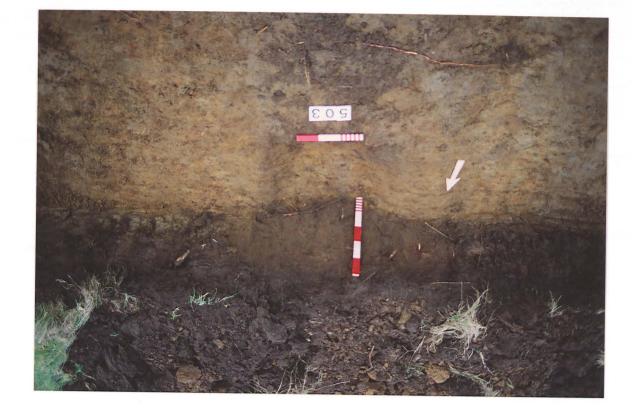
PI. 23 Trench 5 Gully 503, looking north
