LINDSEY ARCHAEOLOGICAL SERVICES

Lincoln, Glebe Park Mains Replacement Scheme

Archaeological Monitoring

LAS Report No. 608 September 2002 Conservation Services

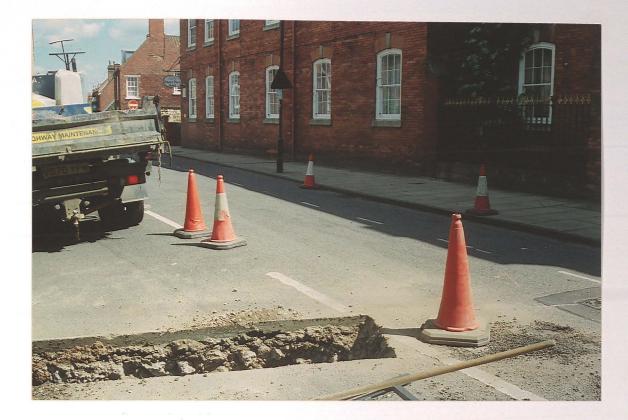
1. No Anglian Water works were monitored in Eastgate, but monitoring of works in Greetwellgate coincided with backfilling of a trench across the northern side of Eastgate by other contractors (Pl. 1). With their consent, this trench was inspected. Only the upper 0.4m of this trench

- PI. 1 Trench across the northern side of Eastgate, east of St. Peter's Church, (Observation 1).
- PI. 2 Compact layers of soil, gravel and stone chips below the centre of the modern road and its limestone rubble bedding layer, at Eastgate (1), looking south.

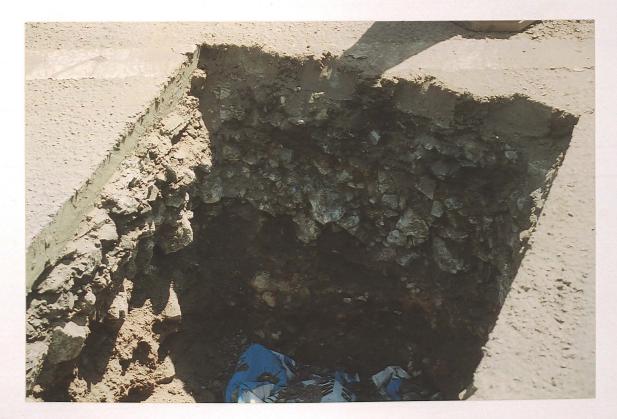
remained visible, with the modern tarmac surface overlying a layer of stone rubble. Beneath this was a very compact mix of stone chips and gravel (PI. 2). Suspicions that this was the Roman road from Eastgate were supported by the contractors' claim that this had been 'the most solid ground to dig in Lincoln'. Immediately to the north of the road, the front entrances of houses are set below street level, possibly within the flanking ditch. No trenches were seen in Langworthgate, the assumed path of the Roman road.

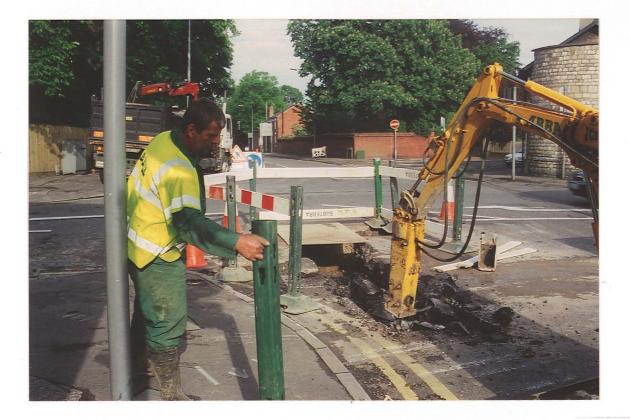
- PI. 3 Location of the Anglian Water trench (2) at the junction of Greetwellgate and Wragby Road (looking east).
- PI. 4 Compacted gravel deposits cut by later service pipe trenches at the junction of Greetwellgate and Wragby Road (2), looking NE.

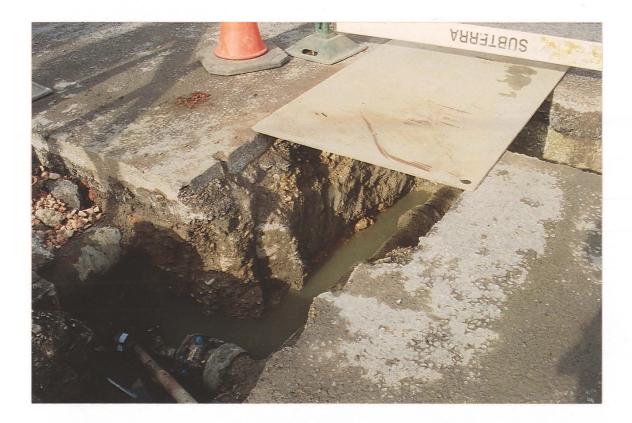
2. In the centre of the Wragby Road/Greetwell Road/Greetwell Gate road junction, the 0.6m thick modern road surface and bedding layer sealed 0.2m of yellow sand. Beneath the sand was compacted gravel, which extended below the trench base. In this location, the gravel has been introduced, and this would seem to mark a former road surface. The compaction was initially taken to indicate that this road may be Roman, but as no similar deposits were observed further to the east, this is unlikely. It is more probable that the section of Wragby Road southwards to Lindum Road was particularly well constructed in the post-medieval period.

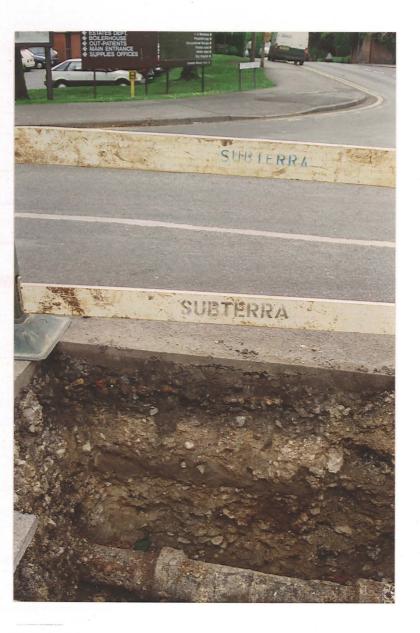
5. At the junction of Greetwell Road, St. Annes Road, and Monks Manor Drive, the 0.4m thick tarmac and asphalt surface had a 0.2m thick bedding layer of clay with limestone chips (PI. 5). Beneath this was 0.1m of dark brown loam, with what seemed to be undisturbed weathered limestone below. The dark brown loam layer may have been a turf or subsoil layer, onto which the medieval or later road was laid. The underlying layer, although not bedrock, contained patches of orange clay loam which probably denotes root disturbance.

PI. 5 Band of dark loam, possibly a buried ground surface, below the modern Greetwell Road, at the junction with St. Annes Road (5), looking south.
