Osgodby-cum-Kirkby S101A Sewerage Scheme

Archaeological Watching Brief

Report for Anglian Water Services Ltd

LAS Report No. 590 June 2002

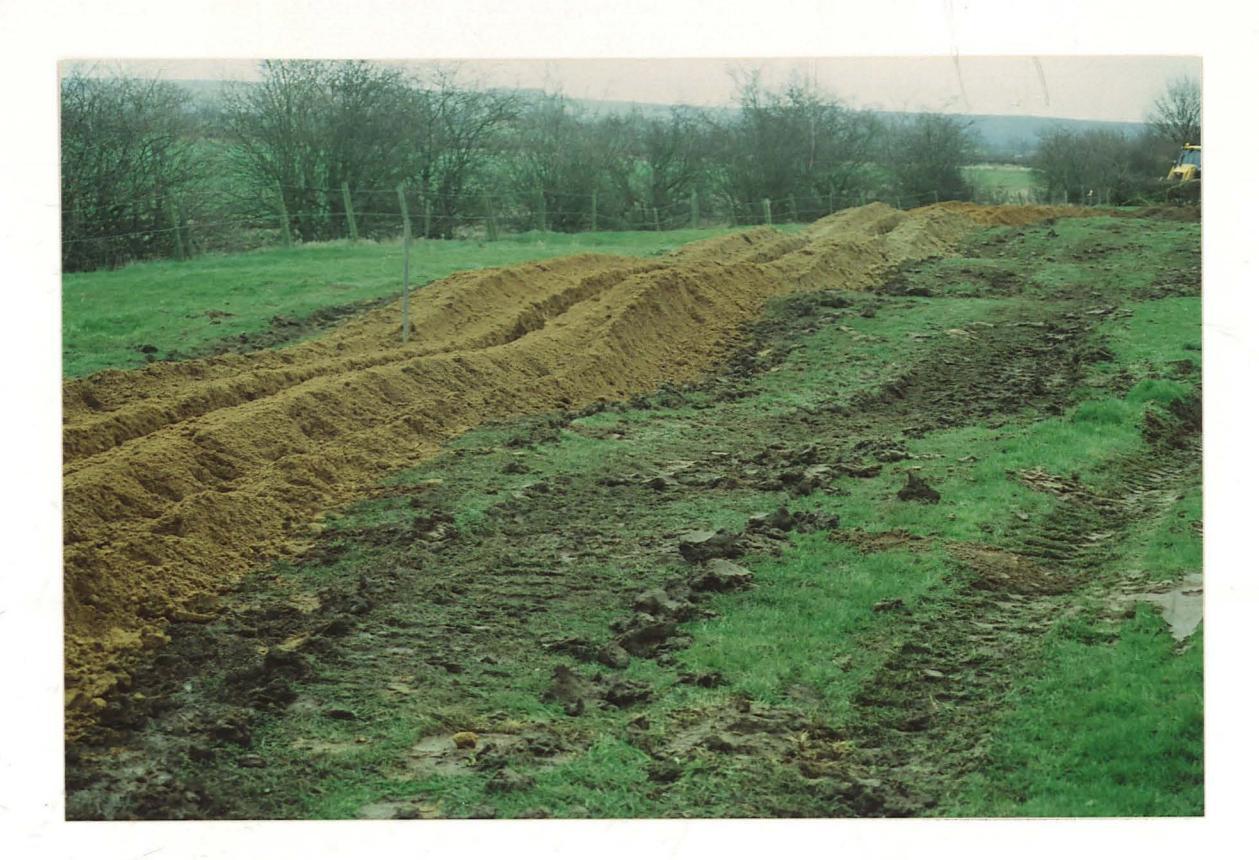
The pipe trench crossed the northern ends of a series of regularly spaced SE-NW aligned linear depressions, identified from the earthwork survey as drainage ditches. No further information could be obtained from the pipe trench, as sandy deposits 4 caused the trench to be particularly unstable. Variations in the colour of the sand from the trench indicated the presence of channels and banks, but the cutting chain of the trenching machine deposited upcast material a short distance west of its source (Pl. 1). Beside the eastern field boundary, the sand became a brown sandy loam 5, 0.7m thick, with a grey sandy clay beneath it.

- Pl. 1 Upcast soil beside the pipe trench, showing colour variations from the fills of banks and drainage channels at the eastern side of Field 2 (looking NE).
- PI.2 Soil from the pipe trench was redeposited a short distance away from its source; the dark sand fill of the former ditch 9 between Fields 3 and 4 appears across the adjacent earthwork bank (looking east).

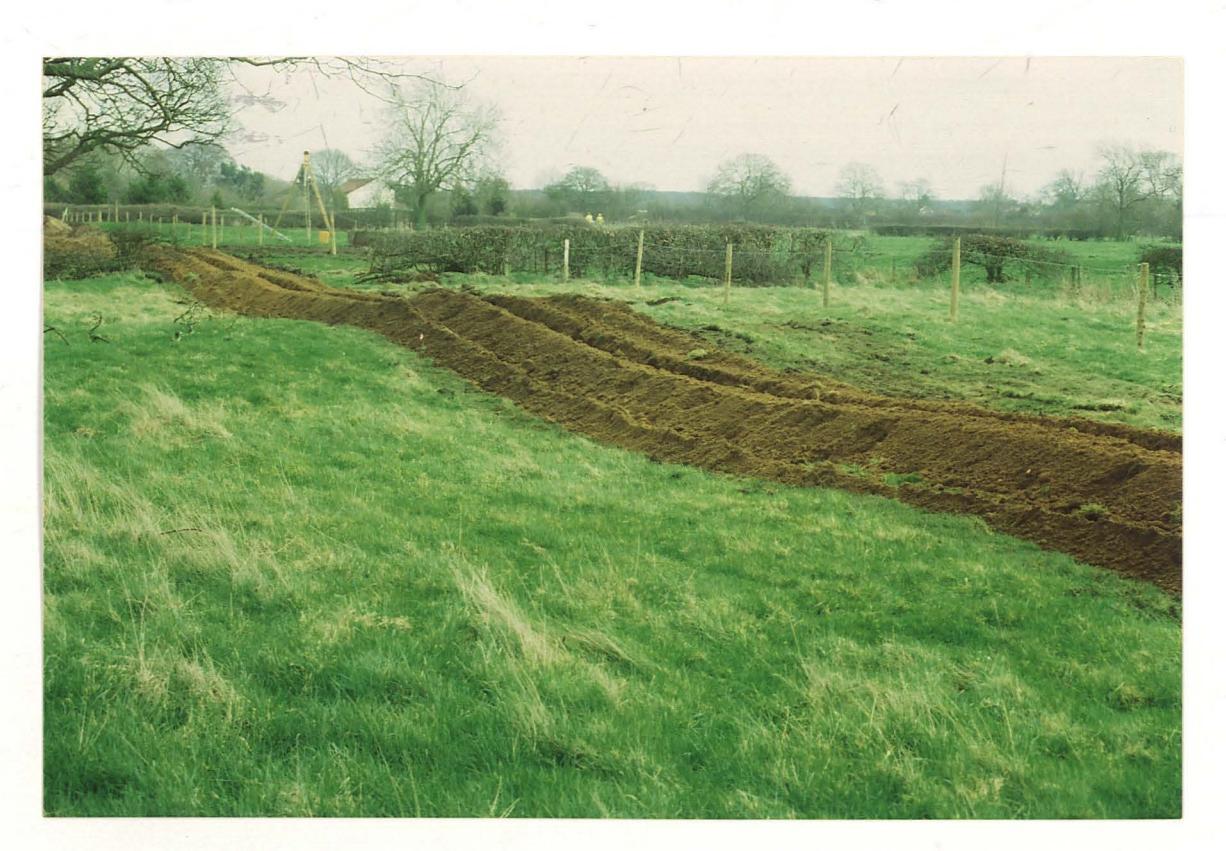
The trench revealed a 1.5m wide and 0.7m deep ditch **9** on the eastern side of the hedge boundary between Fields 3 and 4 (Pl. 2). This backfilled ditch appeared to be on the same north-south alignment as the existing residual ditch alongside the hedge, and is therefore contemporary with the existing field arrangement. It has been excavated across an earlier, roughly east-west aligned, channel which is present in both fields about 20-30m from the stream edge. To the east of the ditch the turf overlay sand.

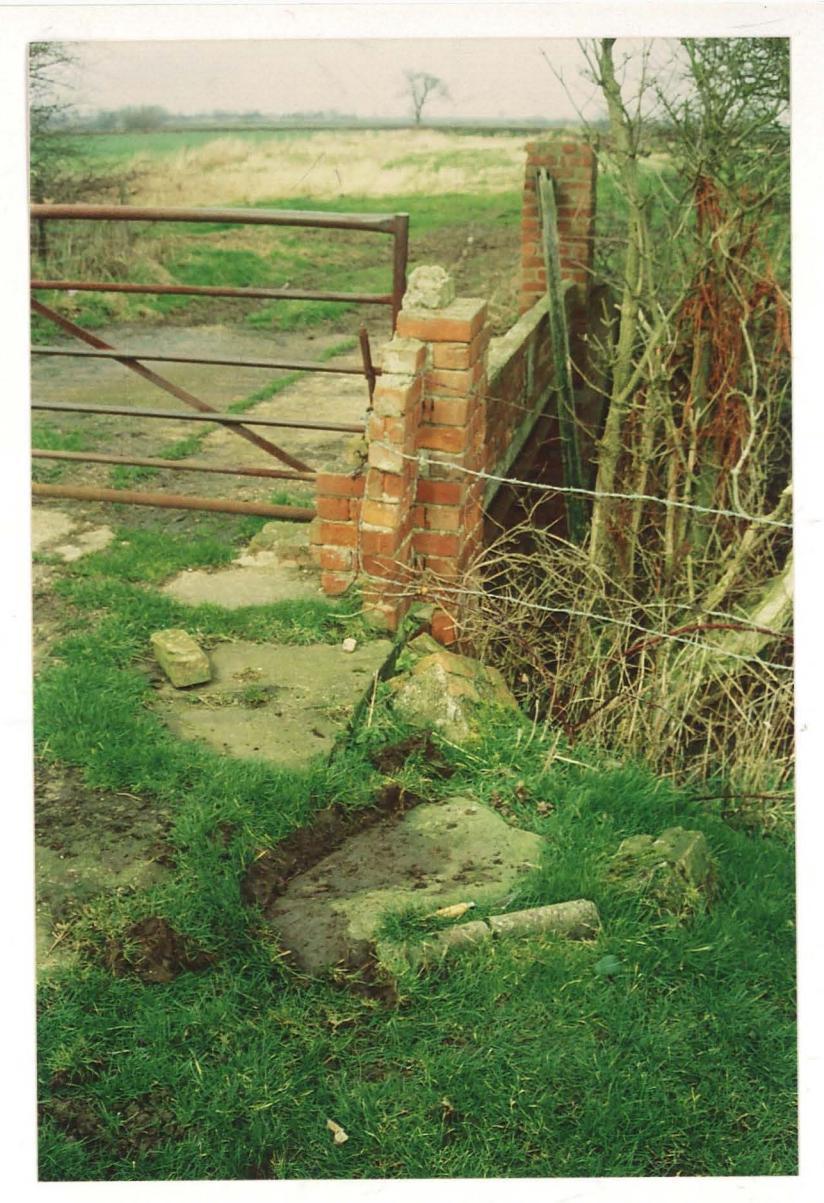
A large piece of smooth weathered sandstone or limestone **11** was seen beside the modern bridge across the stream (Pl. 3). The stone is either a glacial import, or has been deliberately introduced to the site. In its present position it has been used either for construction of the twentieth century bridge, or for rubble in the farm track leading to the bridge. This was the only piece of potential building stone seen during monitoring of the pipe trénch.

- Pl. 3 Stone boulder 11, seen (centre foreground) beside twentieth century bridge across the stream (looking north).
- PI. 4 Course of the pipe trench in Field 4, cutting across artificial drainage channel (centre, beside old fence), and possible backfilled natural stream meander 12 (foreground). The evaluation trenches are visible to the right of the pipe trench (looking east).

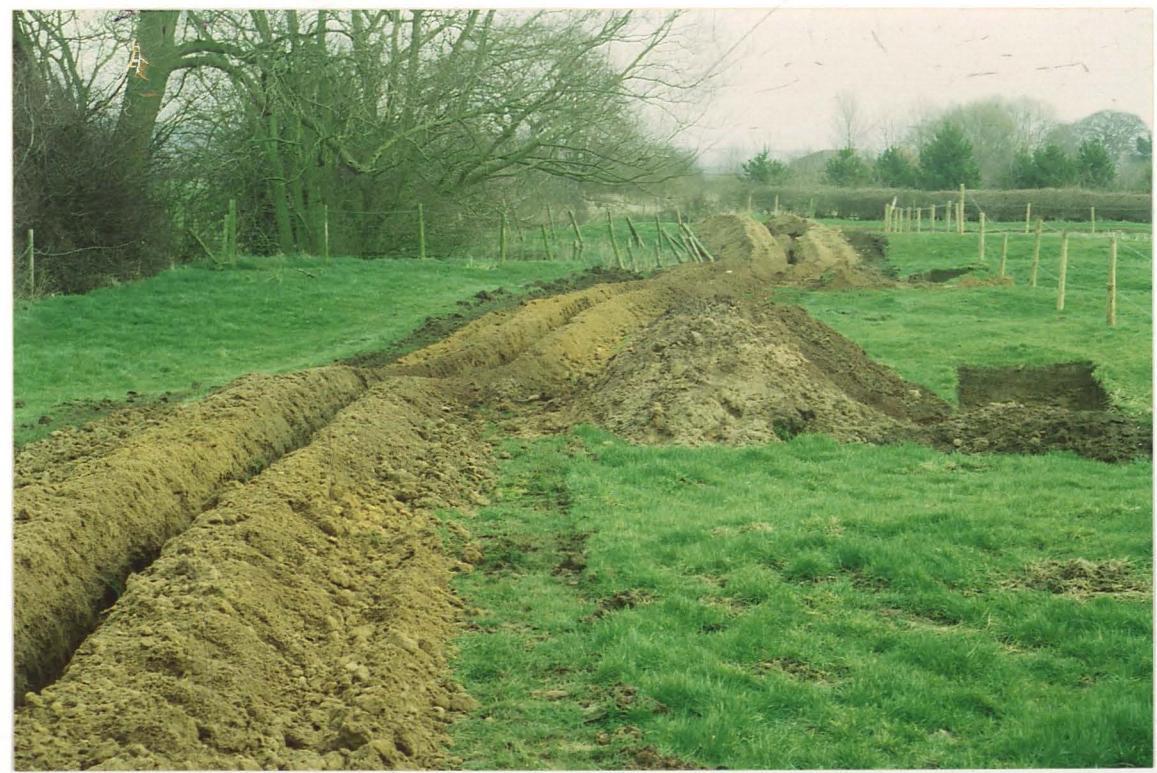
A small curvilinear depression 45m from the western side of this field proved to be a 10m wide ditch **12**, with its base below the base of the 0.9m deep pipe trench (PI. 4). Immediately to its east, the topsoil covered sand **13**, but within about 7m there was an intervening 0.2m thick deposit of clay which could be traced for a further 25m to the east **14-16**. At its eastern limit, the sand was 1.1m deep, and it appeared that an earlier ditch had been filled and overlain by the existing bank. Collapse of the pipe trench occurred before this could be investigated. After excavation and recording of two trenches across features here (prior to the pipe trenching) the interpretation of the earthworks remained uncertain, although that at **12** was suspected to be for drainage. Reconsideration of the complex suggests that a 45m diameter relict natural stream meander has been bifurcated by the eastern return arm of the extensive west-east ditch. Anomalies evident on the northern bank of the stream, opposite the putative meander points, give added credence to this interpretation.

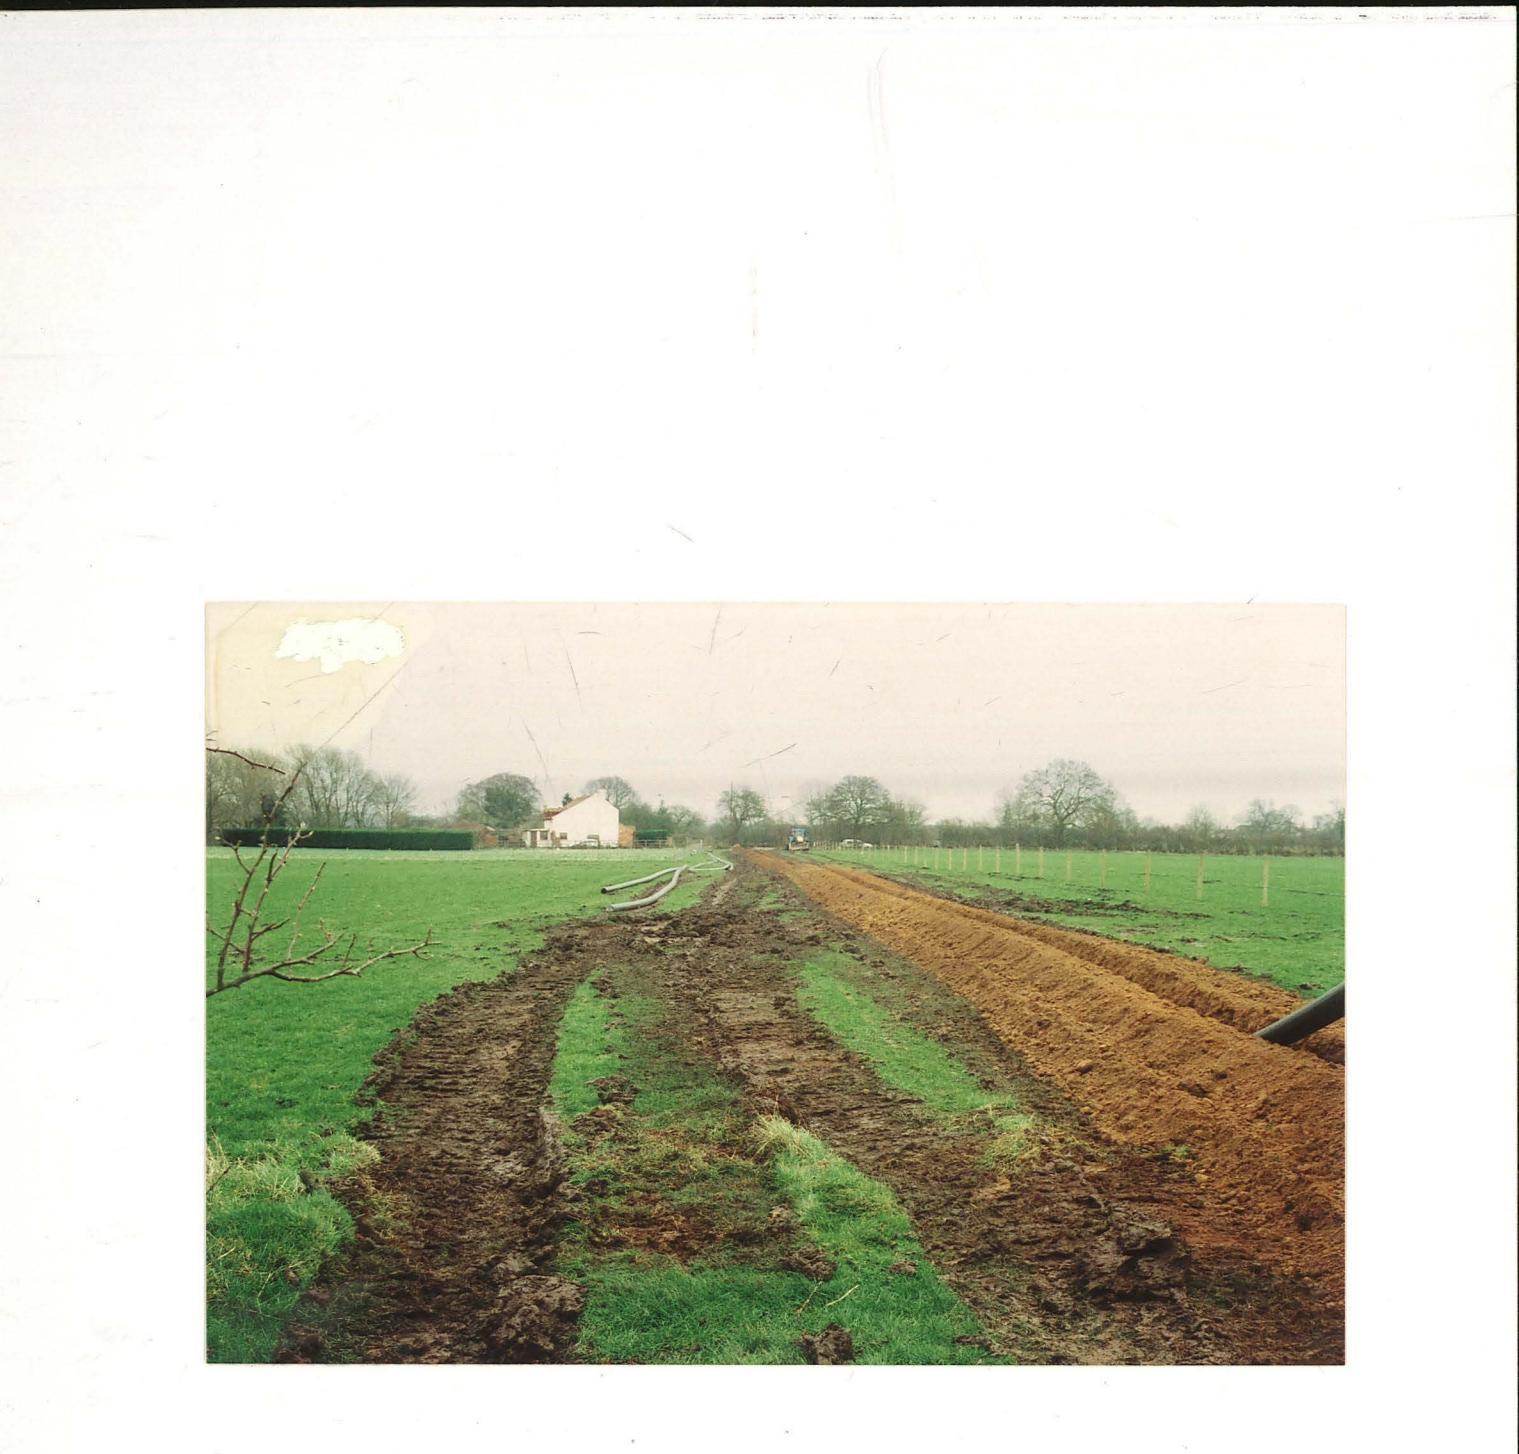
The topsoil at the western edge of this field overlay about 0.5m of clay, with sand 0.8m below the field surface **25** (Pl. 5). This field is used for arable crops, and no earthworks remained visible within the area of the easement. A 2m wide, and 0.8m deep ditch **26** was seen in the trench face 50m east of the field boundary subsoil, but its alignment remains unknown.

Pl. 5 The pipe trench course, Field 5 (looking east).
