St. Martin's Church, Waithe, Lincs.

Archaeological Desk-Based Appraisal

LAS Report No. 665

April 2003

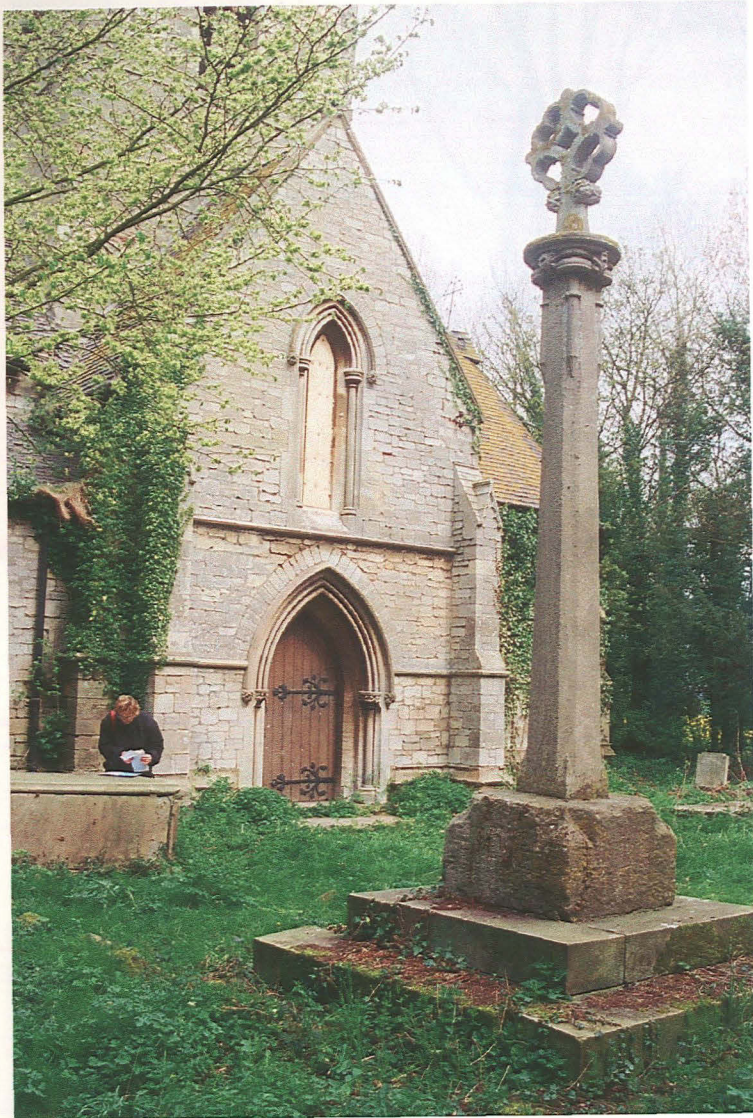
A churchyard cross stands close to the south wall of the church (Pl. 1). The present monument is mostly of modern date, but incorporates a single rectangular block of stone with chamfered upper corners. This is a medieval socket stone, and would have formed part of a standing cross, thought to be of fourteenth century date. Although it was reconstructed in c.1861, it is thought to be sited close to its original position. The cross is a scheduled ancient monument (SAM 22729) and a Grade II Listed building.

Pl. 1 The base of a medieval churchyard cross forms part of the restored monument to the south of the church (looking NE).

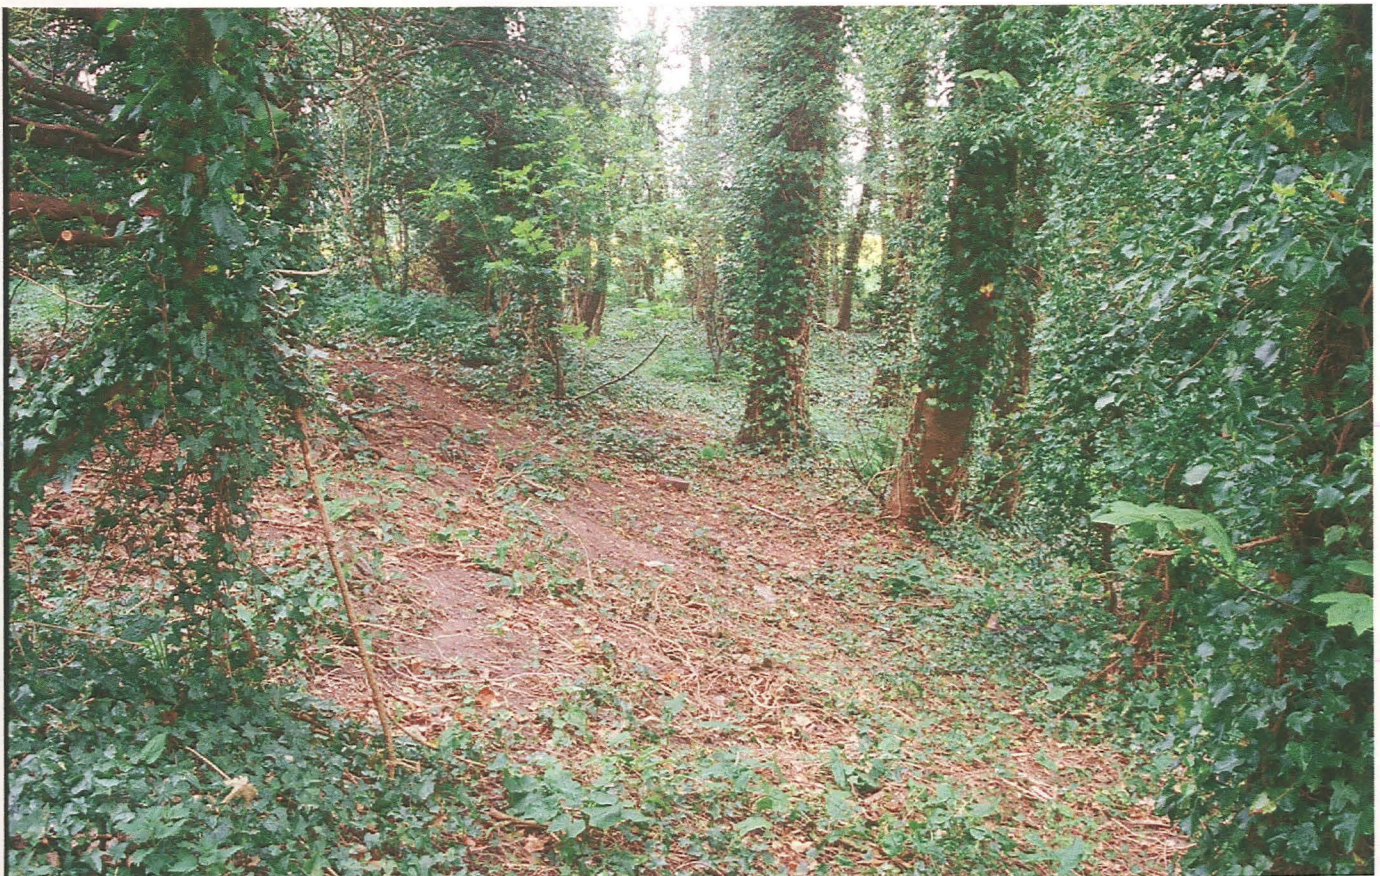
The site visit demonstrated that the church lies within a plot of land, approximately 45m x 45m, which is raised by up to about 1.5m from adjacent properties (Pl. 2). From a rapid appraisal of the surrounding topography, this is not a natural knoll, as the ground slopes downwards towards the Waithe Beck from about 400m south of Church Road. The Saxon church may have been built on an earlier raised site, or the natural site may have been enhanced at that date. Soil build up within a rural churchyard is not sufficient to explain the difference in level.

Pl. 2 The pronounced slope to the east of the churchyard probably marks the western edge of a medieval road through Waithe, now replaced by the A16. It may also be the edge of an artificially raised site, on which the church stands (looking NE).

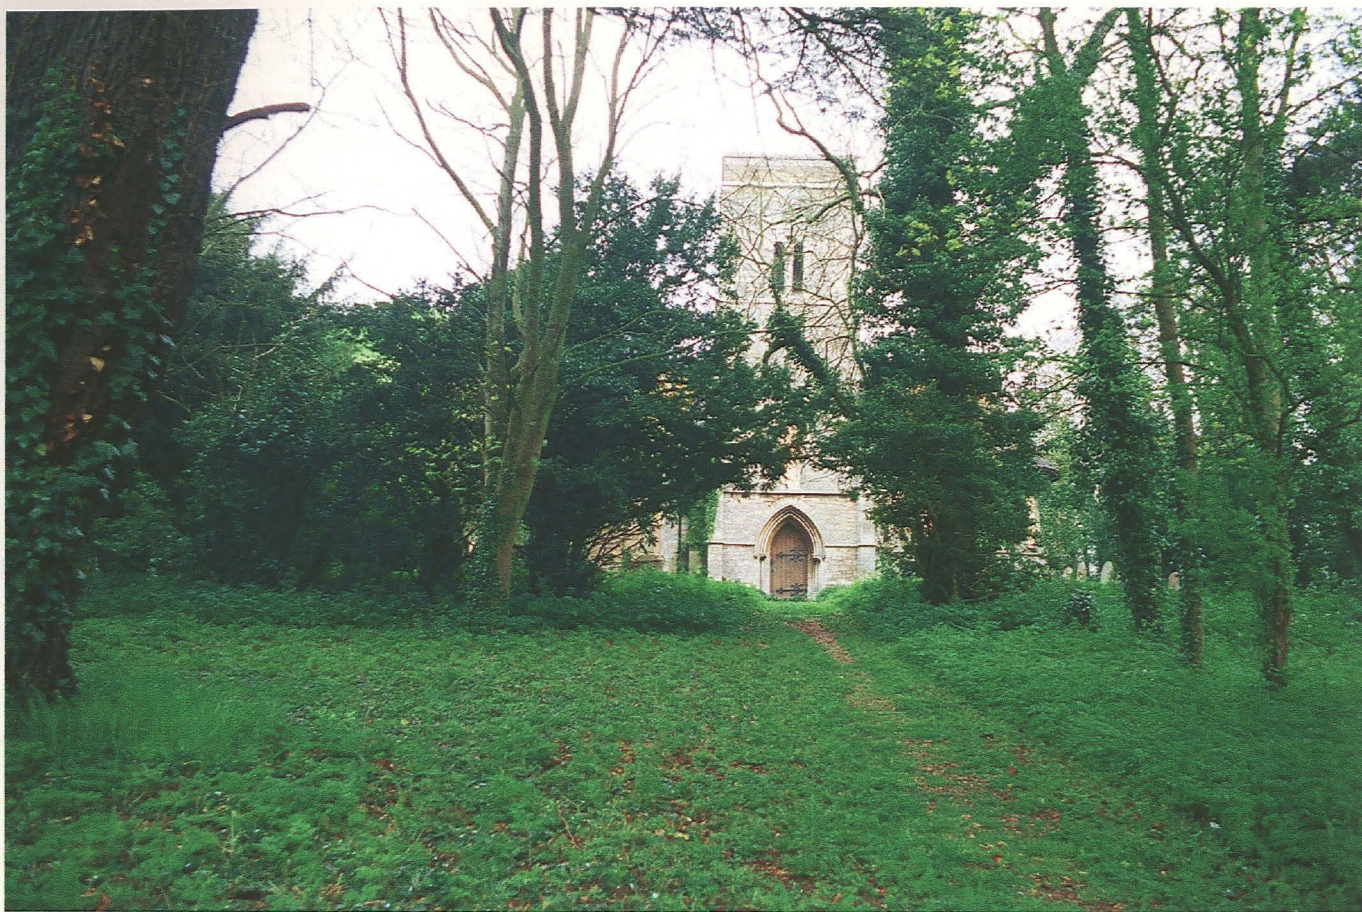
Entry to the churchyard is from Church Road, in the centre of the site frontage, through wooden gates between stone gate posts. A broad pea-grit path leads centrally across to the church. It is immediately obvious that the churchyard is divided, north-south, by a former bank, over which the path leads (Pl. 3). Several aspects of the division are apparent:

Pl. 3 The path from church road to the south door crosses a low bank, marking the southern limit of the medieval church yard. The plot to the south was added, as a shrubbery, in the 1860s; before this it had been the rear of a medieval croft.

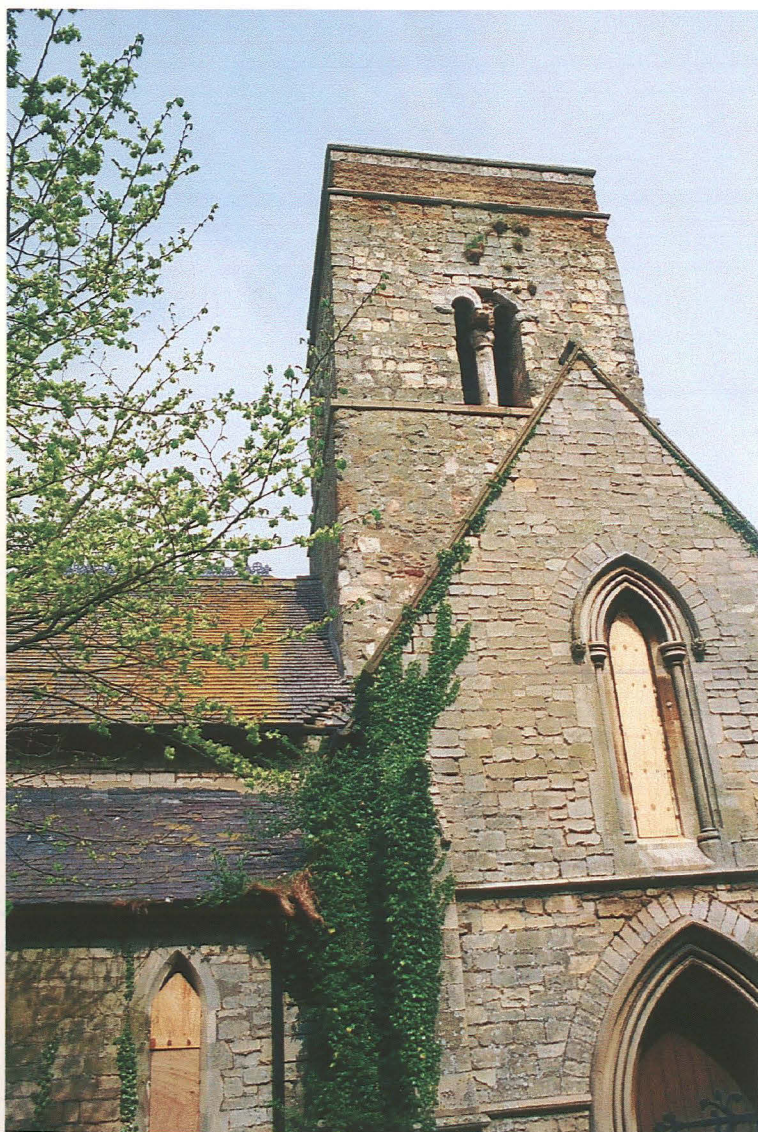
Two fragments from one of the voussoirs of the belfry opening on the south side of the tower

were found on the ground beside the chancel south wall, together with several other stone fragments (Pl. 4).

Pl. 4 South wall of the Saxon tower, showing damage to the belfry window (looking north).

23.1a Measured and photographic survey of affected stonework on external wall of tower, ideally as part of an entire survey of the tower walls while scaffolding is available.
