**The Glassmill, Brayford Wharf, Lincoln
Archaeological Watching Brief**

LCNCC Accn No.: 2005.38

Site Code: LBWG 05

**LAS Report No. 832
June 2005**

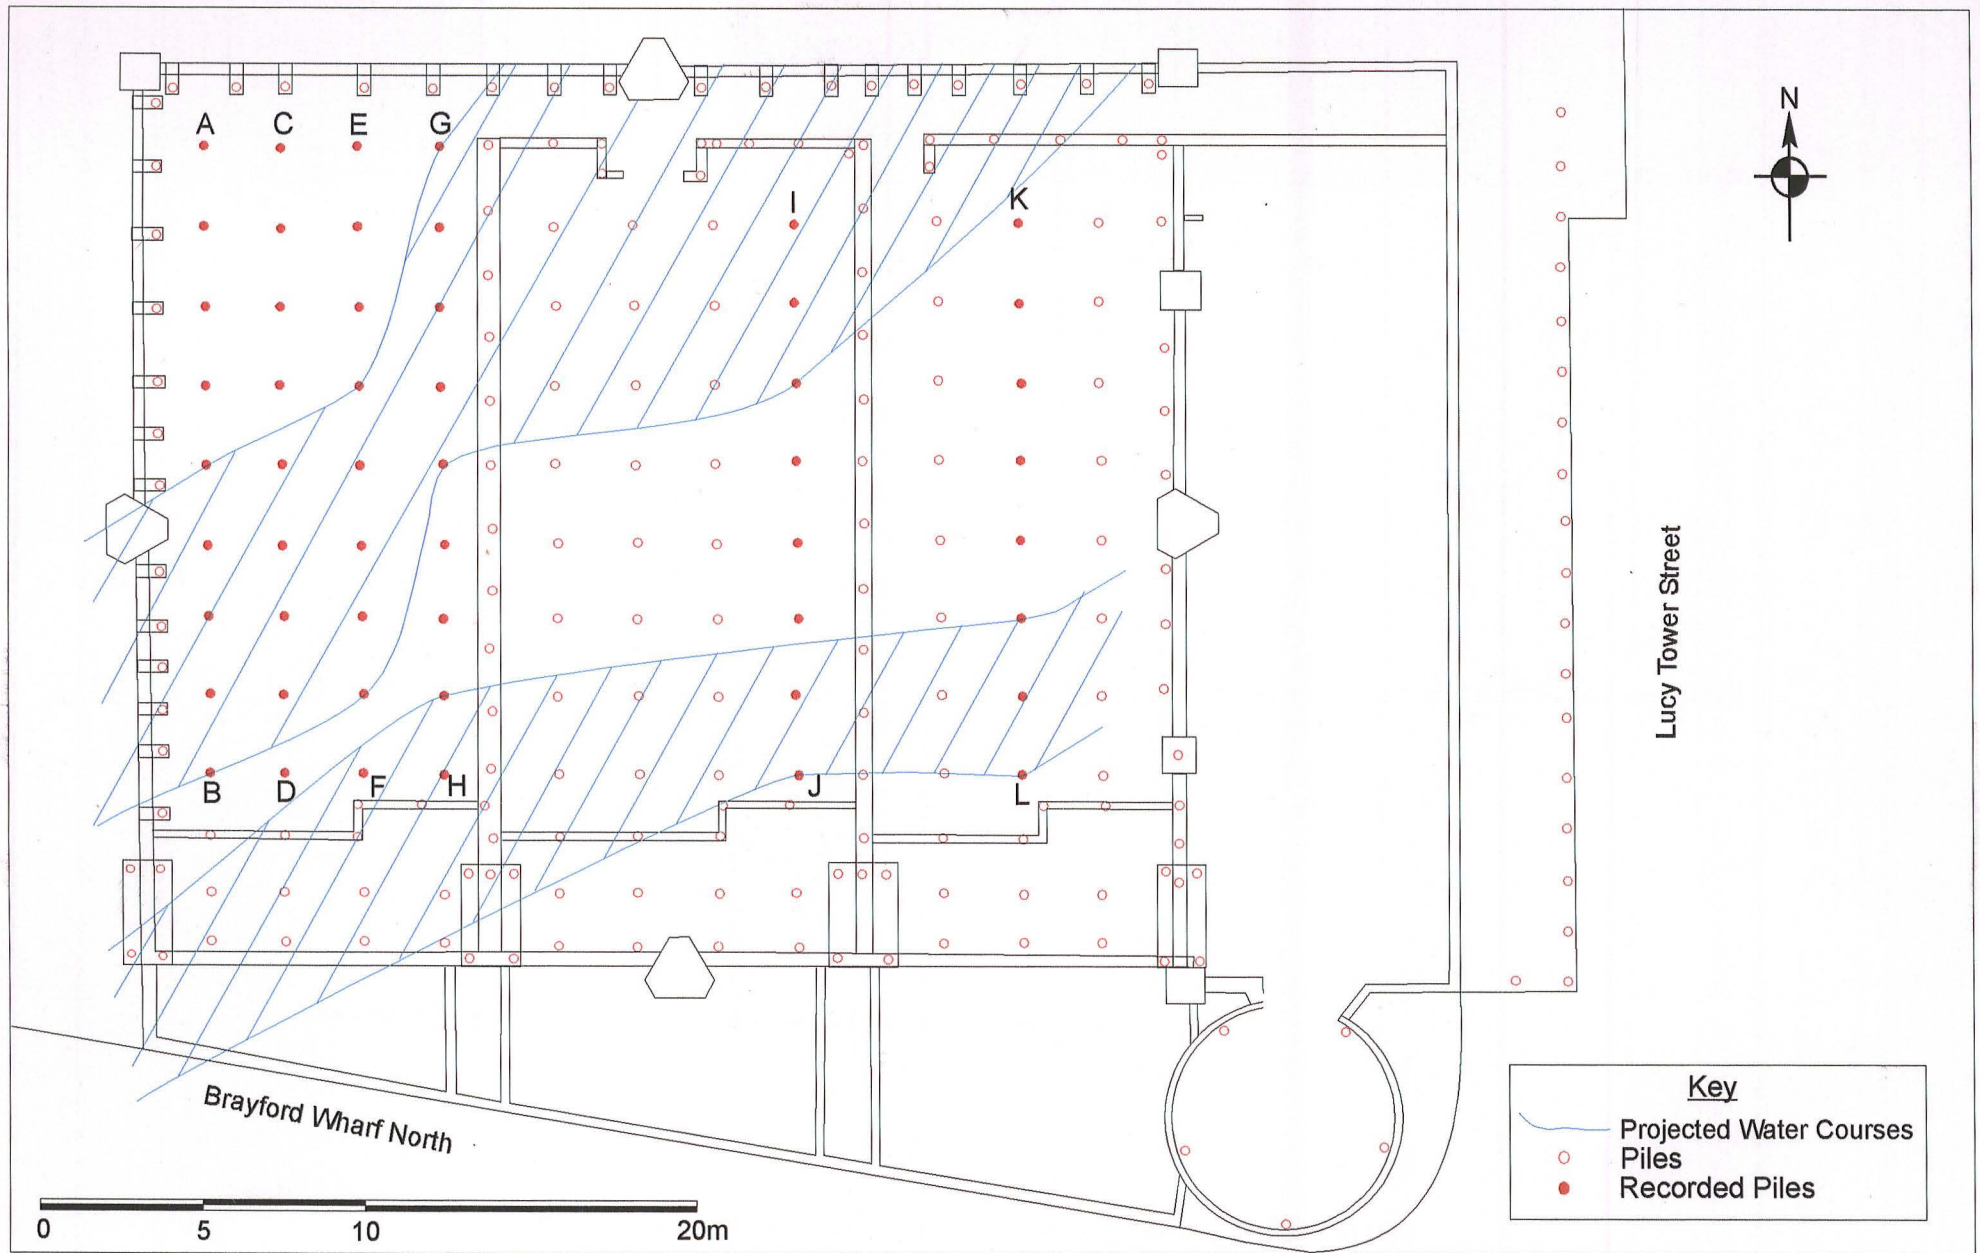
There was no open-cut excavation and no archaeological finds were noted within the development area. The upcast material observed during the piling operations appears to suggest waterlogged deposits and possible infilled water courses running diagonally north-east by south-west across the

Fig. 2 Plan of the development showing the projected water courses and the piling locations. Those highlighted in red were archaeologically recorded (taken from a plan supplied by the developer)

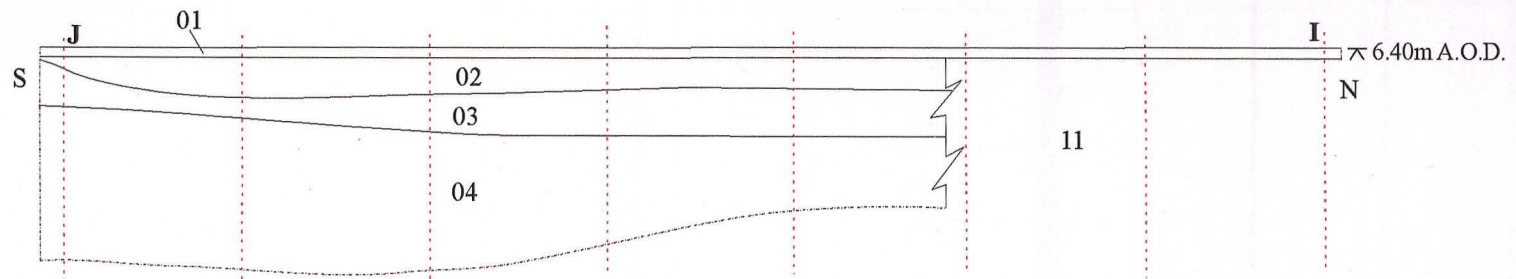
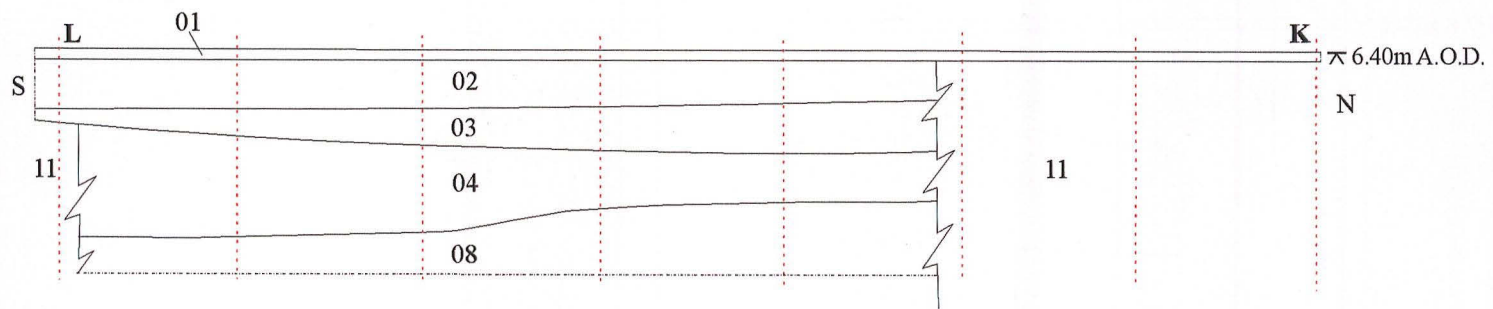
Fig 5. Projected sections I-J and K-L showing location of piles in red.

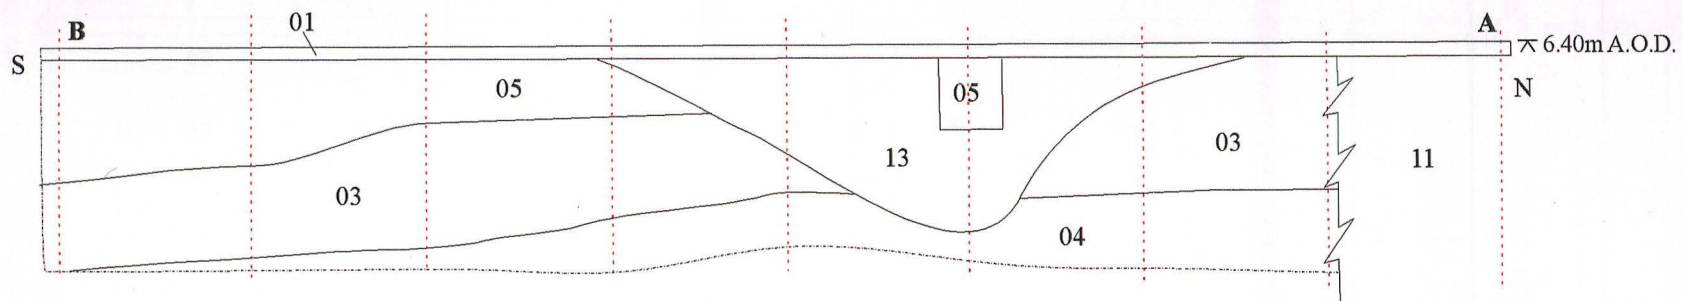
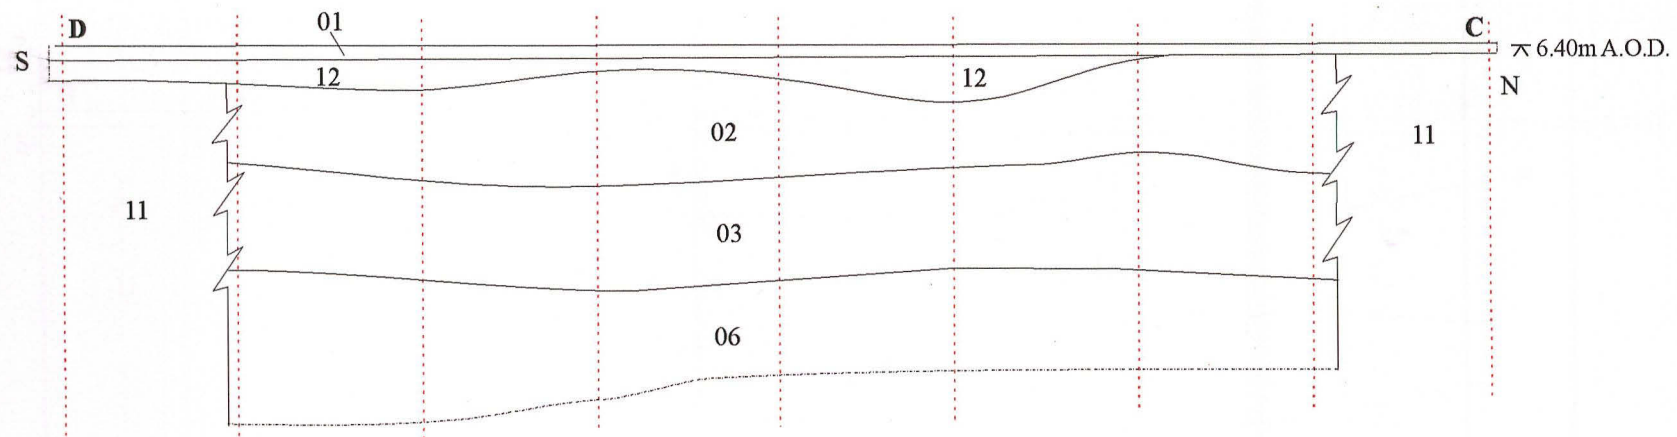
Fig 3. Projected sections A-B and C-D showing location of piles in red

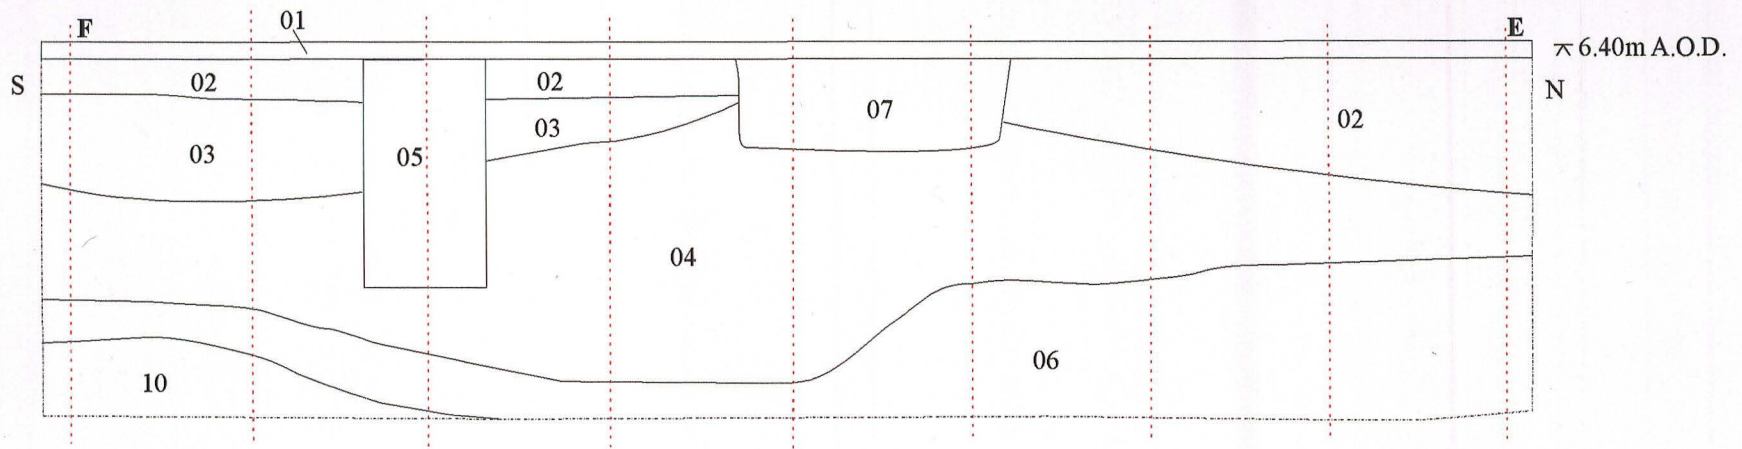
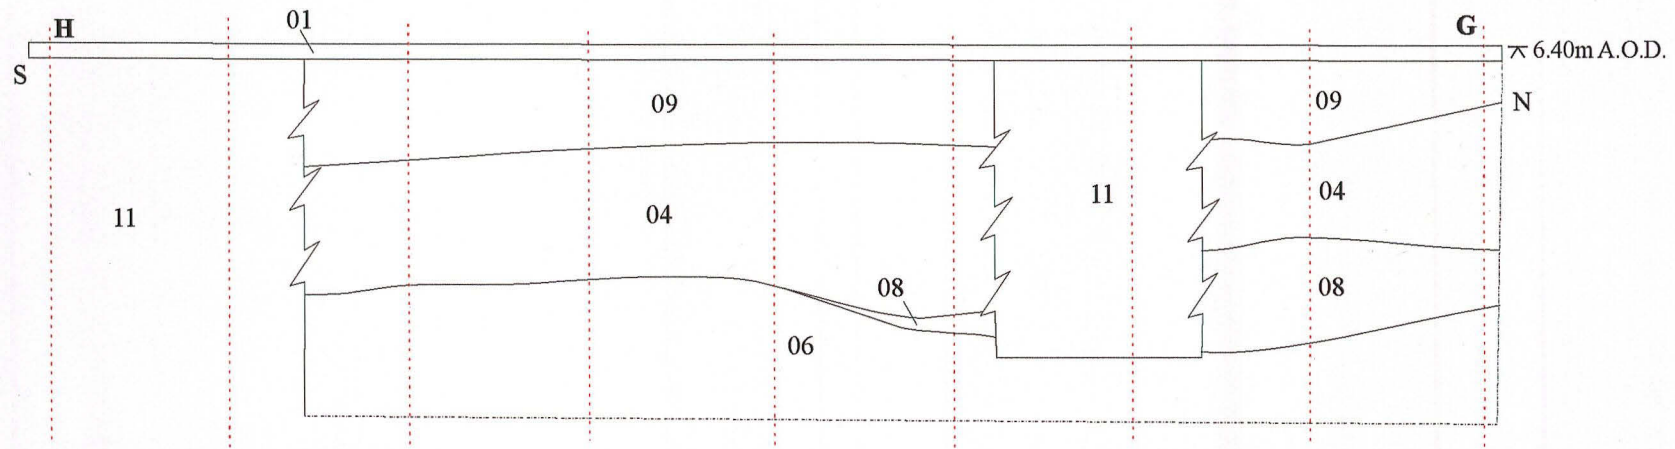
Fig 4. Projected sections E-F and G-H showing location of piles in red
