**St. John the Baptist Church,  
Yarburgh, Lincolnshire  
Archaeological Watching Brief  
LCNCC Accn N<sup>o</sup>.: 2006.232  
Site Code: YACL 06  
NGR: TF 3501 9301**

**Report**

**LAS Report N<sup>o</sup>. 936**

**September 2006**

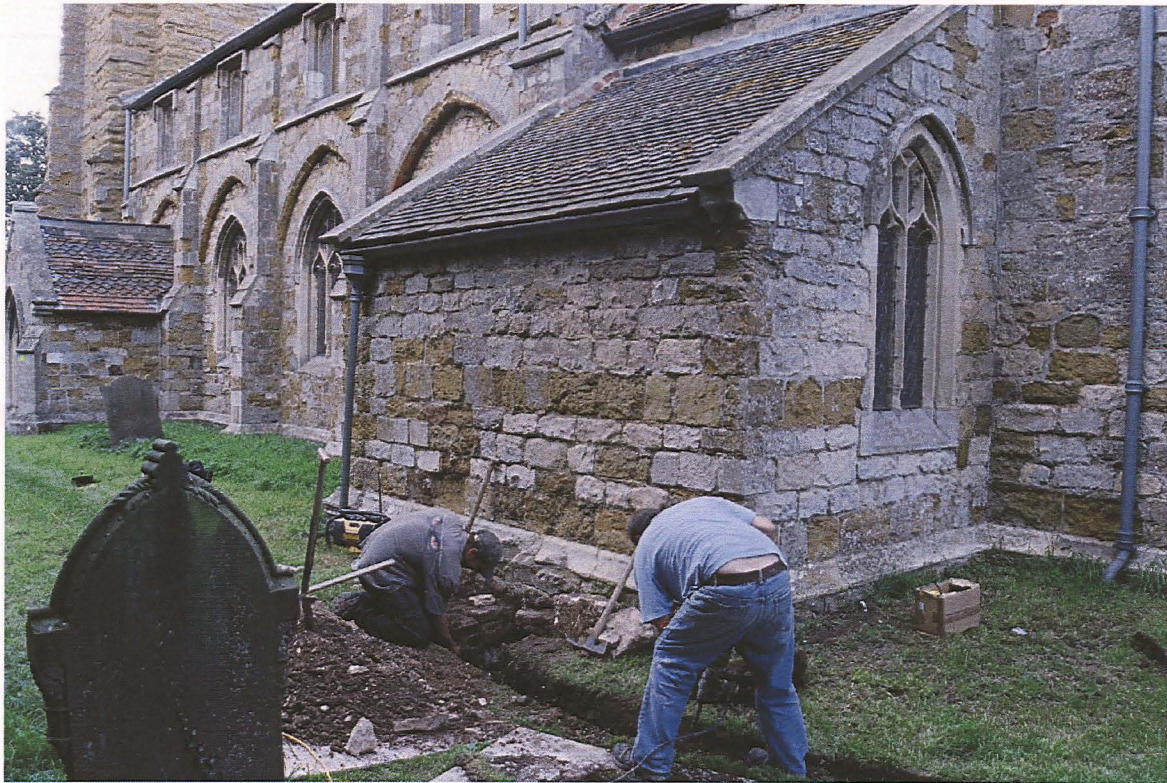
Pl. 1 Looking northwest (showing the exit route for the cable).

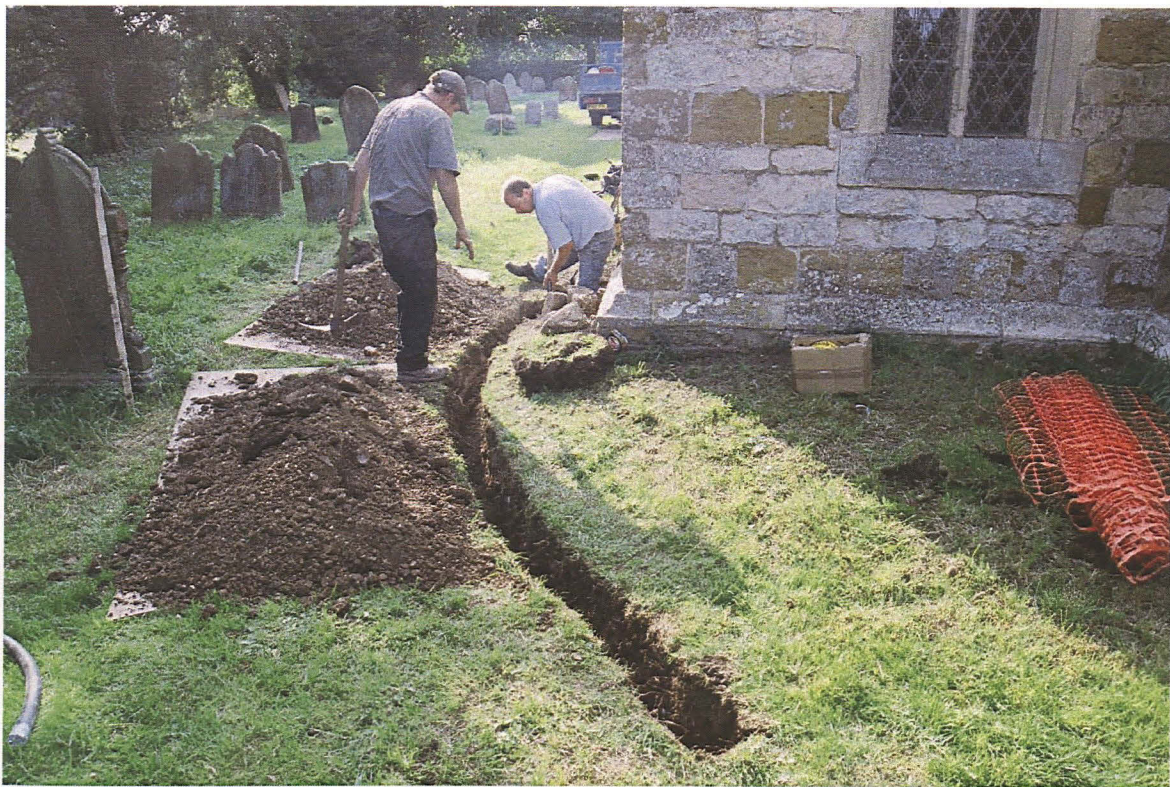
The cable trench was dug through ground already disturbed in the past by the insertion of a water pipe. The cable connection into the church was through a drilled hole in the vestry wall which had been underpinned in recent times. In conclusion, there was no disturbance to any early church fabric and no archaeological deposits were disturbed in the churchyard.

Pl. 2 Looking south (showing the cable trench).

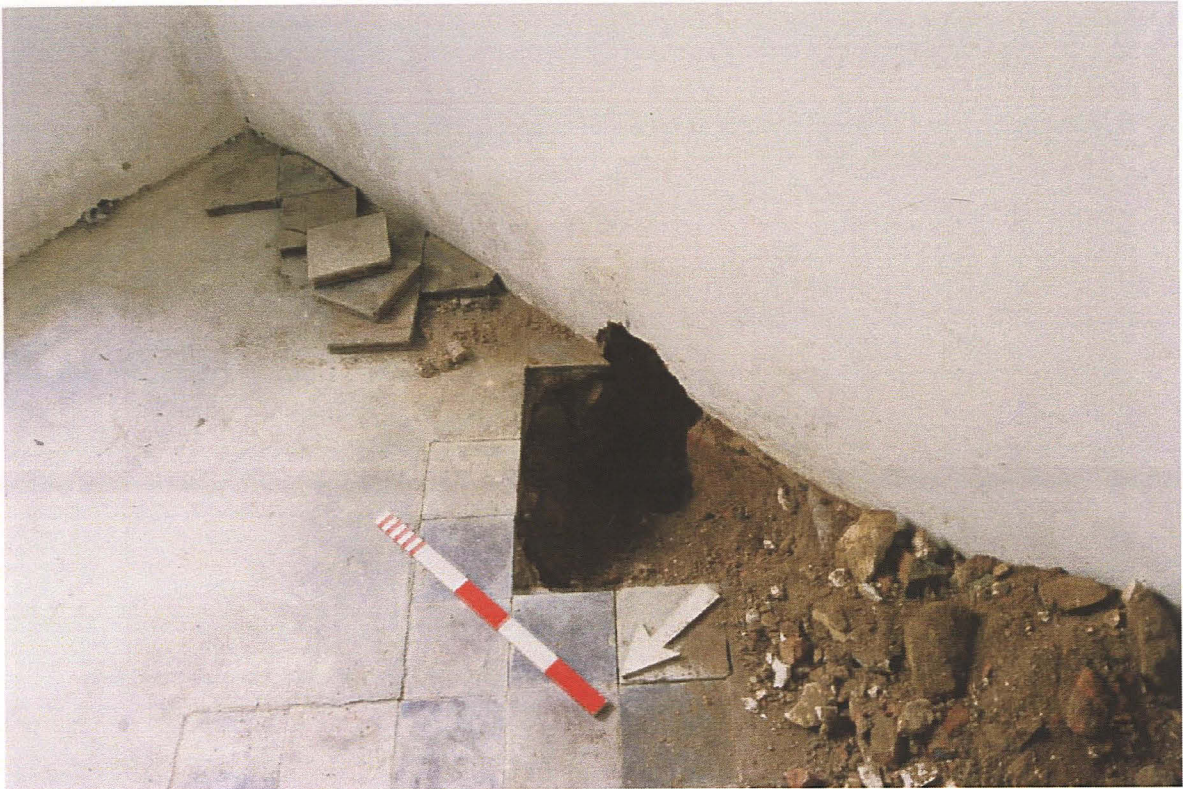
Pl. 3 Looking southeast (inside the vestry), showing the hole for the cable, drilled through the modern brick underpinning

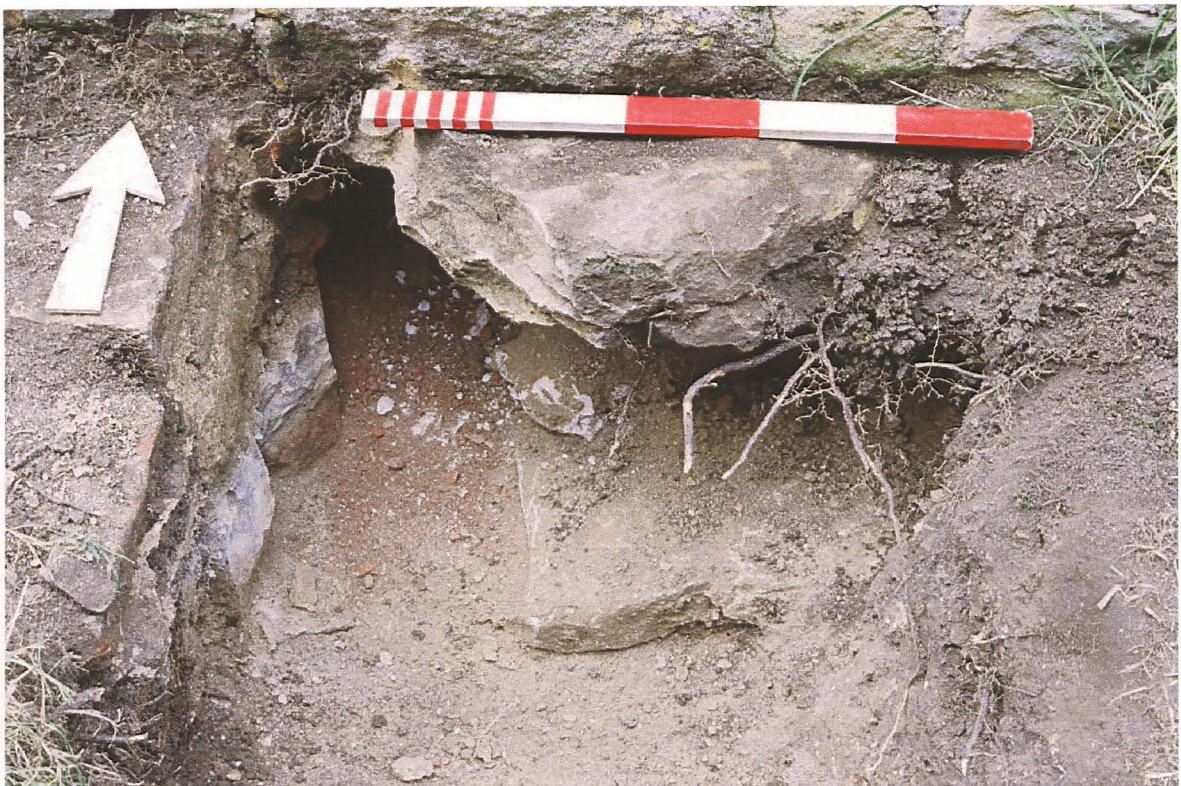
Removal of the topsoil **100** next to the vestry wall revealed underpinning material, **101**, comprising courses of brick and (re-used) limestone contained within a construction trench, **102**. Beyond the construction trench and beneath the topsoil **103**, a silty clay which contained the remains of a modern water pipe. This material was probably the backfill of the pipe trench whose edges were not observed in the narrow cable trench. Underlying **103** was the natural clay **104**, which was present at a depth of 0.12m below the present modern surface. Fragments of early modern tile were observed in the topsoil but there were no other finds.

Pl. 4 Looking north (outside of the vestry), at the exit hole for the cable, drilled through (re-emplaced) limestone and brick underpinning.

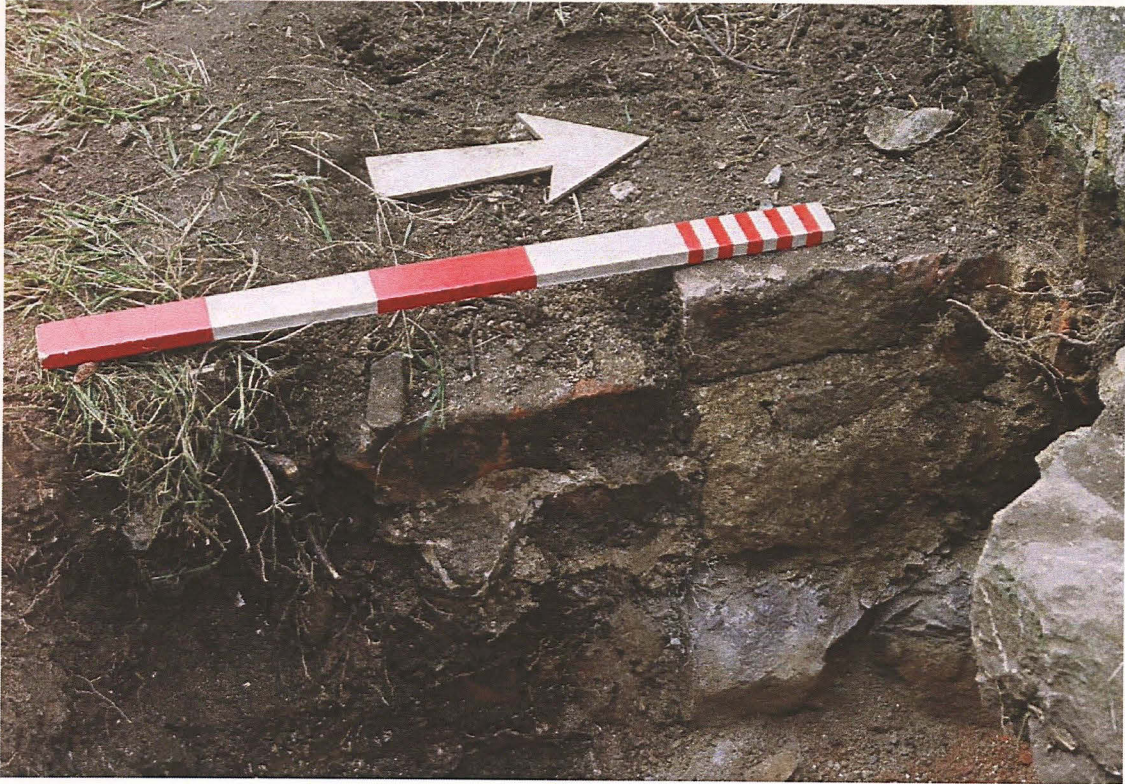
Pl. 5 Looking northwest (outside the vestry), showing the hole for the cable, drilled through the underpinning

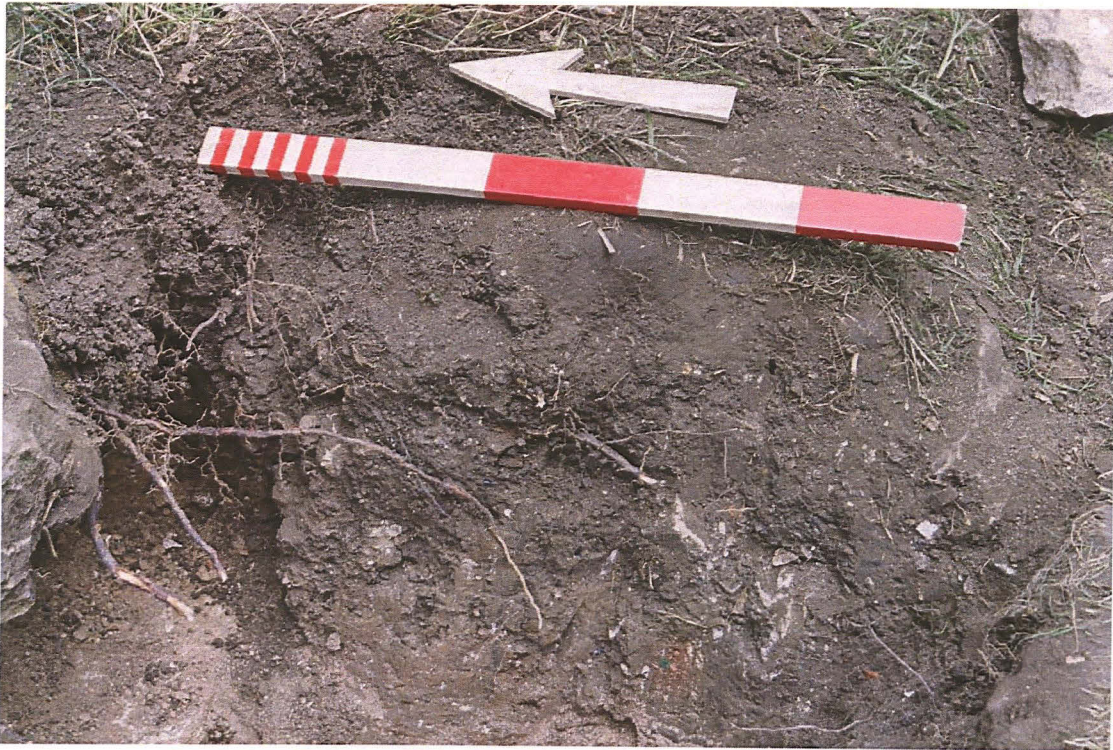
Pl. 6 Looking northeast (outside of the vestry), at the exit hole for the cable, drilled through the limestone underpinning.
