ARCHAEOLOGICAL EXCAVATION REPORT PHASE 3:

ST. CATHERINE'S CHURCH, LINCOLN

Allen Archaeological Associates  
Report Number 2009027

June 2009

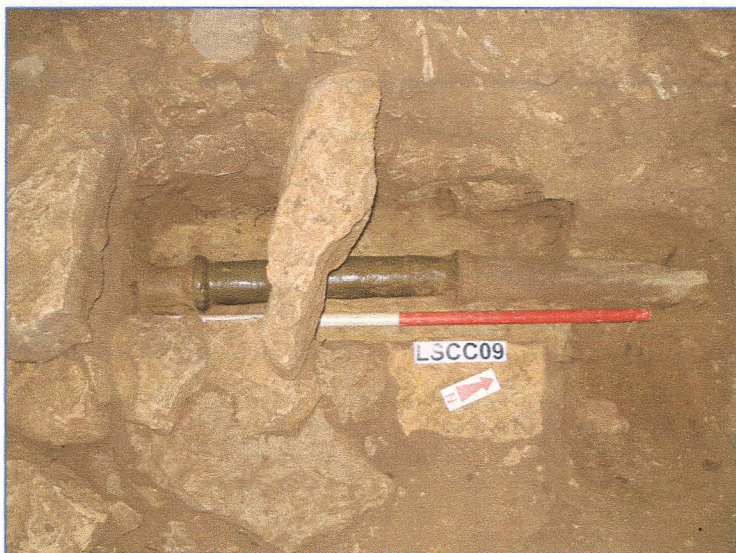
- 6.3 The extension of the trench to the north showed that the final section of pipe had been broken at its northern end, very close to the northern limit of excavation. The stones along the eastern side of the culvert had also been removed at this point.

- 7.4 The northern extension of the site showed that the pipe had also been damaged at its north end. The c.0.5m length of pipe remaining *in-situ* was similar to the length of the complete pipe sections exposed, suggested that it was only the splayed collar at the end of the pipe that had been broken off. Adjacent to this damage, the stones forming the east edge of the culvert had been removed, with a small spread of stone rubble to the east suggesting that the culvert had been disturbed to allow access to the pipe.

**Plate 2:** Northern end of the glazed water pipe, looking west-north-west. The pipe has been broken off at its northern end, close to the limit of excavation.

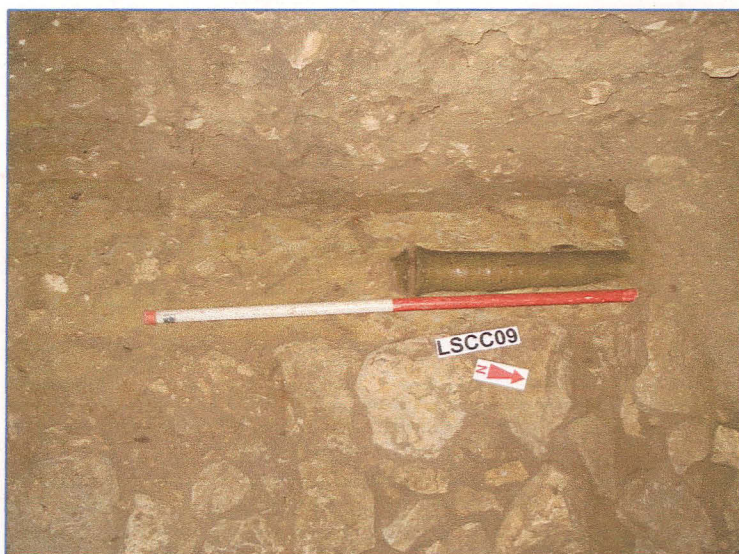
- 7.3 Further investigation of the glazed pipe showed that there was no southern continuation of the pipe beyond that identified in the previous works (AAA 2008a and 2008b). It was observed however that the clay bedding layer and the stone culvert remained *in-situ*, indicating that the pipe had been removed with some care, perhaps for re-use elsewhere.

**Plate 3:** Southern end of the glazed water pipe, looking west-north-west. The pipe has been broken off close to the collar, but the clay lining of the culvert remains *in-situ*.
