# LINDSEY ARCHAEOLOGICAL SERVICES FRANCIS HOUSE SILVER BIRCH PARK GREAT NORTHERN TERRACE LINCOLN LN5 8LG

STAMFORD SCHOOL LINCOLNSHIRE Archaeological Recording at New Carpark Stamford School, Stamford Site of Brazenose College Stamford, SAM 256 (SMC ref. HSD9/2/2631)

## REPORT

# **ENGLISH HERITAGE**

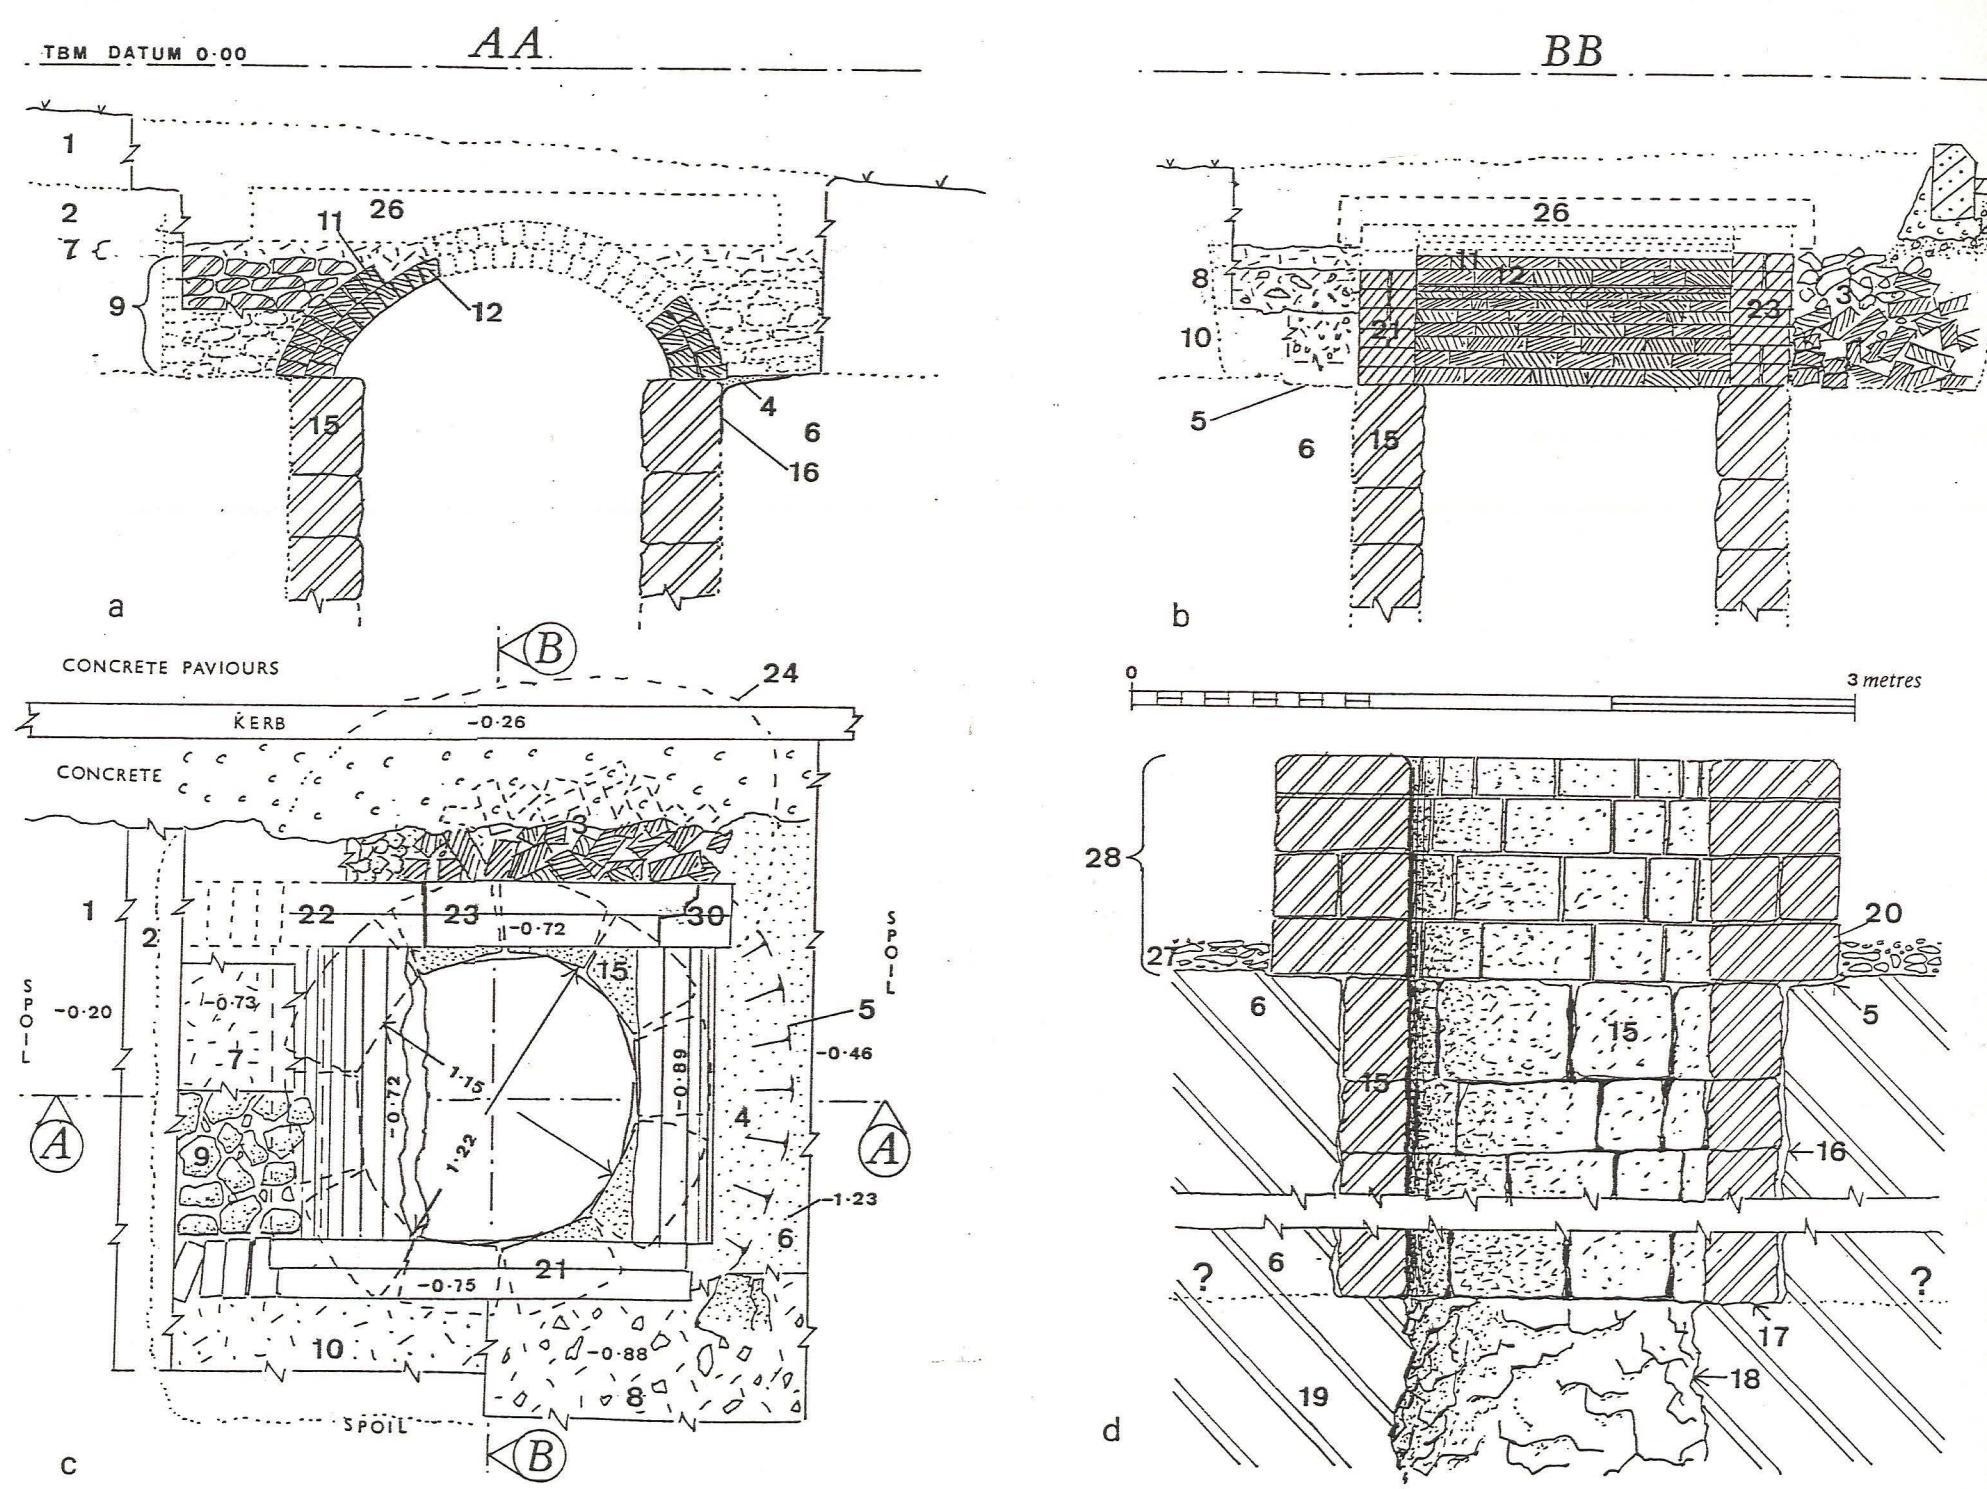
Fig. 8 a and b sections; c plan d reconstructed section through well shaft

### RESULTS (Fig. 8)

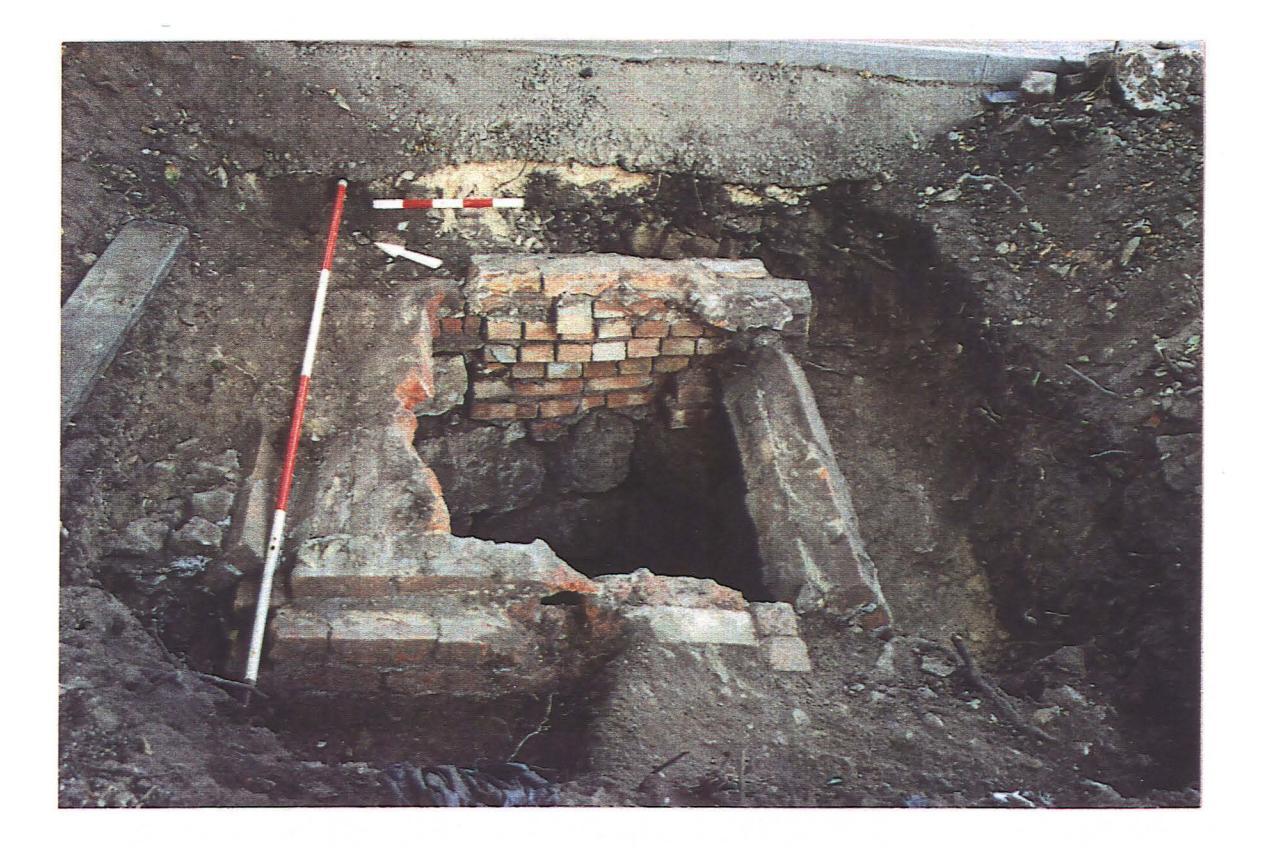
- PI. 1. Well location in new carpark; from SW.
- PI. 2. NE repair 23; general view from SW.

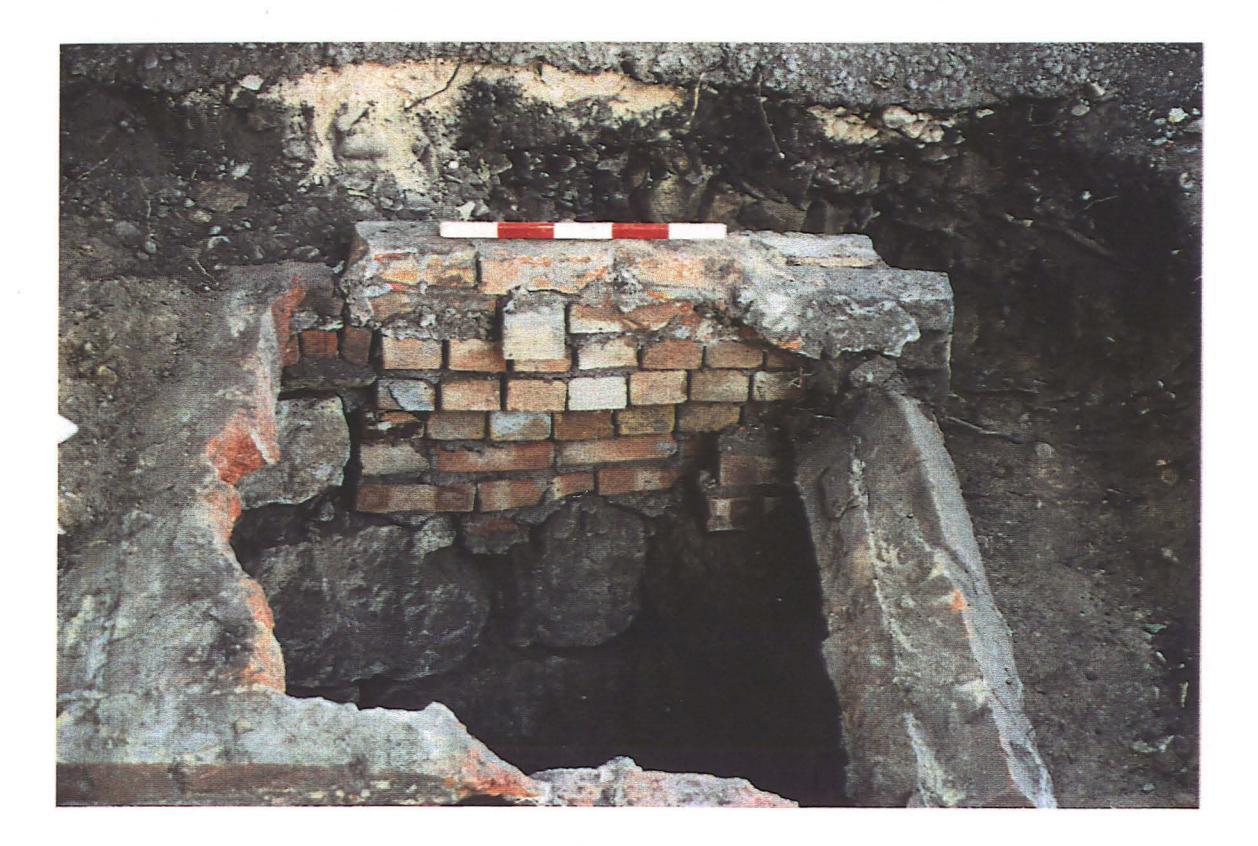
(23) therefore, is a repair to a breach of the wall which displaced the earlier bricks (3) which were used as a backfill behind it before the mortar had set. The date of the repair and backfill is indicated by a beer bottle of c.1910-1920. Wall (22/30) bricks were apparently of a later type than those in the opposite wall (21) and vaulting (11/12) and it is logical to conjecture that (22/30) was itself an even earlier replacement of late 19th century date. There was, however, no distinct difference of colour or texture in the mortar to support this. The only anomaly was the re-use of a limestone block in (22), this being the only block surviving assumed to have belonged to a course higher than the level of truncated well-head (PI. 3). This could be taken as an indication either that (a) the well-head courses (or their remains) were removed and partly re-used when closing-wall (22/30) and the main vault were built or (b) wall (22/30) was a later replacement of a wall constructed entirely of re-used blocks, one of which was used in the replacement wall.

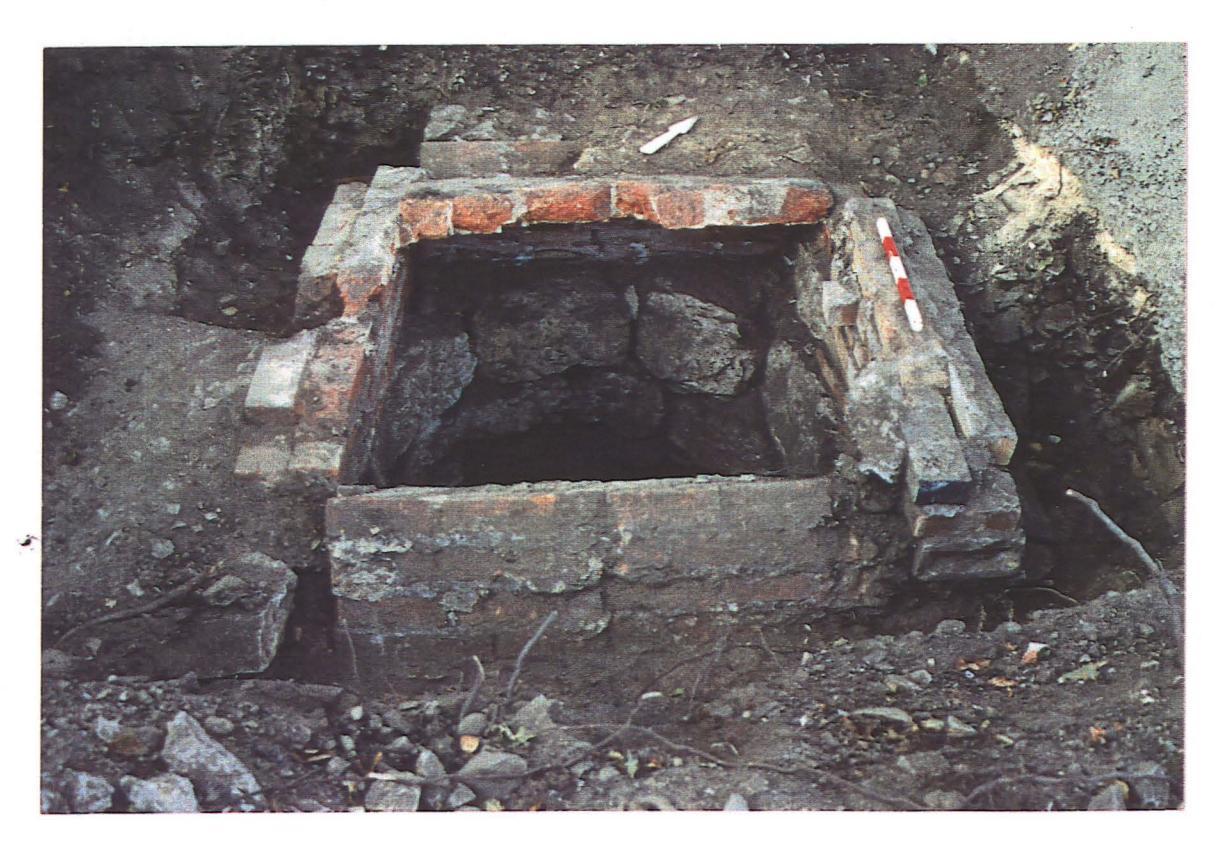
- PI. 3. NE infill repair 23 to wall 22/30 (block 25 in 22 to left); from SW.
- PI. 4. Re-used bricks in end-wall 22/30 (right), backfill bricks 3 to right. From SE.

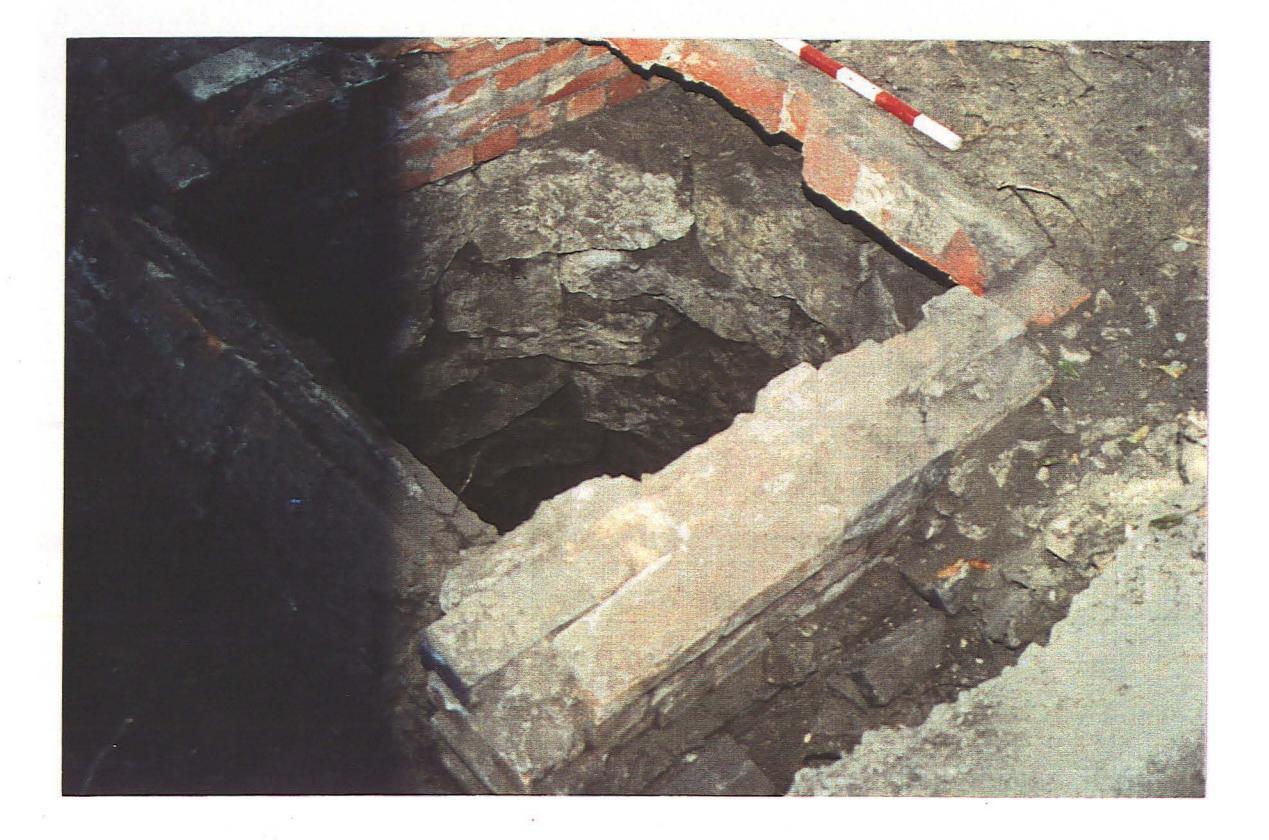
The closing-wall itself was built of bricks to the NW (22), and to the SE (30), all of mixed brick types similar to the backfill (3) (Pls 5 & 6).

Pl. 5. Backfill bricks 3 (lower right) behind end-wall 22/30. From E.

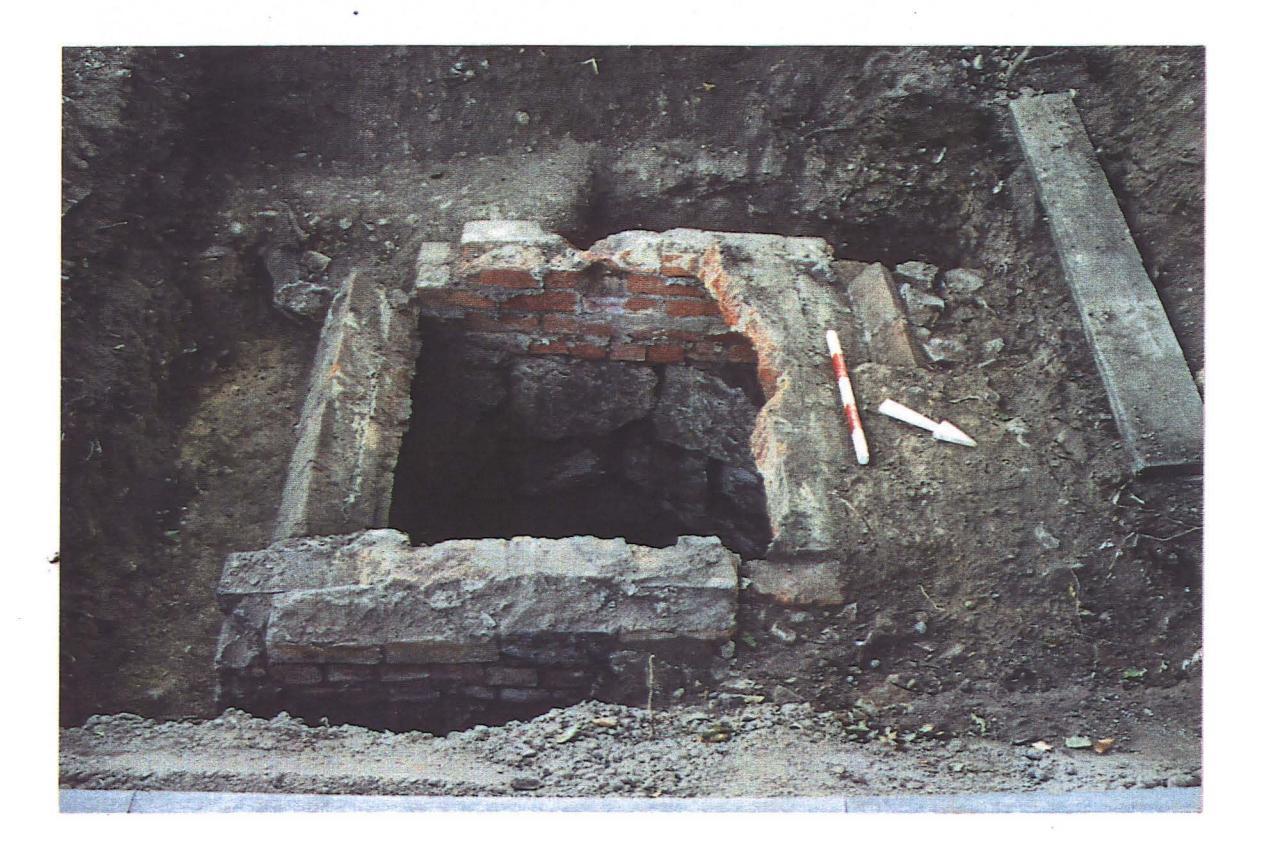
Pl. 6. End wall 30/23/22 (lower centre). Backfill 8 (far left). From NE.

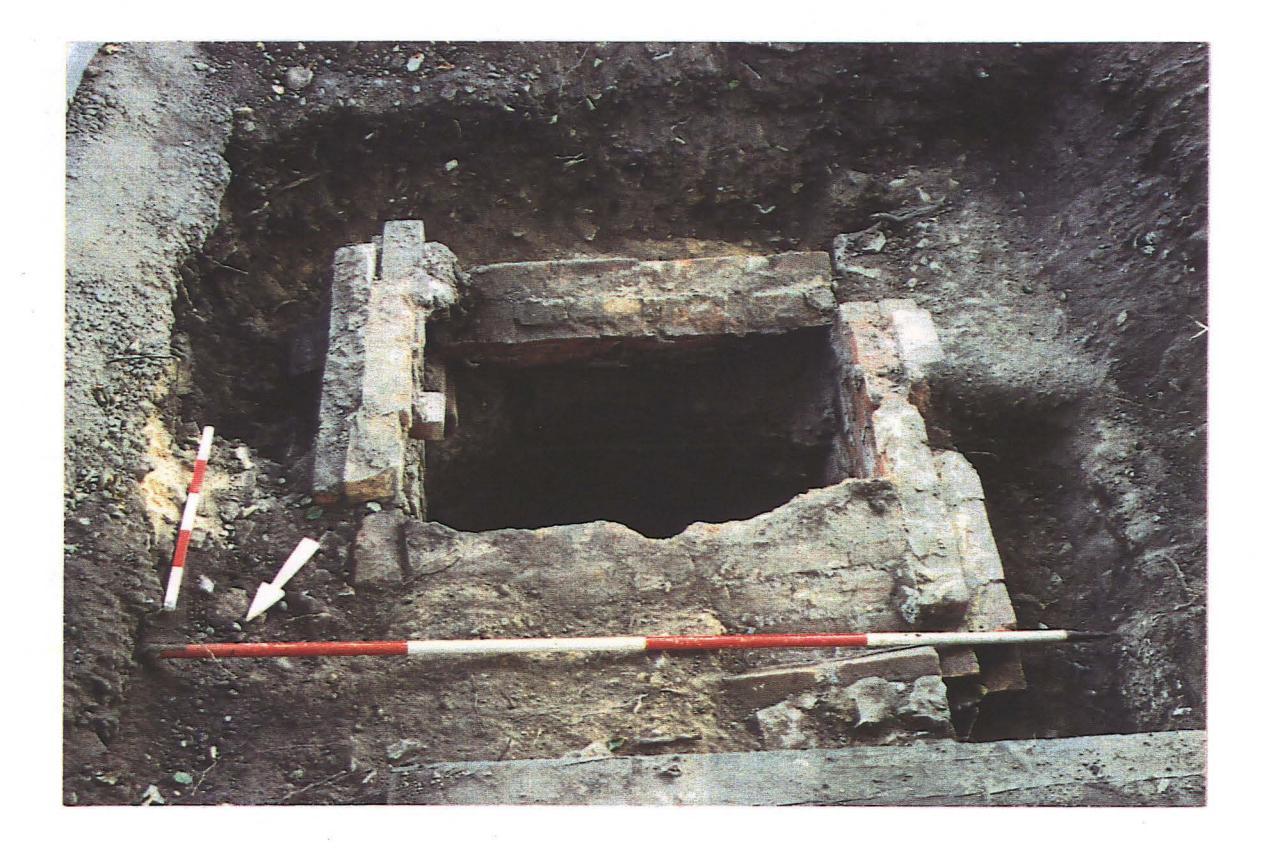
Pl. 7. Backfill 8 (upper right). Layer 7 (lower left). From NE.

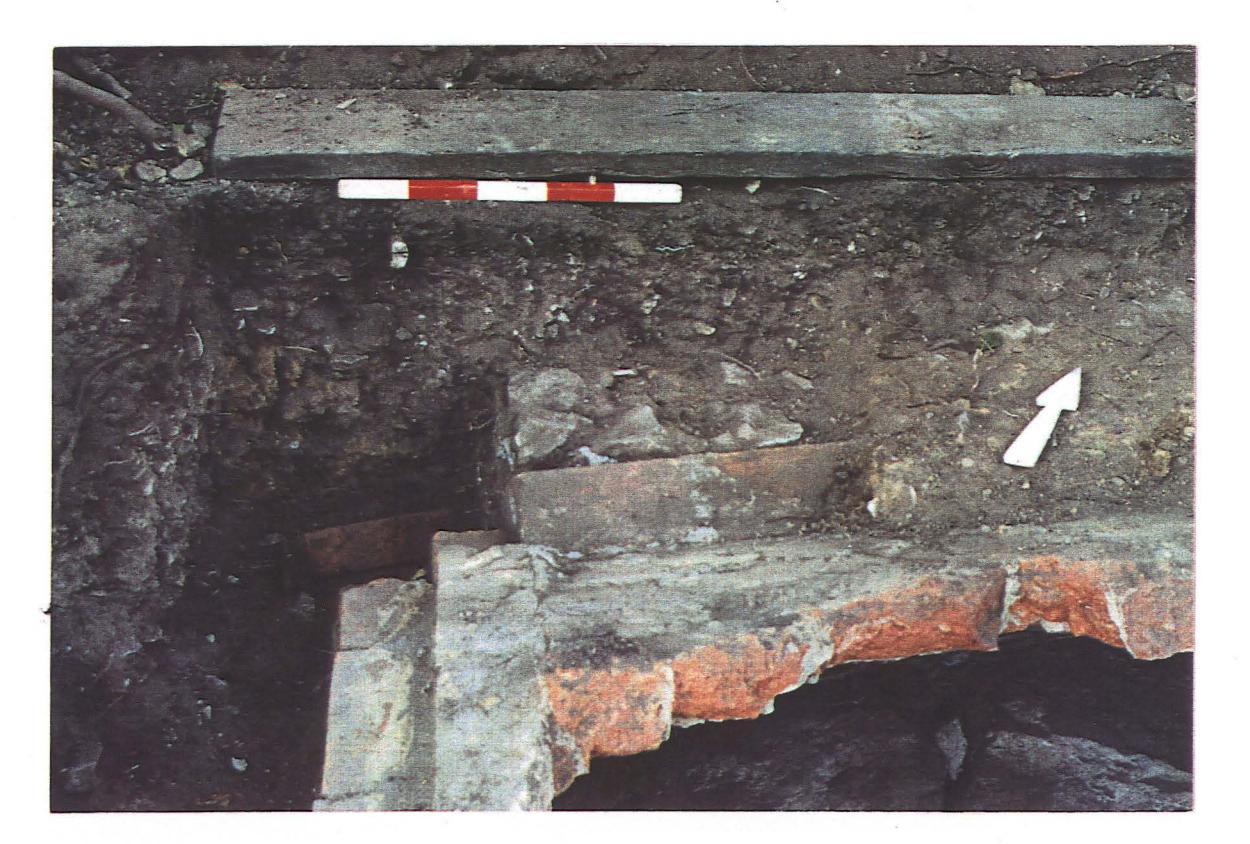
(9) survived only at the NW vault springing (the SE side having been already excavated by the contractors) and consisted of limestone with natural edges either rough mortared or having been rammed in with the remains of a mix, evidenced at the joints by a white ?salts eruption similar to that in the adjacent vault brickwork internally and externally. The SW vertical face of (9) showed that it had been installed either (a) behind shuttering to the open vault or (b) after the construction of closing-wall (21) (Pl. 10). The former is more likely since (21) did not extend far enough to the NW to enclose (9) and showed no sign of being disturbed. It is probable in any case that the closing-walls were a separate stage of construction after the vault mortar had set and any arch template removed. There was no trace of timbers on the truncated well ledge to suggest that a crude template had been left in situ, neither were there any impressions in the mortar to show that one had been used.

PI. 8. Layer 7 (upper right); abutment 9 (centre). From SE.

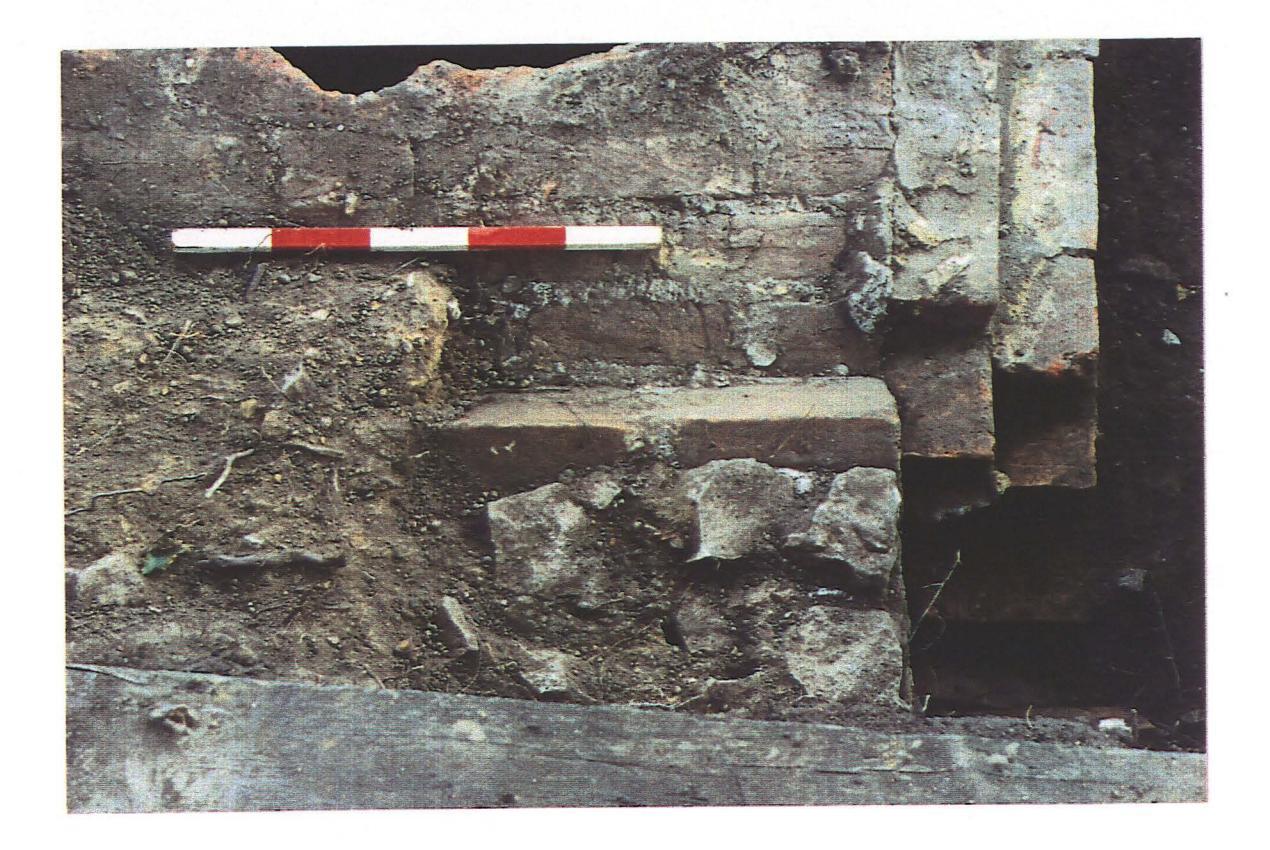
This was a brick wall c.230mm thick (sample brick dimensions 235 x 110 x 72mm) of five surviving courses which closed the SW side of the vault. In common with wall (22/30) its SE extremity terminated somewhat abruptly with no apparent stepped courses as found at the NW end. Overall coursing was of no particular bond but simply a convenient mix of headers and stretchers. The highest surviving course in both walls (including repaired area (23)) was mainly stretchers. No frogs were found. The exposed stepped courses at the NW end showed a thin coat of yellowish mortar adhering and appeared to have been previously cleaned for re-use.

PI. 9. Layer 7 (left); abutment 9 (centre); end-wall 21 (right). From NW.PI. 10. Abutment 9 over extrados; backfill 10 to wall 21. From SW.

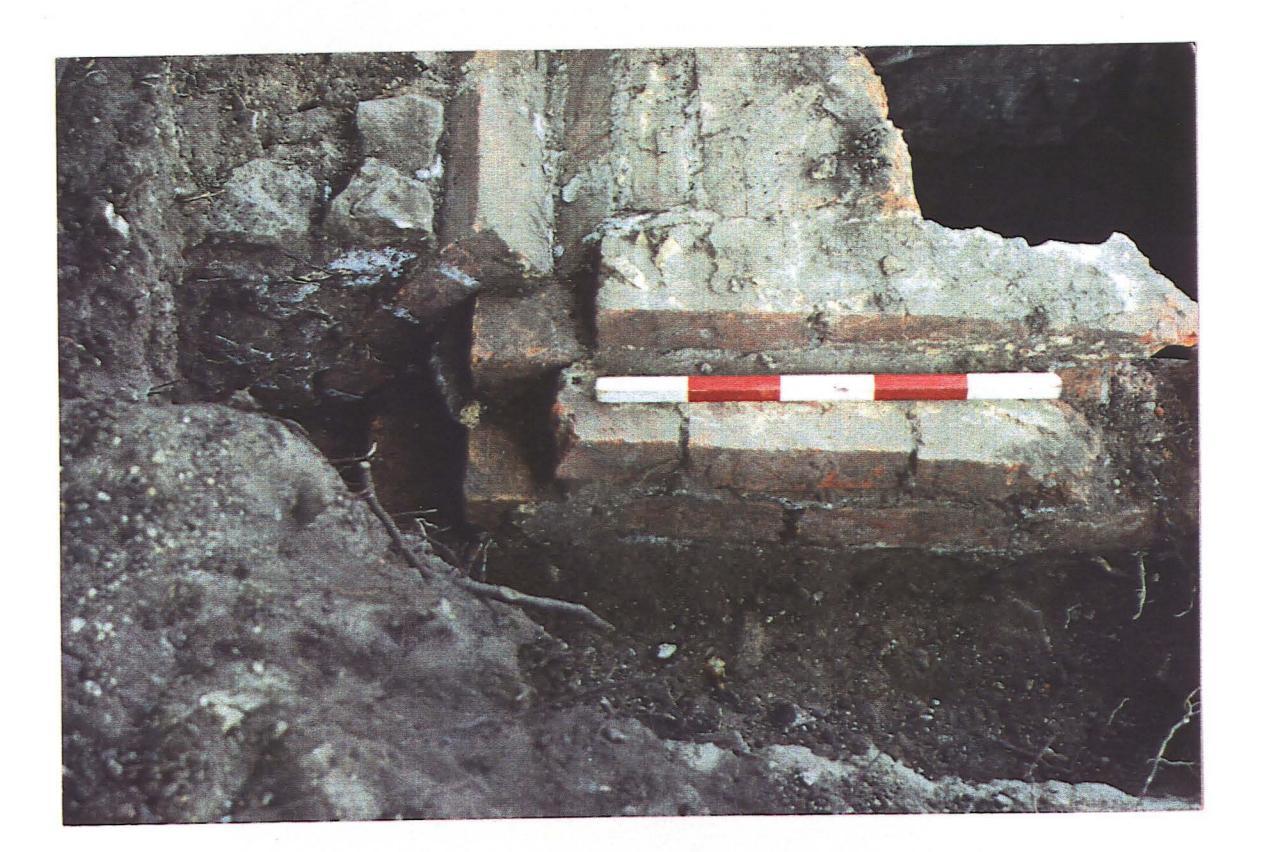
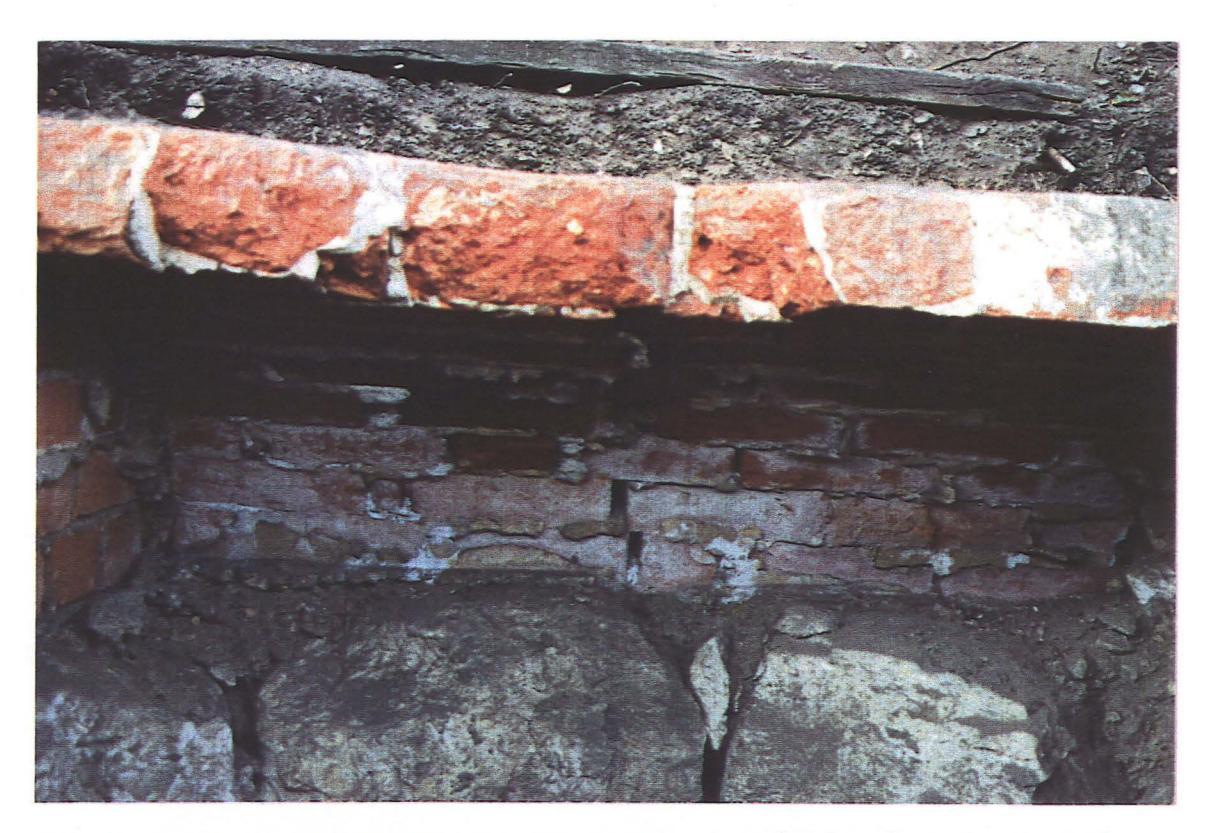
This was a simple open segmental arch vault springing from the truncated well-lining, having a width between openings of 1.20m and an internal span between springers of c.1.38m. It comprised two courses of voussoirs: the intrados (12), of which eight courses survived at the NW and four at the SE; and extrados (11), of which approximately five courses survived at the NW and four courses at the SE.

Sample brick dimensions were 230 x 112 x 73mm and 230 x 105 x 75mm perhaps of mid to late 19th century, other bricks observed were of less thickness, e.g. 230x114x65mm, perhaps of early to mid 19th century. At the highest surviving part of the arch the exposed brick cores were of an even, orange-red colour the mortar being of a cream-white colour. Internally, the mortar colour of (12) varied from white through buff to grey-brown. The base springer-bonding mortar which had been liberally spread over the wide joints of the shaft lining was partly obscured (and discoloured?) by dust and debris, giving an overall grey colour.

- PI. 11. Broken vaulting intrados 12; mortared springing from truncated stone lining. From SE.
- Pl. 12. Fill 4 to cut/matrix 5. Blue brick in wall 30 (lower right). From NE.

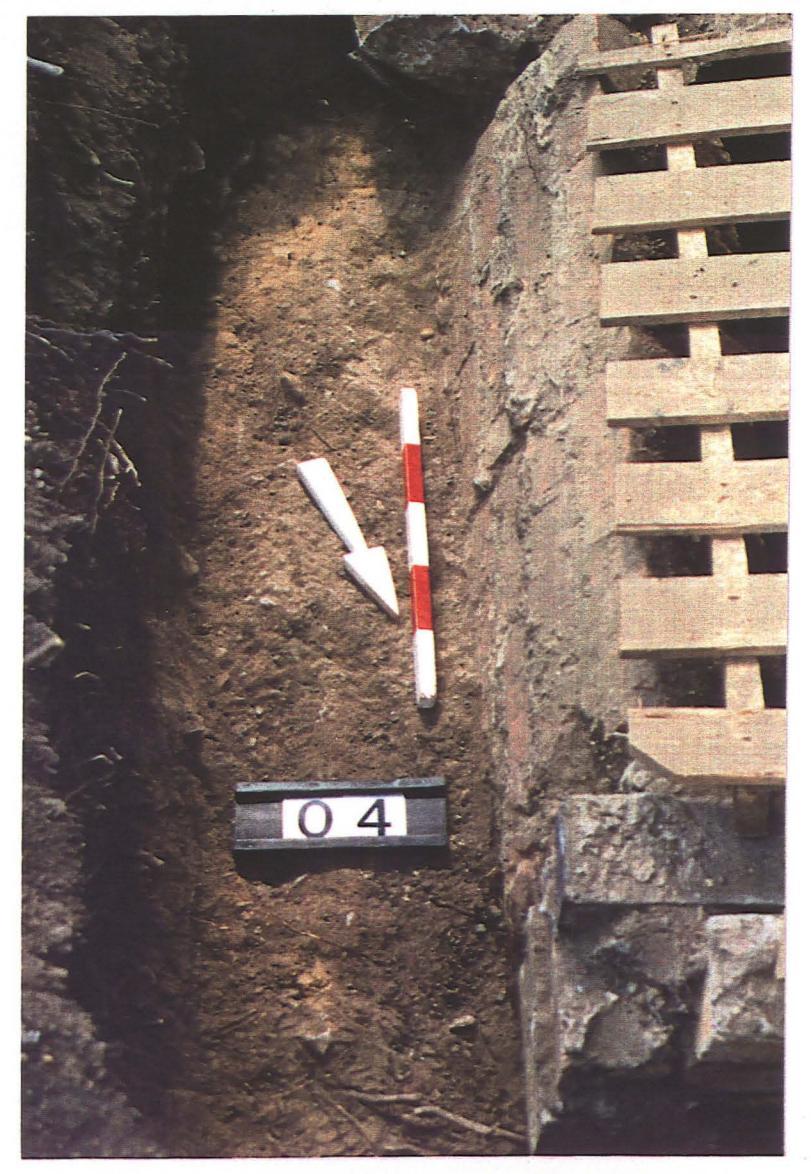
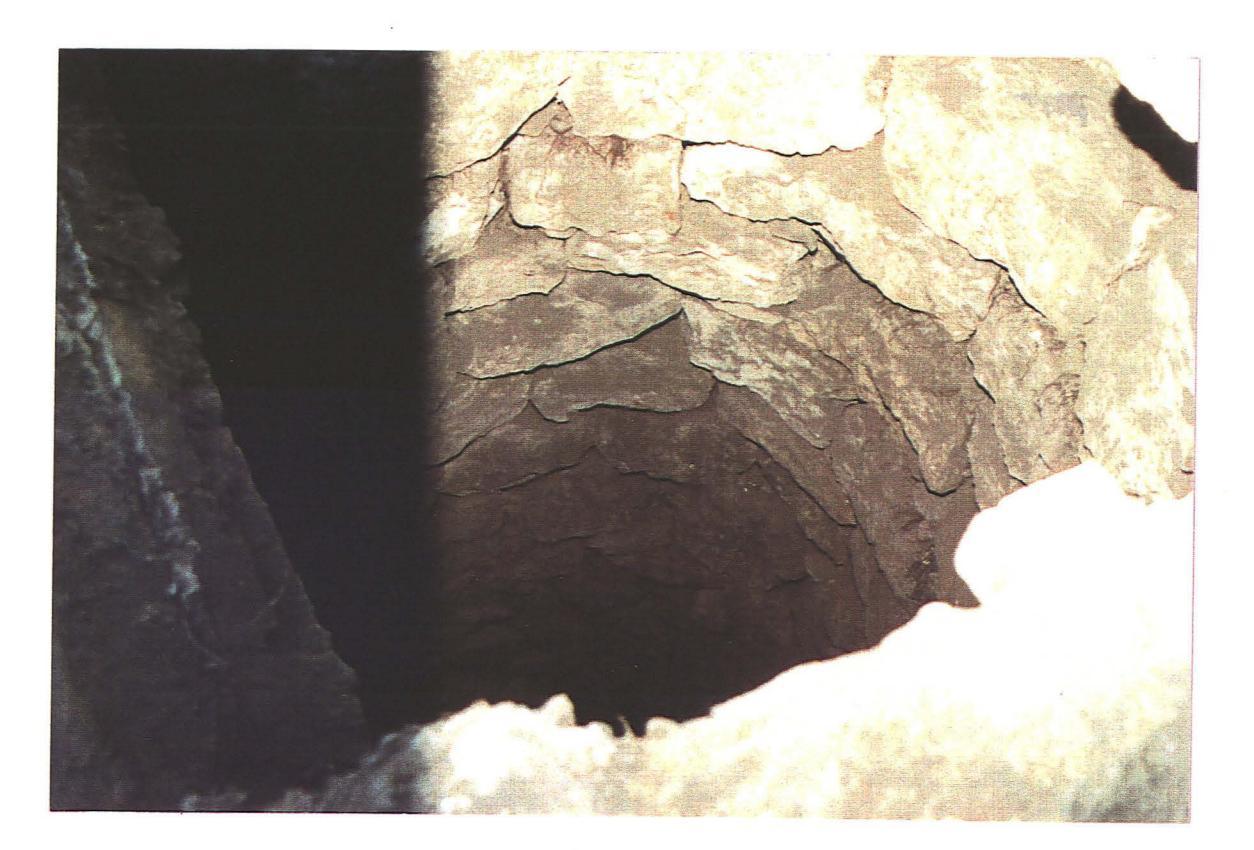
Probing below the extrados springing (11) (SE side) showed the upper shaft cut (16) was immediately behind stone lining blocks (15) which were seated on a ledge (17) about five courses below. The rough-hewn blocks varied from c. 200x150mm to 500x400mm (and up to 320mm thick) averaging nine blocks to a course, with no evidence of any bonding material (Pl. 15). It is assumed that the natural material occurring between the truncation level and ledge (17) was perhaps inadequate for a natural lining or to support a wellhead and that the constructed ledge (17) marks the level at which a more solid rock horizon occurred.

PI. 13. Shaft lining 15 (upper). From E.
