ARCHAEOLOGICAL WATCHING BRIEF REPORT

Heydour to Aisby Water Mains Replacement

Site Code:	HAP 96
LCNCC Acc. No.	95.97

Report prepared for Anglian Water Services Limited by James Albone
May 1997

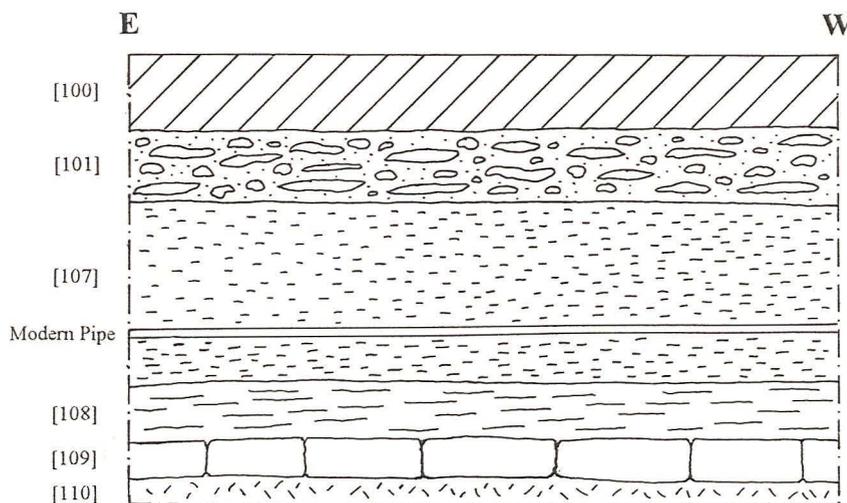
Beneath the modern road deposits this pit contained a series of natural clays within which, at a depth of 1.0 m., was a layer of limestone which had broken into blocks. A modern pipe was present running through the upper clay, the absence of a visible cut for this would suggest that it was backfilled with the same material.

Fig. 4: Section of Access Pit 3 showing natural clays, layer of limestone [109] and modern pipe, scale 1:20.

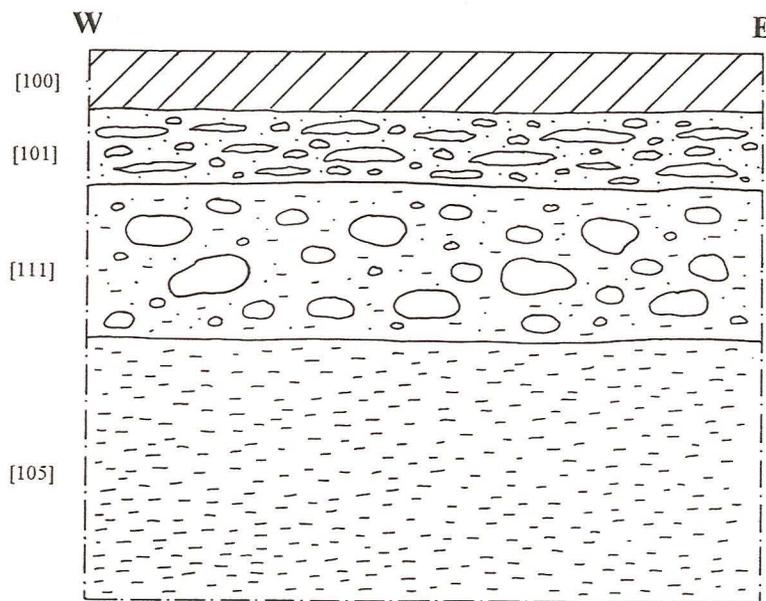
Sealed beneath the modern road deposits in this pit was a layer of rubble [111] with a mixed grey and yellow brown sandy clay matrix. It is possible that this deposit consists of material from the collapsed outer earthworks of the castle, which are situated c.10 m. to the north. However, in the absence of dateable material the association can only be tentative. Underlying this layer was a natural clay.

Fig. 5: Section of Access Pit 5 showing rubble layer possibly from the castle earthworks [111], scale 1:20

The development has had a minimal impact on the archaeological resource. The small size and wide distribution of the access pits has resulted in a certain amount of stratigraphic discontinuity, making interpretation difficult. In the absence of dateable material the rubble layer in pit 5. can only be tentatively associated with the castle earthworks.

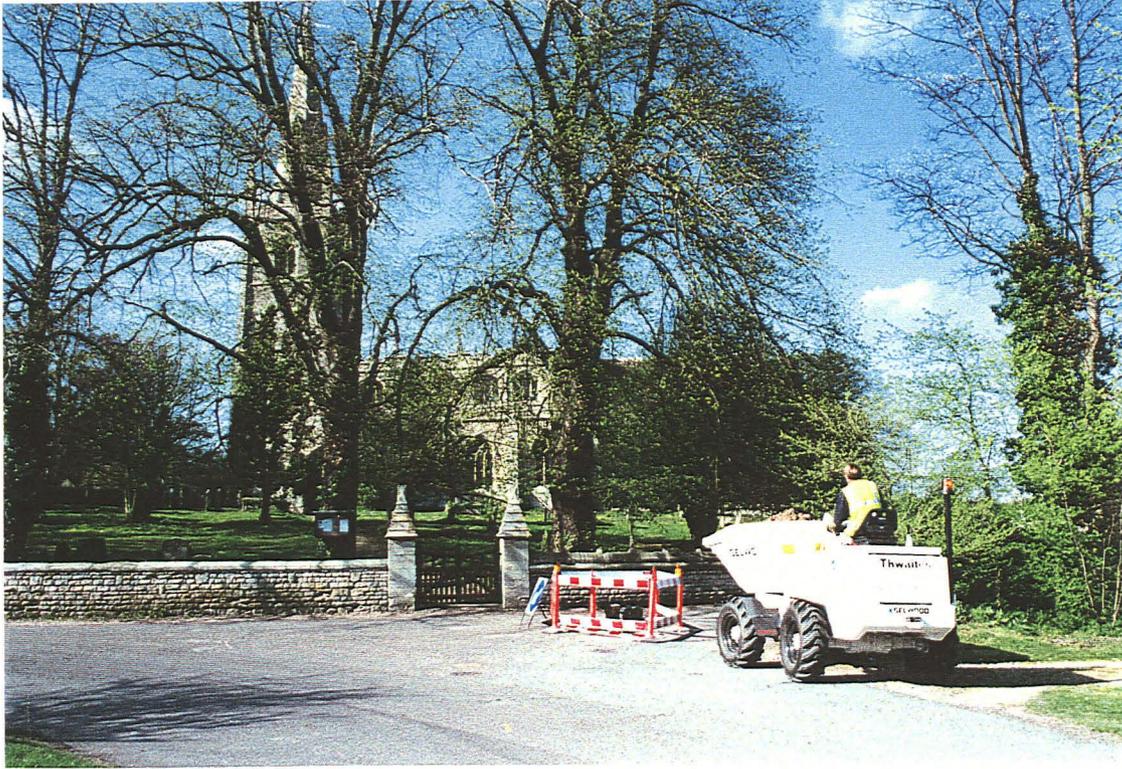
A T-shaped pit which measured 1.8 x 2.3 m. and approximately 1.1 m. deep. Beneath the modern road deposits were two natural layers; a clayey sand containing rubble limestone and a soft silty sand with occasional limestone fragments.

P1. General view showing location of Pit 1, looking north

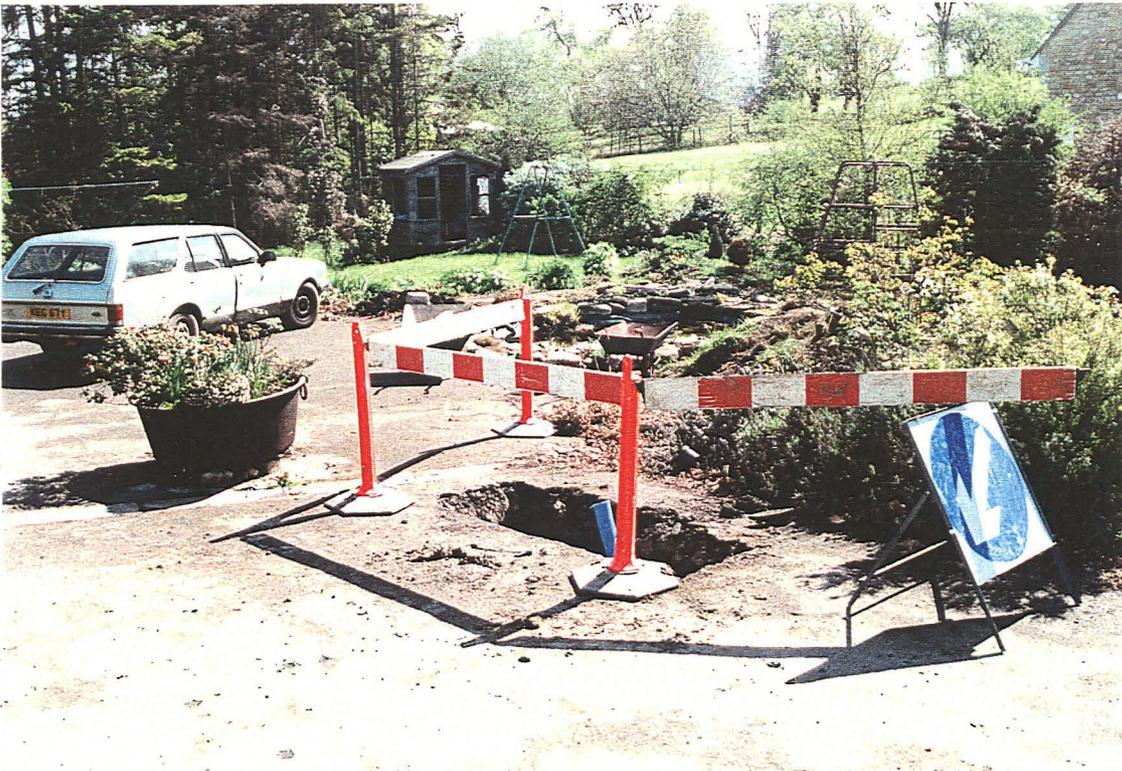
This pit showed a natural grey clay underlying the modern road deposits. A modern water pipe ran through this pit, the cut for which was backfilled with ashy material and rubble.

P2. Pit 7, looking south-east (note small size of trench, making close-up photography difficult)
