Stixwould, Lincs.

Mains Replacement Scheme:

Archaeological Monitoring

Report prepared for Anglian Water Services

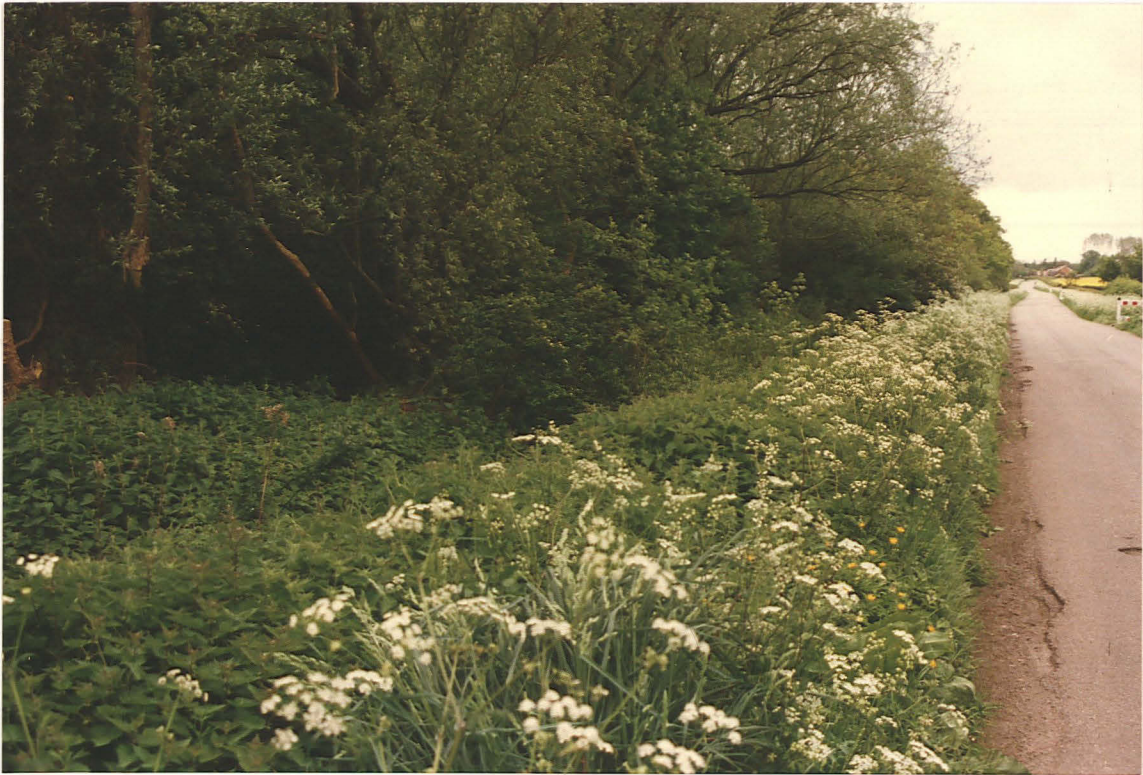
0.3km to the west of Halstead Hall is a complex of interconnecting water-filled pits beside the road to Stixwould and opposite Stixwould Plantation (Pl. 1). These have traditionally been interpreted as clay extraction pits serving a brickworks. Two existing buildings with outhouses are sited on the NE side of the pits and are known as Halstead Cottage and Halstead House (formerly Brick Pit Cottages). The pits lie to the north of Edlington Moor, which according to documentary records was the source of bricks used in the construction of Tattershall Castle in about 1430. By association, it has been suggested that these pits contributed to the bricks for that building. Another suggestion has been that the pits supplied material for the bricks used in Halstead Hall during the early 16th century and in its late 16th century brick barn.

PI. 1 Overgrown clay-pits close to Halstead Hall (looking SW; the barriers mark the pipe trenches).

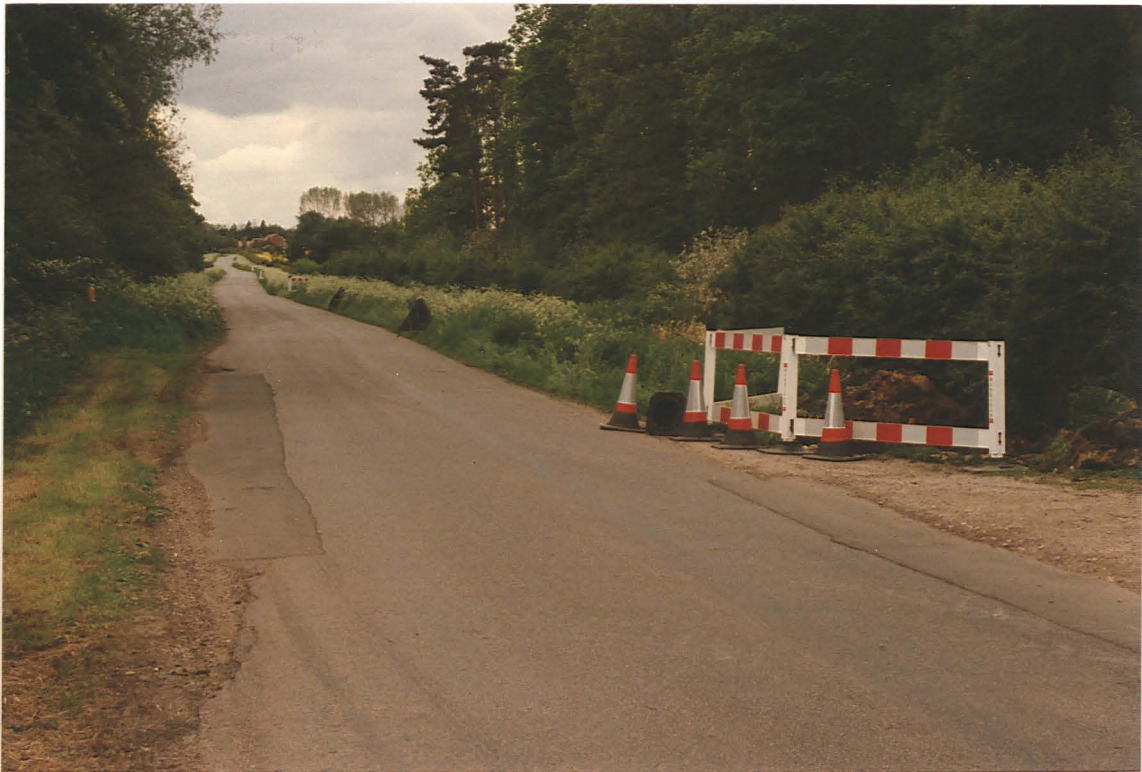
PI. 2 Position of moling access pit 3, beside the entrance to Stixwoud Plantation (looking SW).

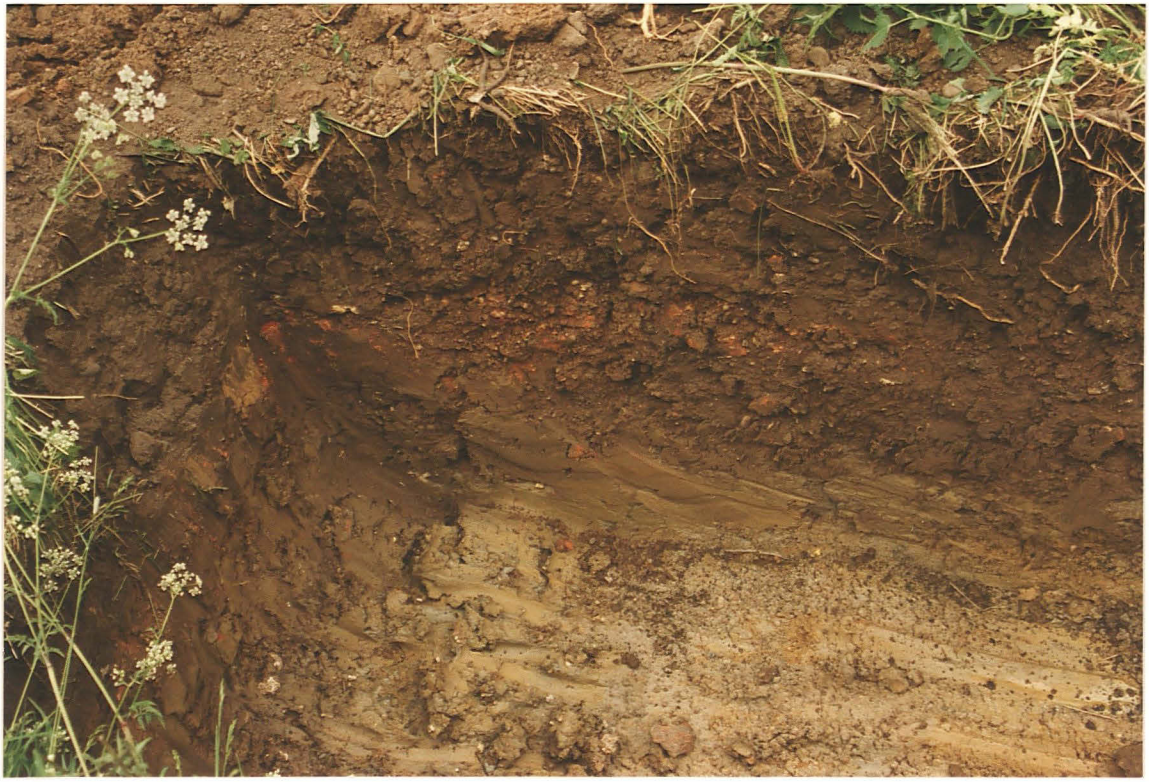
1. This hole was 100m SW of the track to Halstead Hall. The 0.35m thick topsoil layer sealed 0.55m of clay flecked with orange iron-panning stains. Beneath this deposit was mixed yellow/grey clay and fine sand lenses.
2. NW of Halstead Cottage, the topsoil layer incorporated red brick fragments. The sandy clay deposit was encountered 0.7m below the surface.
3. Midway past the water-filled pits, the hole on the opposite verge cut through 0.4m of topsoil sealing a dark brown loamy clay layer 0.25m thick (Pls. 2 and 3). This layer contained frequent fragments of roof tile and brick rubble, some highly overfired and presumably never used for building, and other pieces with adhering mortar showing it to be demolition rubble.

Below this demolition spread was 0.45m of yellow clay, overlying a sand and gravel lense of unknown thickness.

Pl. 3 Brick rubble backfilling a small feature at 3 (looking NW). Note the sand at the trench base.

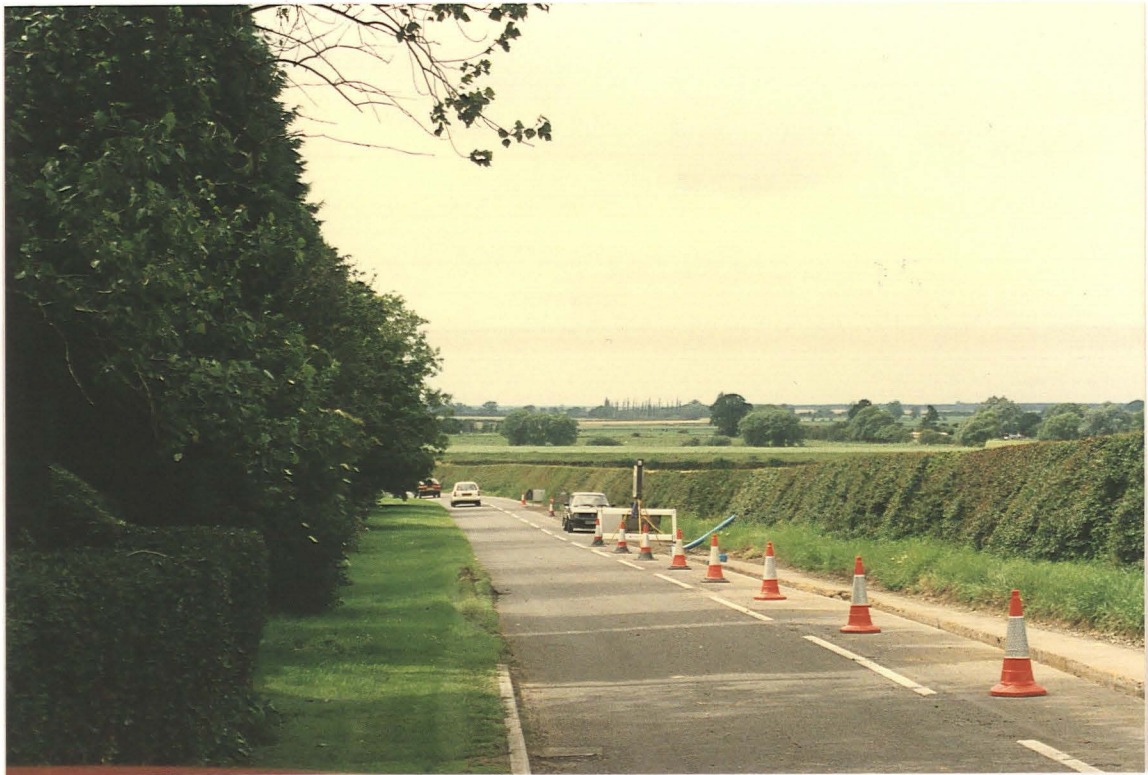
5. 35m NW of the farmyard boundary hedge, a 3m wide backfilled ditch or hollow was visible in the pipe trench (Pl. 4). The feature survived to a depth of 0.15m, below the tarmac and asphalt road surfaces, and was filled with a dark brown clay loam with limestone pieces and pebbles (Pl. 5). It is possible that this feature was a medieval furrow, levelled when the post-medieval road was constructed.

Pl. 4 Duckpool Lane. Feature 5 was located opposite the elder tree (looking NW).

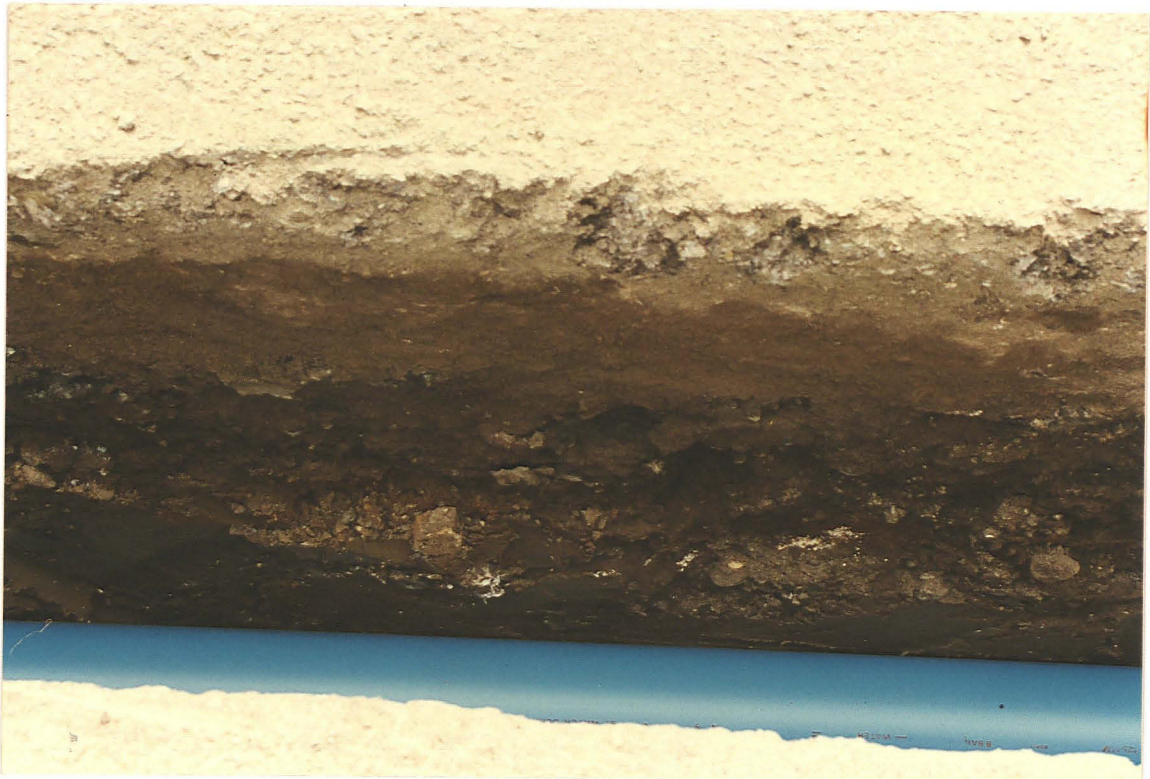
Pl. 5 Limestone and pebbles in the fill of 5, possibly a medieval plough furrow. Looking NE.

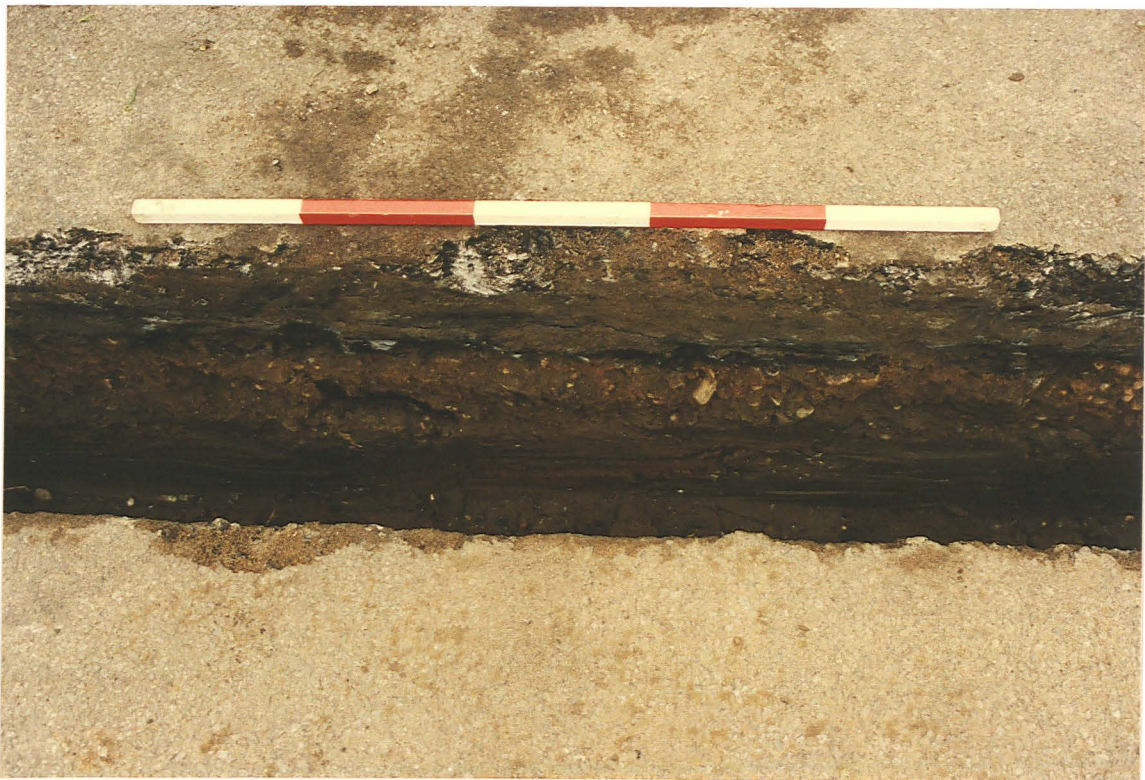
6. The tarmac road here was 0.3m thick and covered a layer of gravel with sand which was 0.15m thick (Pl. 6). The well-preserved condition of this short stretch of metalled surface may indicate a track or path crossing the course of the modern road, rather than part of the post-medieval precursor of the present road.

Pl. 6 Gravel path or road metalling, 6. Scale 1m; looking NE.

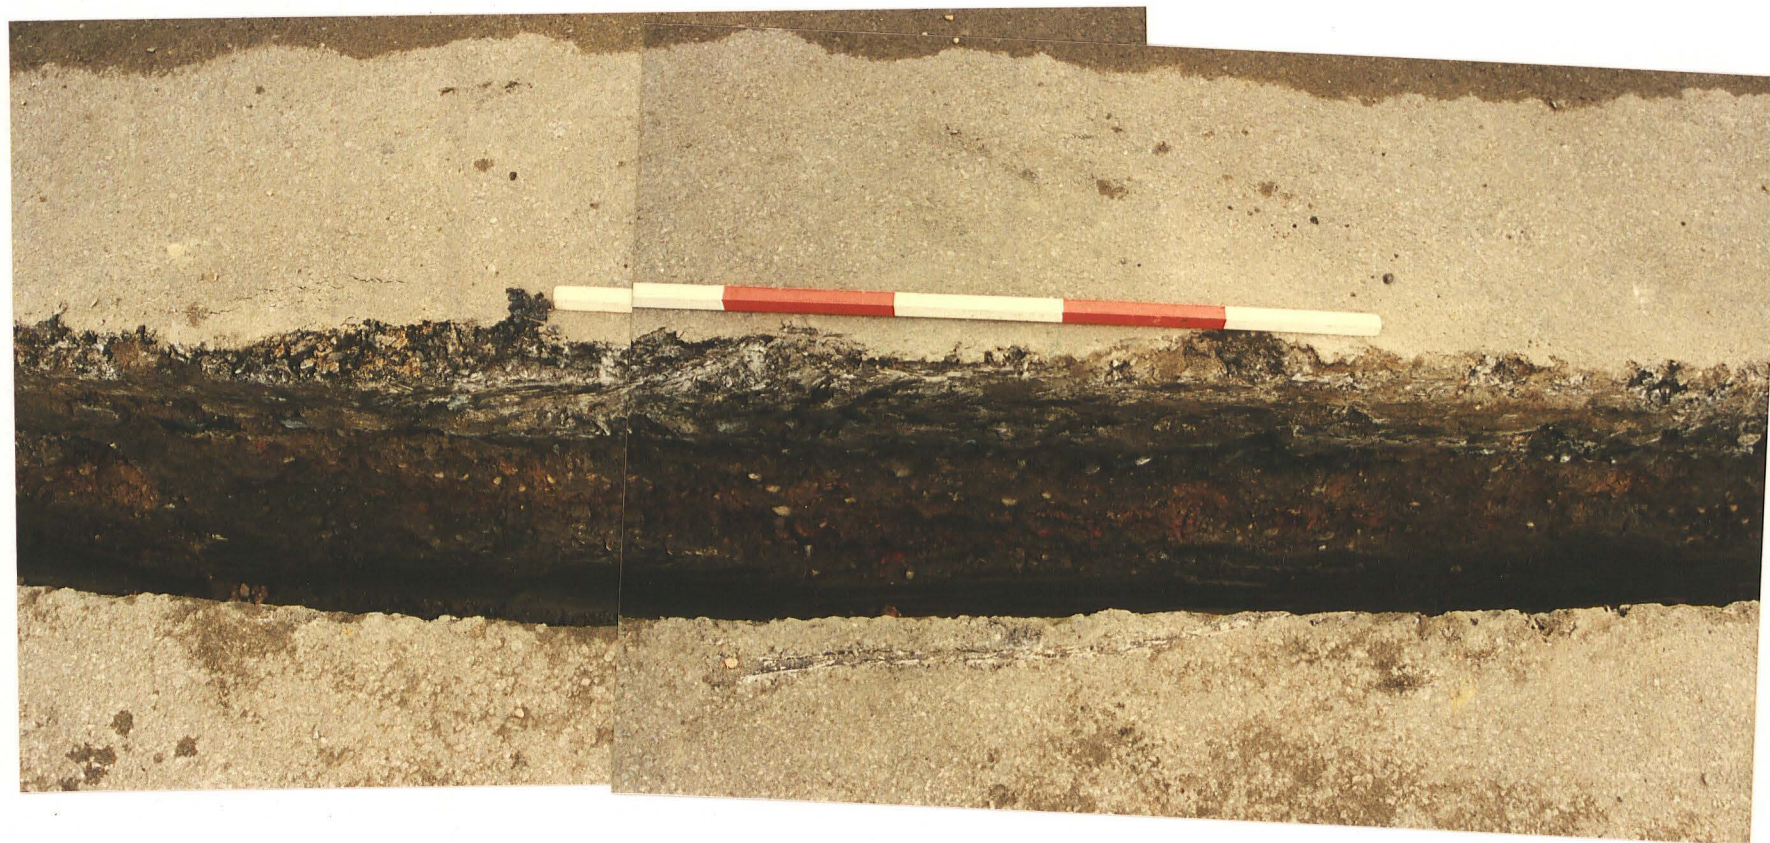
7. 8m SE of 8, the road metalling gravel overlay a 0.12m thick spread of brick rubble; it extended 3m along the trench 0.4m below the modern road surface (Pl. 7). The rubble presumably dates from construction of the metalled road, and may have been used to fill a damp depression (possibly marking an archaeological feature, although nothing was identified beneath it).

Pl. 7 Brick rubble infilling 7. Scale 1m, looking NE.

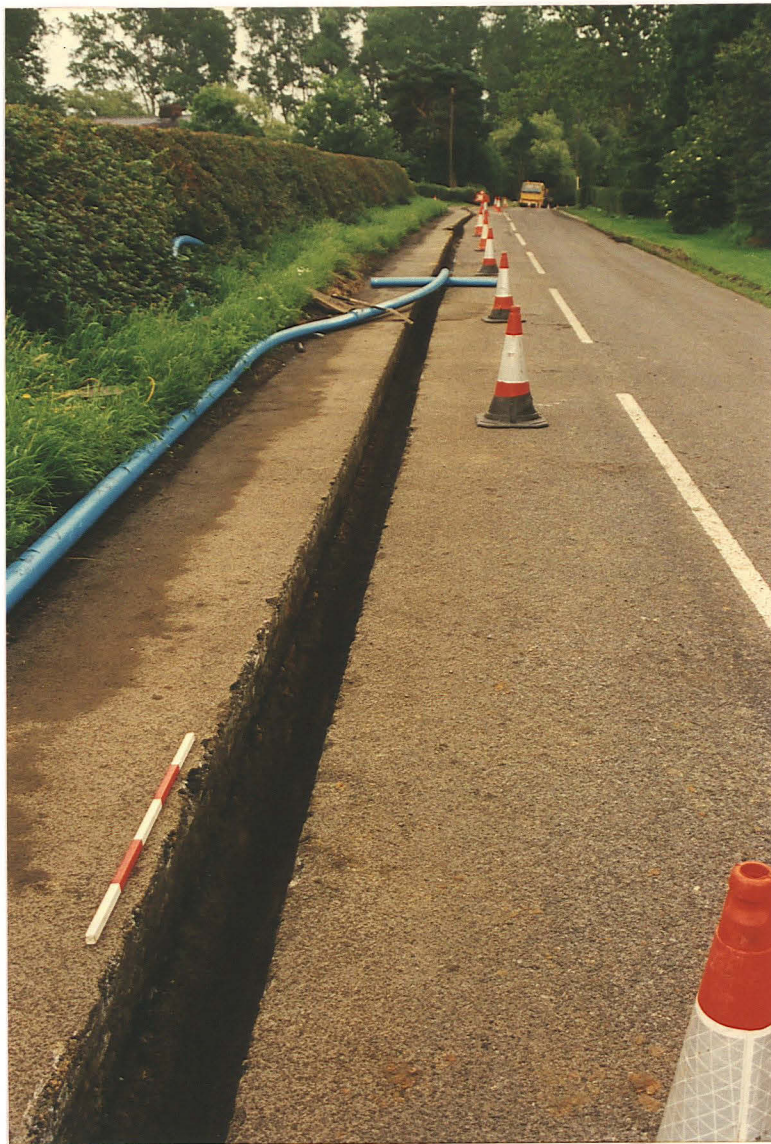
8. A narrow ditch, 0.4m wide, crossed the line of the pipe trench in a SW-NE alignment, apparently extending the line of an existing field boundary ditch south of the modern bungalow (Pl. 8). The ditch cut below the trench base and had been backfilled with orange/brown sand.

This feature had been filled before the road had been constructed; its fill was sealed by a layer of sand beneath the post-medieval gravel metalling under the present tarmac road. The ditch may be of medieval date but no dating evidence was seen.

PI. 8 Location of a narrow ditch 8, crossing the trench below the scale (looking SE).

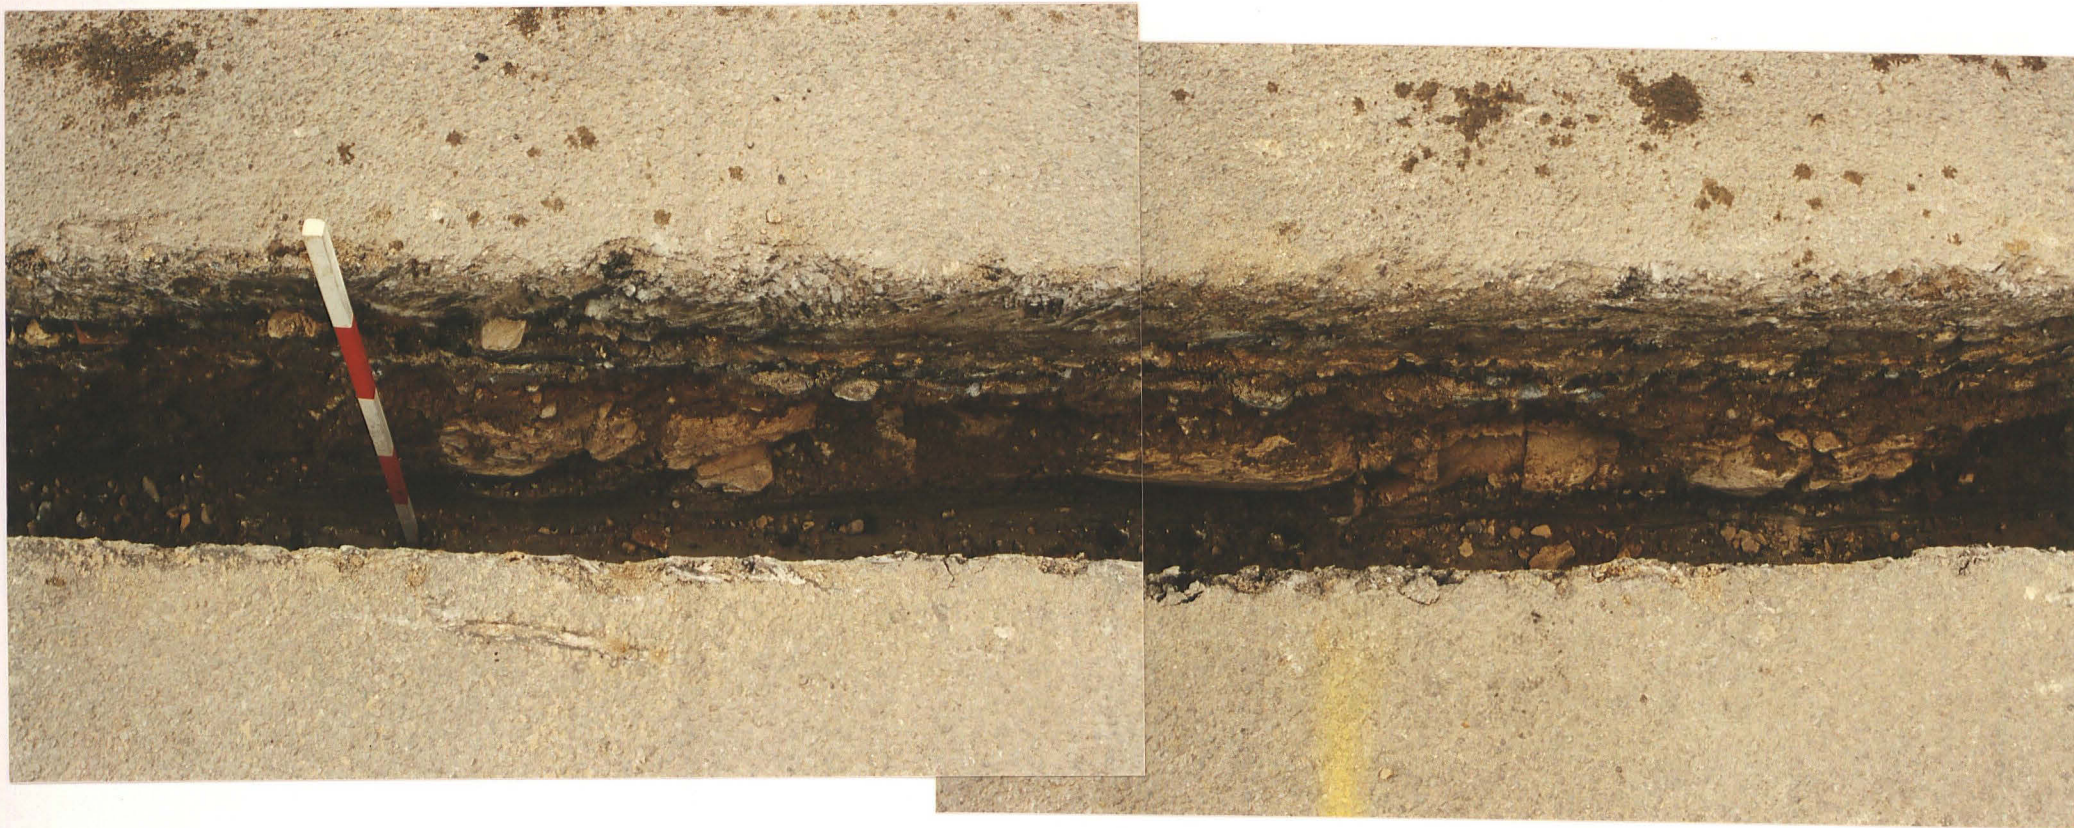
10. 12m east of the southern field boundary, the trench cut through a single 0.25m thick course of large blocks of limestone, unmortared but laid closely fitting. The blocks were only visible on the southern face of the trench, 0.5m below the modern road surface (Pl. 9). They were set into a layer of dark grey clay (possibly fill of a natural or artificial channel) and were covered by a levelling deposit of light brown stony clay loam 0.1m thick. Above this was 0.12m of stones and pebbles forming a metalled road surface and the 0.28m accumulation of tarmac road.

To the east of the blocks, the ground beneath the levelling deposit dropped away, as if at the western edge of a depression. This was filled with a brown sandy loam and an underlying dark brown loam which may have been a buried topsoil; this contained an undiagnostic fragment of clay roof-tile. It was unclear whether the soil had formed over the limestone blocks or had been cut by that feature.

The trench probably cut across a corner of the priory grounds at 10, although no finds were visible. The Ordnance Survey indicate earthworks, probably a return of the embanked enclosure ditch or moat, beside the road hedge on the north side of the road. This would be consistent with the observations of this project.

Pl. 9 Laid limestone blocks below the post-medieval road, and probably filling the medieval moat at 10. Scale 1m.
