**Report on an Archaeological Watching  
Brief at Dungman's Tack,  
Montrose, Angus, DD10 8SJ**

**NGR NO 71770 59005**

**Cat Peters and Alison Cameron  
Cameron Archaeology Ltd  
10 May 2013**

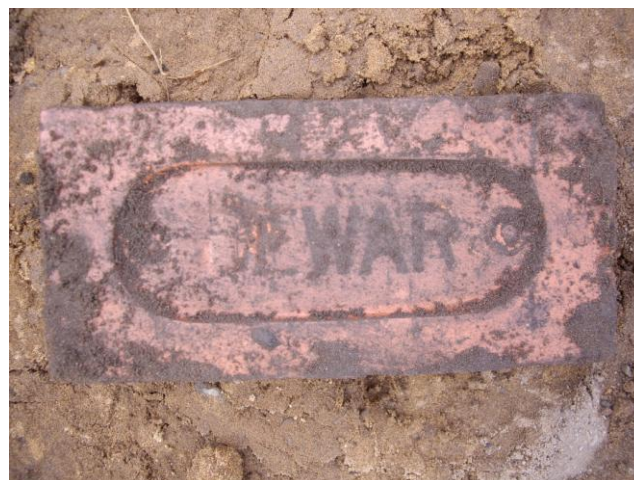
*Illus 3: 'Dewar' inscribed brick*

The sewerage excavations revealed a mid-brown topsoil across the area of up to 0.2m thickness. Beneath this, on the east-west aligned part of the dig, was a loose sand. The topsoil in this area revealed 19<sup>th</sup> and 20<sup>th</sup> century pottery fragments, as well as some bricks with 'DEWAR' printed on them (Illus 3). This relates to the Dalmellington Iron Company, their Dunaskin Brickworks, established in the 1850s and closed in 1928.

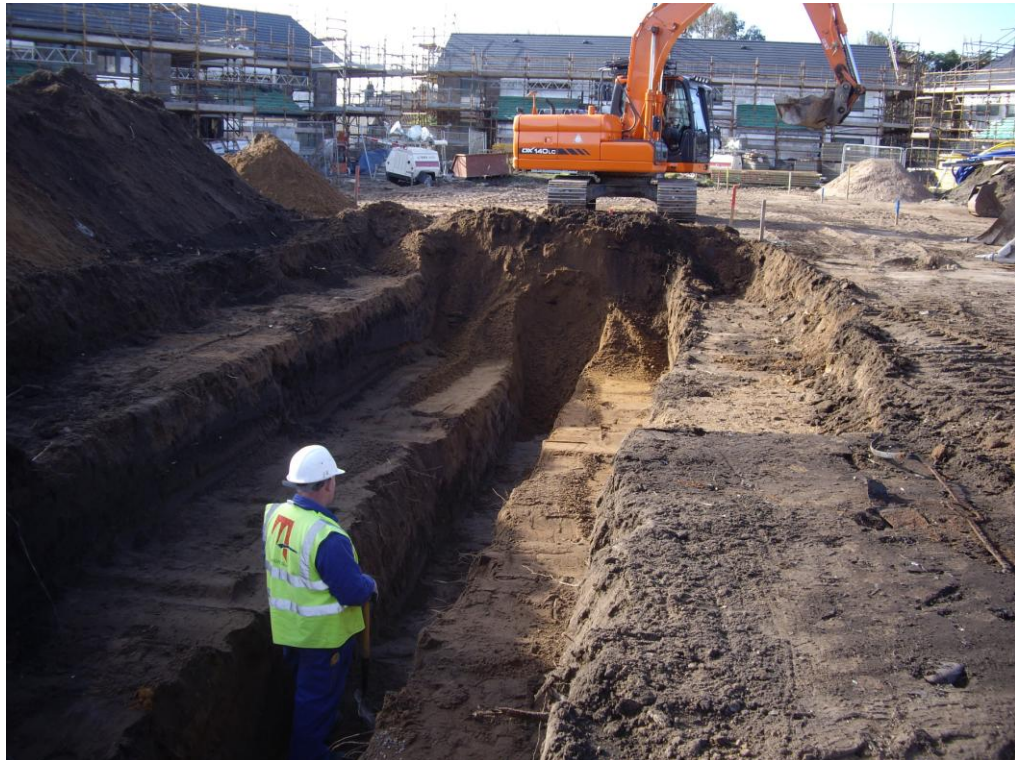
*Illus 4: Dark-brown mixed deposit containing 20<sup>th</sup> century material*

Beyond the dog-leg of the sewerage route, to the north-east south-west aligned leg of the excavation, was a narrow band of made up ground, observed up to the second western short branch dig, consistent with recent use of the area for car parking/ hard standing. Beneath this was a dark-brown mixed deposit which included scrap metal debris, modern bricks and pottery and glass bottles of 20<sup>th</sup> century origin. This deposit was up to 0.7m thick, and directly overlay a loose sand (Illus 4). To the south of this western branch, the dark-brown deposit disappeared and only made-up ground and sand was revealed, showing the recent disturbance of the area by the recently demolished building.

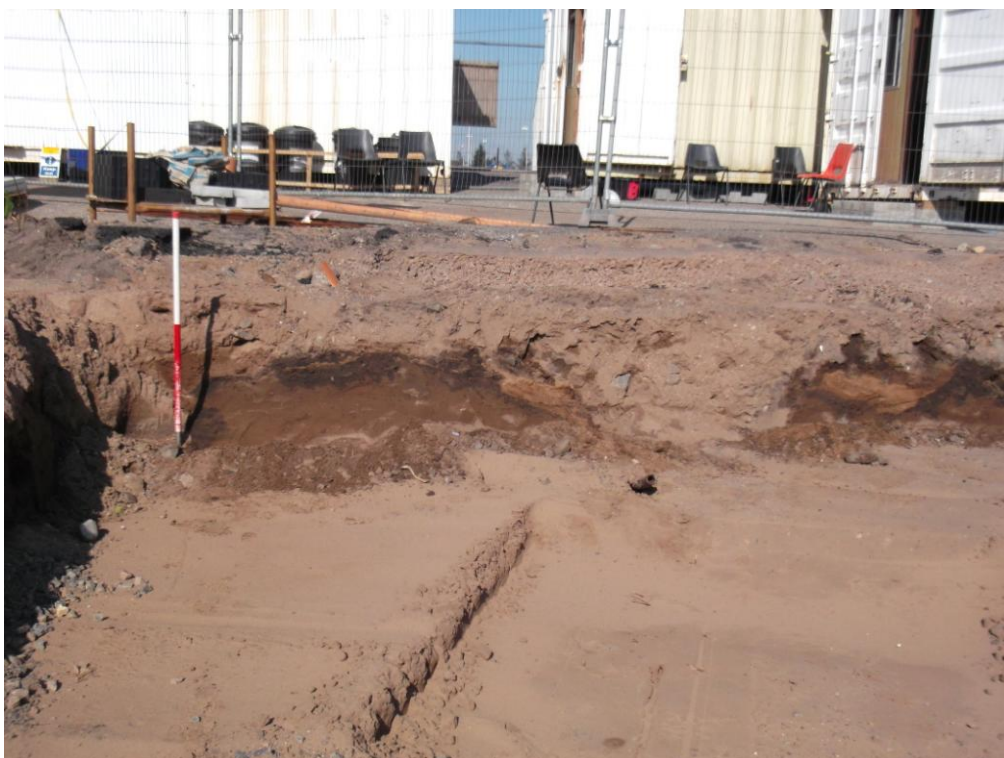
Soil strip was recorded north of the former location of Wirren House. A former car park surface was noted as well as soil levels associated with the 19th-20th-century use of this site. No significant archaeological contexts were recorded and all details appear in archive.

*Illus 5: section through soil north of former Wirren House showing soil levels associated with later use of this site*
