**A WALKOVER SURVEY OF THE FORESTED AREAS AT  
CRATHES CASTLE, BANCHORY, ABERDEENSHIRE**

Dr Robert Lenfert  
Cameron Archaeology  
February 2015

# **A Walkover Survey of the Forested Areas at Crathes Castle, Banchory, Aberdeenshire**

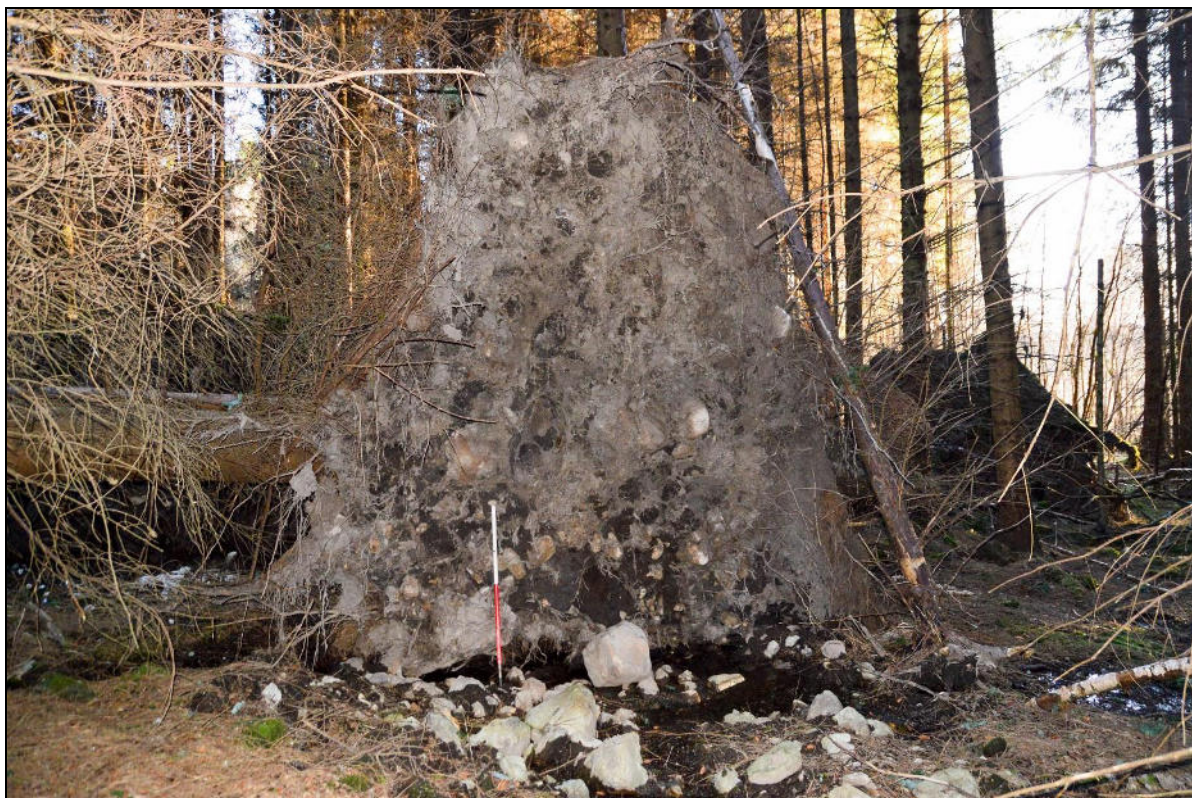
**Illustration 4a:** A recently fallen pine attached to a typical large 'rootplate'; these denuded areas revealed the clearest views of the forest floor underneath.

Nonetheless, the impact of this extreme weather event on the forested areas, and the implications for the identification of archaeological remains is clear. As the root plate (illus. 4a) is torn up, it creates a crater-like depression in the ground which creates a rolling, hummock-like terrain when this occurs in number. This impact, in addition to the dragging out of trees, ploughing and replanting, would conceivably remove all vestiges of visible archaeological activity except the most robust types such as upstanding drystone features (e.g. stone walling) or large earthworks. While there is little doubt that considerable archaeological remains are present in the ground, particularly prehistoric remains based upon existing records for surrounding areas, it will be difficult or impossible to identify without intrusive efforts.

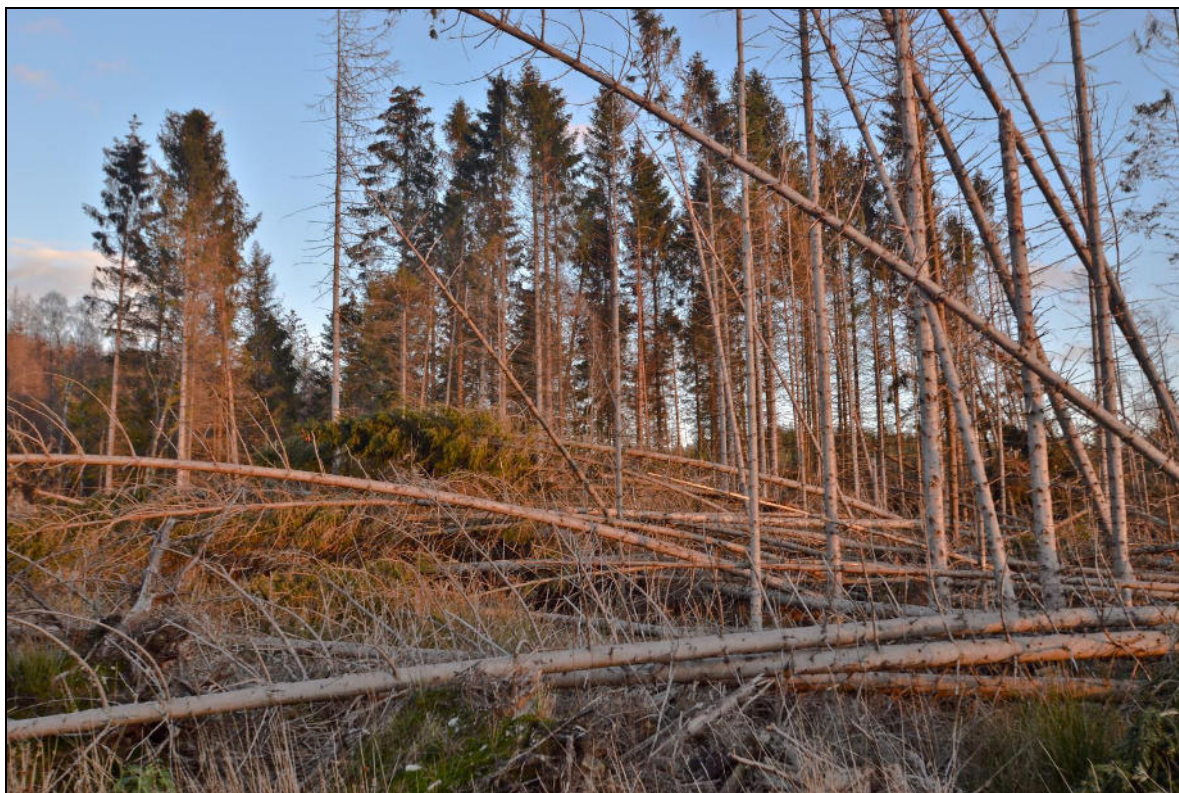
**Illustration 4b: Wind damage, albeit sporadic, in compartment 4.**

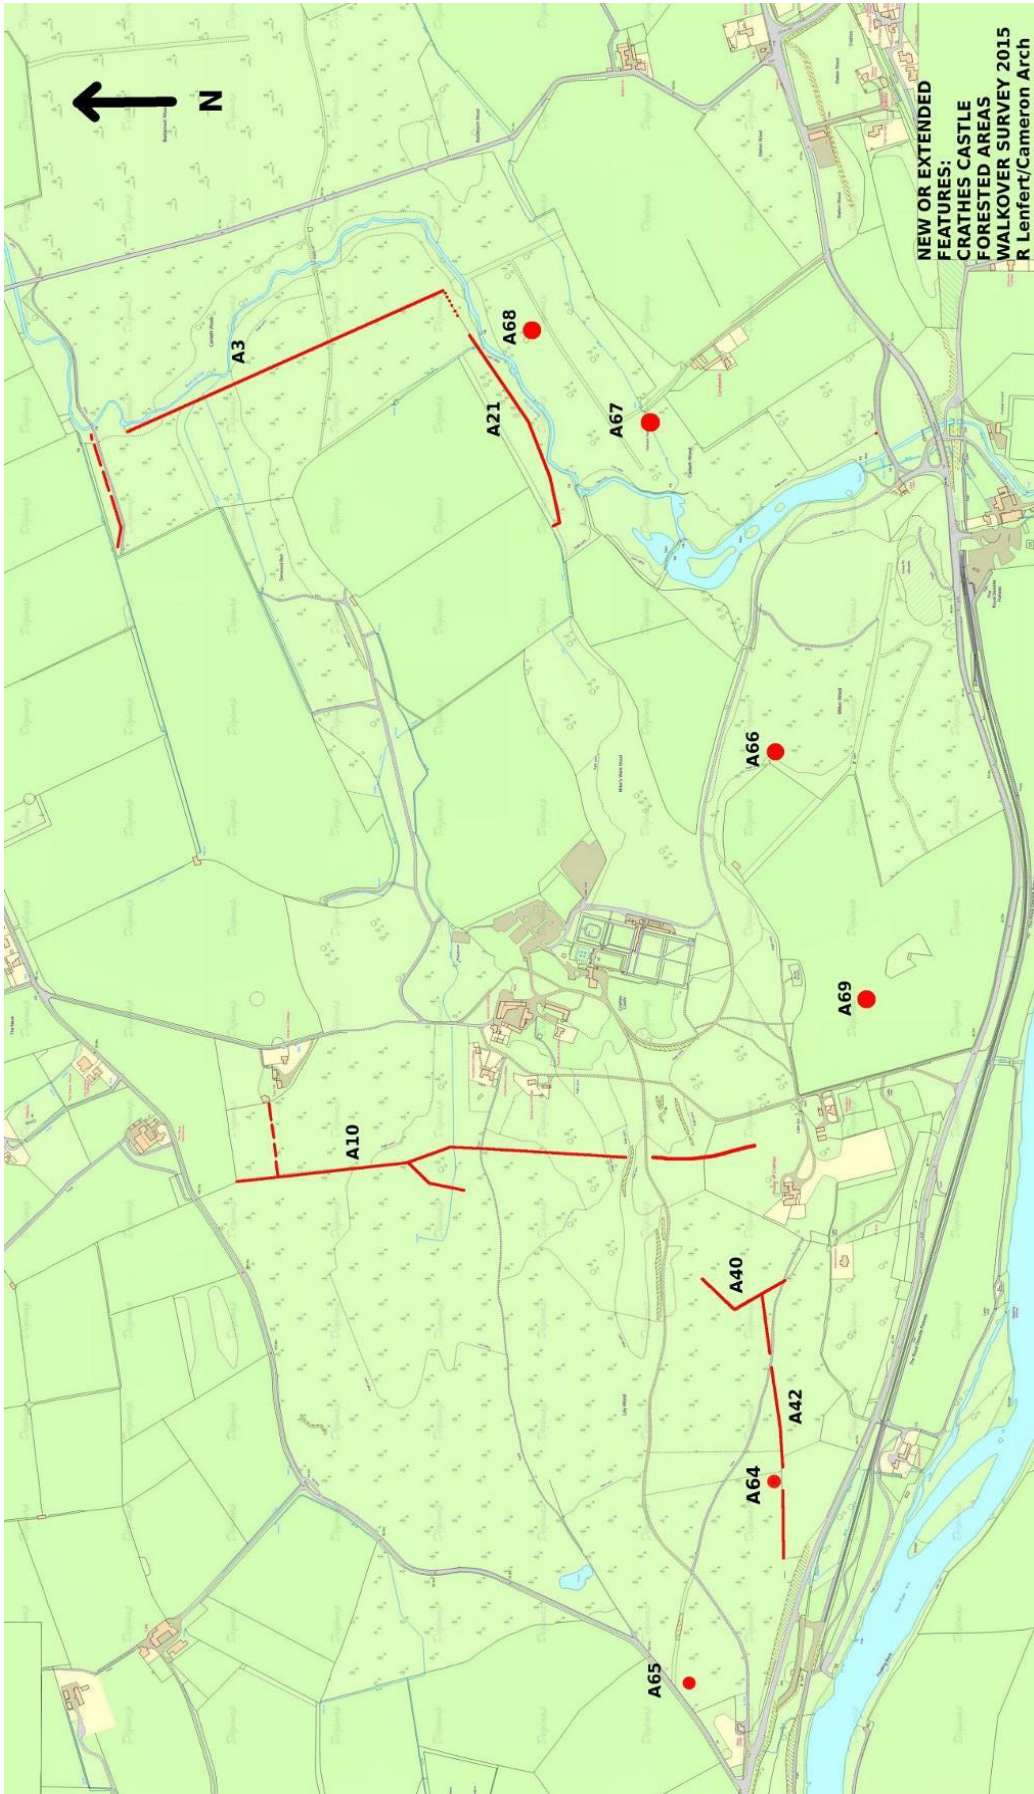
Former field boundaries or stone walling were extended in the existing features (W to E): A42, A40, A10, A21 and A3. A42 was marginally extended eastwards in places, though the remaining sections are far from intact. The terminus of A40 was slightly extended at both S and NE ends. A10/A42 and A3/A21 represented the largest increase in traceable walling not recorded on the AOC survey. A10 may be roughly traced in what appears to be an attempt to link up with A42, indicated by an intermittent, but identifiable, remnant wall extending from the cliff above 'Caroline's Garden' to the SW boundary of the field west of the Keeper's Cottage and south of the Neuk Farmhouse. This is represented by the junction of compartments 29 and 5 in illus. 1, 8a and 8b. At the eastern end of the property, walling was extended on features A3 and A21 from the AOC survey, meeting in a robustly built, sharply defined right angle junction (photos 22-01:23 & 24). Finally, A10 is also seen to extend east, in a direct line towards the saw mill, though

**Illustration 6: New or extended features added to existing records from AOC Survey**

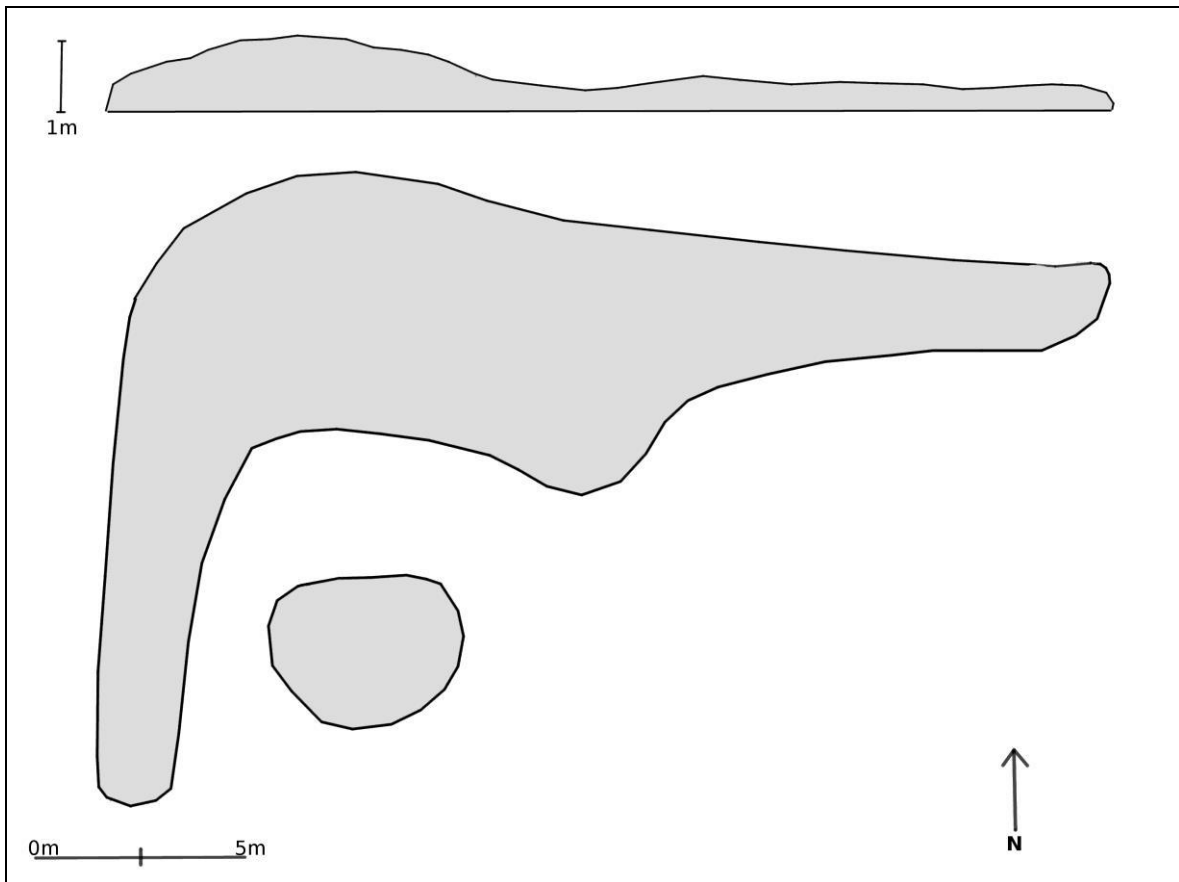
The first objective was relocating the possible prehistoric cairn (A64, Compartment 3) in the SW of the property (illus. 1, 5 & 7), originally noticed by Shannon Fraser (NTS) which had been previously obscured by bracken at the time. The mound and outlying bank of stone is comprised of sub-angular boulders some 20-40cm across, and is located near the SW corner of the property, 8-10m due north of an existing stone wall (A42) with a c.3-4m section missing. This raises the question if the feature represents removal and subsequent dumping of walling material (as evidenced by a c.4m gap in the walling), or if the source of the walling material is in fact stone that has been robbed from the cairn. Additional clearing and examination of the feature took place on February 18<sup>th</sup> which indicated that the stone has been haphazardly stacked in places, but a definitive answer will most likely require extensive clearing and at least partial excavation. In the NW corner of the feature, the low-lying stone forms a relatively neat linear right angle approximately .8m-1m high and c.2.5m wide, which perhaps suggests later (i.e. Medieval or post-Medieval) activity. An existing 1838 map of Crathes shows the walling intact in this area, and makes no mention of a cairn, but this could perhaps be a result of surveyor bias in what information was included on the map.

**Illustration 8: Digitisation of simple field sketch of feature A64.**

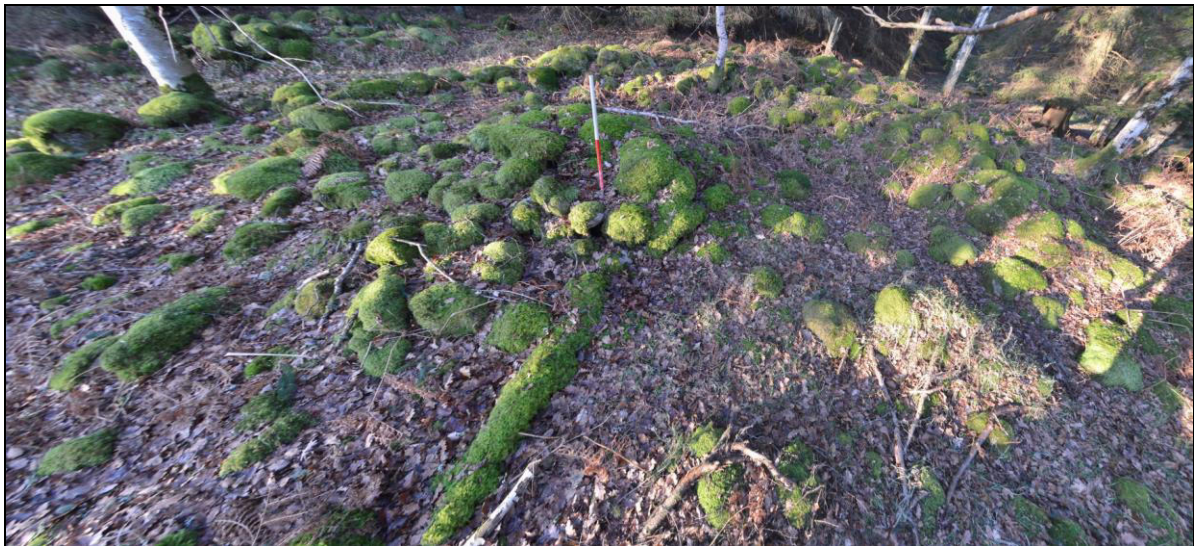
**Illustration 9: Panoramic photo of feature (A64). Note angular corner in back.**
