# Dunninald Stables, Montrose, DD10 9TD

## Report on Level 1 Standing Building Survey

**Alison Cameron**  
**Cameron Archaeology**  
**28 December 2017**

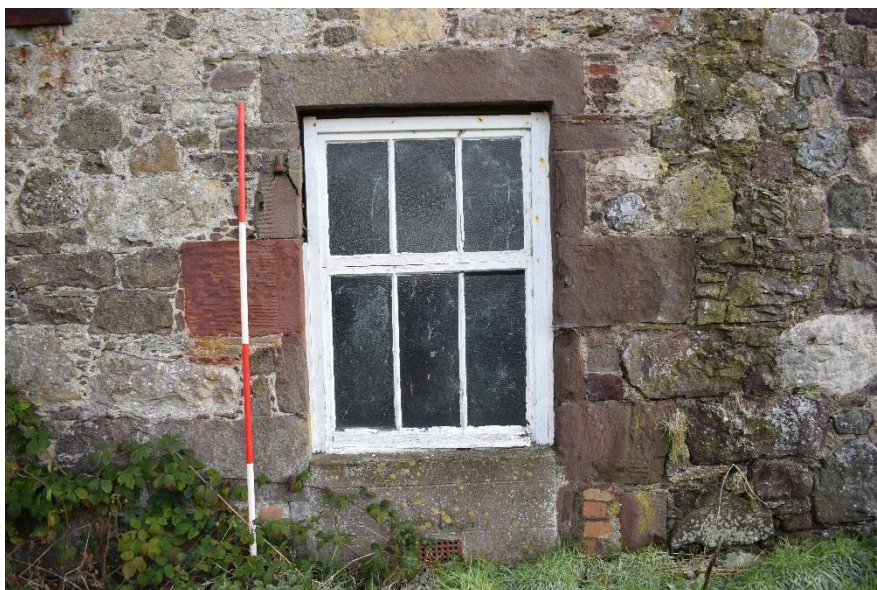
The steadings appear to have been built in one phase but have had many redevelopments. The N half of the E wing originally had three doors onto the courtyard (D31, 32, 33; Illus 2, 21) and these were later converted to windows.

Illus 2 E wing Room 16 W wall D31 converted into window W49; facing E

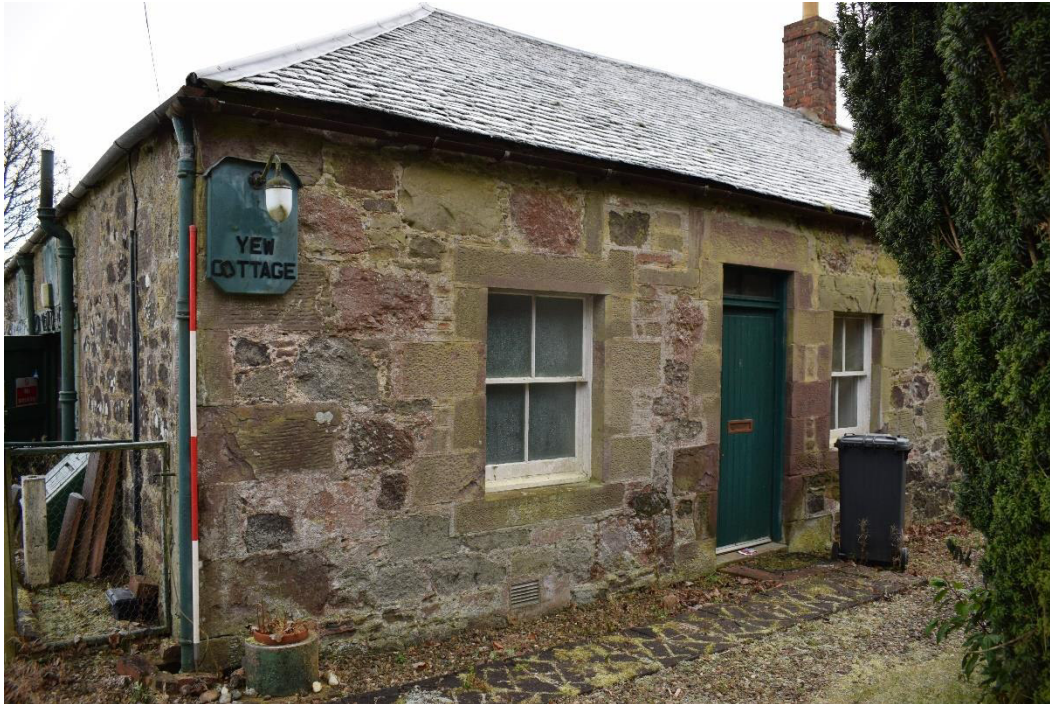
subsequently blocked and replaced by the later cottage windows (W17, W19, W61, W62, W17; Illus 5, 6). The upper floor of this cottage is a single room conversion of the roof space.

Illus 5 Cottage W façade W wing N end W16 (left), D6, W18 with Phase 1 upper window W17 blocked above W16; facing SE

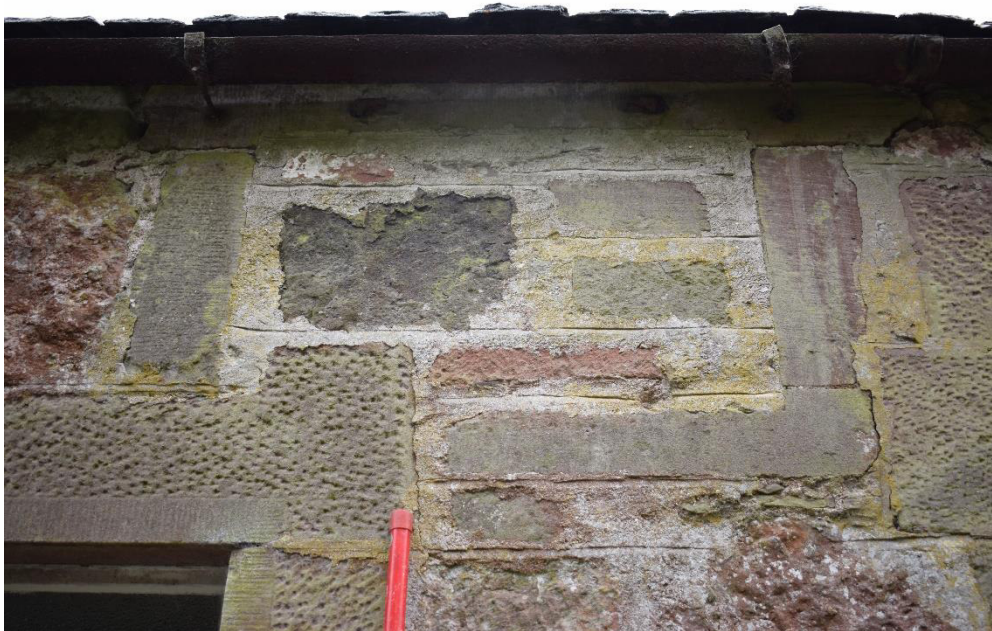
Illus 6 Phase 1 blocked window W17 above W16; facing E

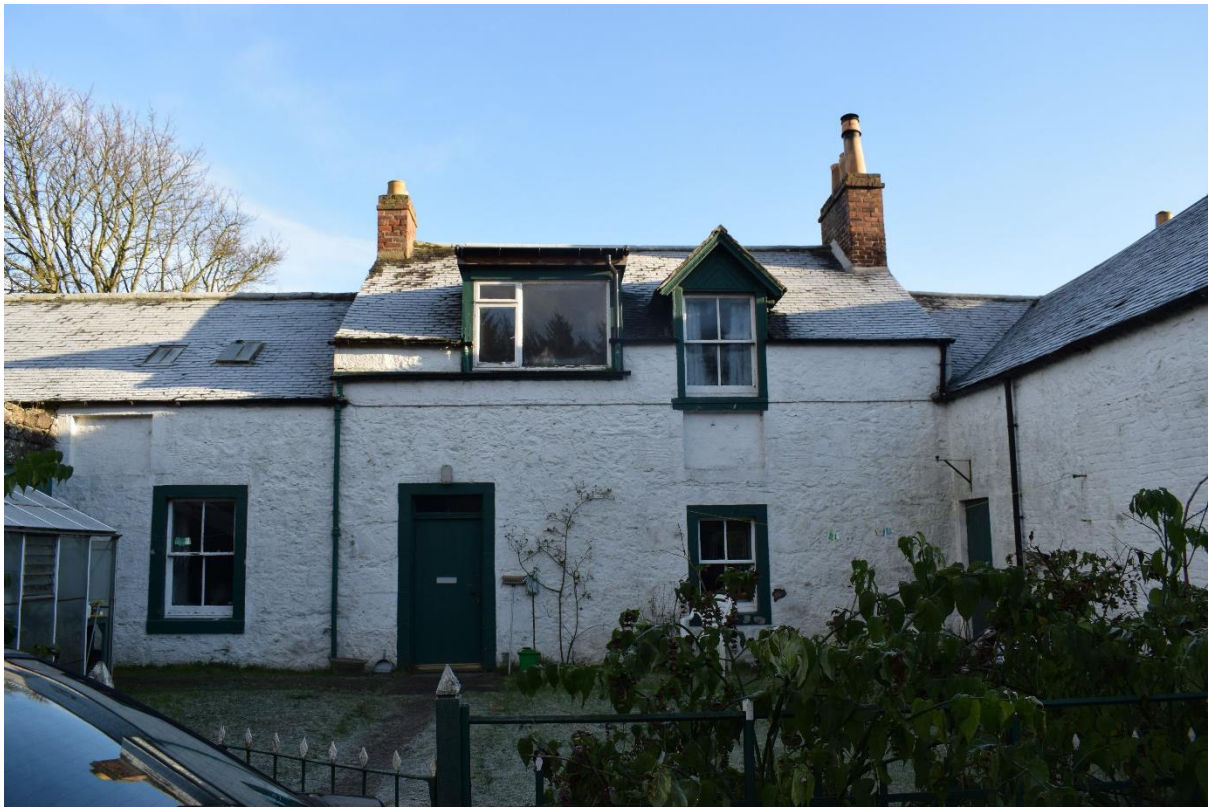
The third cottage is also a conversion of a steading. Rooms 27-31 are now living accommodation with added windows (W47, 48, 53, 54, 55) and doors (D17) and walls rebuilt with hand-made red brick (Illus 7).

Illus 7 Cottage E wing S end W façade W52, D18, W57 with W54 and 55 (above); facing E

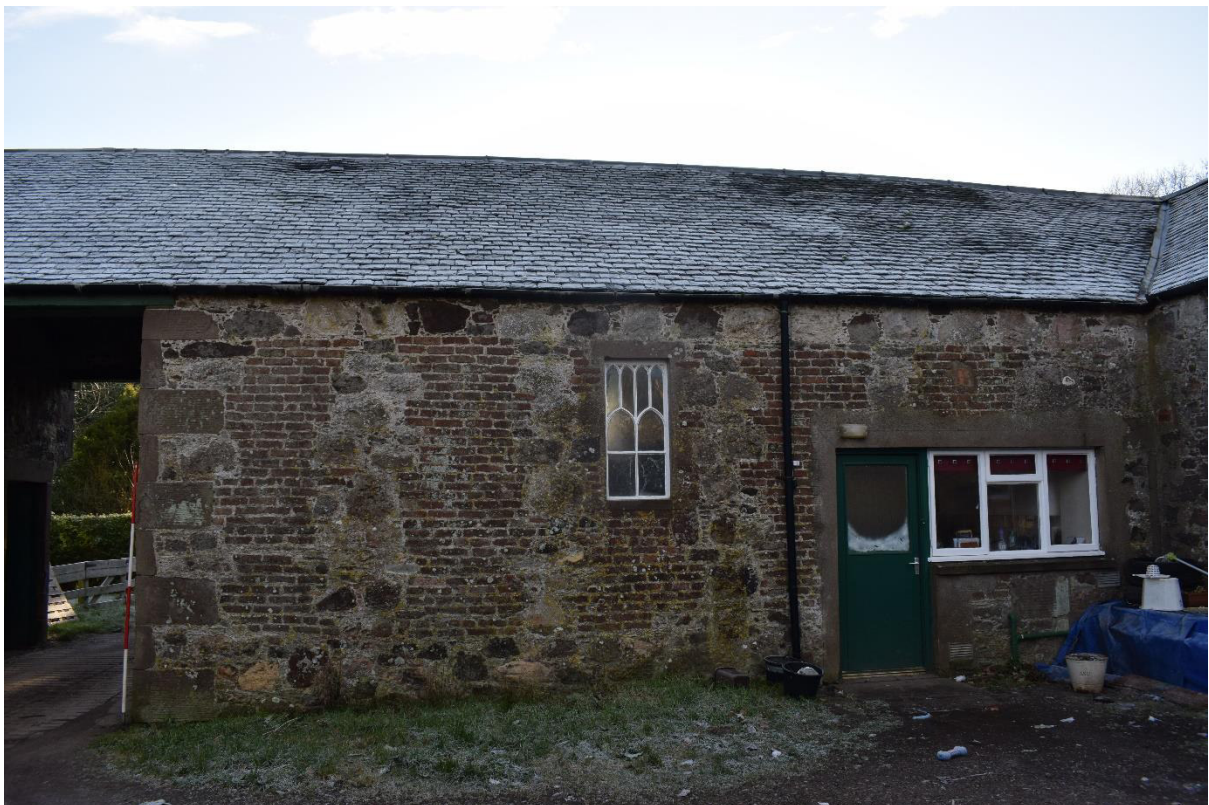
Illus 8 South wing N wall W end D3 (left) rebuilt wall sections F27, F28, F29 around window W47 and modern door and window into cottage D17/W48; facing S

A small building was constructed on the S wing N wall and a door opened in between (D39; Illus 15) which has since been blocked with breeze blocks and whitewashed. There are four areas of brick blocking at the W end of this wall where stable features (probably feeders) have been removed and the wall rebuilt with red hand-made bricks (F27, 28, 29; Illus 8, 20).

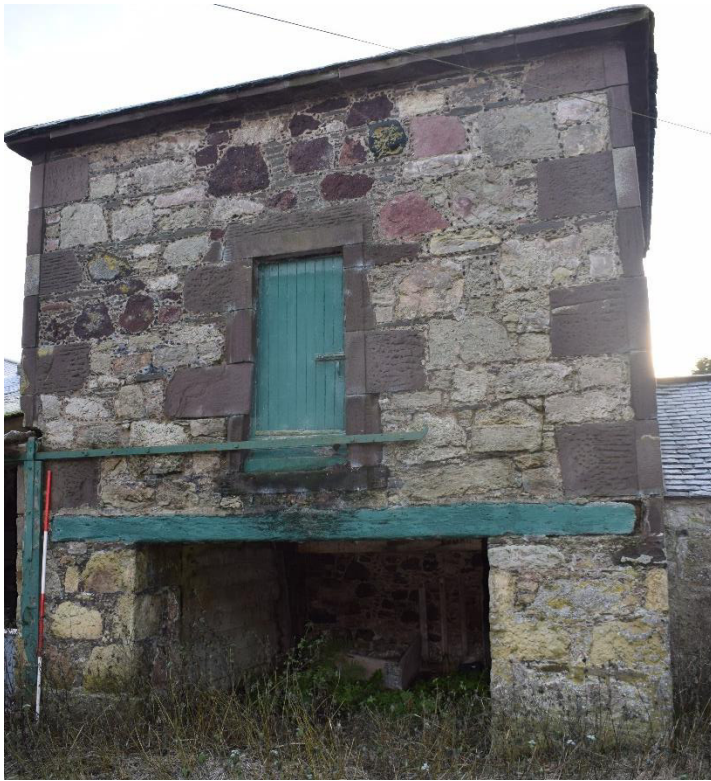
Illus 16 Doocot Room 34 N façade D36 (ground floor) with D21 above; facing S

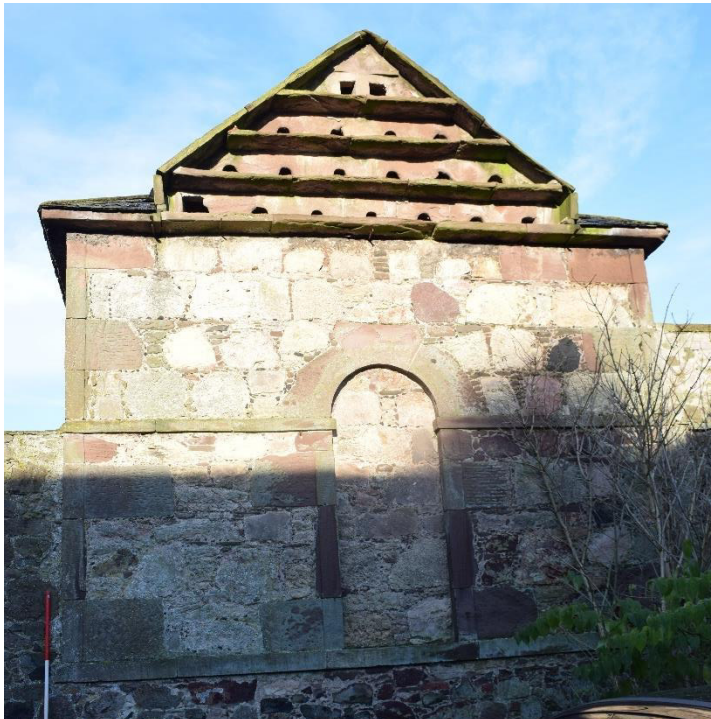
Illus 17 Doocot Room 34 S façade with D38 (centre) and entrances to roosts (top); facing N

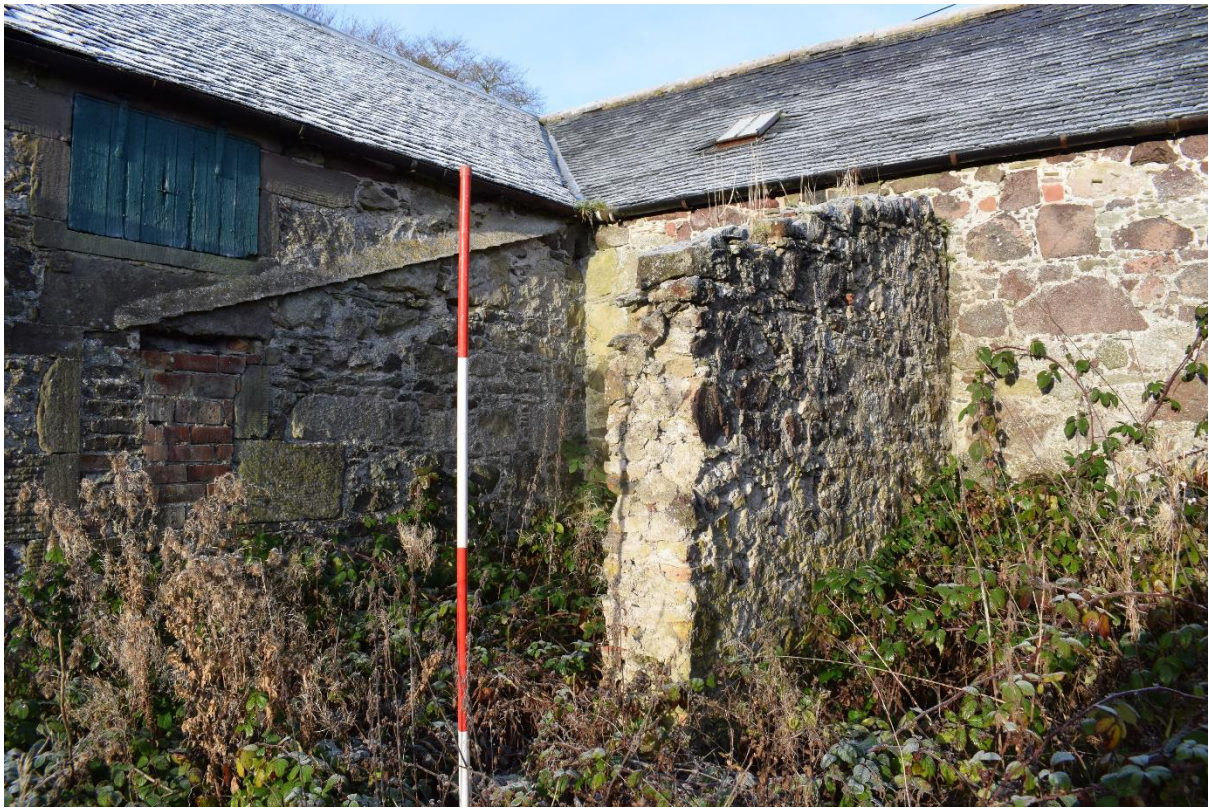
In the NW corner of the courtyard are three small rooms (Rooms 9, 10, 11; Illus 18); their rubble walls are in a poor condition, but they have been butted onto the main building. They are on the First Edition OS map but there is no indication of their use. There is also a low stone wall around a square area in the N courtyard area (F9; Illus 19) which was constructed between the First and Second Edition dates. There is one entrance into this small courtyard through a gap in the W end of the S wall.

Illus 18 Room 9 (left) and Room 10 (right); facing NW

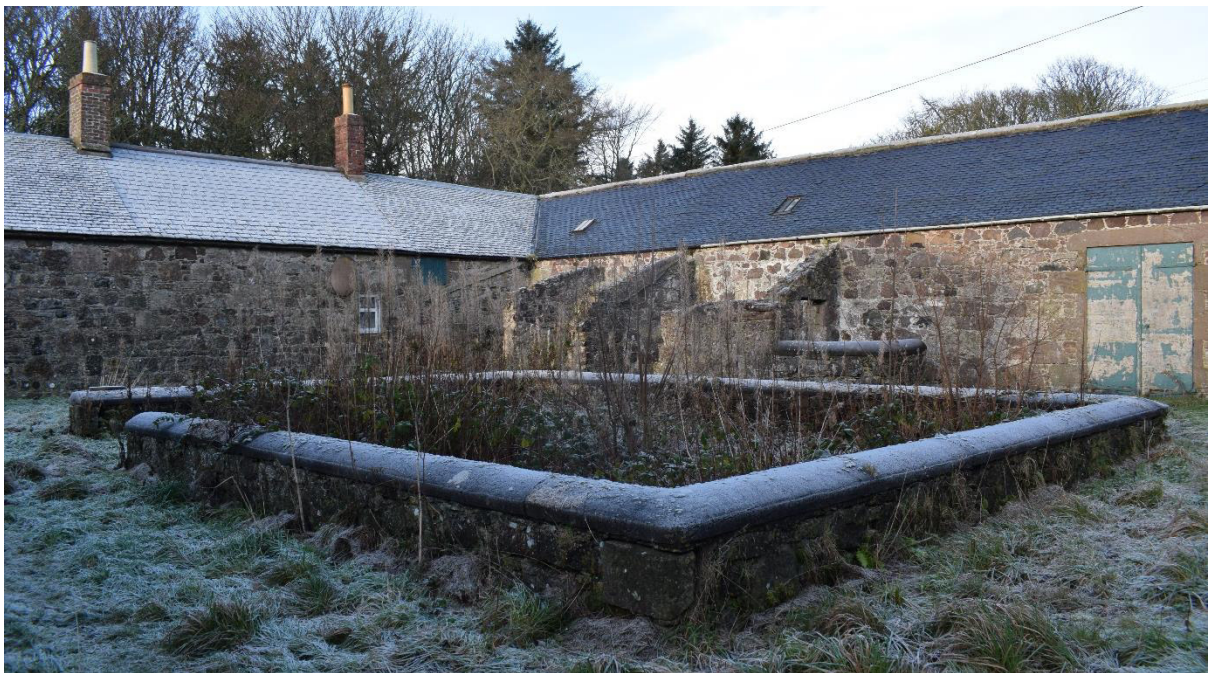
Illus 19 N courtyard low walled enclosure F9; facing NW

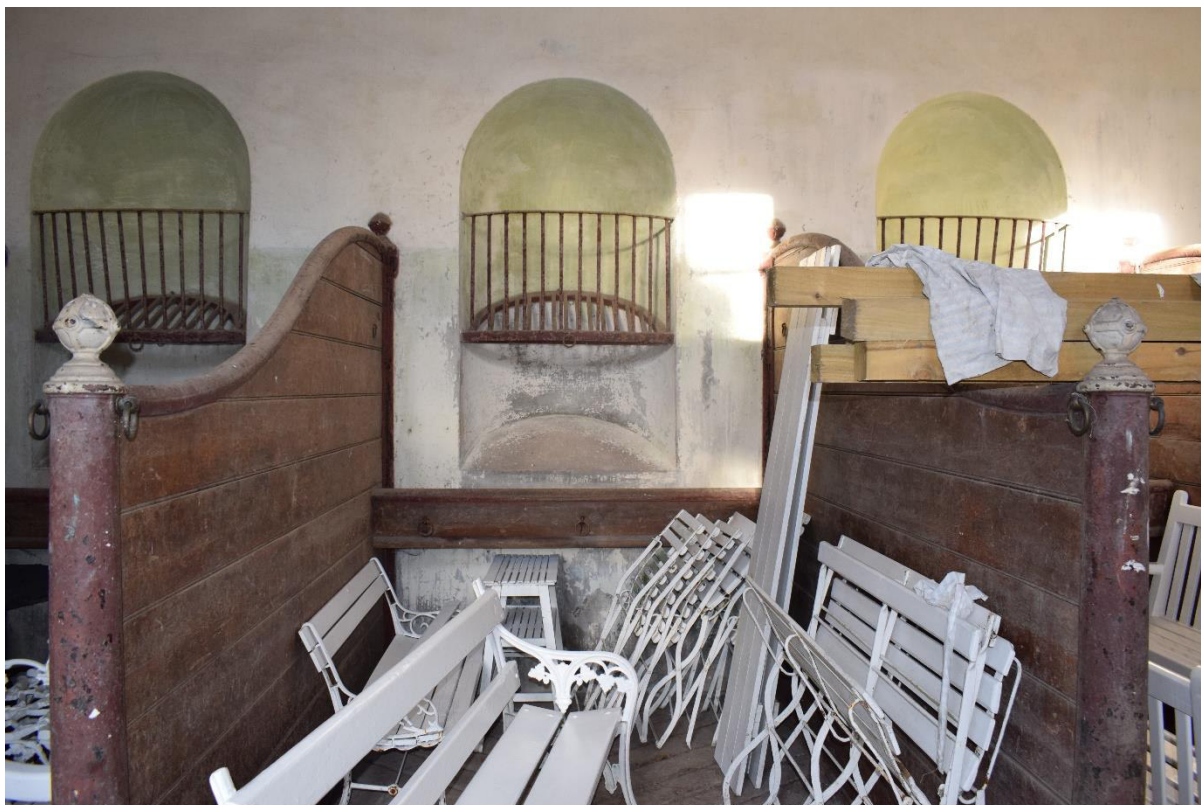
Illus 22 Room 25 wood and cast iron stalls F10 and feeders F13, F14, F15; facing N

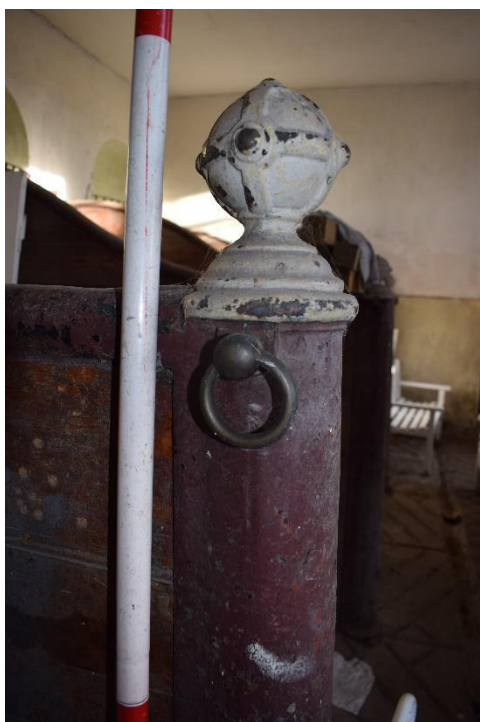
Illus 23 Room 25 wood and cast iron stalls, F10, detail, facing E

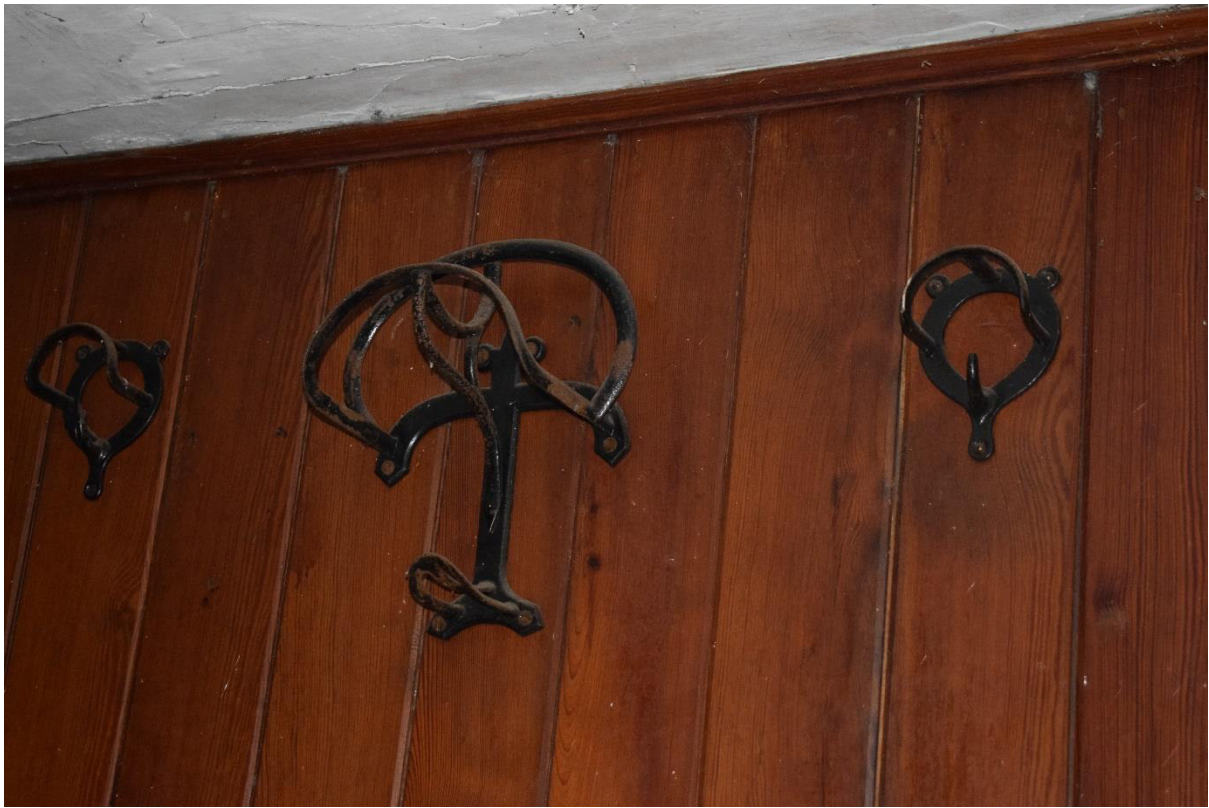
Illus 24 Room 23 tack room fittings F17; facing N

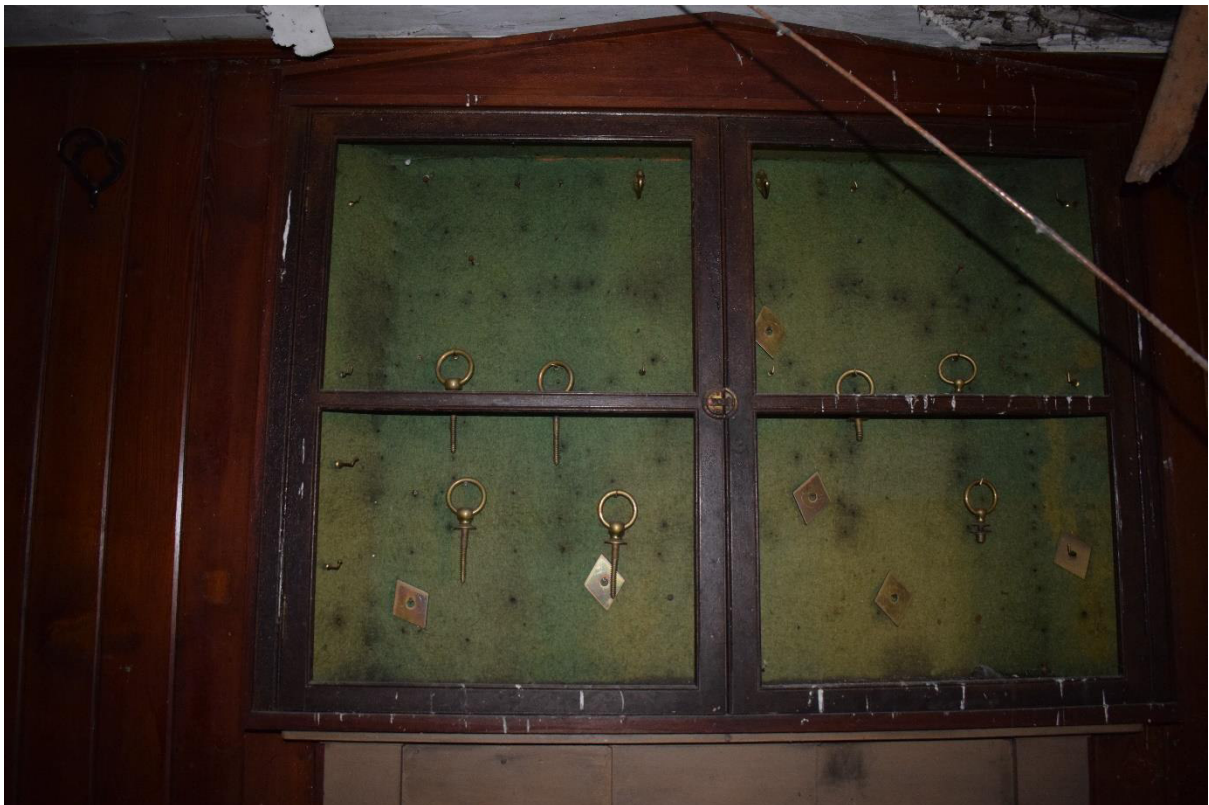
Illus 25 Room 23 key box F16; facing N
