# **St Clether holy well and chapel, Cornwall**

## **Access and improvement**

**Ann Preston-Jones**

Report No: 2005R012

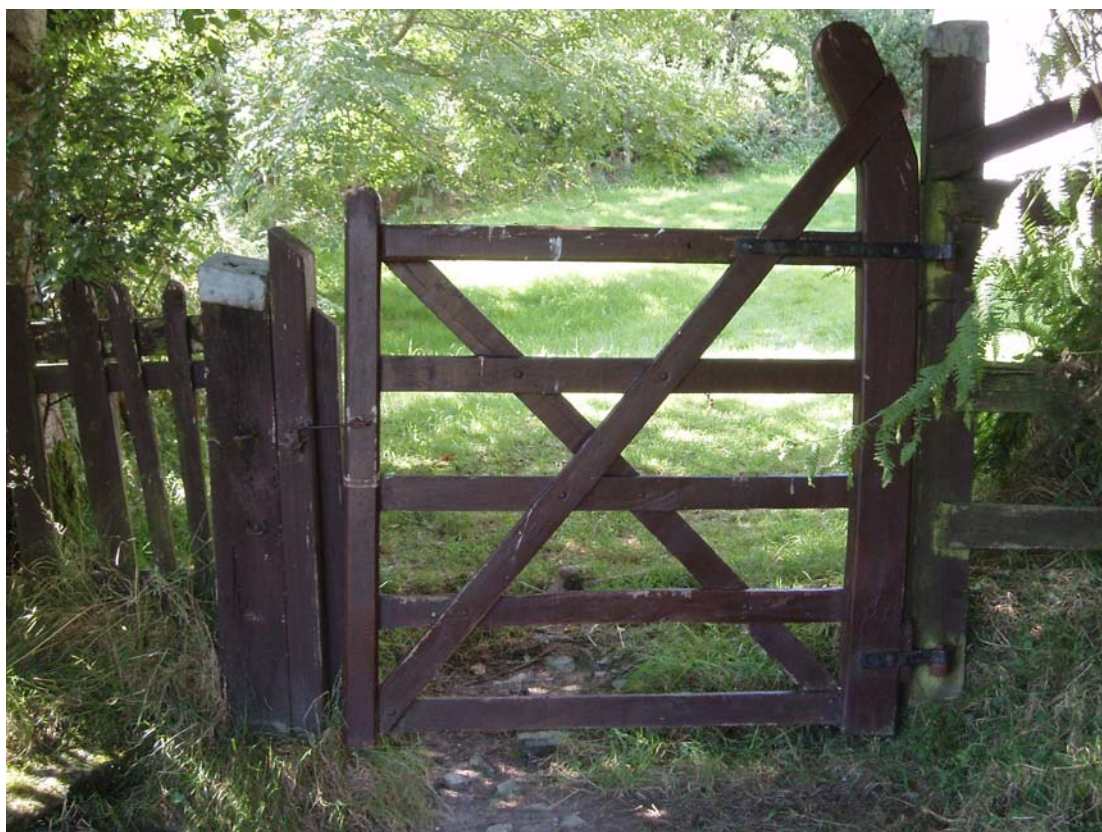
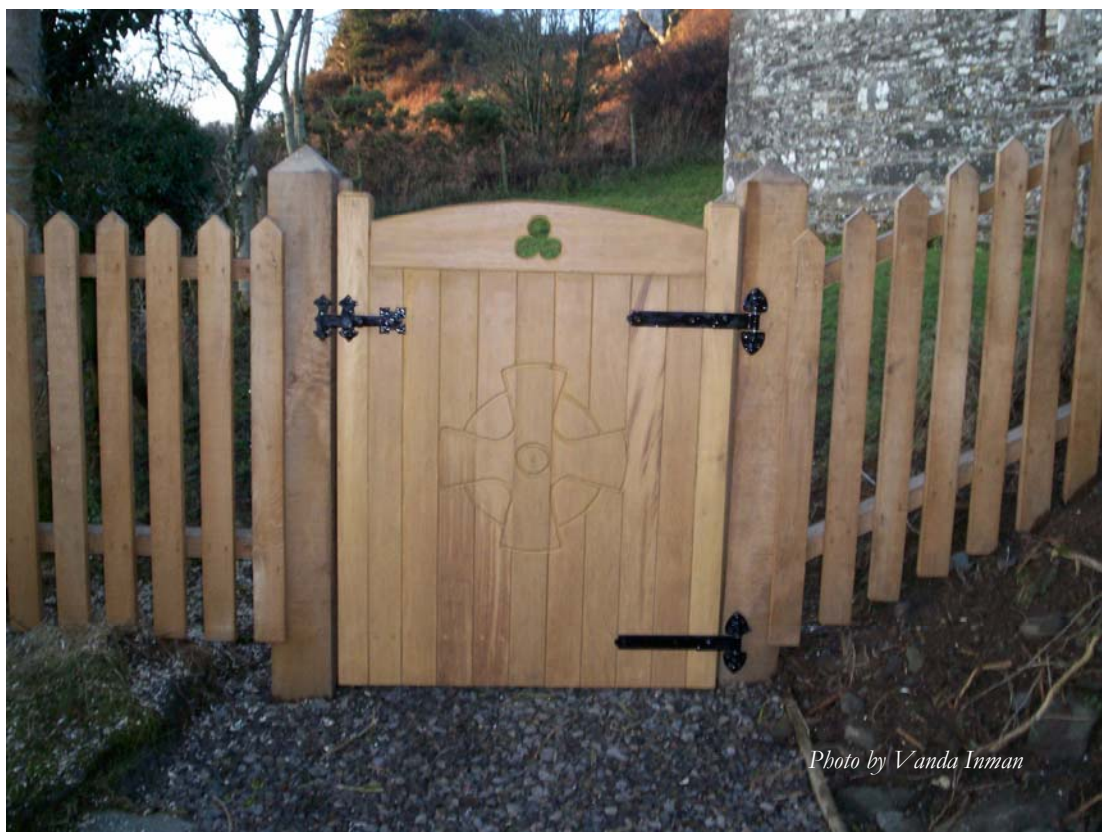
*Fig 4 The main gate leading into the chapel's enclosure: before, and after the provision of the new gate*

4. A grand new gate and short lengths of picket fence were placed at the entrance to the chapel enclosure (Fig 4). Built of oak, to ideas of Vanda Inman's, these were created specifically for the site by Barry Jones. They were designed to be a long lasting and fitting enrichment of this very special monument.

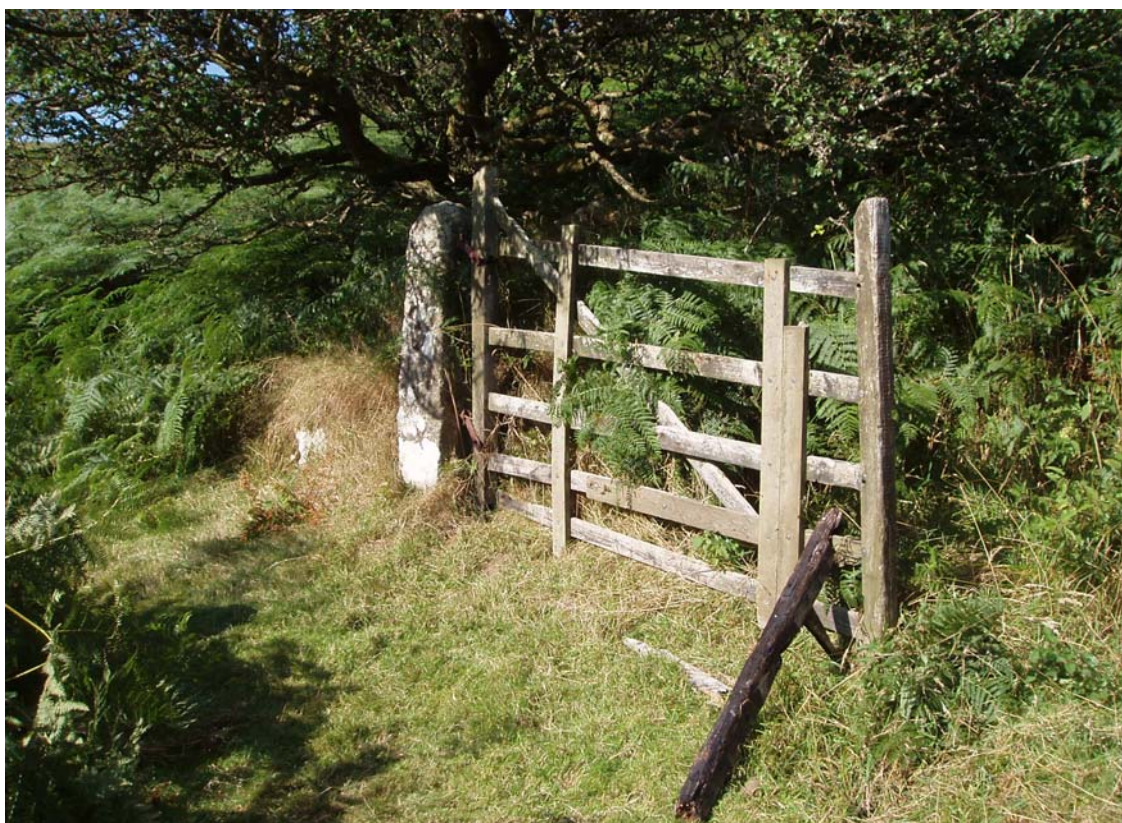
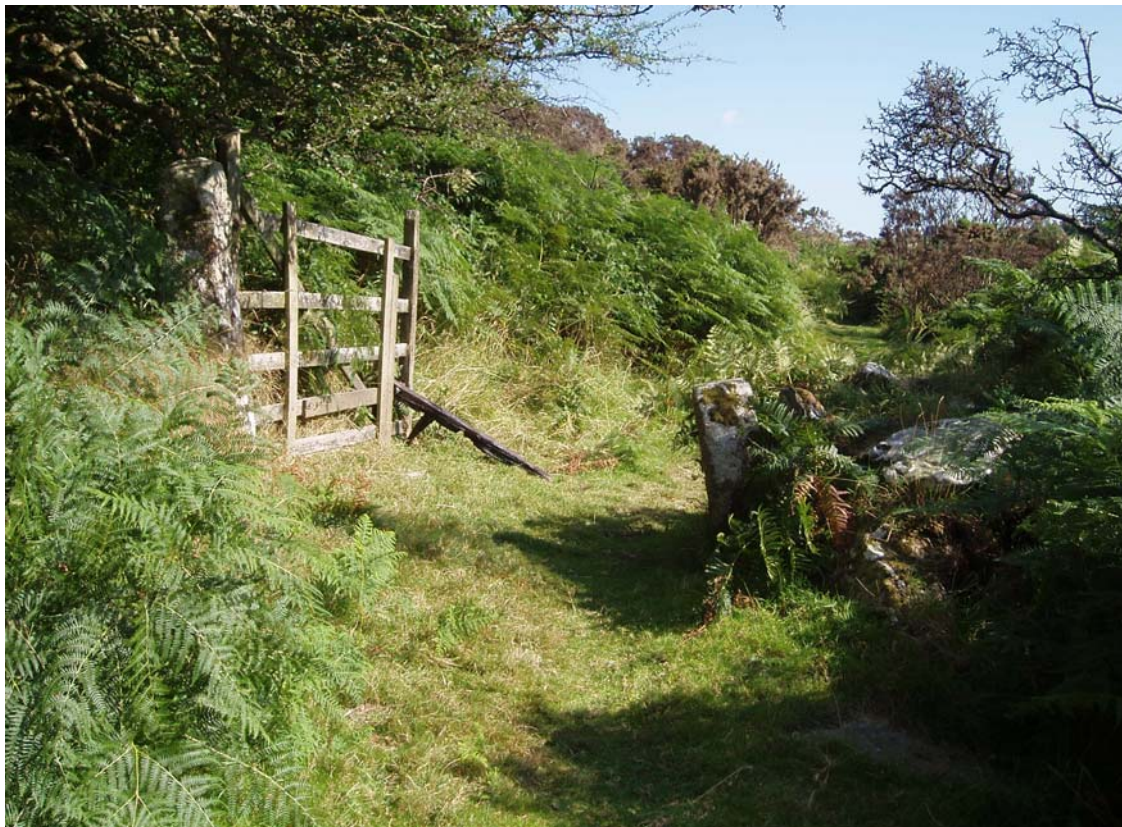
1. At the point where the permissive path enters the field to the monument, the existing gate had deteriorated so badly that it was almost impossible to open and close, and so was permanently propped open. The plan here was to replace the existing gate with a smaller one and a kissing gate alongside, that would be easier for visitors to use, while also keeping the opening of the same width. This would have the further benefit of preserving *in situ* a piece of carved stone which had been re-used as a gatepost. The gates were finally installed by 24<sup>th</sup> December.

*Fig 5 The gateway into the chapel field, before the provision of the new gate and kissing gate*

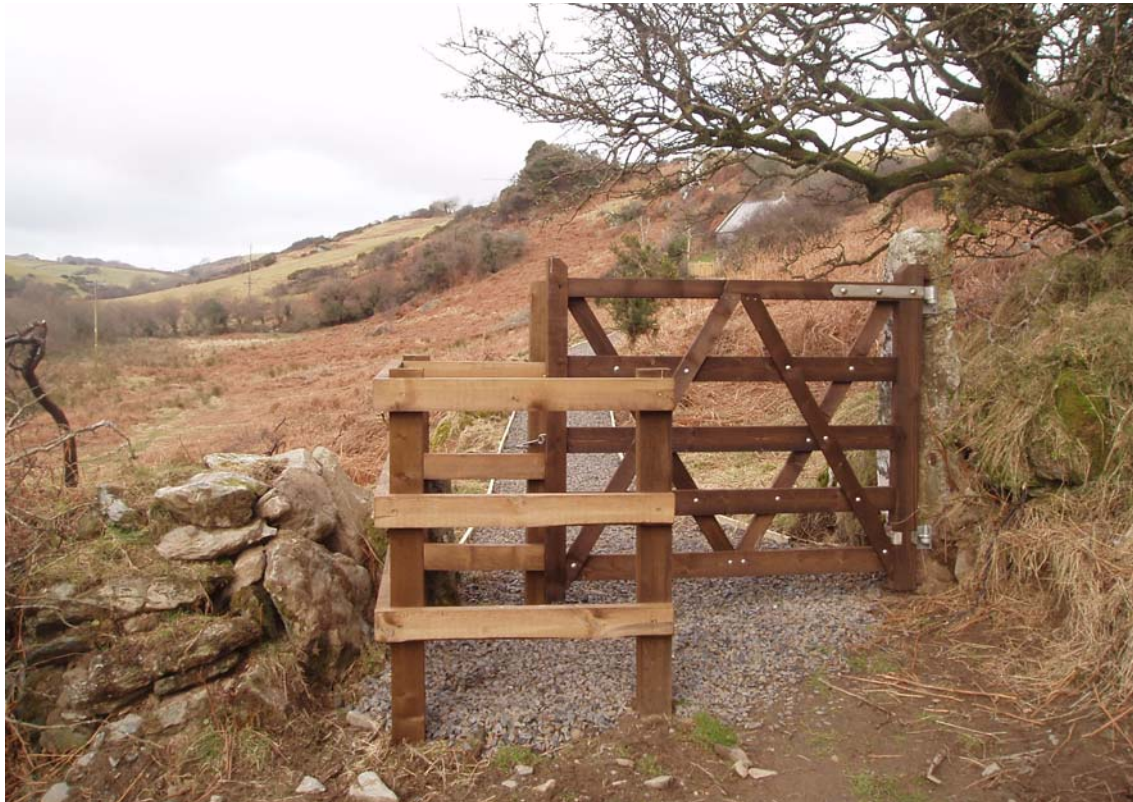
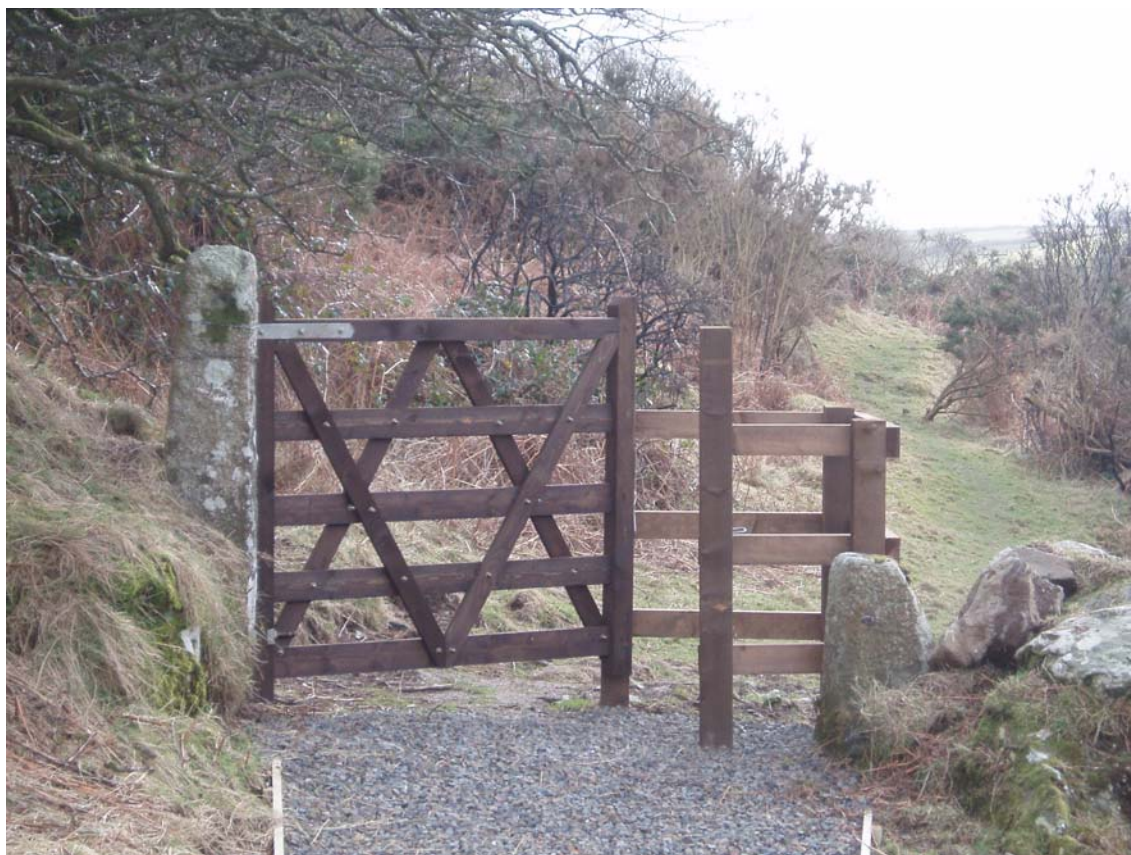
*Fig 6 The gateway into the chapel field: after the provision of the new gate and kissing gate(note the carved stone formerly re-used as a gatepost)*

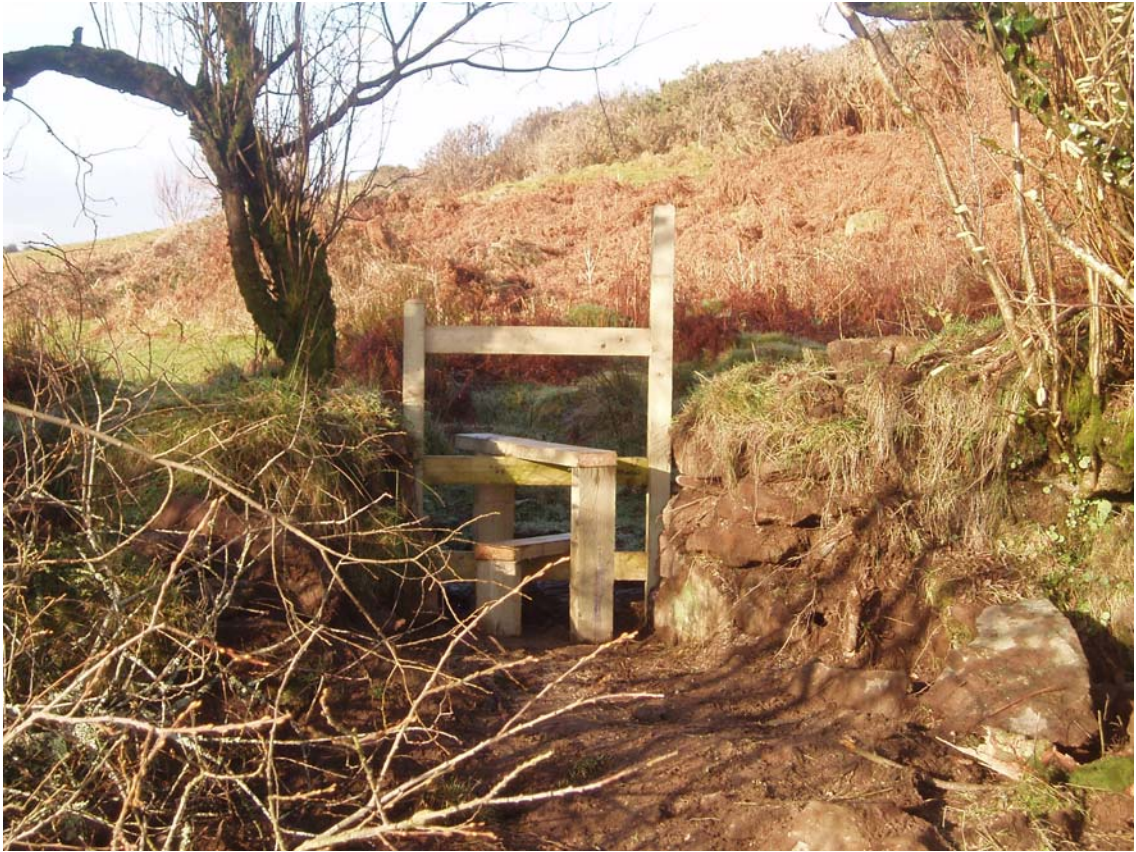
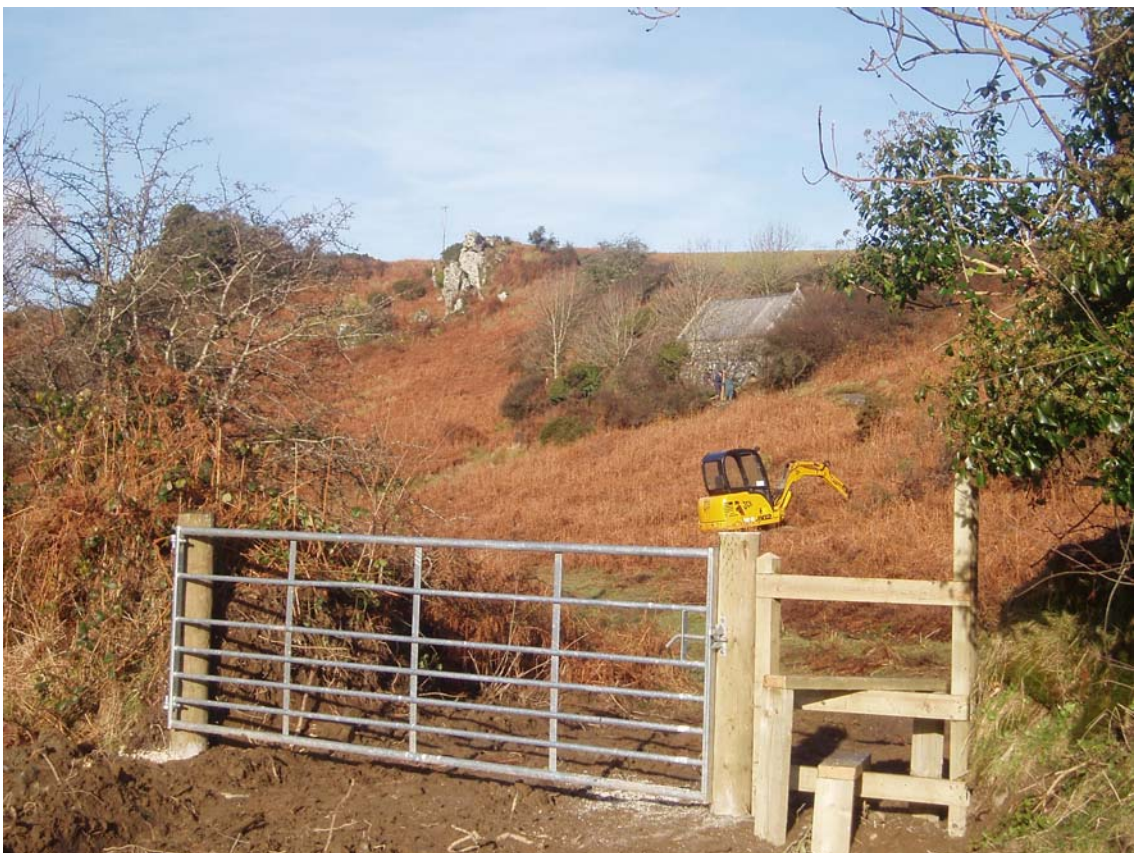
*Fig 7 The new stiles on the public right of way*

2. and 3. Two stiles were installed at the points where the public right of way enters and leaves the chapel field, and an 8 ft wide gate was put in beside the southern of these to allow access for machinery to the field and the chapel, for any future management works (Figs 5 and 6).

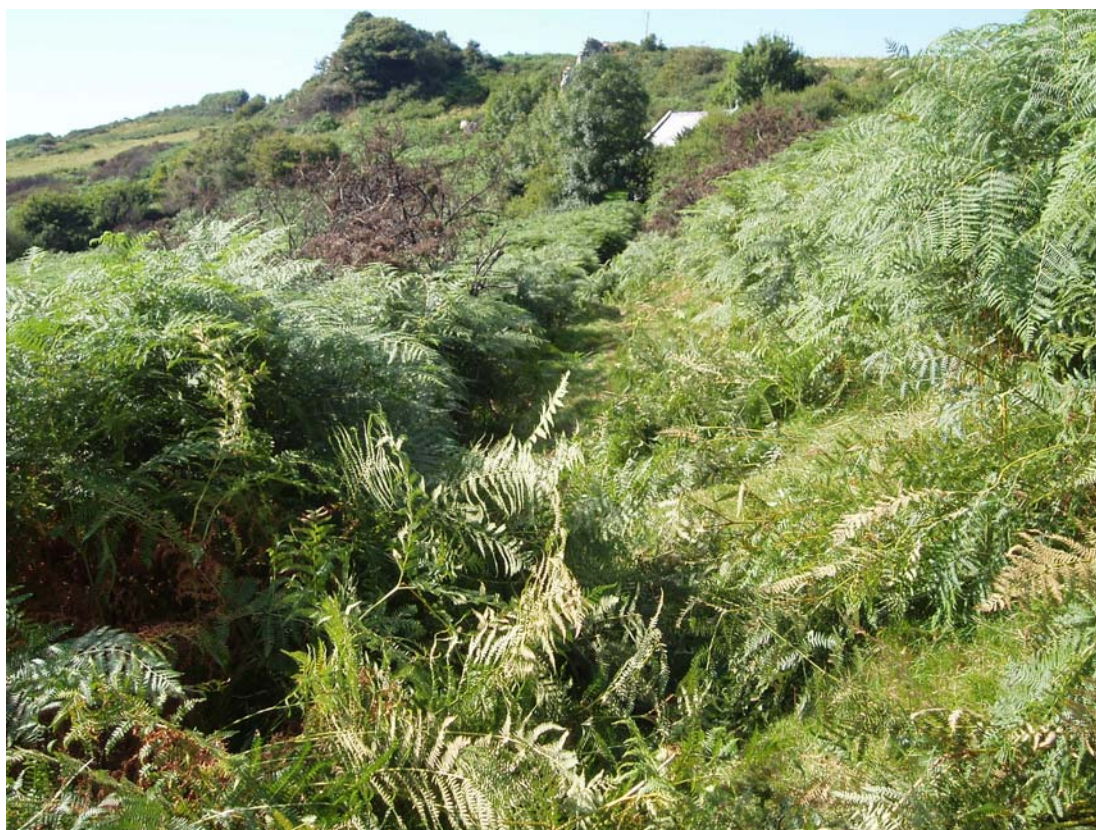
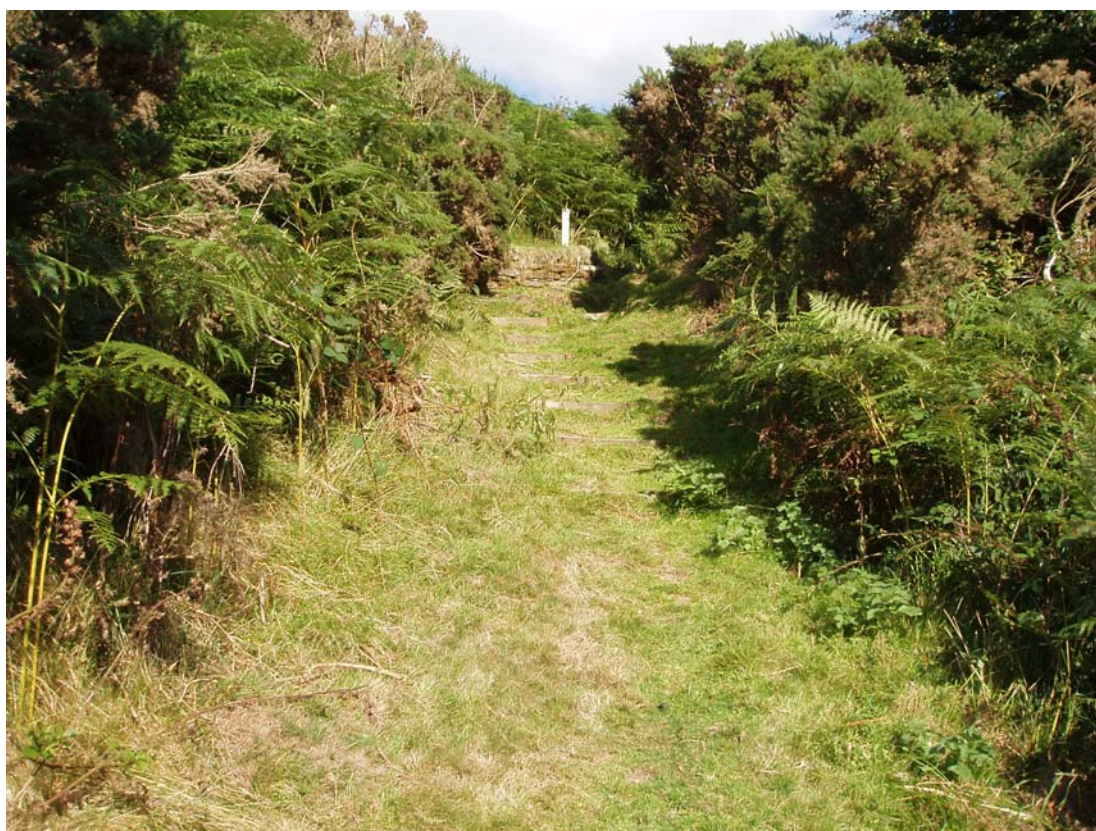
Although the holy well and chapel are privately owned, the site and the surrounding field are open and fully accessible at all times, by means of a permissive footpath from St Clether churchyard. The path is signposted from the churchyard, but not otherwise. The walk from the church to the chapel, over about a quarter of a mile through unspoilt countryside, along the side of the river Inny, is delightful, though the path is rough, slippery and steep in places, and hampered in one place by a difficult gate. A public right of way also passes nearby, along the bottom of the valley and through the field containing the monument; however this entered and left the field by rough breaks in the hedges, so that the access was awkward and the field not stock-proof. (Figs 4, 5 and 8)

*Fig 8 The path to the chapel before surfacing*

The path is 3 foot wide, and was created by levelling into the hillside, and building boarding of tanalised timber to retain the 20 mm Pigsdon chippings. Disturbance was kept

to a minimum; the dull grey/green chippings blend well in this environment and are easy to walk on; and it is likely that within a year, as the vegetation grows back, the path will become relatively inconspicuous. (Figs 8 and 9)

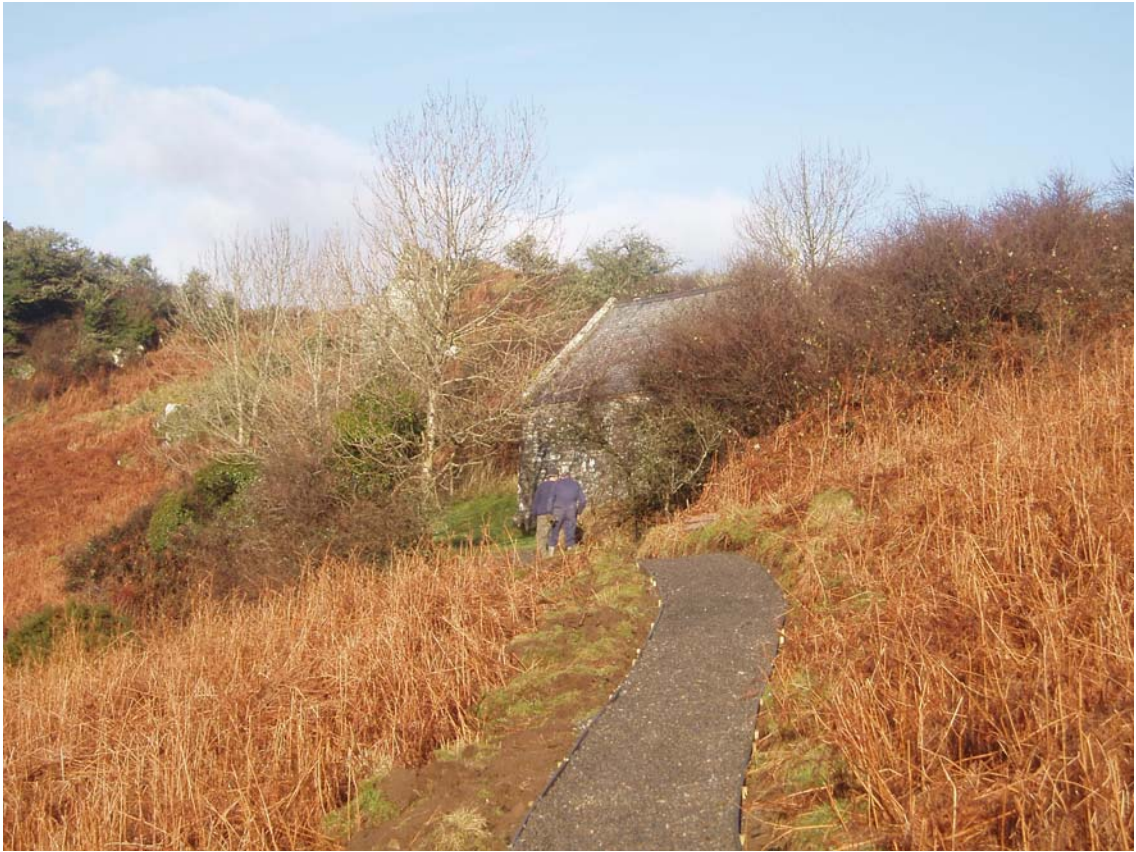
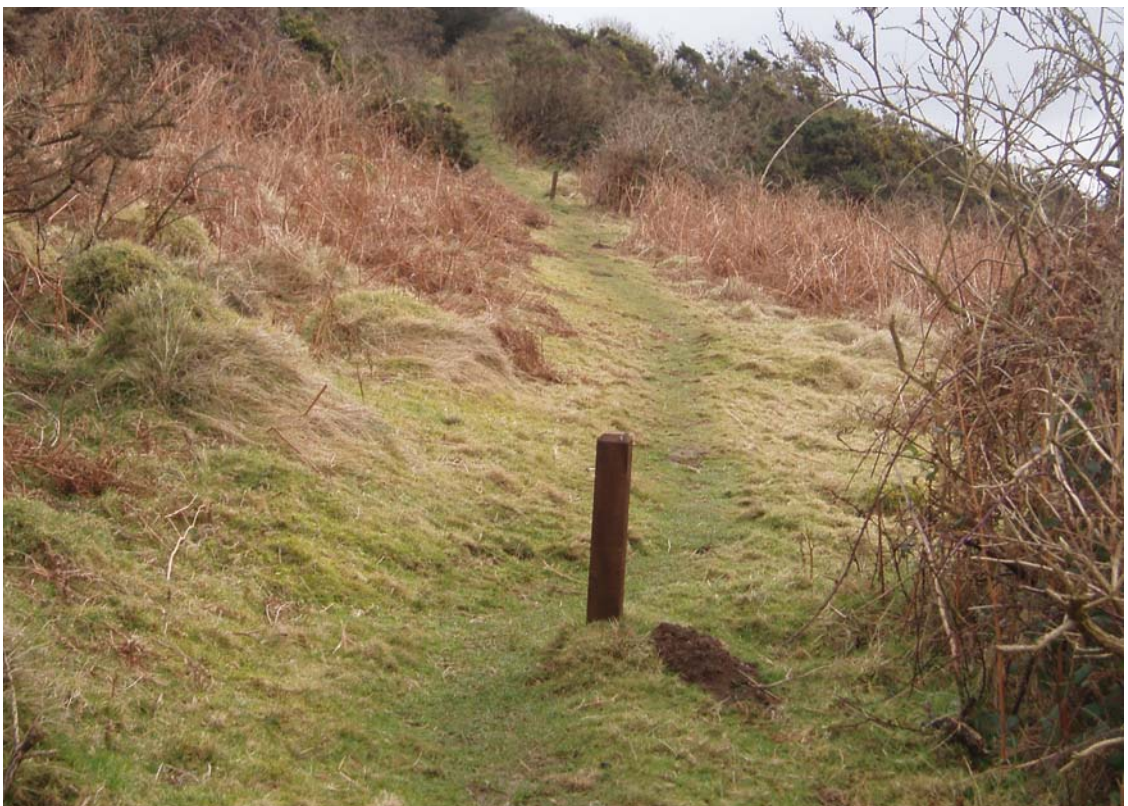
*Fig 9 The new path and the posts marking the way to the site.*

An existing sign to the well was embellished with a number of posts, leading visitors across fields to the site, where the path had not been improved (Fig 9 ).

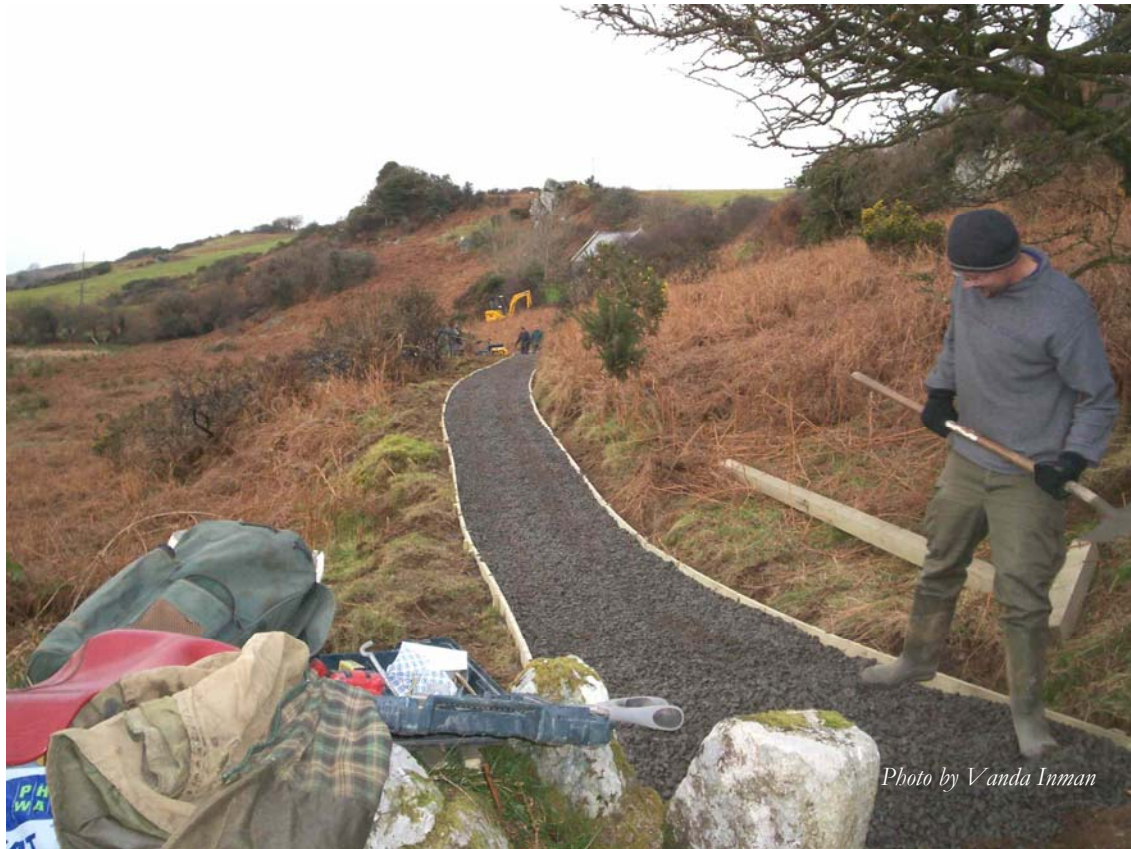
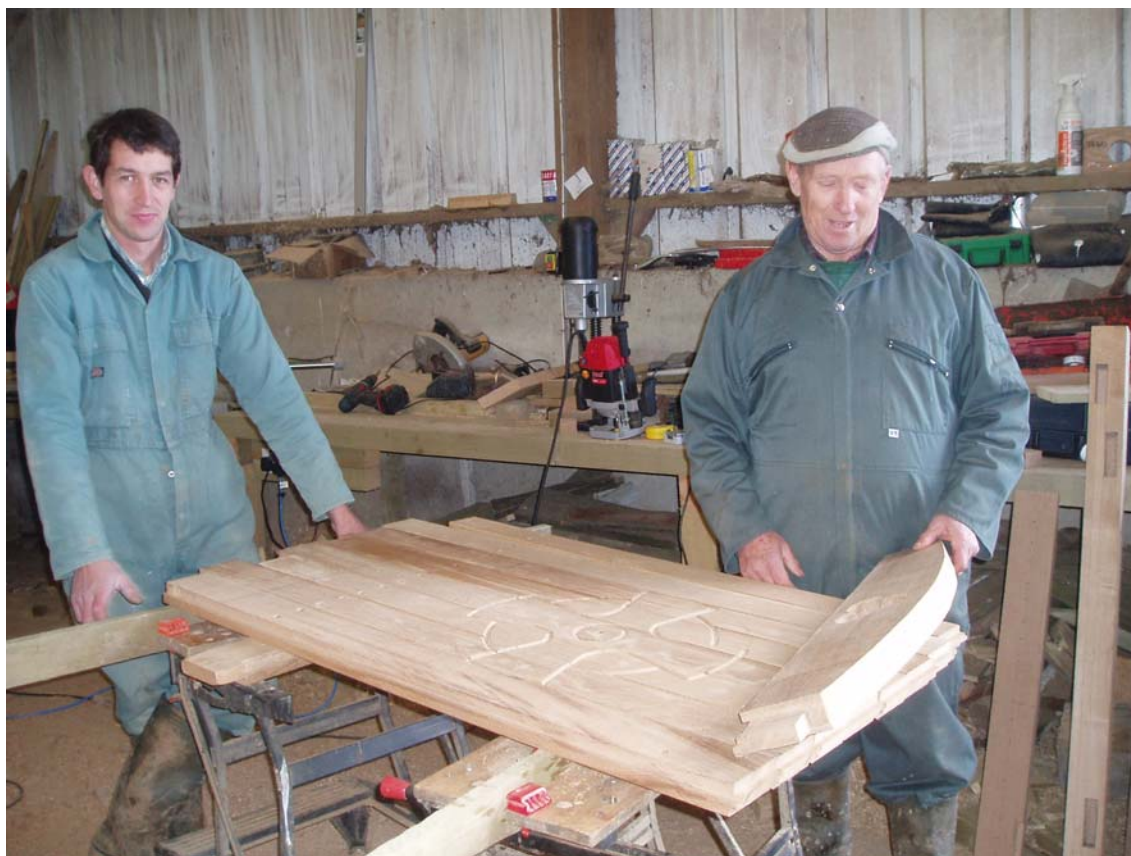
*Fig 12 Work in progress on the path (above) and the gate (below)*

*Great progress made today.. The path has been dug out, boarded up at the sides and topped with chippings. It curves and dips with the landscape and I think it looks really nice. Also much safer! New drainage has been put in just outside the chapel gate and the ground built up, so should have no more problems there - it has been really wet and dangerous of late.*

The drainage works beside the gate into the chapel yard consisted of lifting the slabs of an old culvert, which had become blocked with stones, and reinstating it at a slightly deeper level. Further drainage was provided by installing a 4-inch perforated pipe under the new path, at about 3 metres from the gate.
