# The Samson Buildings Project 2006-7 Samson, Isles of Scilly

# Lichen Assessment, Archaeological Recording and Building Consolidation

March 2007

Report No: 2007R015

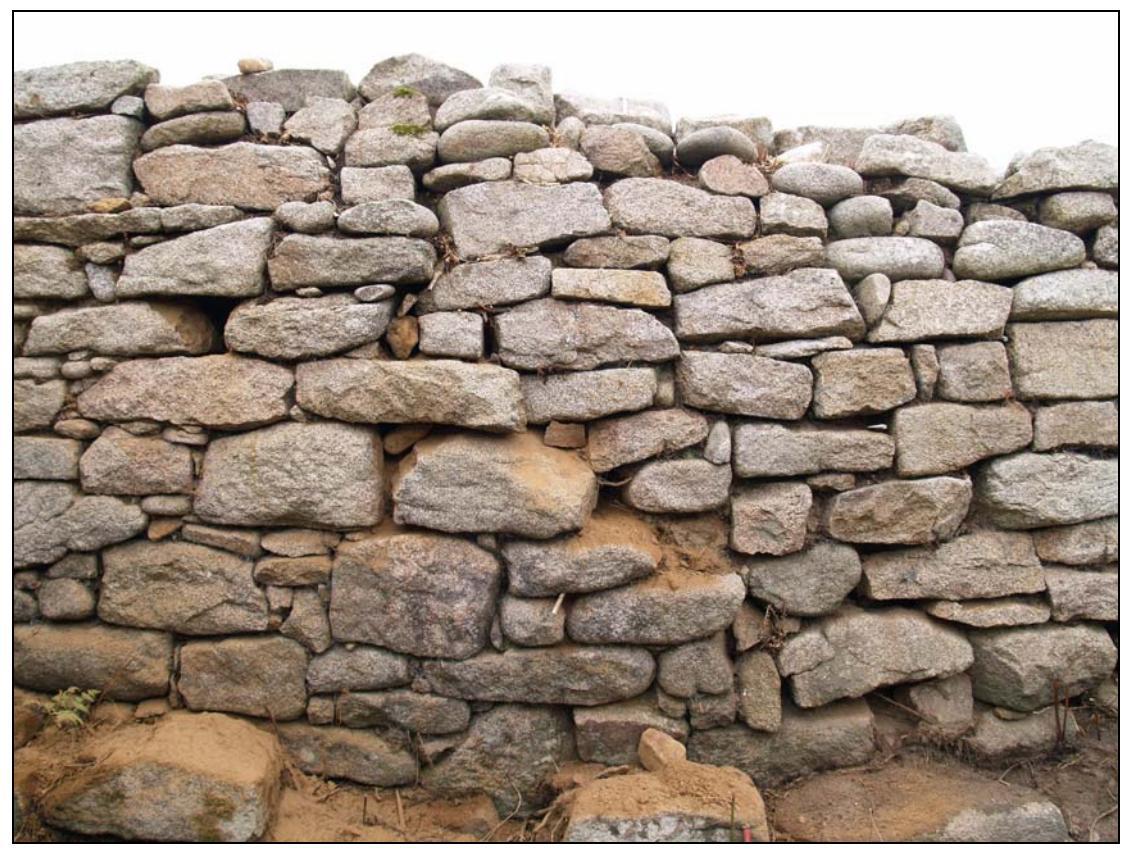
Building C had been the subject of some well-meaning but not entirely appropriate repair supervised by Royal Marines in the 1970s. These repairs included the incorrect reinstatement of two of the lintels over door and window openings of the front wall and the replacement of eaves stonework above, and replacement of the lintel and associated stonework (subsequently collapsed) to the kitchen fireplace. Repairs to the rear wall included some rebuilt inner wall face using sand as bedding support.

Fig 47 House C: rear wall (left) during repair (note s/s threaded tie rods through wall) (photo: Eric Berry)

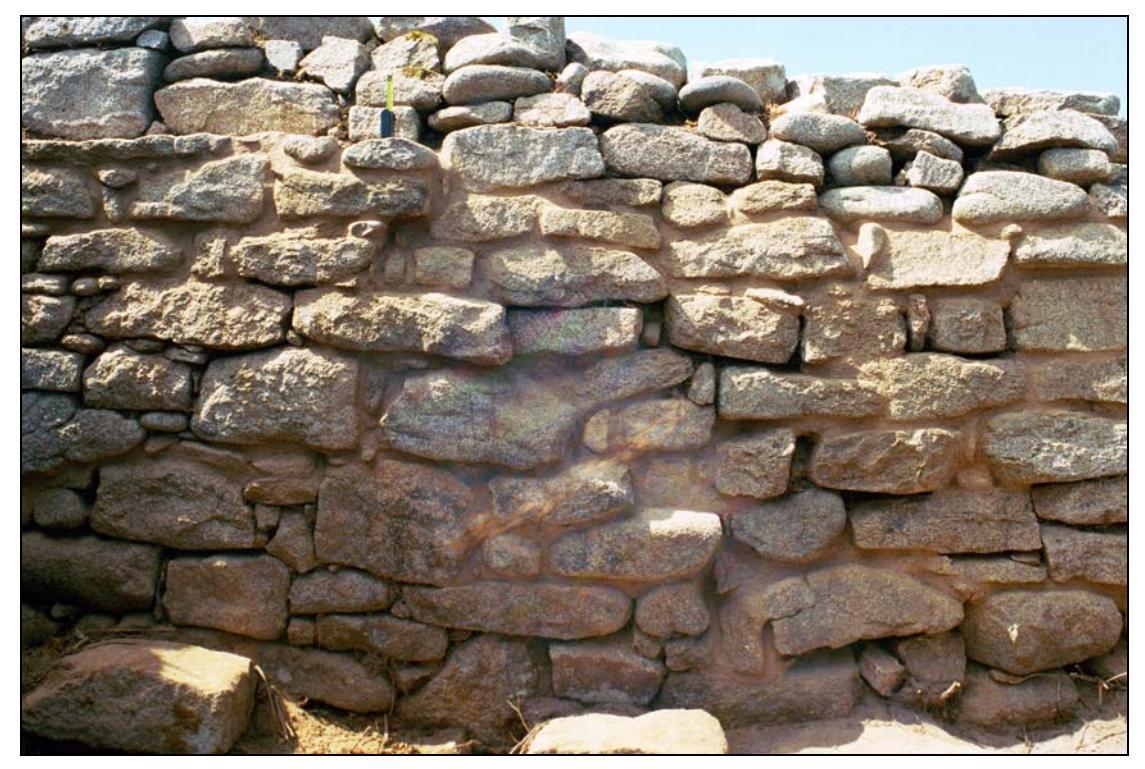
Fig 48 House C: rear wall (left) after repair (photo: Eric Berry)

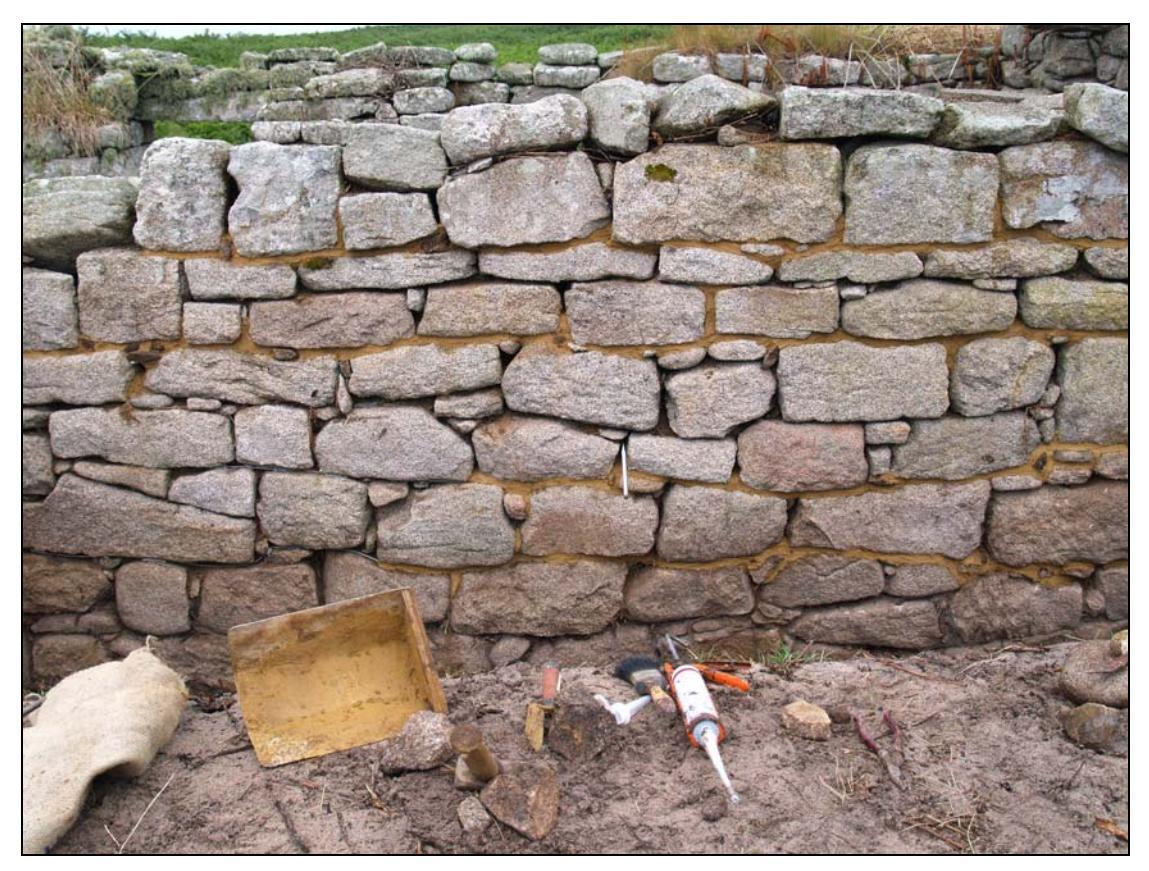
Fig 49 House C: rear wall during repairs (note s/s tie rods and mortar over cabled joints) (photo: Eric Berry)

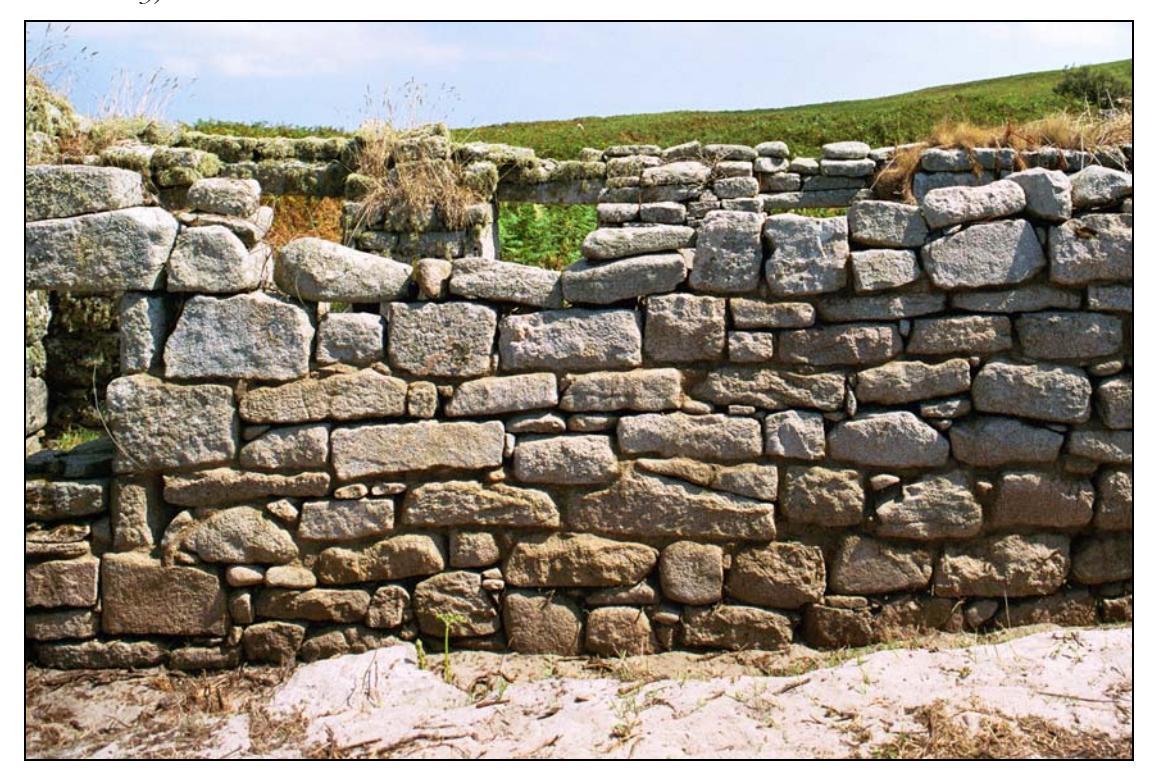
Fig 50 House C: rear wall with urgent repairs complete (photo: Eric Berry)

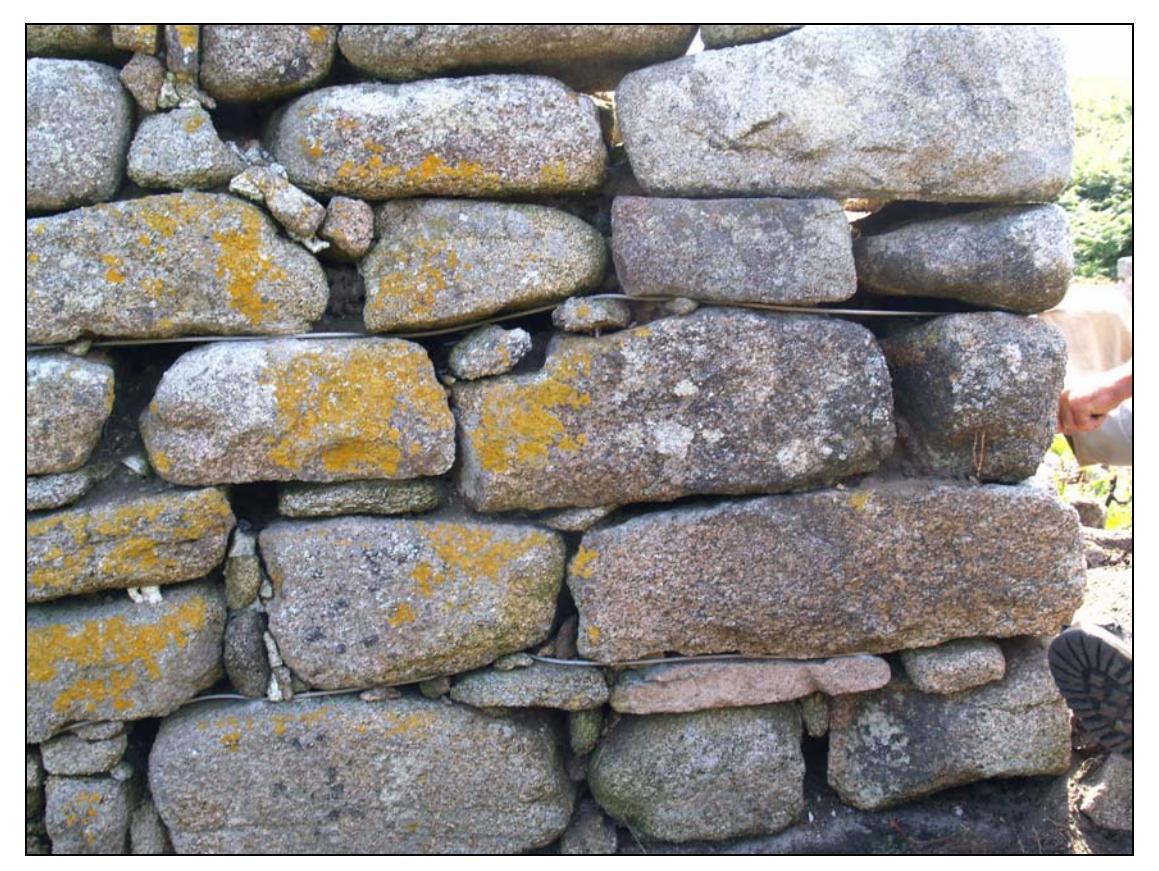
Fig 52 House F: north wall showing s/s cables before mortar application (photo: Eric Berry)

Stainless steel cables were let into the horizontal joints of the stonework at two critical levels, designed to have maximum restraint effect with minimum intervention. The cables were let into the external face of the north gable end and returned at a distance of about 2m to the external faces of the east and west walls. The poor condition of the upper part of the east wall presented a particular difficulty and some of the tumble had to be recorded prior to removal in order to get at masonry joints that were at the right level for the stainless-steel reinforcement. When the target section of the east wall was revealed vegetation had disturbed much of the stonework and the earth mortar had been converted to topsoil. Consequently, to enable secure anchorage for the cable it was necessary to remove some of the stonework and re-bed in lime mortar with the stones returned to their

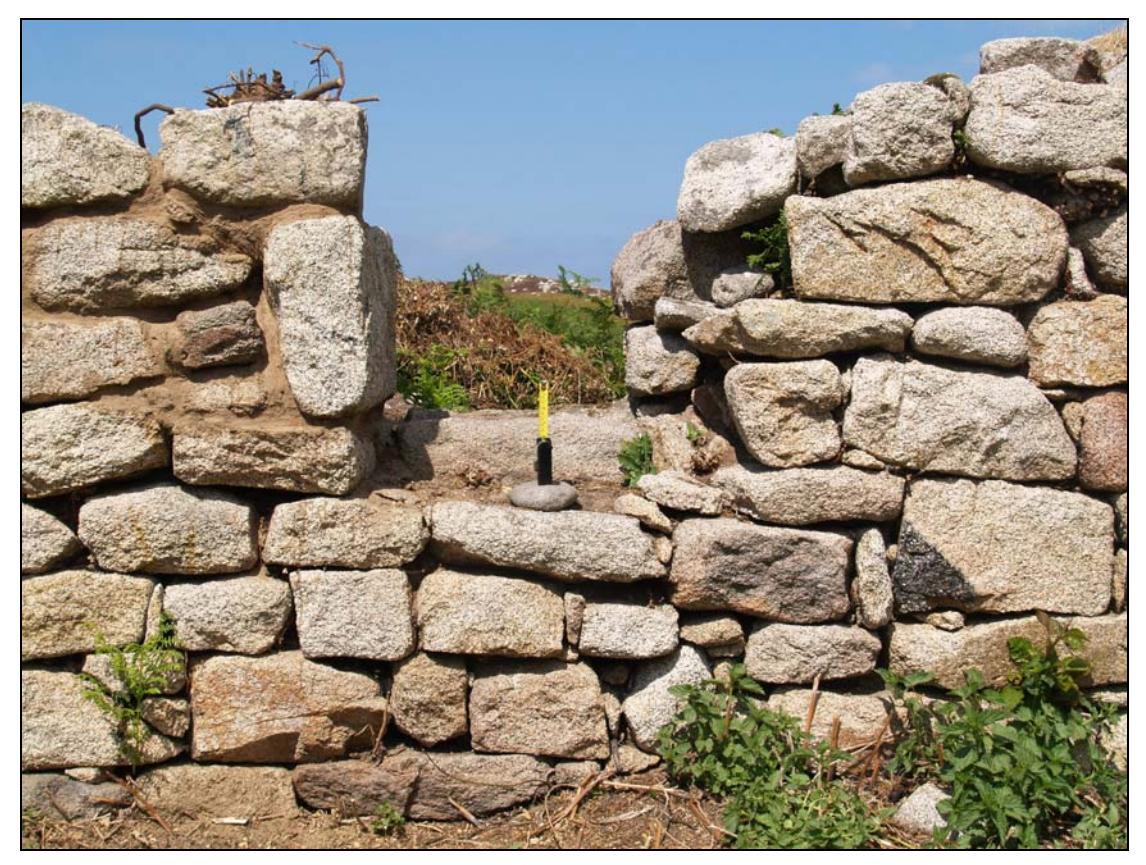
Fig 53 House G: rear window repaired following root removal (photo: Eric Berry)

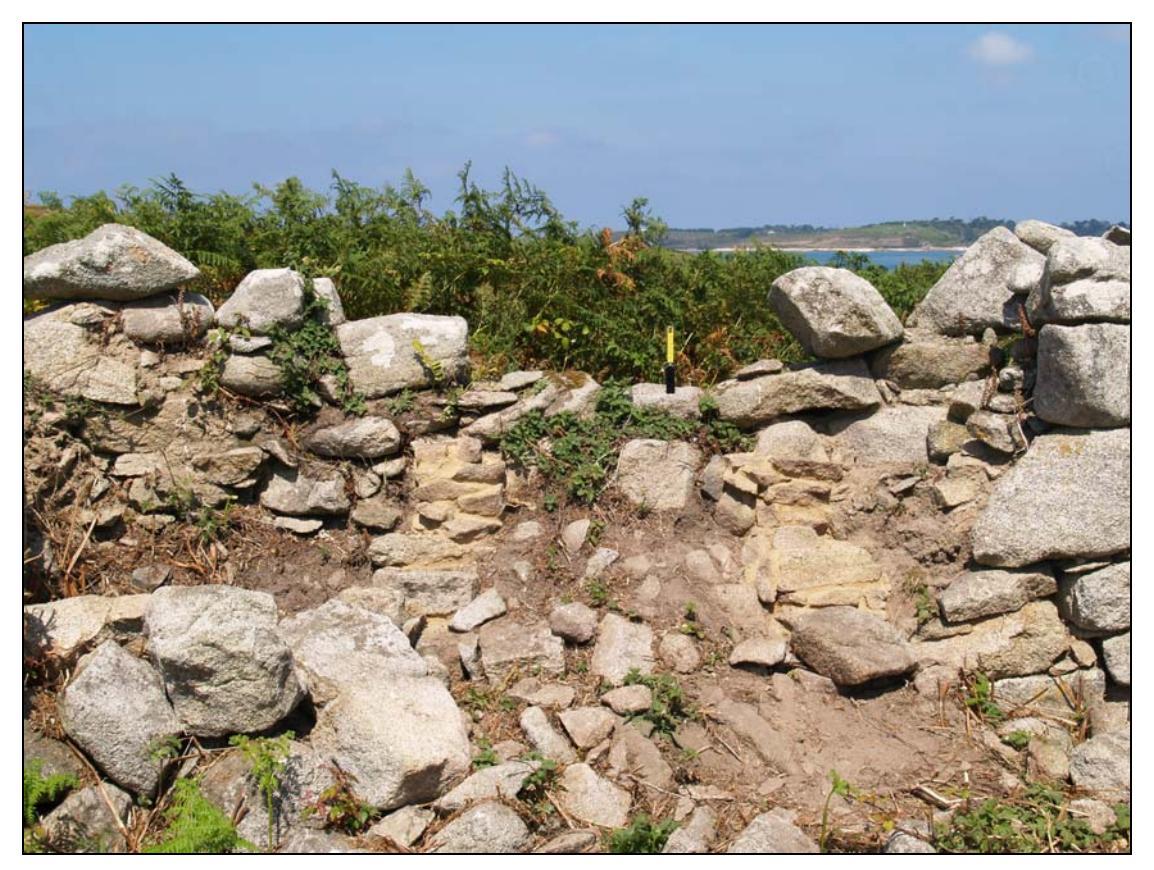
Fig 55 Building J from south: note rubble 'buttresses' to support outer wall face (photo: Eric Berry)

Repair remedies to the north wall were in some respects similar to the repair to the rear wall of House C but involved a further innovative dimension. Small rubble buttresses tied to vertical stainless-steel bars driven into the core mortar have now been constructed to strengthen the wall along its length. This is a much less invasive alternative to the reinstatement of the inner masonry to its former face. The end result is not only discreet but avoids the risk of over-restoration.

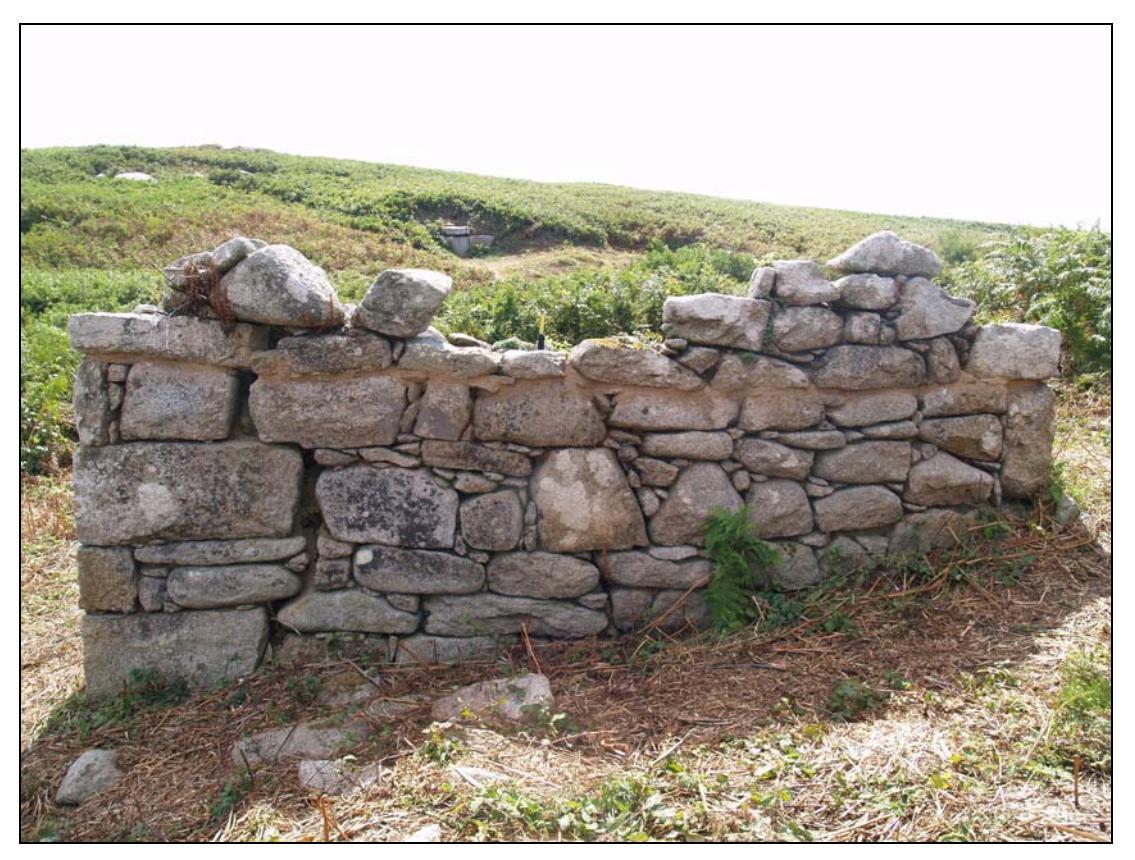
Fig 56 Building J from north: note mortared course with concealed s/s cable reinforcement (photo: Eric Berry)

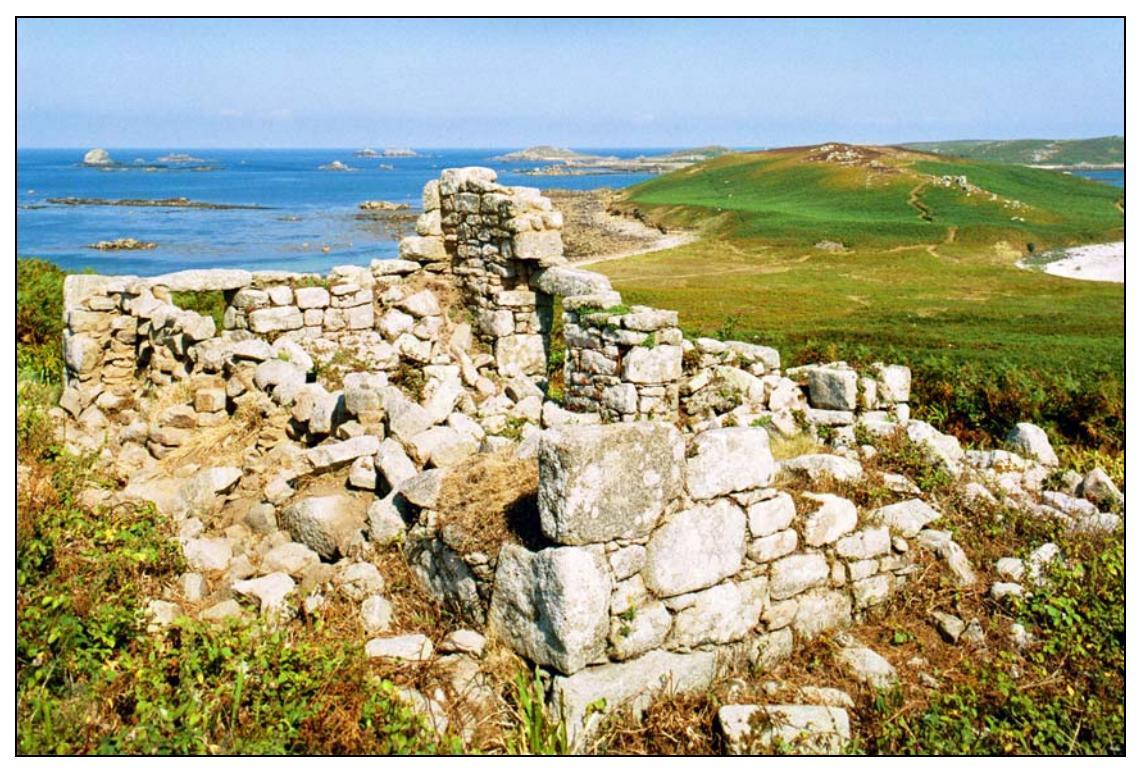
Fig 57 House N following repairs including 'buttress' support of inner face of rear wall (photo: Eric Berry)

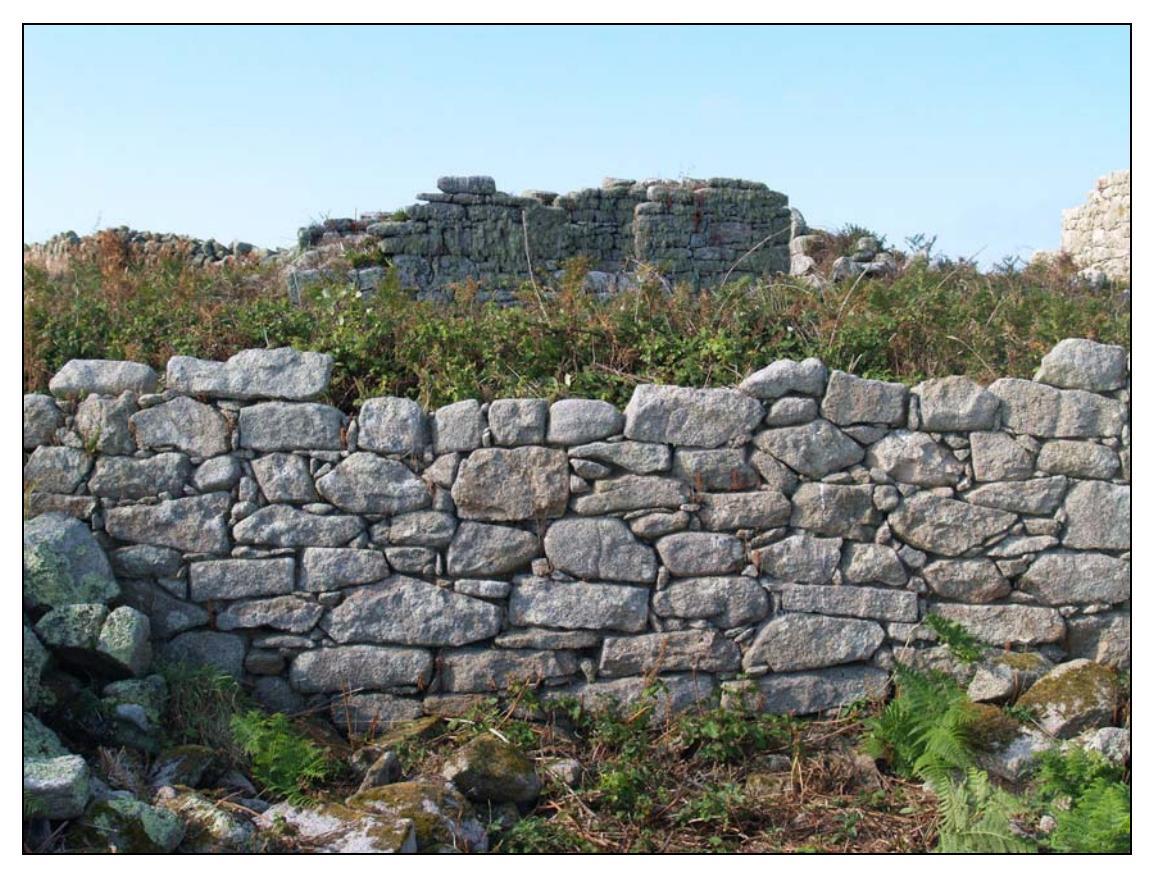
Fig 58 House N showing original inner face of rear wall after repairs to outer face (photo: Eric Berry)

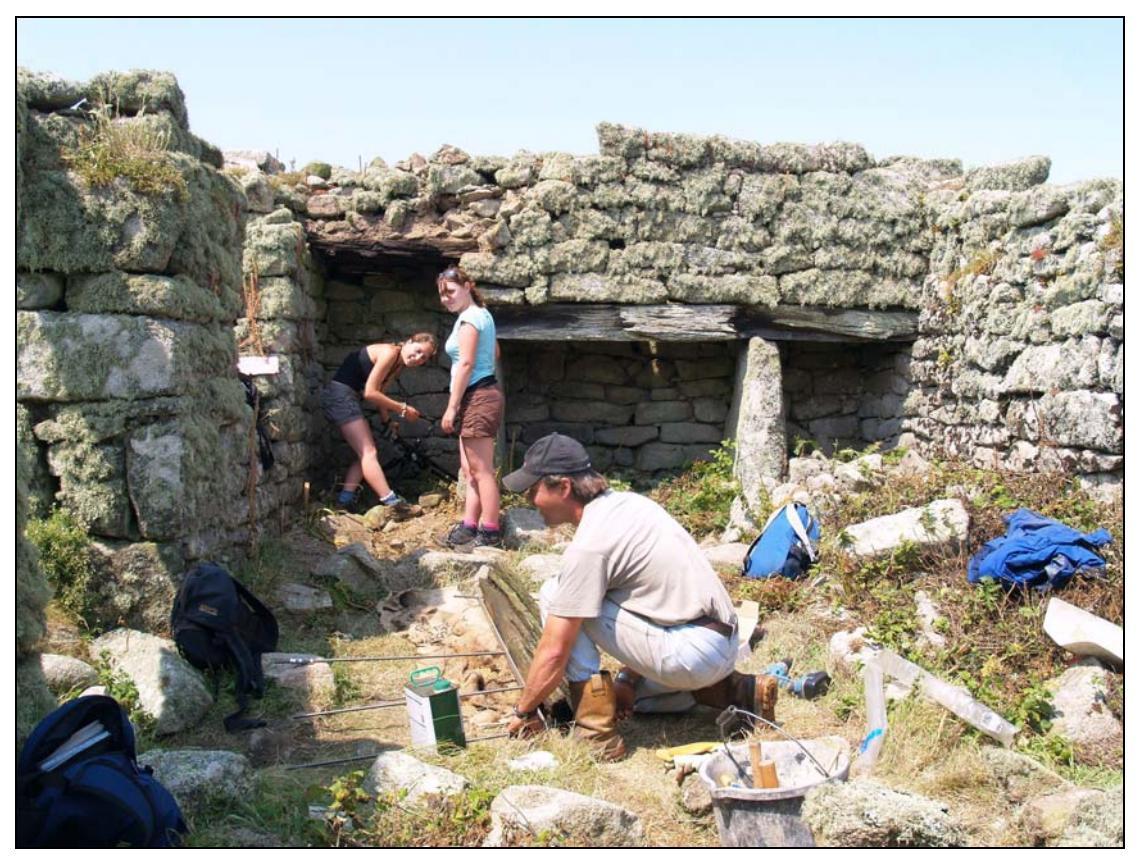
Fig 59 House P: recording by students (Julia Geall and Sara Hope) and early stages of lintel repair (photo: Eric Berry)

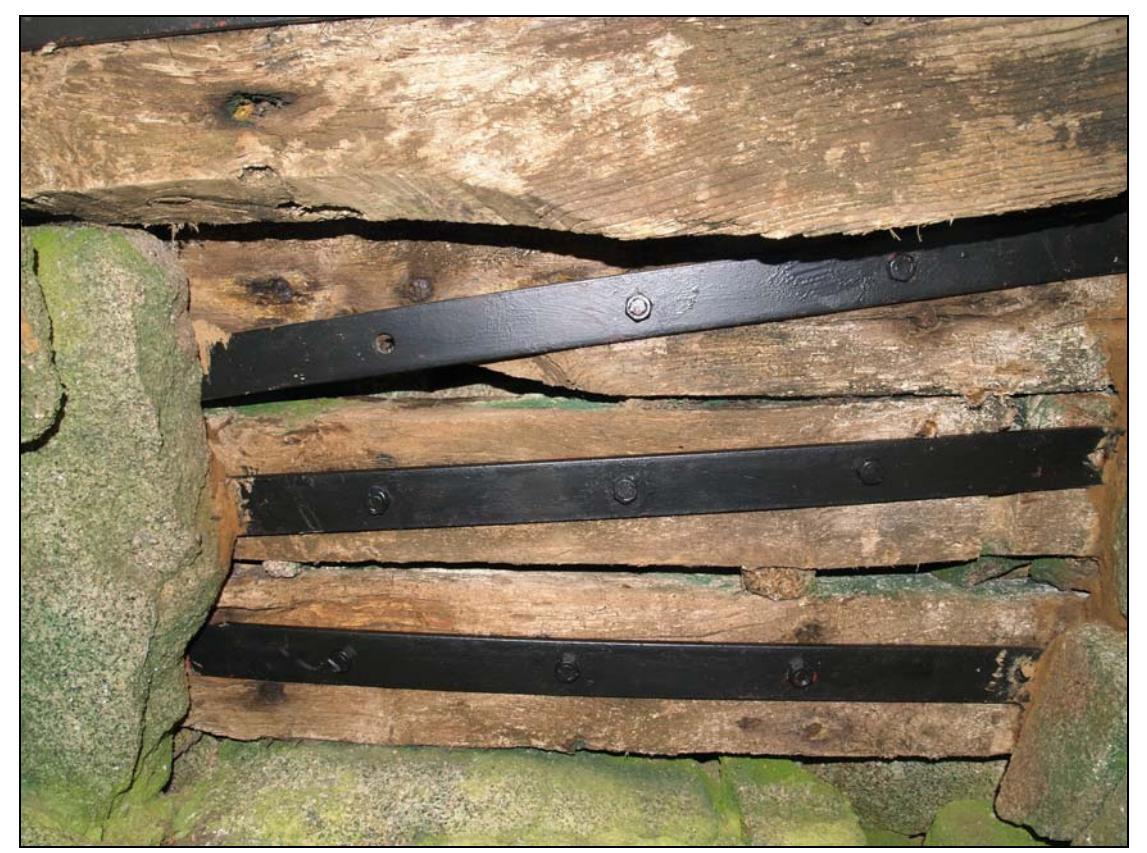
Fig 60 House P showing reinforcement bars in niche right of kitchen fireplace (photo: Eric Berry)

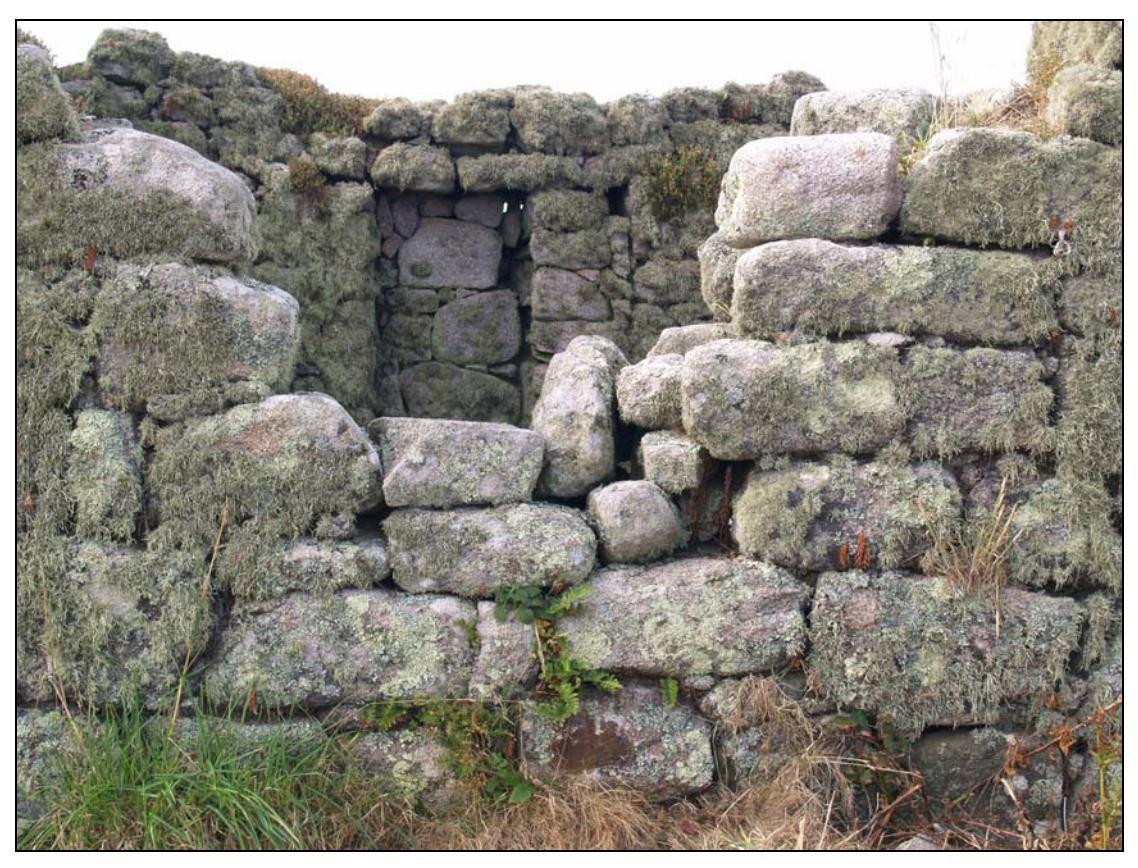
Fig 61 House P, rear wall opening, following resin repairs to lock loose stones in place (photo: Eric Berry)

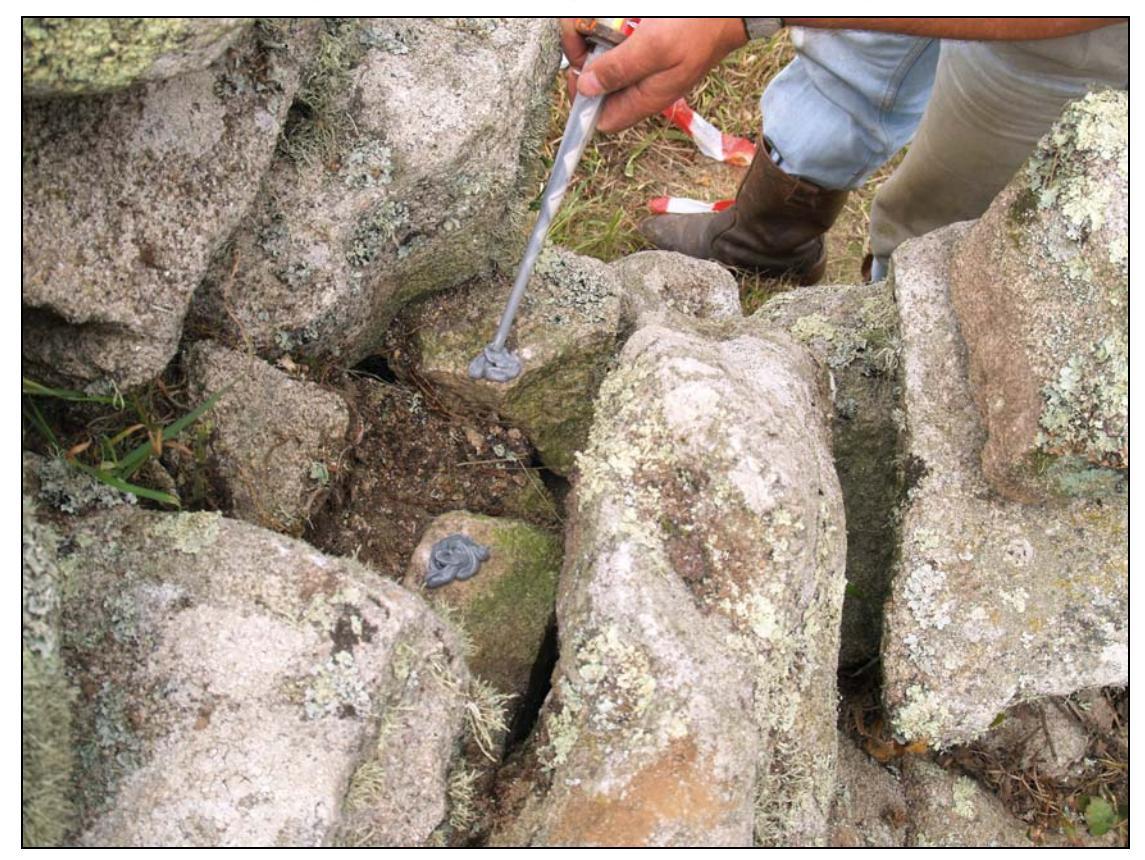
Fig 62 House P, rear wall, resin repairs in progress (photo: Eric Berry)

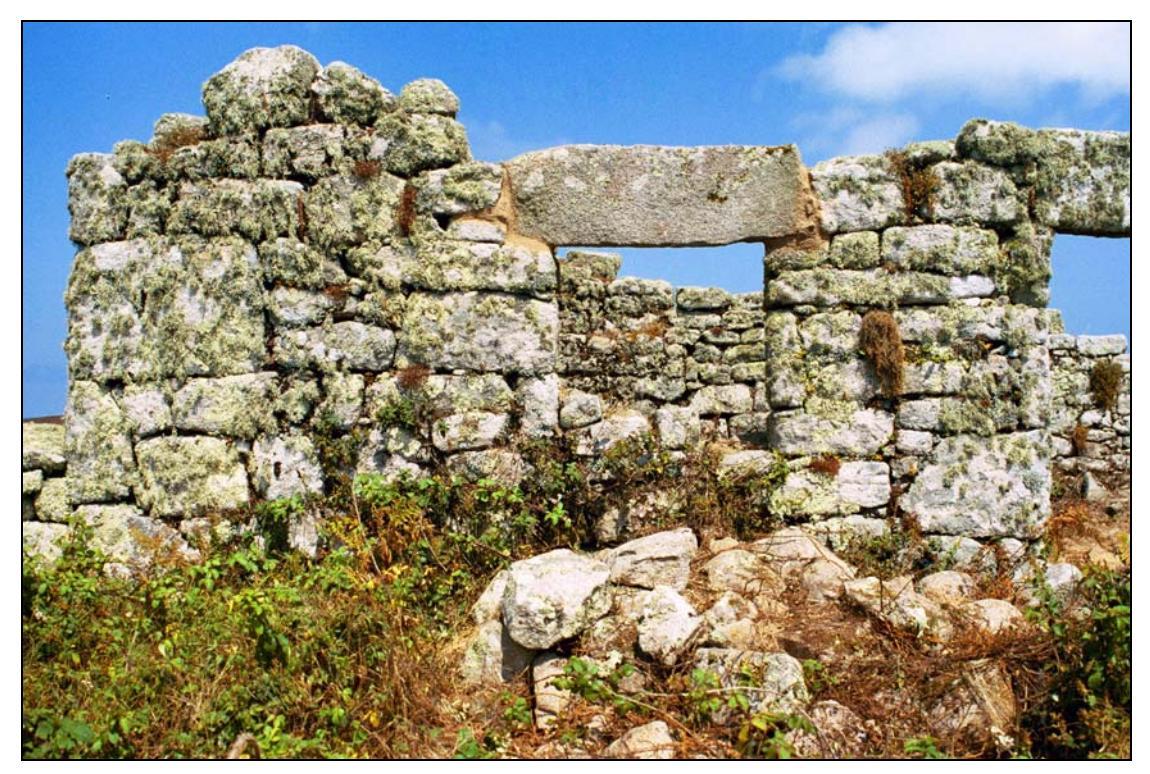
Fig 63 House P, south wall, showing reinstated lintel over window opening (photo: Eric Berry)

Following discussion about the desirability of reinstatement of a fallen granite lintel over a front window opening this work was carried out by the builders under their own initiative.

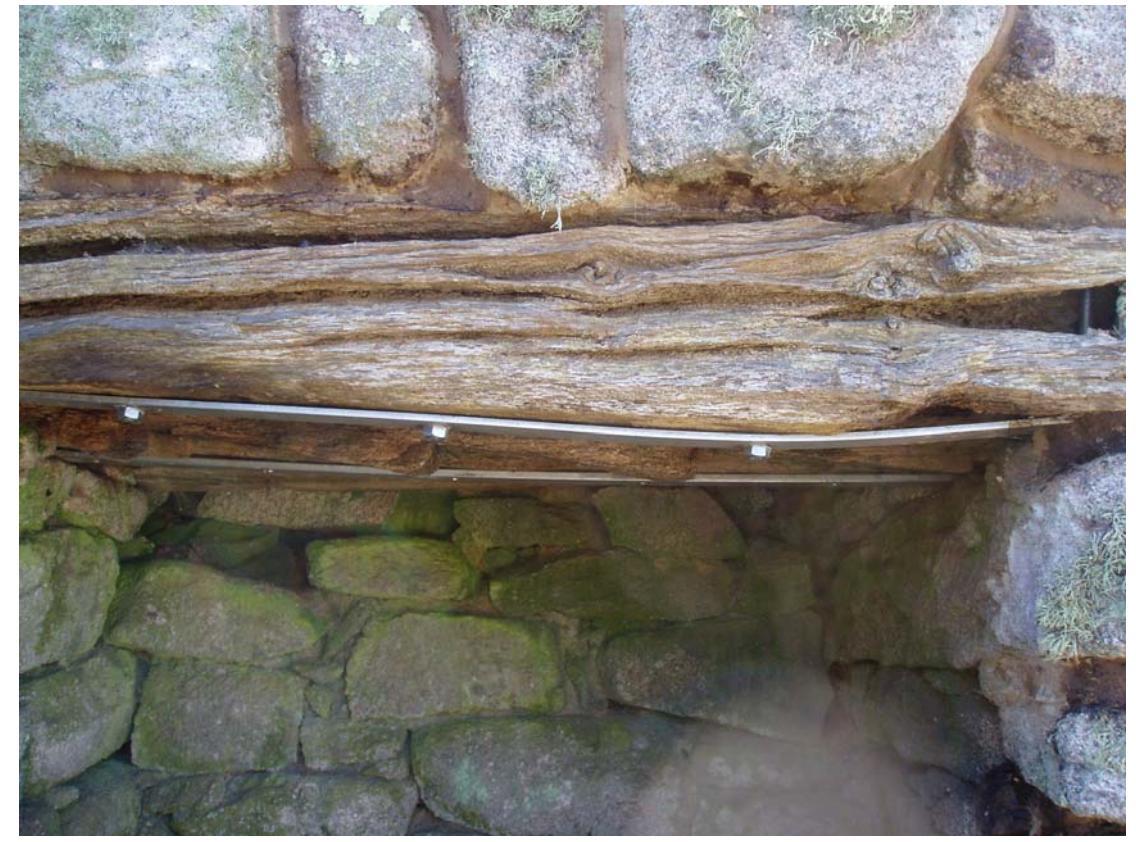
Fig 80 The repositioned fallen lintel on building P

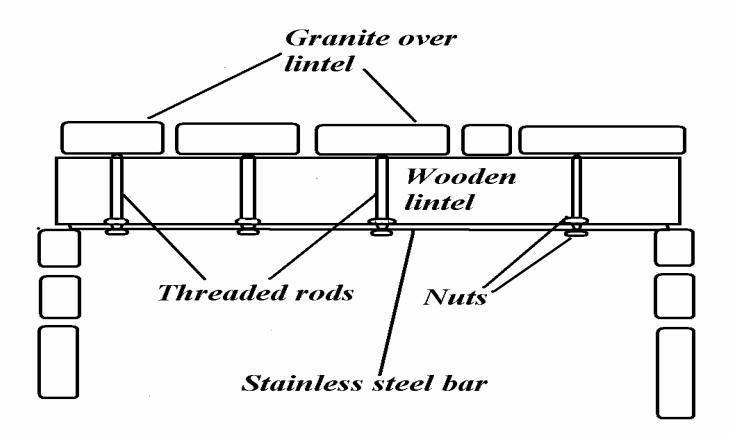
Fig 82 The diagram above shows how the wooden lintels were reinforced by the stainless steel bar

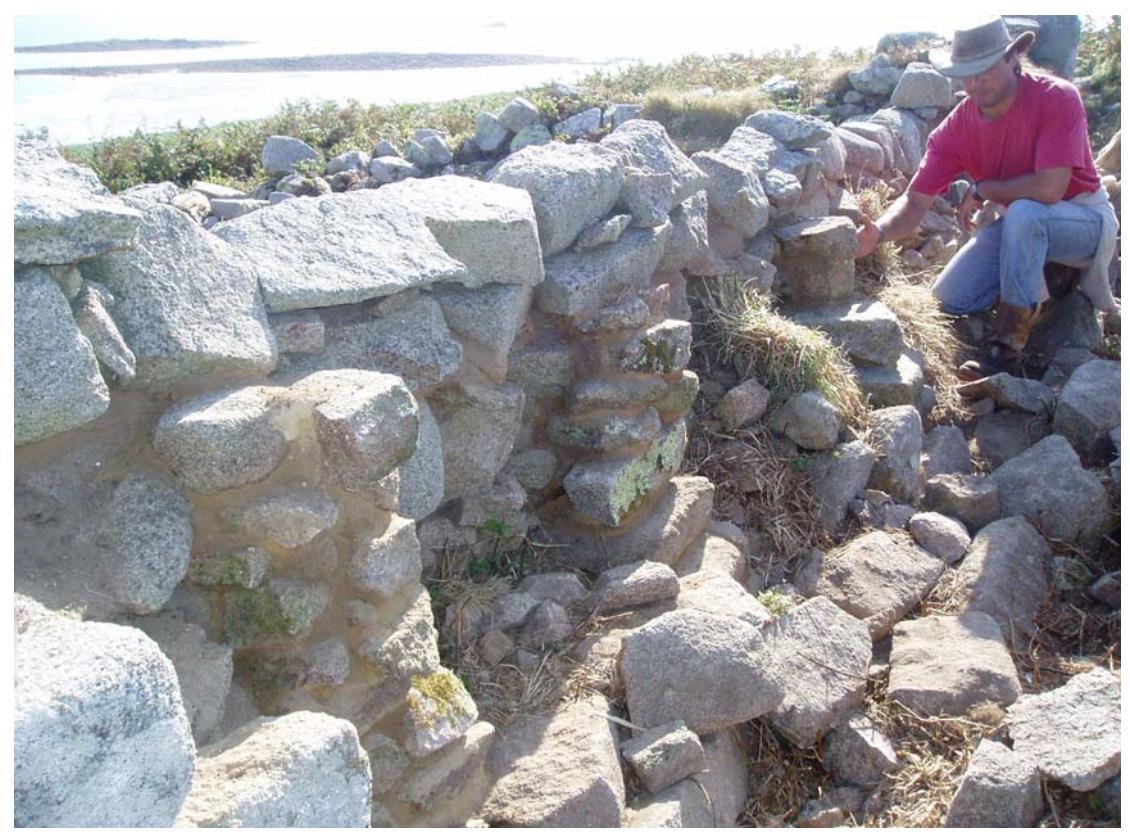
Fig 84 A buttress-supported wall, 3 buttresses can be seen in the picture (Building N)

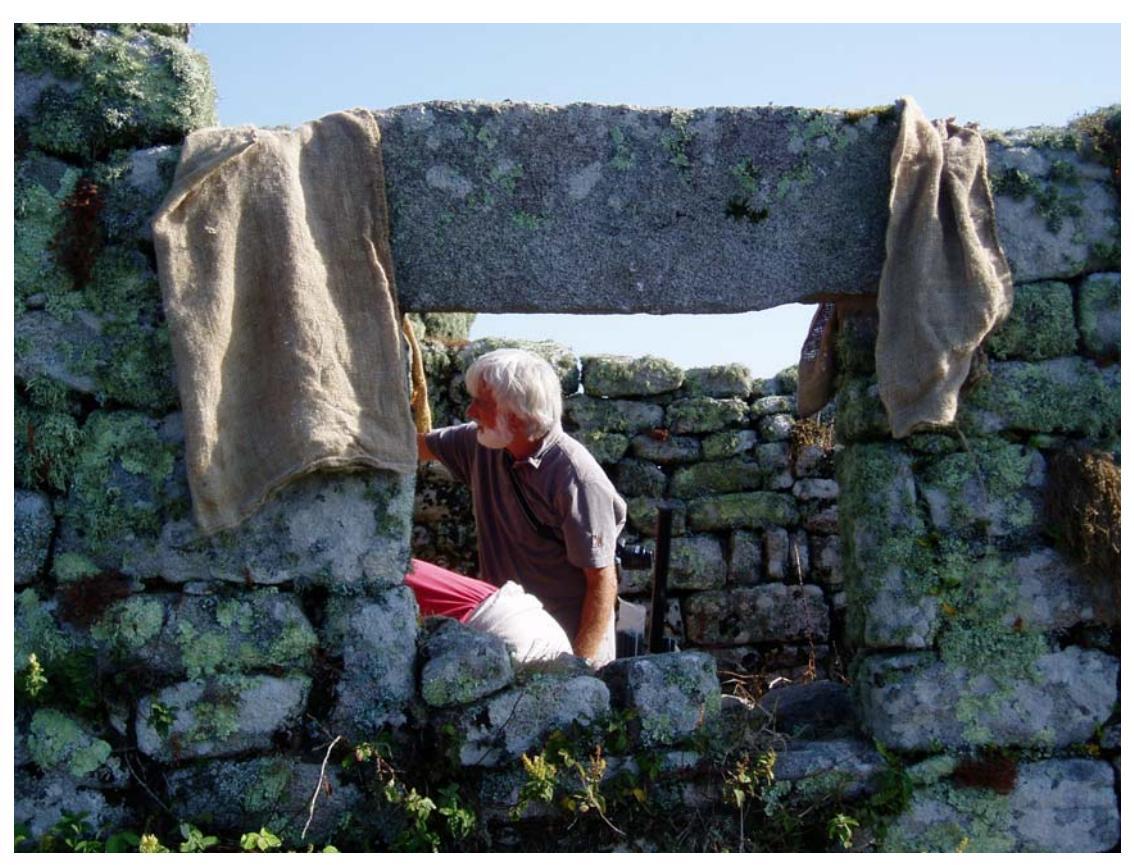
Fig 85 It took four men to lift this heavy lintel back into position. (Building P)
