Trelill holy well, Helston, Cornwall

Conservation and restoration

Trelill holy well final APJ July 2014

Client	English Heritage, Cornwall Heritage Trust
Report Number	2014R039
Date	July 2014
Status	Final
Report author(s)	Ann Preston-Jones
Checked by	Jacky Nowakowski
Approved by	Andrew Young

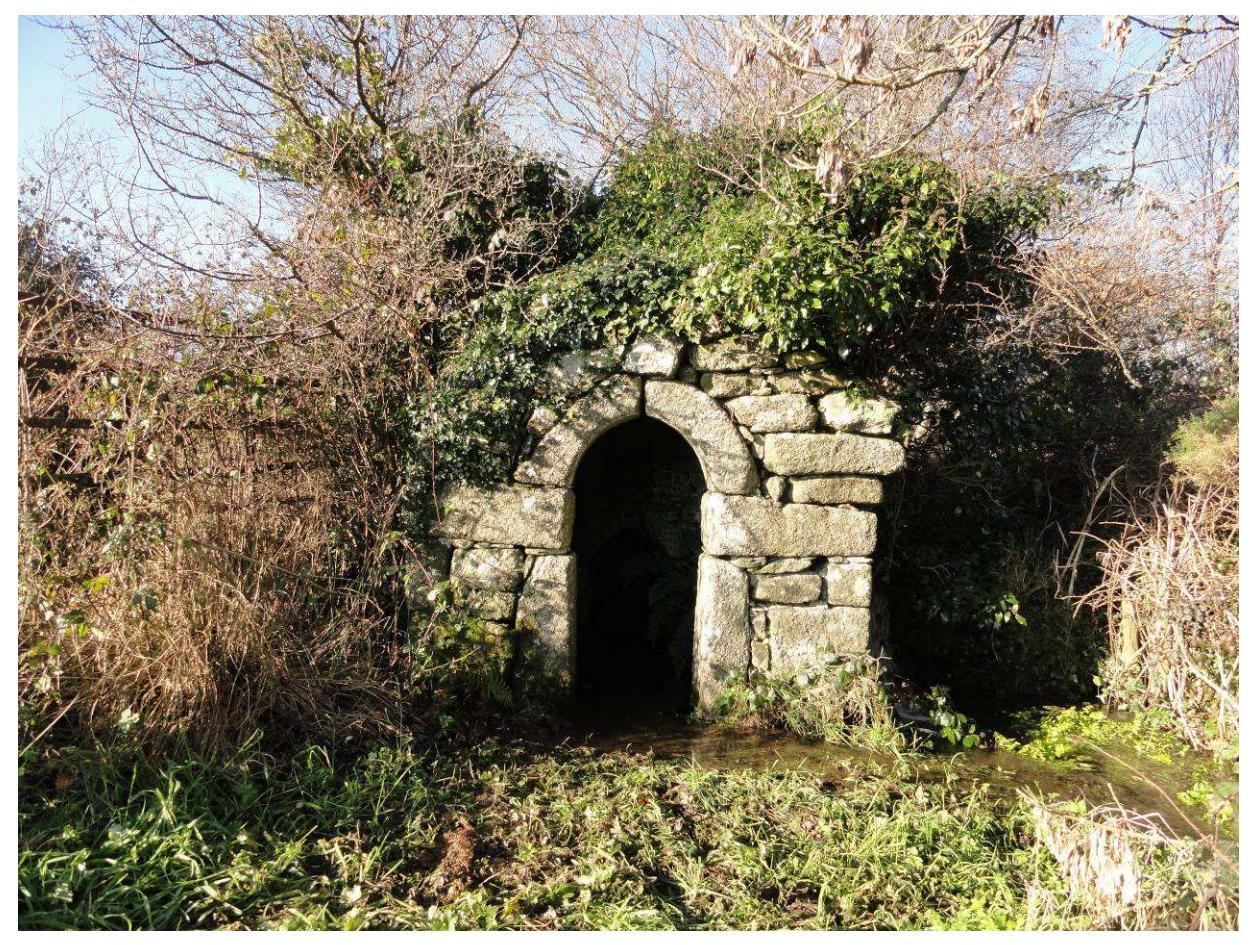
The evidence of the building is that other than one or two dabs of cement, the well was not repaired at all in the course of the twentieth century, and since the report of 2003, has further deteriorated. At the point at which the current initiative began, the well had therefore been neglected for many years, resulting in a gradual deterioration of the structure. Damage was being caused by extensive scrub, ivy and tree growth, coupled with erosion as water from the adjacent stream, dammed by a blocked culvert through the adjoining wall, poured through the walls of the building instead of following its natural course. As a result, the earth bedding mortar had been comprehensively washed out of the walls, and many smaller stones lost, so that light could be seen through the walls in many places and the structure was in a fragile condition. It had only been saved from more extensive collapse because some of the stones forming the walls are such large blocks of granite.

Fig 7 The main elevation of the well before work began

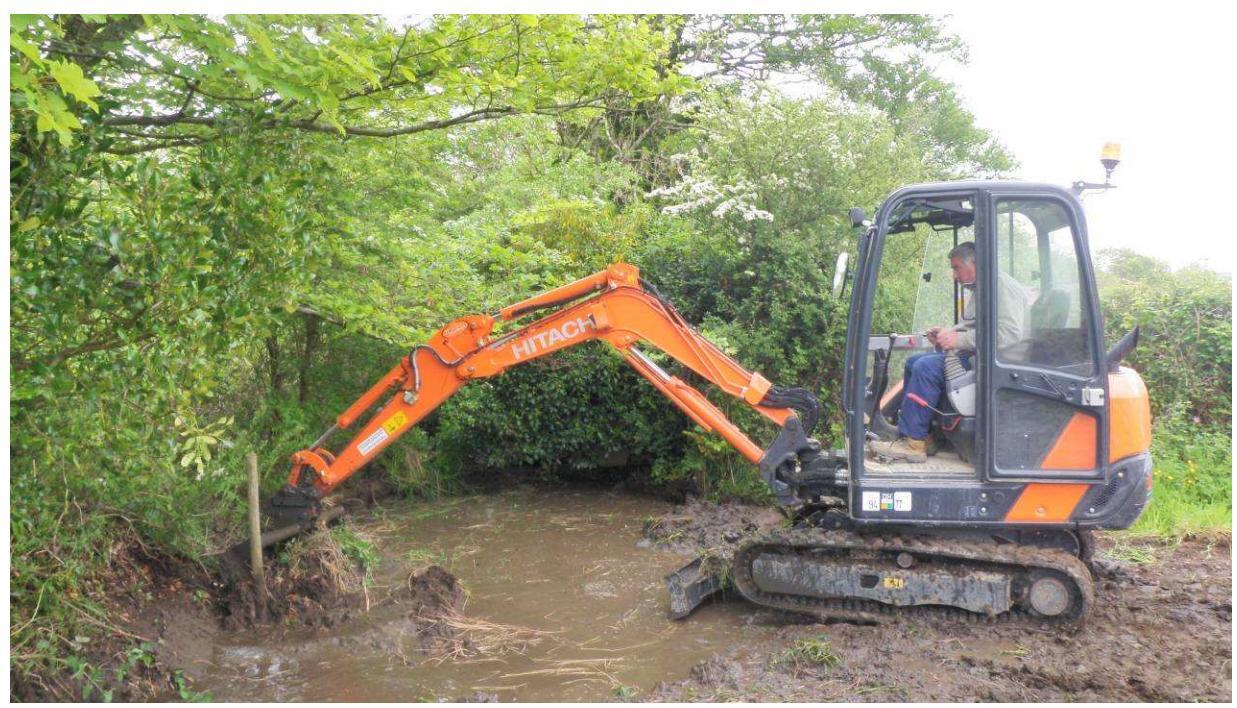
The first task was to remove silt from the rear of the well, to make access easier, to relieve pressure on the building and prevent stream water from flowing through the well's walls. Work began on 4th May 2011. Initial de-silting was done by a mini-digger organised by Mark Rowe. A watching brief was carried out by James Gossip, to ensure that no damage was done to the well in the process (Fig 8).

Fig 8 Clearing silt from behind the well The well-house is immediately behind the arm of the mini-digger, hidden beneath a shroud of dense vegetation

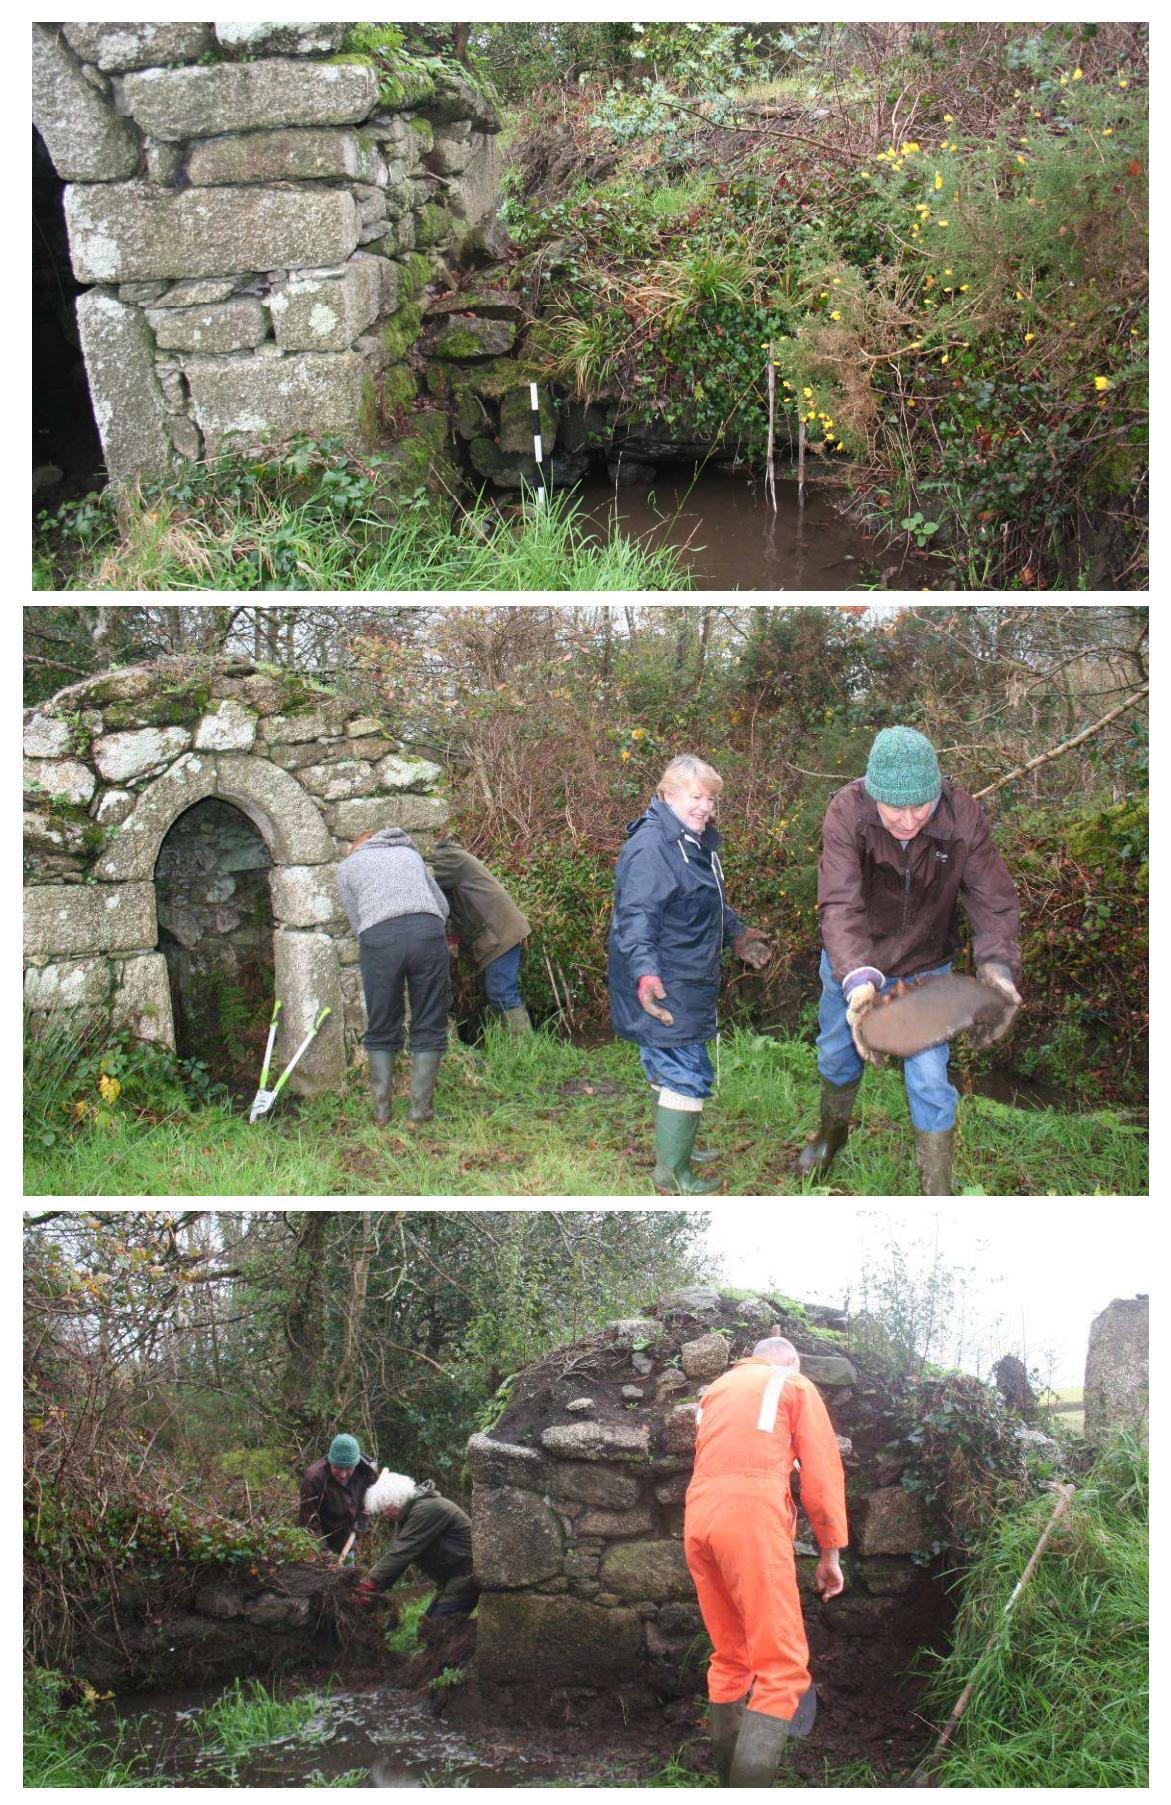
Fig 11 Volunteers remove the hedge and blocked culvert from the stream beside the well in 2011

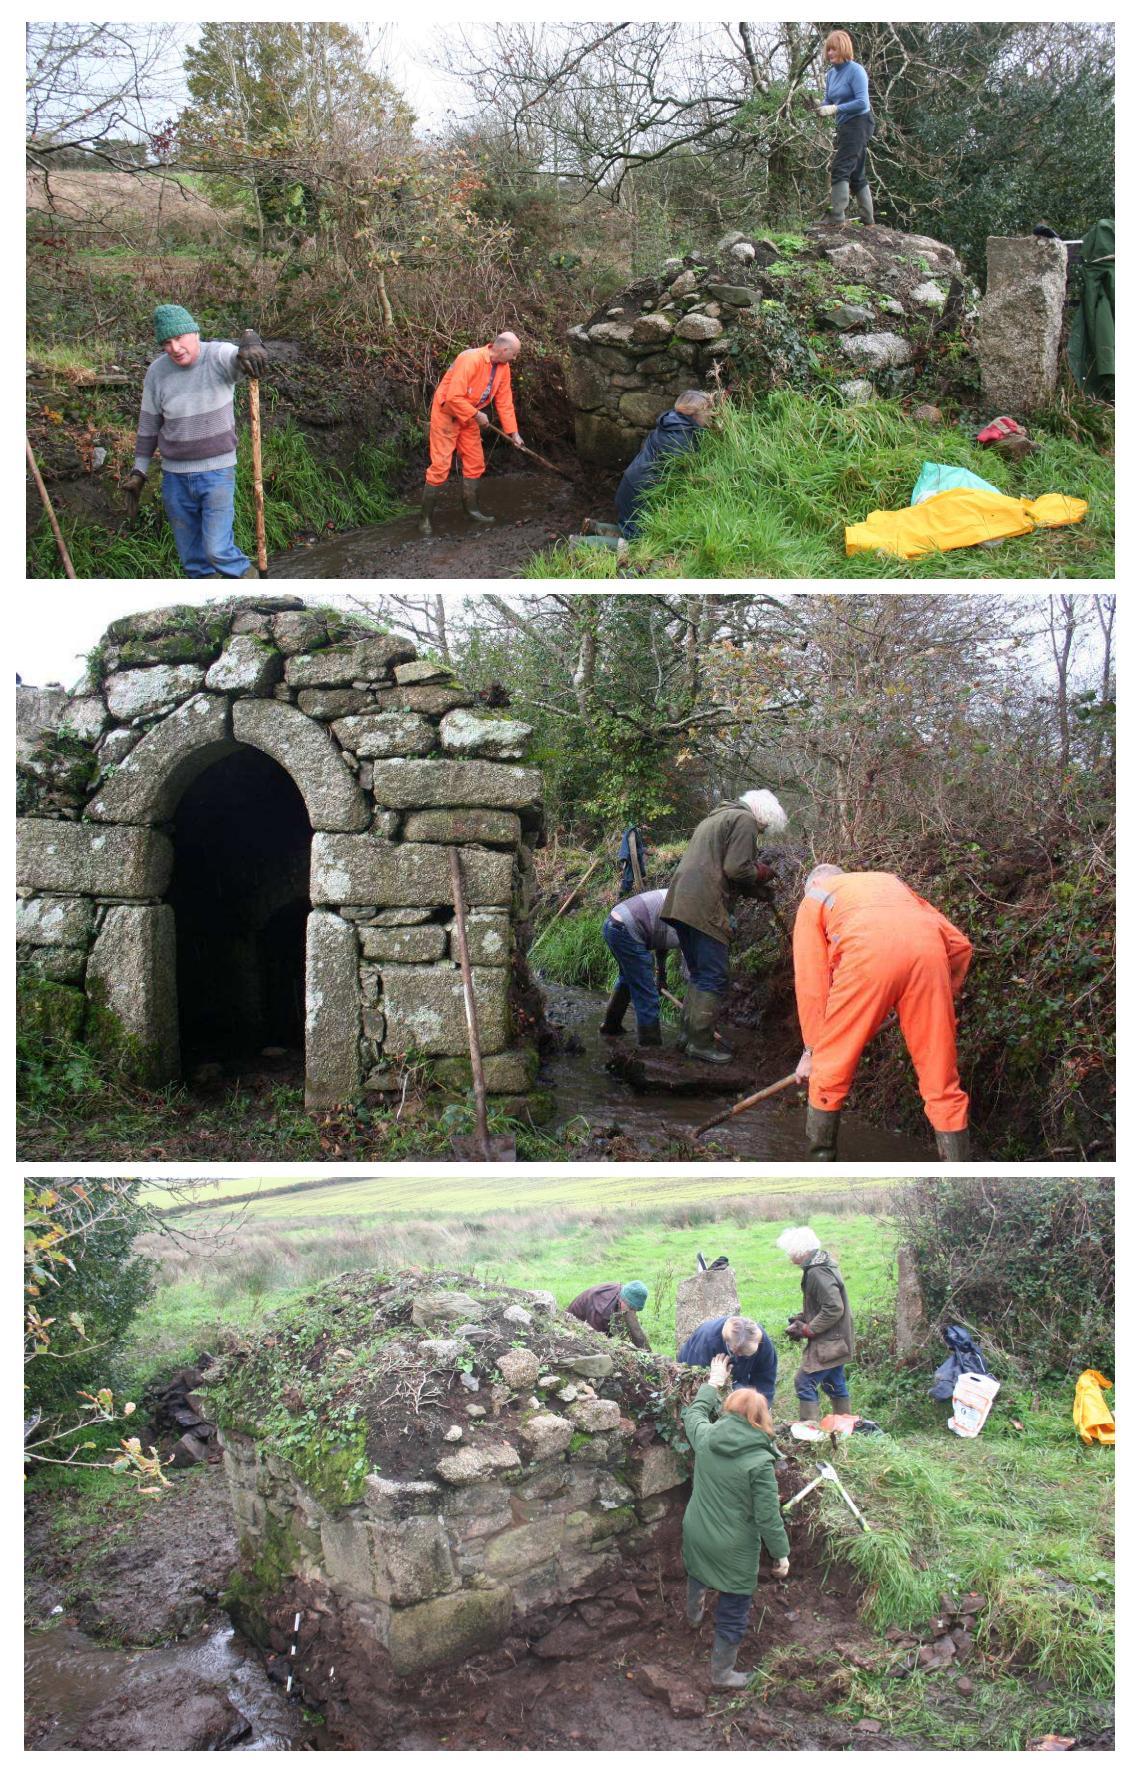
Removing silt from the back of the well showed that the hedge built across the stream on the north side of the well – which from map evidence appears to have been inserted at some time between c 1880 and c 1907 – was the main cause of the trouble. A small culvert carrying the stream under the hedge would have required regular maintenance to prevent it from becoming blocked. Without such maintenance, and once blocked, the hedge prevented the stream from running properly, leading to the problems seen in silt build-up and water cascading over the hedge and through the walls of the well. To prevent this from happening, either the culvert had to be regularly cleared or the hedge had to be entirely removed. In the event, the latter option was chosen. In September 2011, following agreement from Mark Rowe, the volunteers dismantled the hedge across the stream, to ensure a smooth flow of water past the well (Fig 12).

Fig 12 Volunteers remove the hedge with blocked culvert from the stream beside the well, then clear further silt from behind the well in 2011

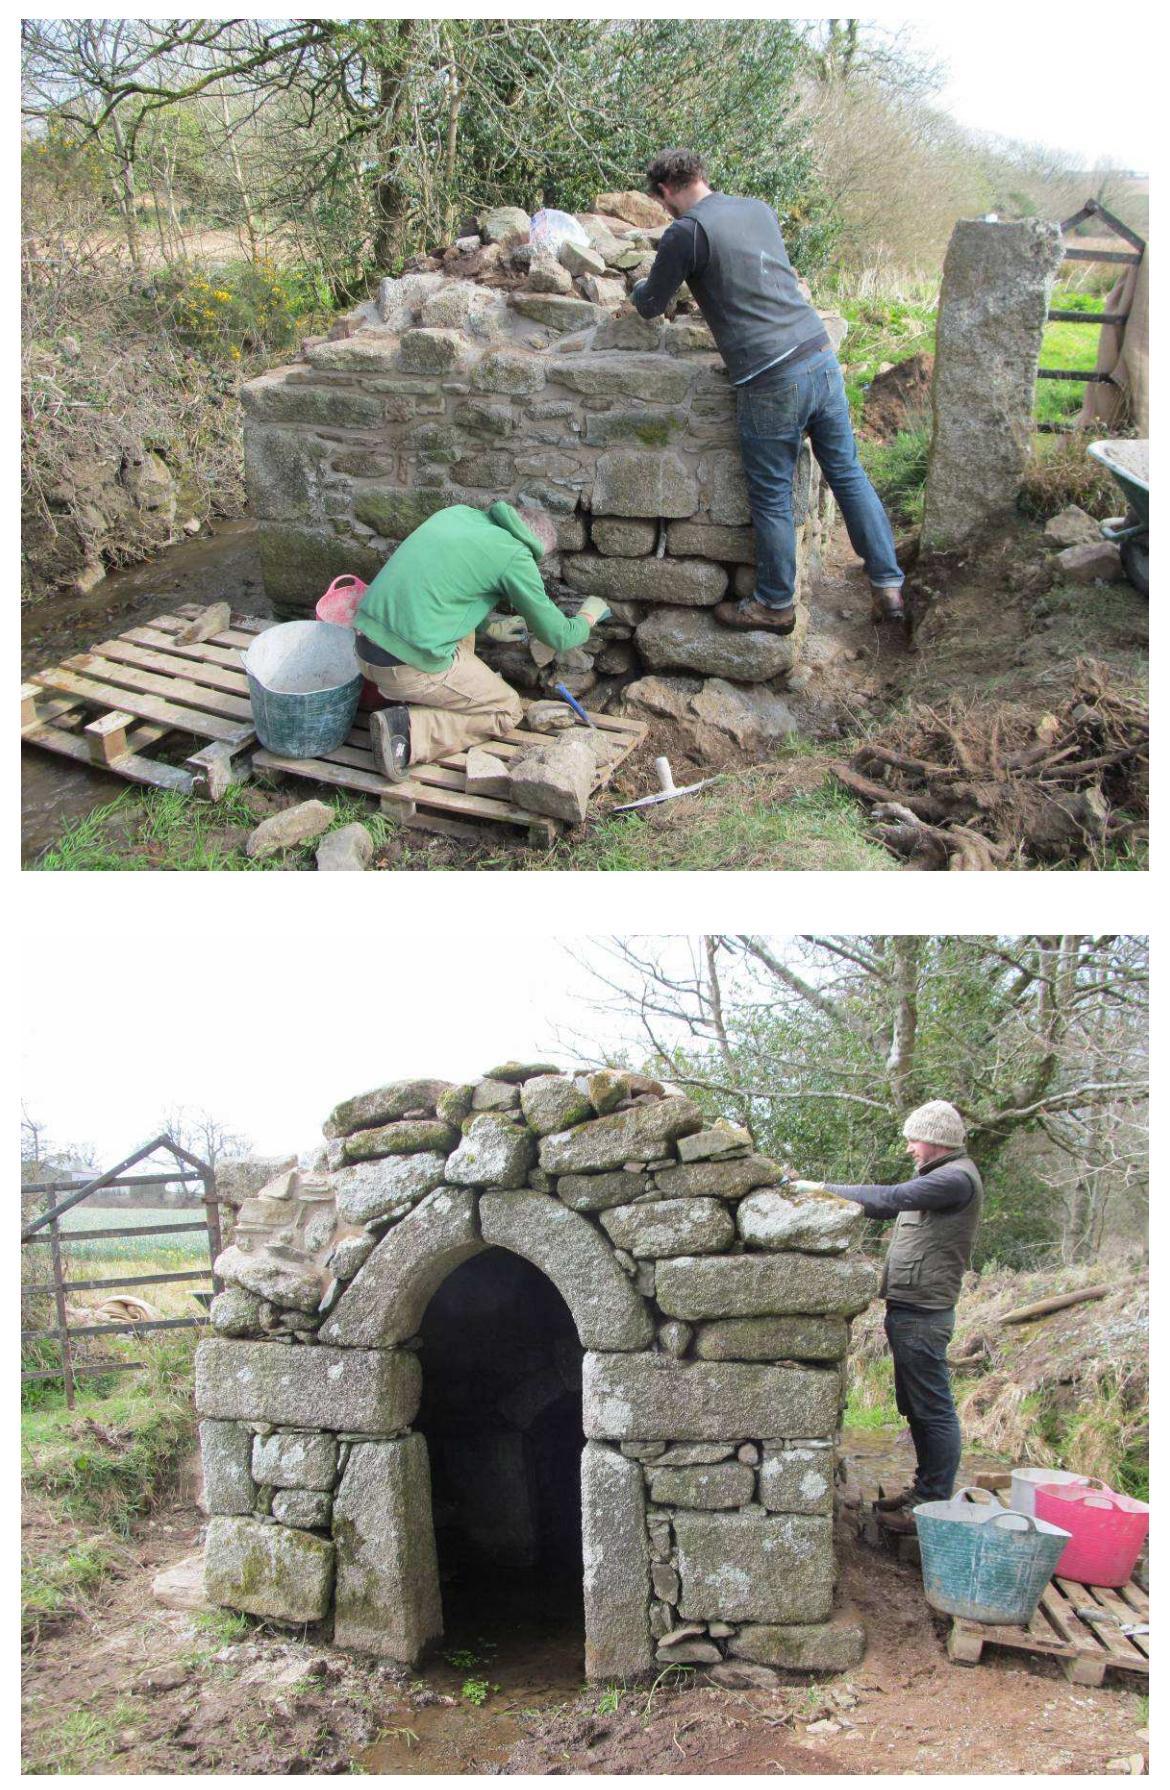
Fig 13 Consolidation and repointing of the well by Joe Morris of Rescape Cornwall, assisted by Tim Lake, in April 2013

The overall objective of the work was to repair the well in such a way as to provide stability whilst ensuring that, as far as possible, the present appearance of the building would be retained. Where needed the structure and aesthetic was improved by resetting some of the external stones. Where internal areas needed rebuilding, this was done to match the existing style and filling any voids with appropriate stone.

We then removed one large stone from the rear corner of the well which was badly pushed out by roots and was in danger of falling off. We re-set this stone on a mortar bed and replaced the corner roof stone above it. We did a similar thing on the other side, (the stream side) of the well and re-laid a stone which had slumped to an angle and looked out of place. It was also quite unsafe. We assessed the rest of the well and decided that the rest of the structure was sound and although some stones had moved over time, they were stable and there was no need to remove and re-lay them.

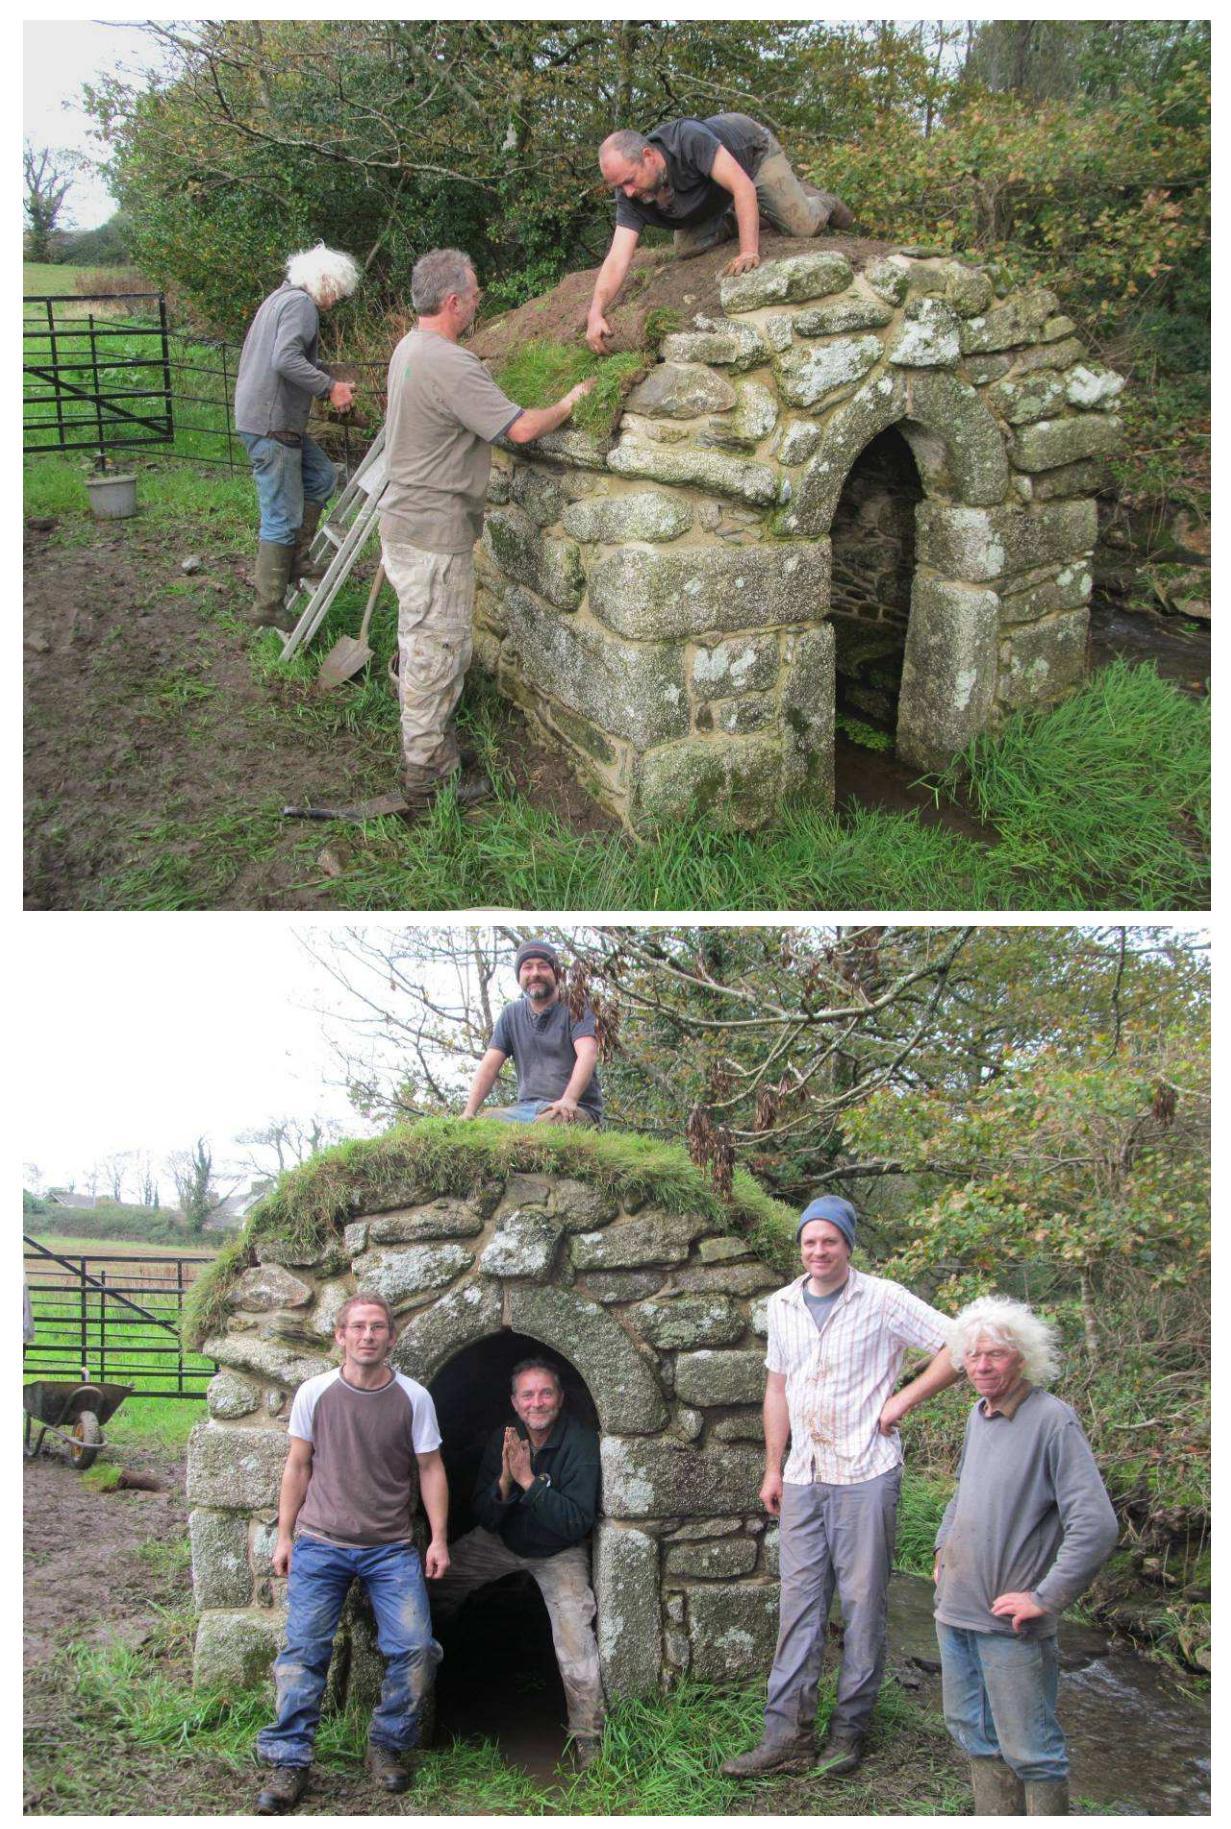
Fig 17 Installing the turf roof capping

- 1. As the top of the well was very uneven, it was first smoothed out by filling all the gaps between the stones with earth dug from the bottom end of the field near the well. This proved very difficult because the soil was very shallow, very clayey, and very stony. It had to be loosened with a pick before shovelling up, and then broken up by hand or wetted with the worst of the stones removed before adding to the top of the wall, where it was firmed down. Luckily, the clay-like consistency proved useful in helping the soil to stick on the well's roof, especially on the steeply sloping sides. Nonetheless, enough was acquired to enable the top of the well be covered so that only a few stones remained sticking out.

- 2. After this, two layers of turf were laid upside down. The idea is that these will rot down and provide a good bed for the top layer of turf to root into. The bottom layer was allowed to overhang the edges and then turned in, to give a neat edge along the top of the walls.

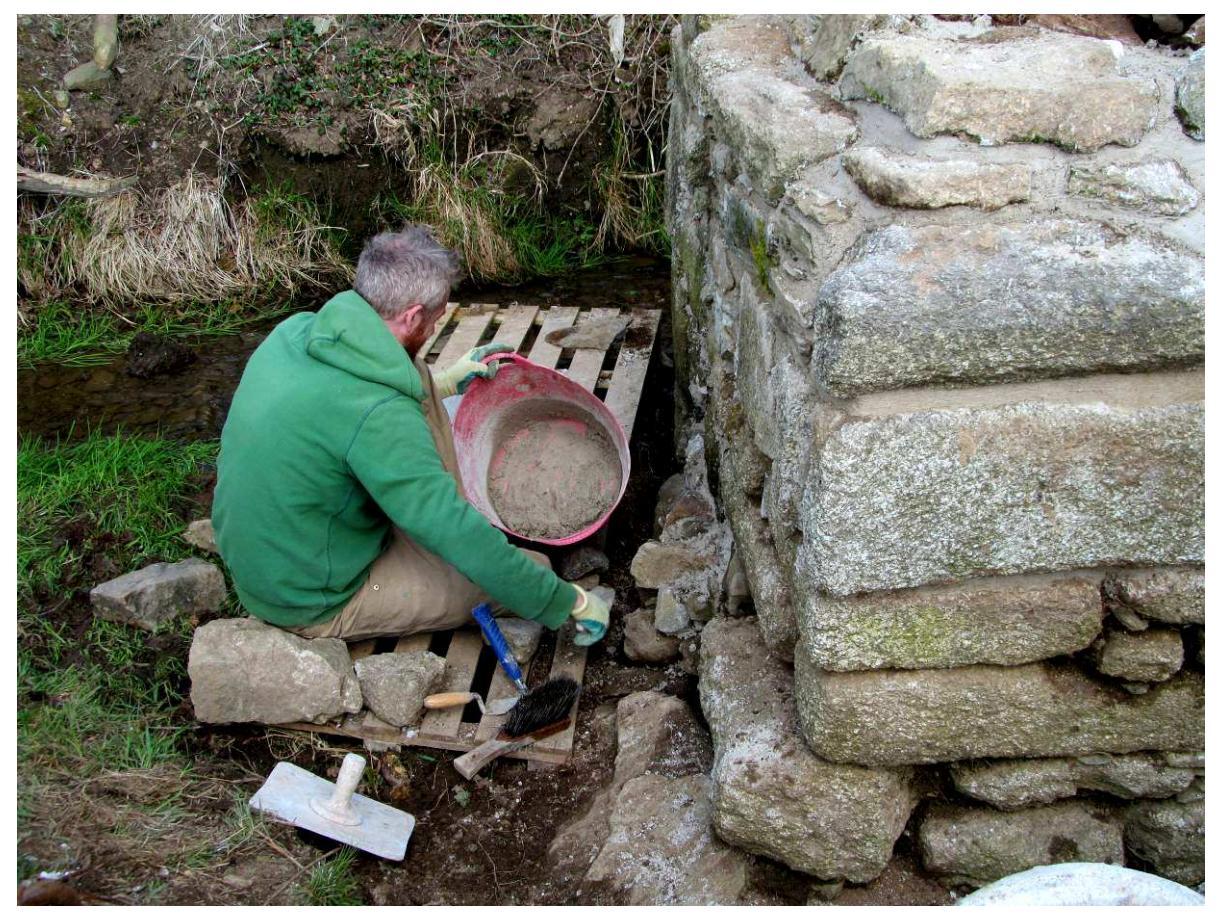
In 2000, it was noted that 'the footings towards the front of [the well's] north-east elevation are stepped out approximately 0.20m, no doubt to help support the wall where the stream runs alongside' (Preston-Jones, Sturgess *et al* 2003, 14 and fig 9).

With removal of silt from all around the building, this feature became even more apparent (Fig 19). It exists on all sides of the structure except the front (SE) elevation. Its distance from the wall above is not even, making the foundation appear to be set on a slightly different orientation to the well-house itself. The greatest projection is on the south-west corner, where it extends out beyond the main line of the well's wall by up to 0.45 metres. Its origin remains a mystery however. It may, as previously suggested, simply represent a foundation for the building, to provide stability in the stream-side location, or it may represent the footings of an earlier building on the same site. Two facts: one that the present structure is thought to be of 18th century origin and possibly a rebuild of an earlier, medieval, chapel or well whose cut stones it incorporates, and

two, that the foundation has a different orientation to the main part of the building, make this a possibility.

Fig 19 Building details: stepped out foundation/footings can be seen at the bottom of the wall (with Tim Lake repointing the wall)

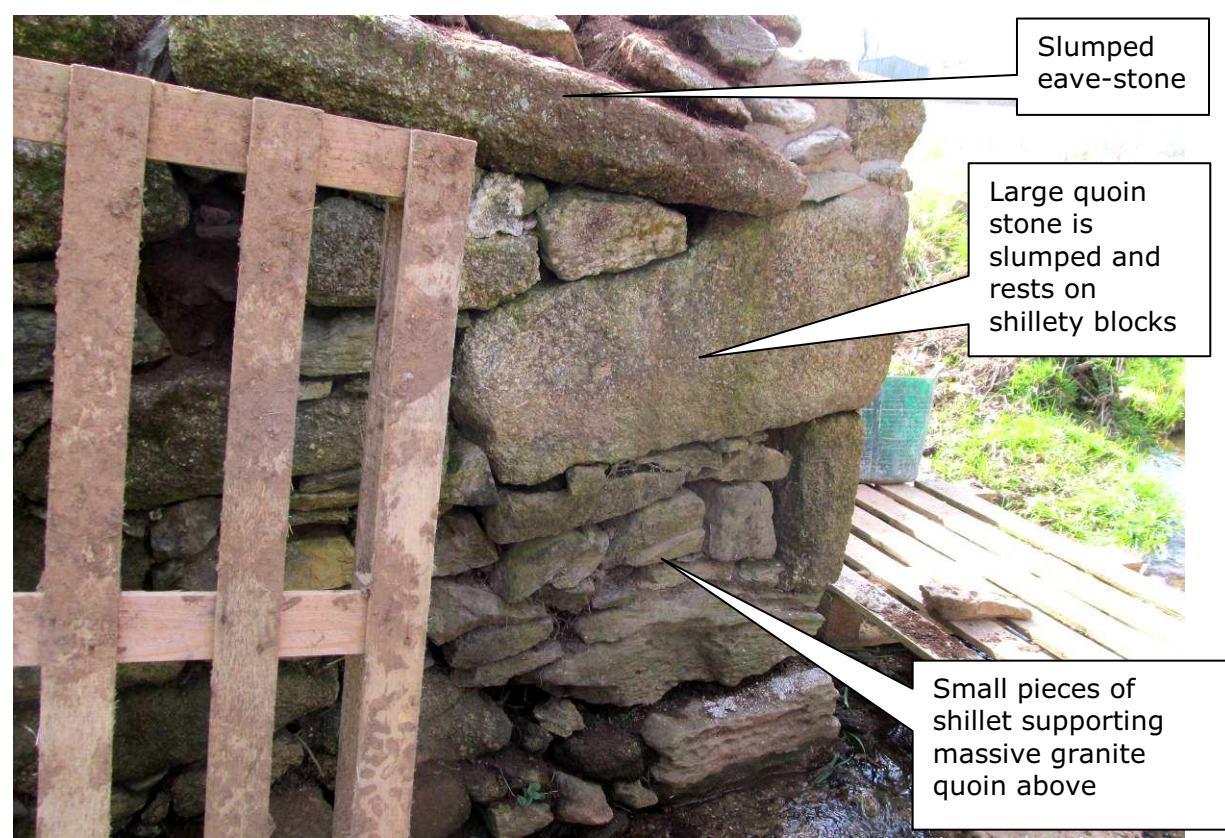
As fig 20 shows, at the south corner of the building is a very large granite quoin stone resting above small blocks of shillet stones, and not on more squared granite, which would give greater stability (and as is the case at all other corners of the building). A misaligned projecting eave-stone above also points to a former episode of collapse in this corner. It looks as though a granite quoin has been lost from the base of the corner and been replaced by the very irregular stonework seen now. Here, the walls were deep pointed and straightened as far as possible but this place of inherent instability will need to be regularly monitored.

Fig 20 Building details: the poorly north constructed corner
