# Heritage at Risk: Grade II Listed Buildings Condition Survey, North & South East Cornwall

## Contractor's Report

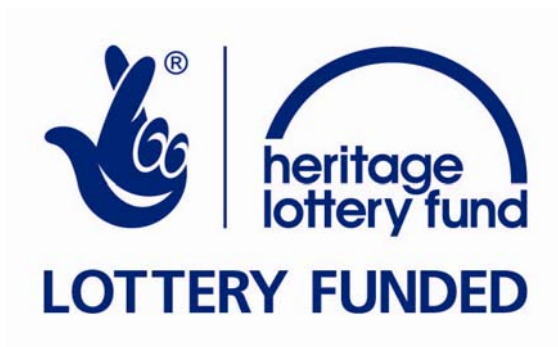
# **Heritage at risk: Grade II Listed Buildings Condition Survey, North & South East Cornwall**

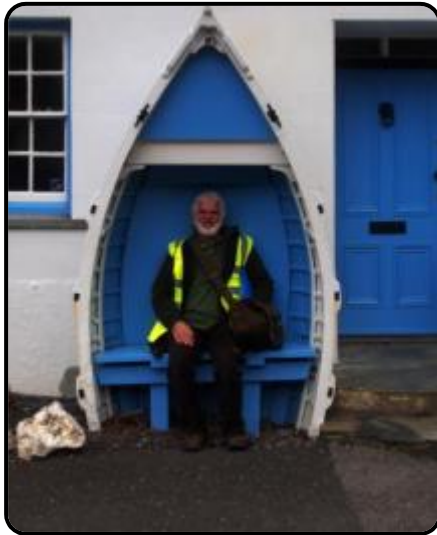
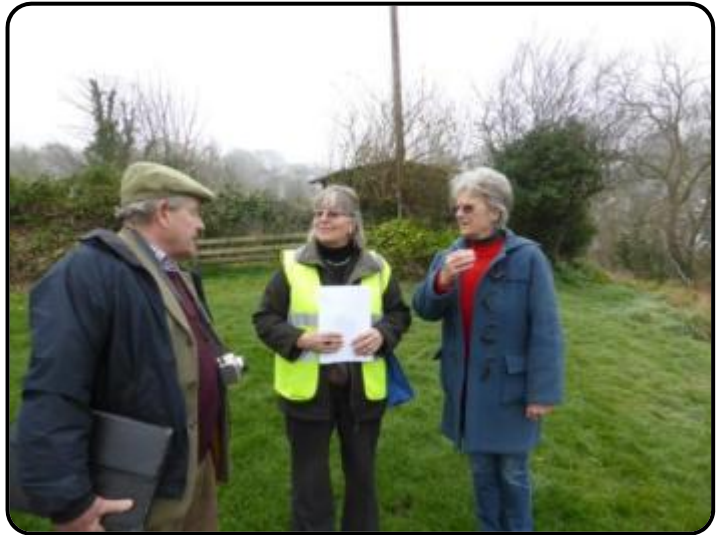
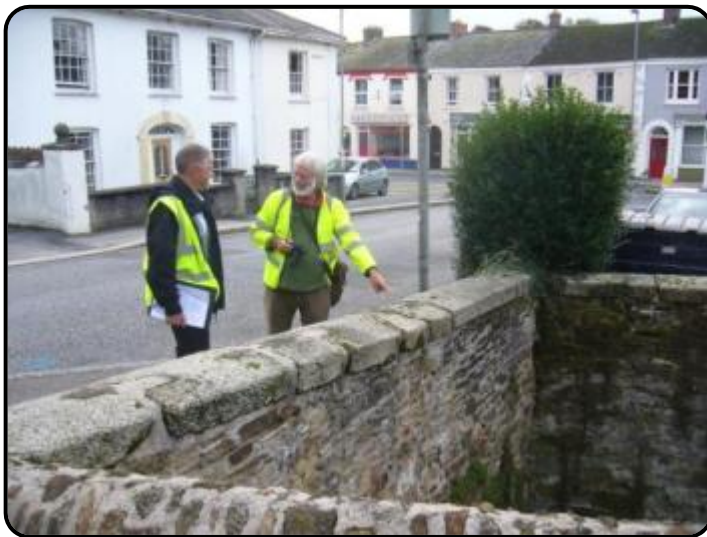
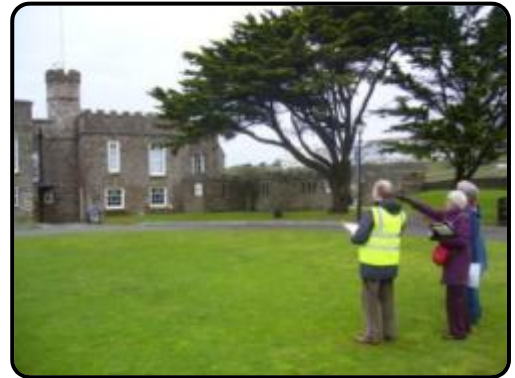
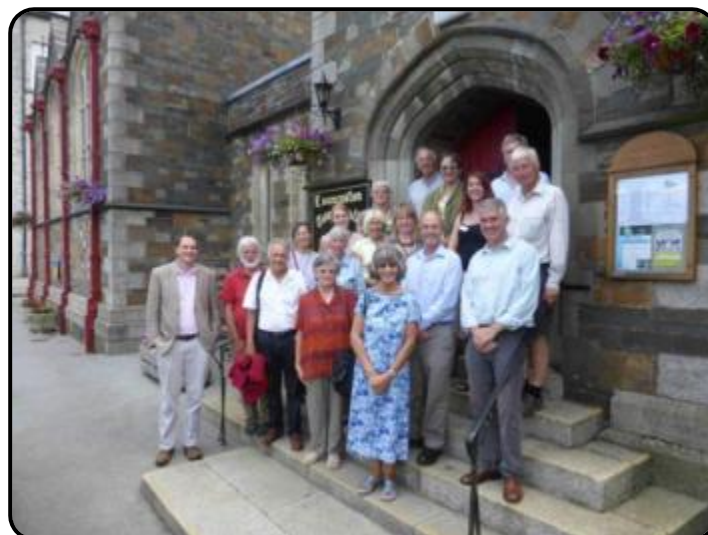
*Figures 1-5 Some of the HE team and volunteers (clockwise from top left); Specialist Buildings Consultant Eric Berry; North Cornwall group volunteers discuss the survey at Boscastle; Surveying Bude Castle Heritage Centre; Volunteers, project team & the Cornwall Council HE team attending the exhibition at Launceston Town Hall; Eric Berry and Andrew Richards (HE) field-testing the survey form in Truro.*

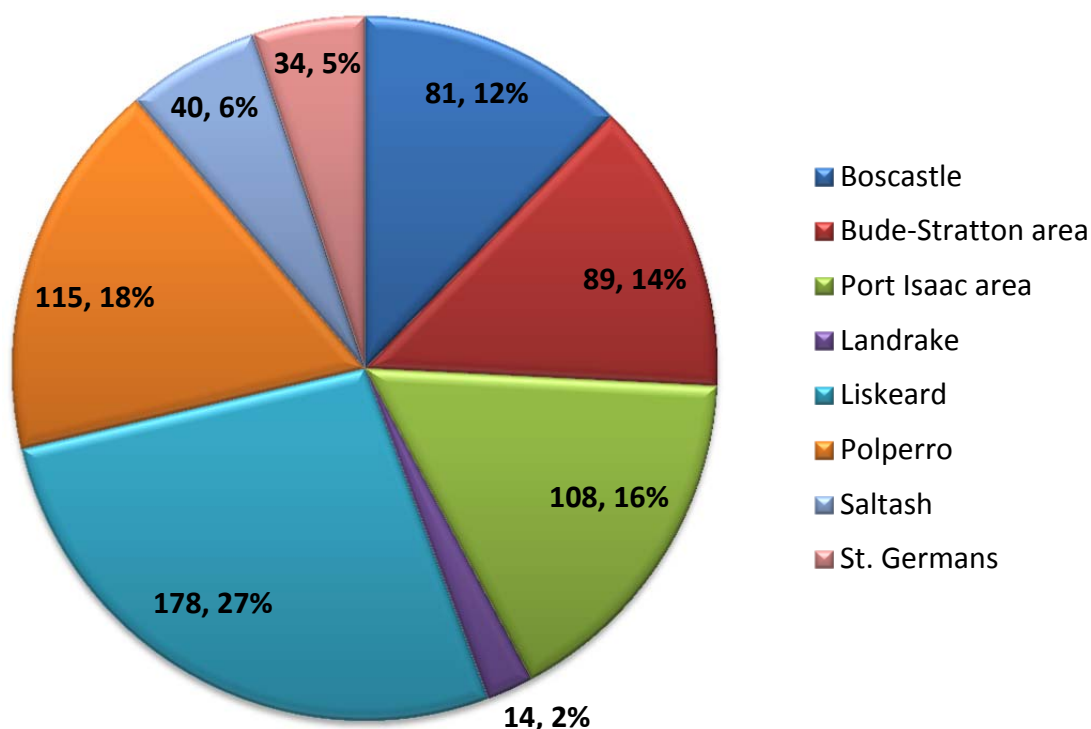
Figure 6 Distribution of Grade II listed buildings included in the final survey sample for the Listed Buildings Condition Survey project in North and South East Cornwall.

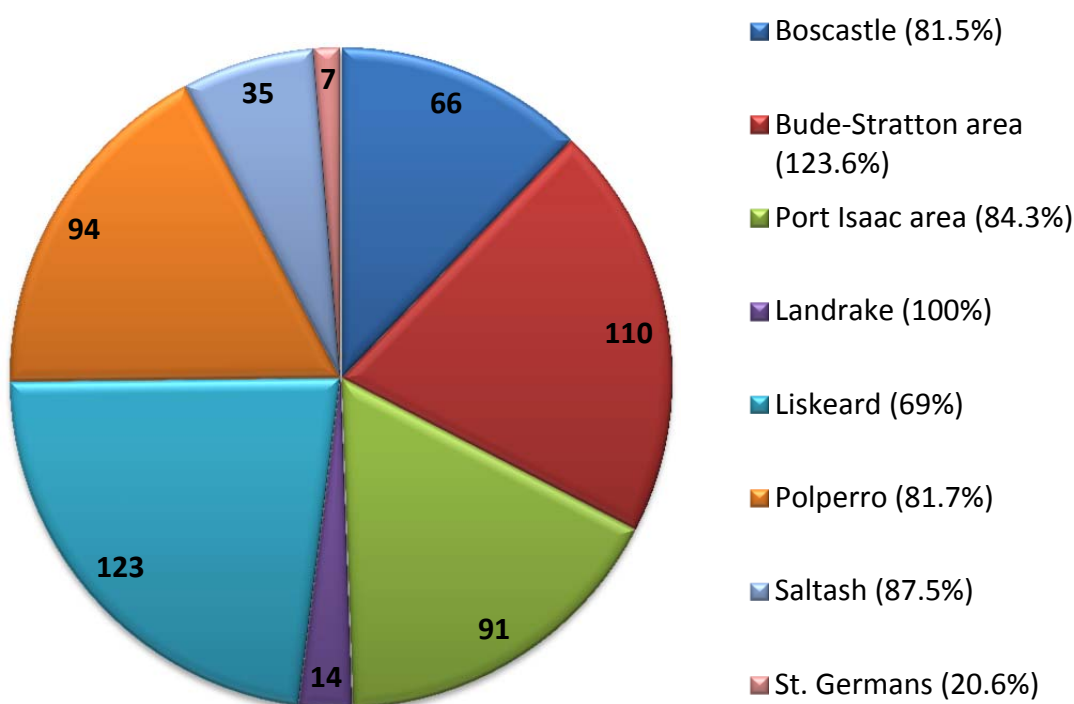
Figure 7 Distribution of Grade II listed building surveys completed during the Listed Buildings Condition Survey project (with % of total sample for each area).

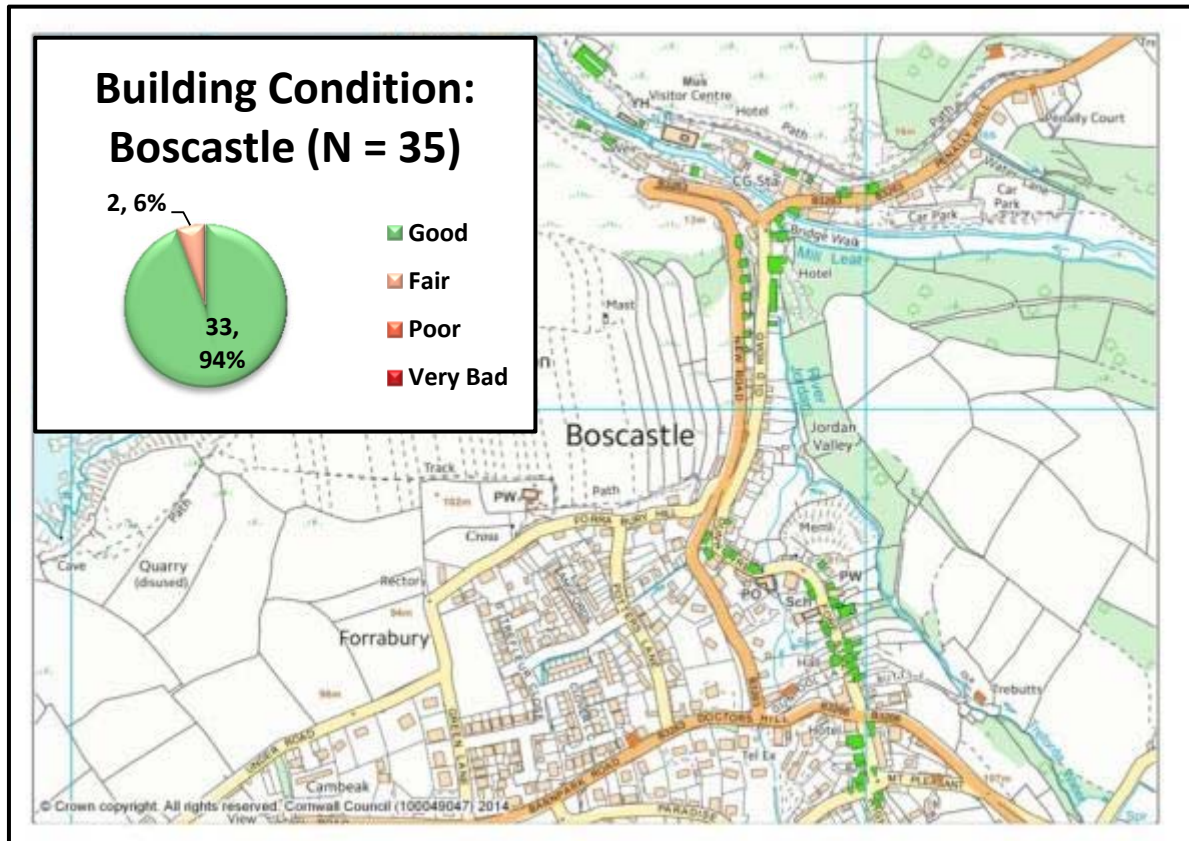
Figure 8 Map of Boscastle showing overall LBCS project progress, with listed buildings surveyed (green) and not surveyed (orange). Inset: Comparative condition data for those buildings for which records have been updated on the Cornwall HER as of 8<sup>th</sup> August 2014.

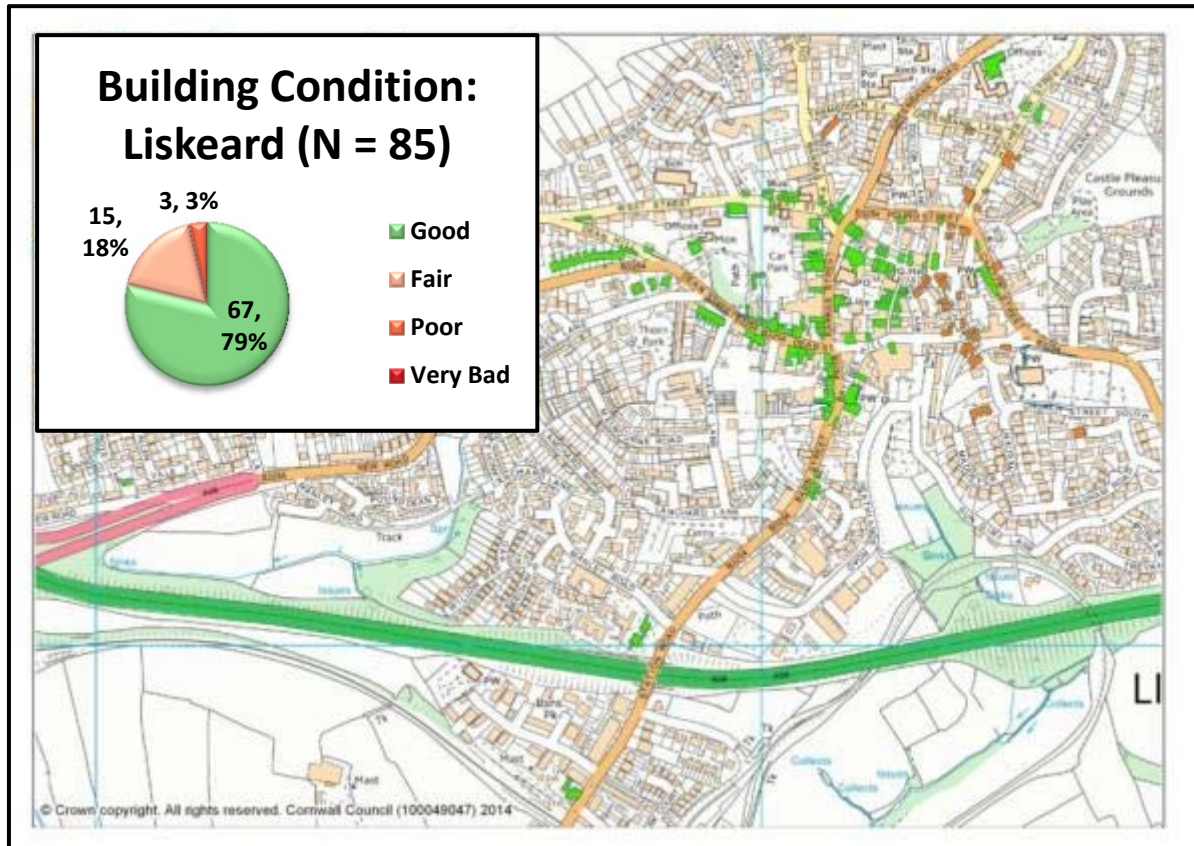
Figure 9 Map of Liskeard showing overall LBCS project progress, with listed buildings surveyed (green) and not surveyed (orange). Inset: Comparative condition data for those buildings for which records have been updated on the Cornwall HER as of 8<sup>th</sup> August 2014.

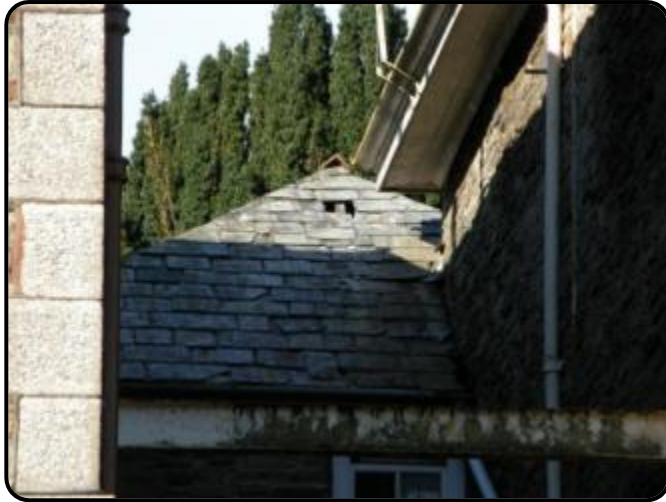
Figure 10 Missing slates, with roof open and rafters exposed.

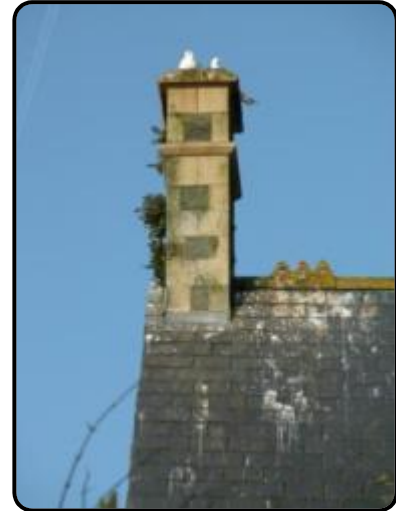
Figure 11 Vegetation and roosting seagulls on chimney.

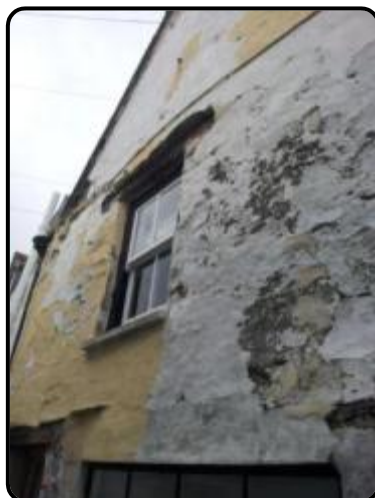
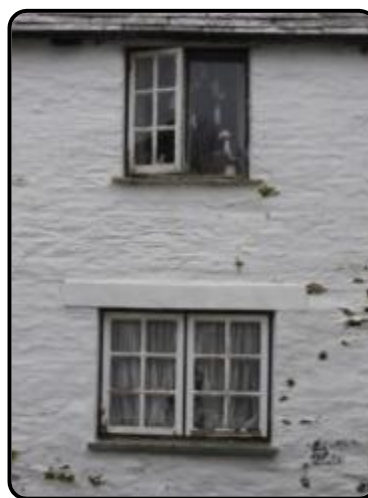
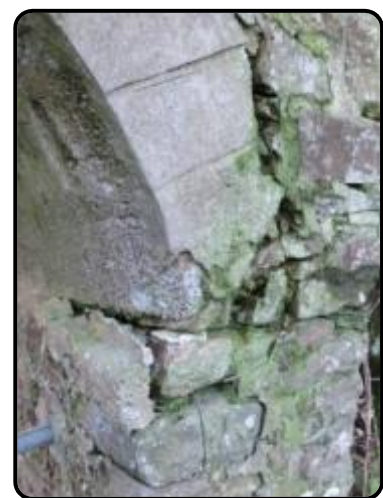
Figures 14-16 Deteriorating render & woodwork (left & centre); Blown mortar, with potential impact on structural integrity (right).

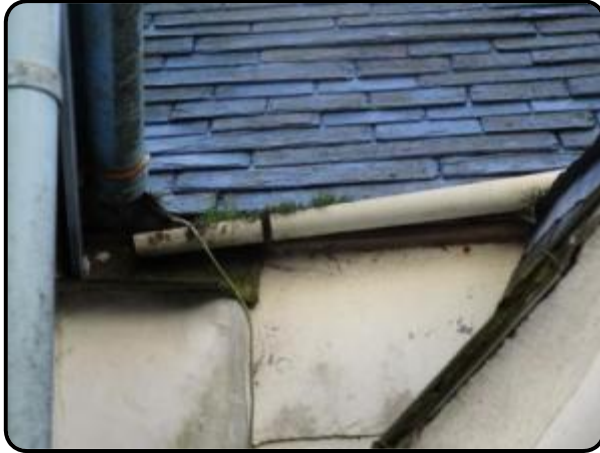
Figure 18 Accumulating vegetation appears to have resulted in disconnection of the gutter.

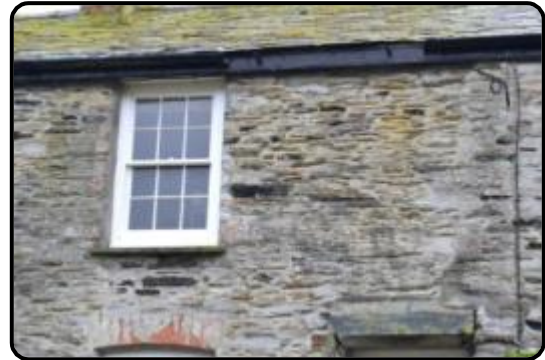
Figure 17 Missing section of gutter.

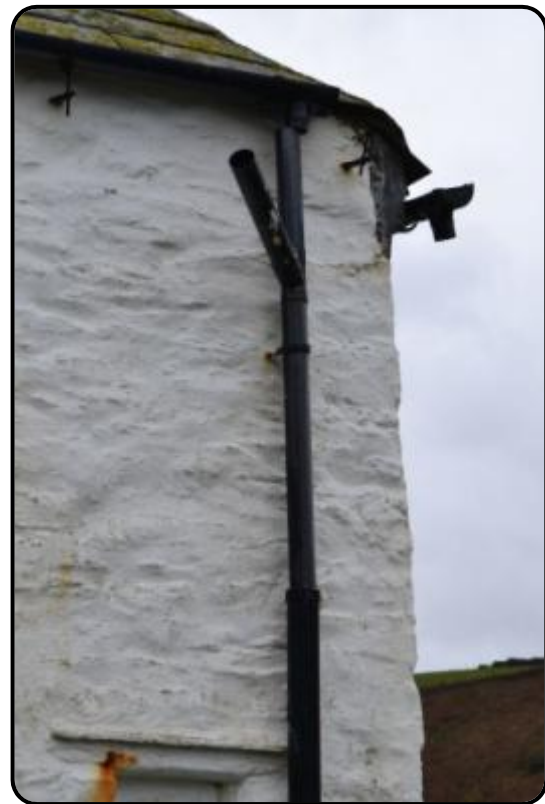
Figure 19 Disconnected downpipe.

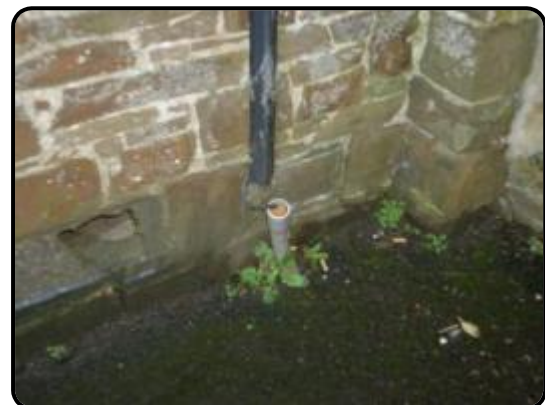
Figure 21 Inadequate downpipe and damage.

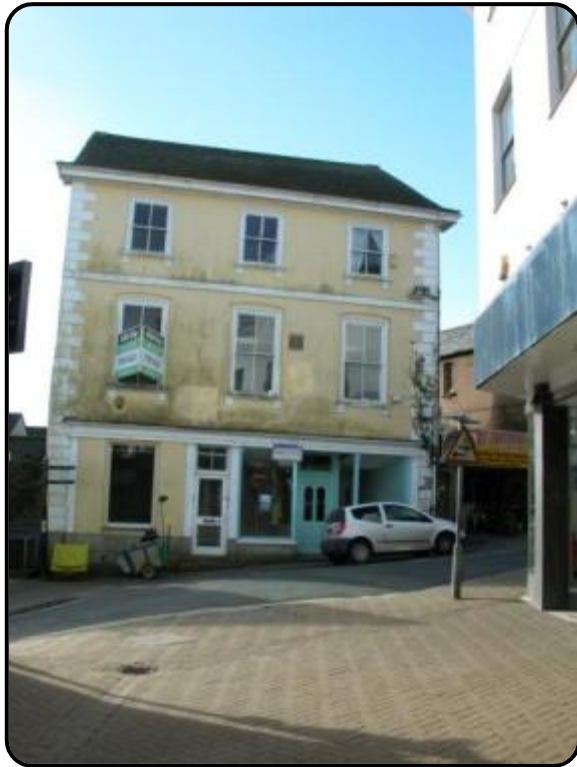
Figure 22 The Great House, Liskeard - announced as one of Mary Portas' pilot towns for her regeneration scheme in 2012.

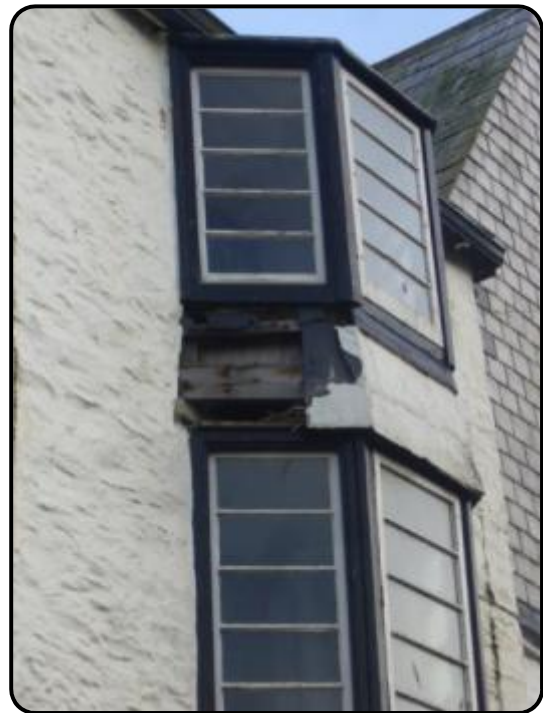
Figure 23 Damage to bay window (missing render-washed slate), with exposure of internal timber structure.

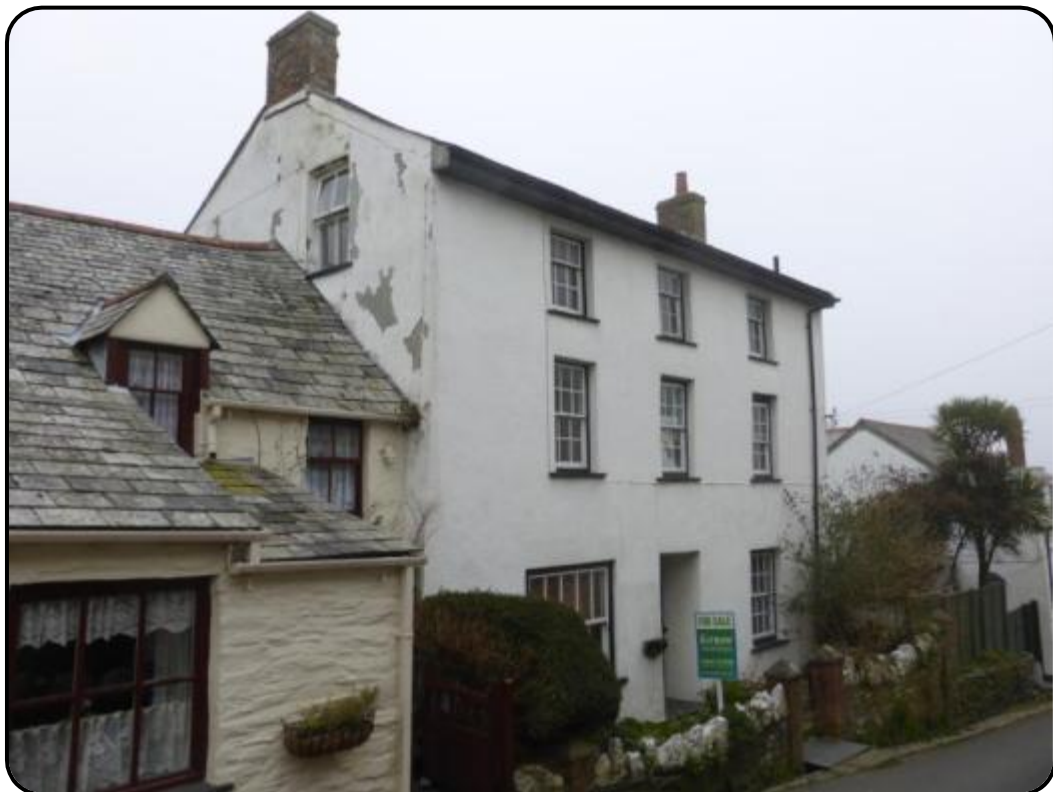
Figure 24 Lack of full occupancy can result in larger properties in particular falling into disrepair.

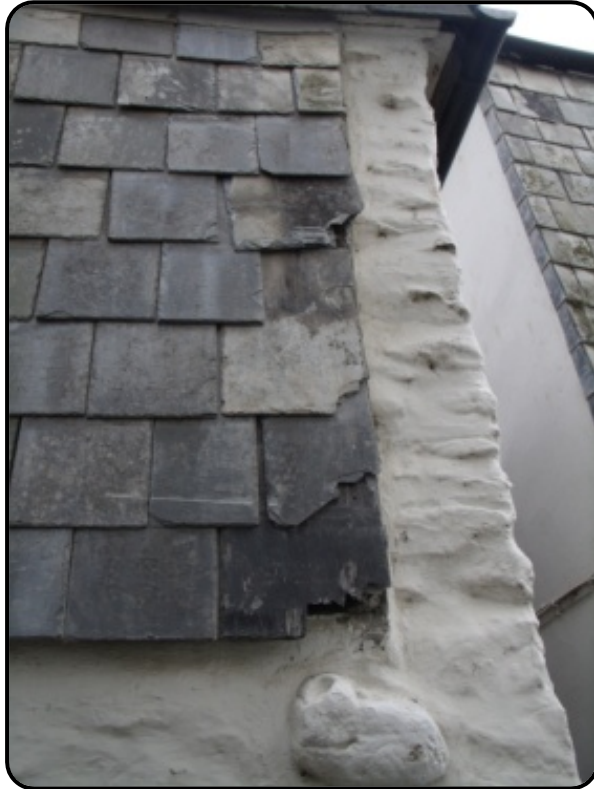
*Figure 25 Damage to hung slate, reportedly caused by vehicular traffic.*

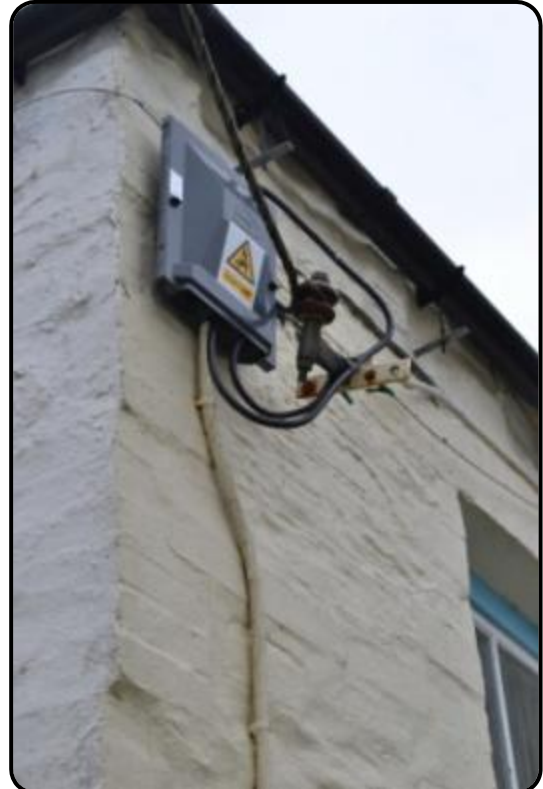
*Figure 26 Wiring to building exterior with rusted bracket and insulator hanging free.*

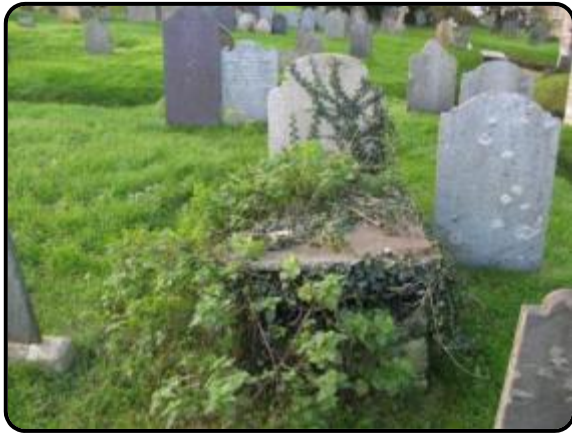
*Figure 27 Overgrown chest tomb (unidentified), Church of St. Michael, Landrake.*

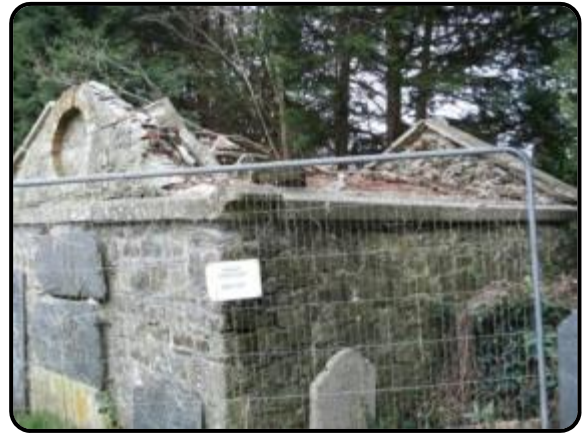
*Figure 28 Collapsed roof of family funerary vault, St. Stephens, Saltash.*

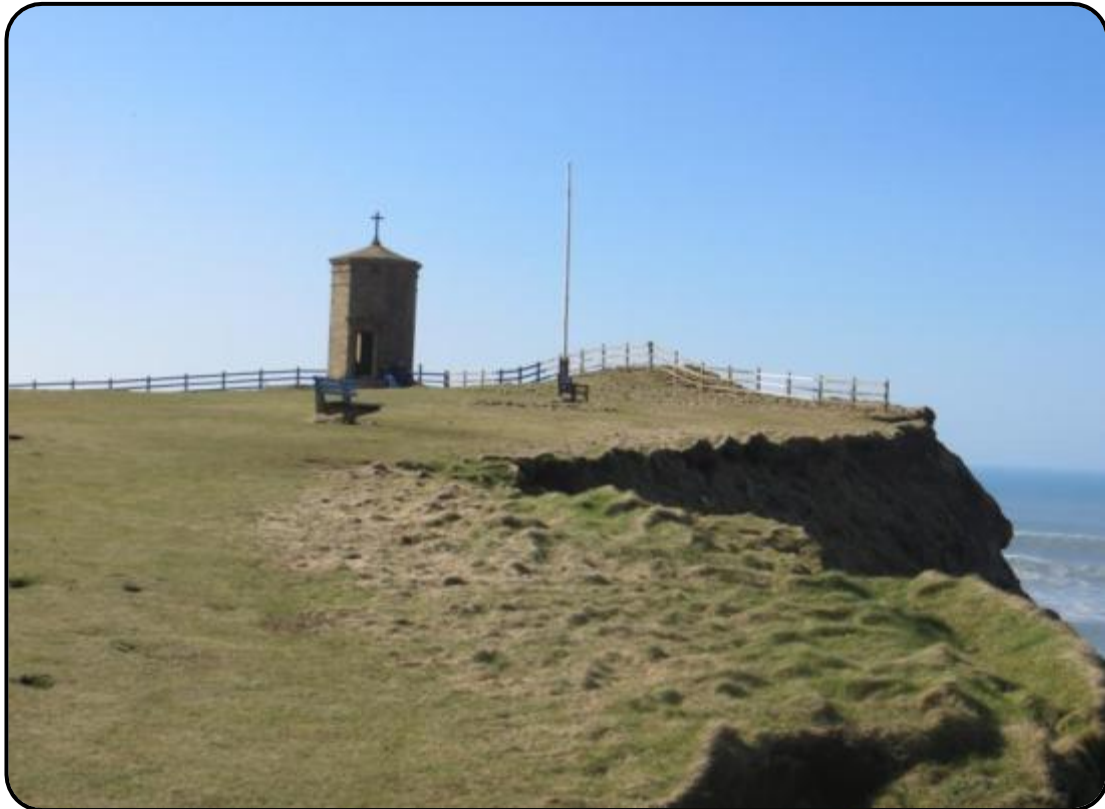
Figure 29 The Storm Tower, Bude.

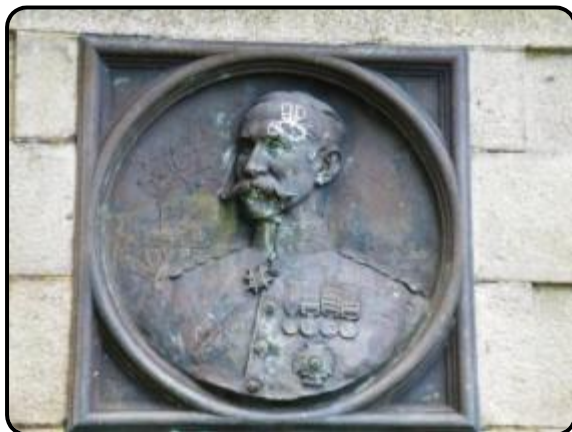
Figure 30 Graffiti to the memorial bronze relief, Victoria Gardens, Saltash.

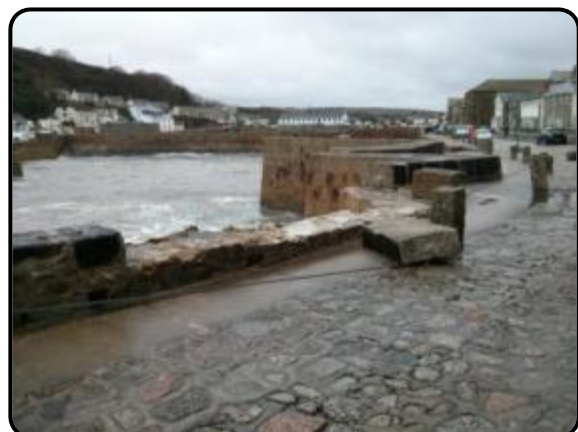
Figure 31 Damage to the historic harbour wall following the recent storms, Porthleven (Image: Peter Smith 2014)

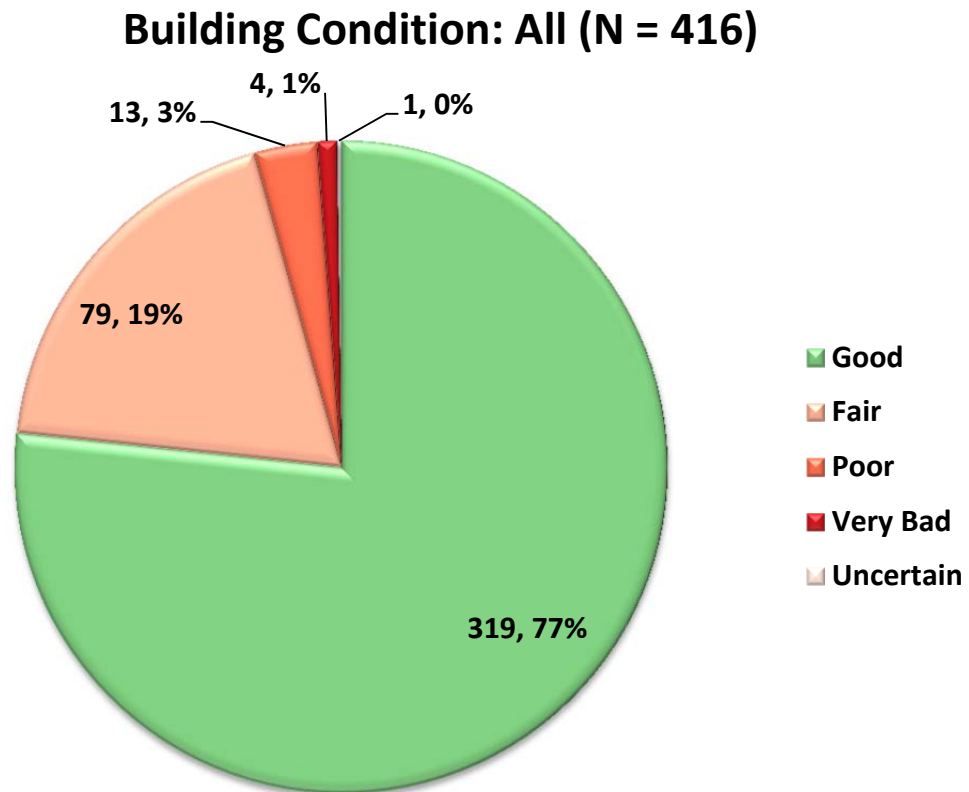
Figure 32 Listed building condition data for updated building records on the Cornwall HER (as of 08/08/2014).

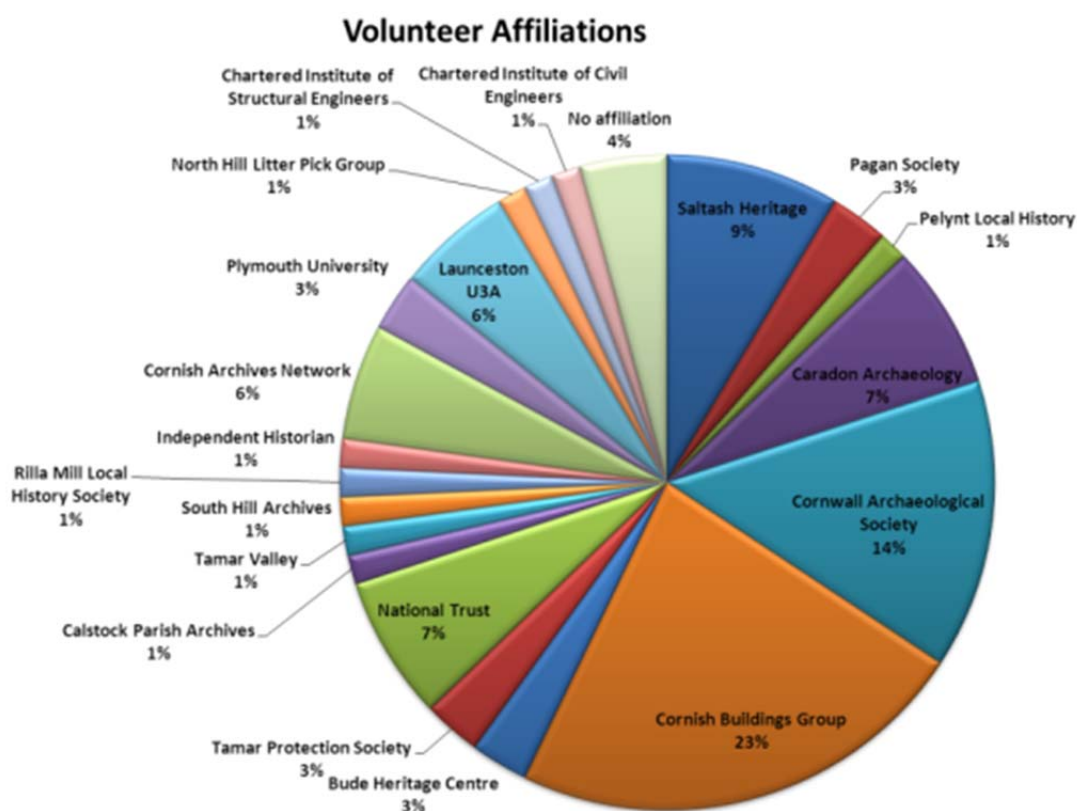
Figure 33 Affiliations of volunteers contributing to the Listed Buildings Condition Survey project, Cornwall.

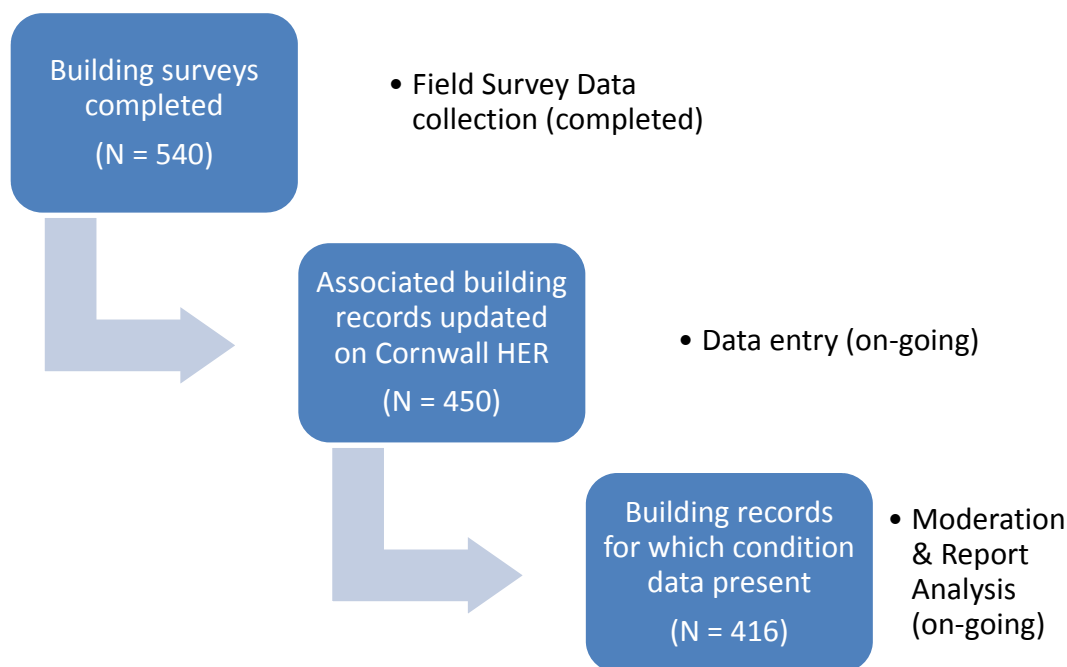
Figure 34 Flow diagram describing results for the different phases of data collection and processing during the Listed Building Condition Survey in North and South East Cornwall.

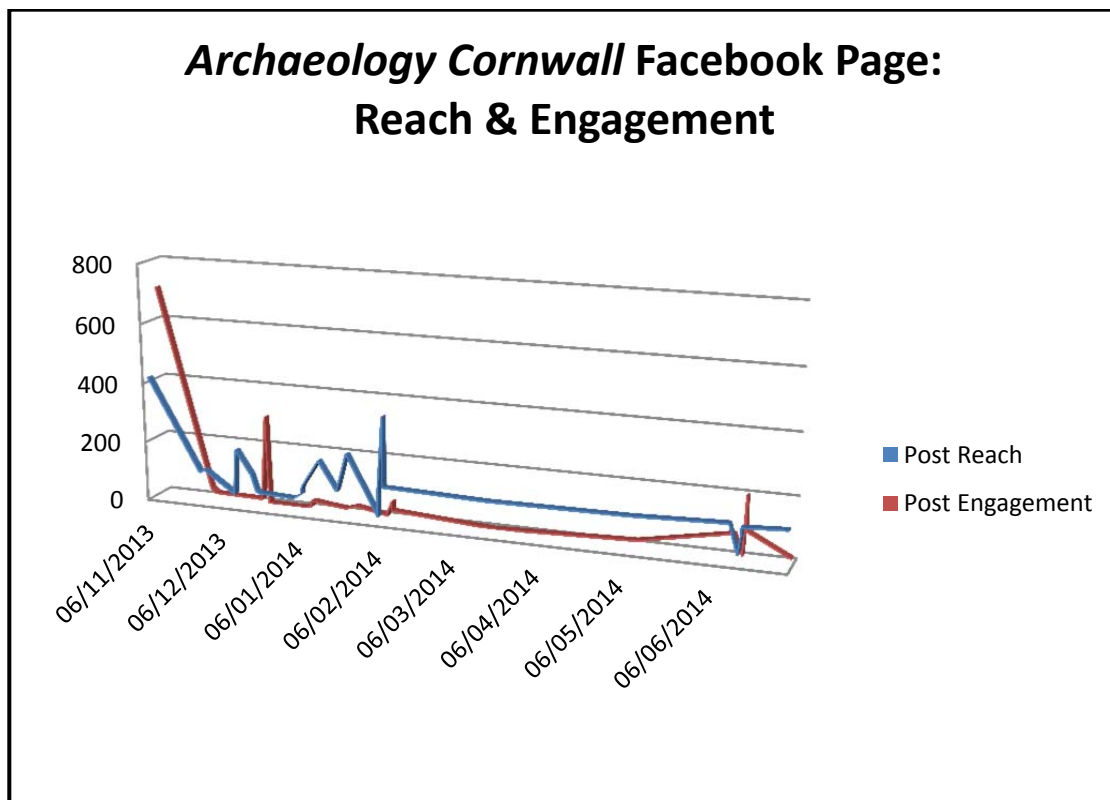
Figure 35 Graph demonstrating outreach and engagement of Archaeology Cornwall Facebook community page posts relating to the Listed Buildings Condition Survey project.

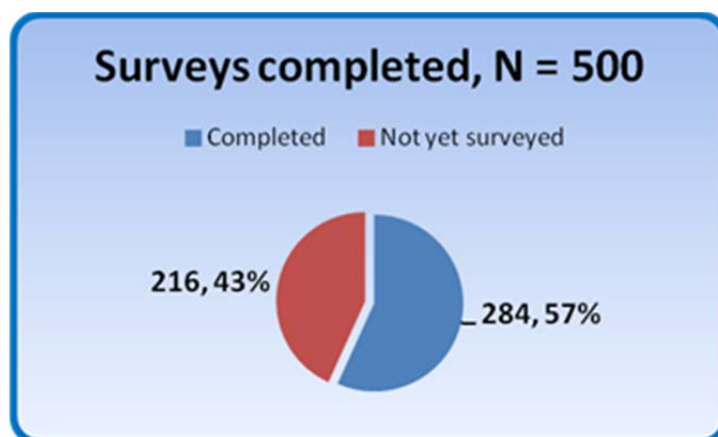
Figure 1: Overall progress of the Grade II Listed Buildings Condition Survey for north and south east Cornwall, 2013-2014

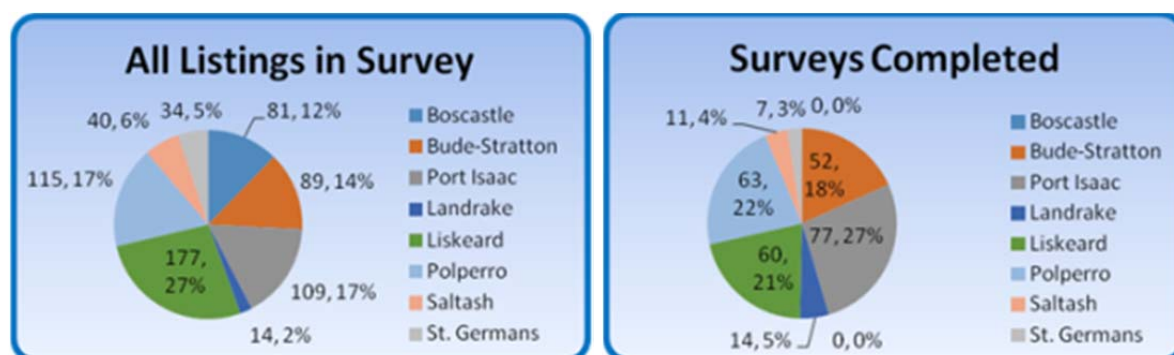
Left: Figure 2 - Pie chart showing the numbers (& percentages of the total) of buildings included in the survey in each geographic area. Right: Figure 3 - Pie chart showing the numbers of surveys completed (& percentages of the total surveyed) in each geographic area.

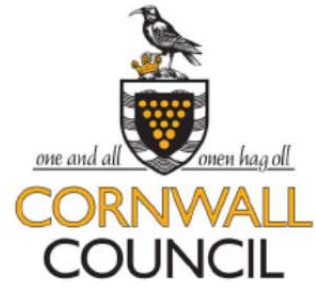
# Cornwall Listed Buildings at Risk Project

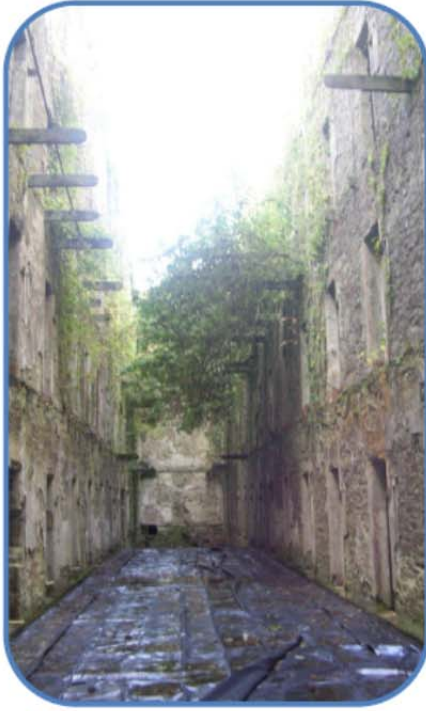
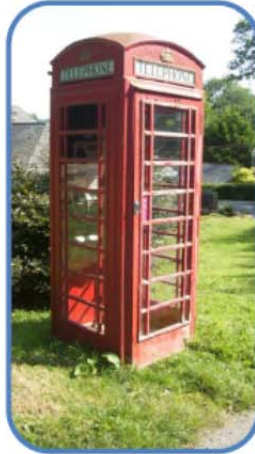
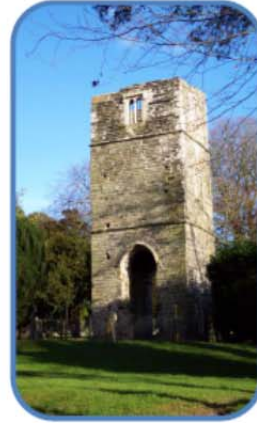
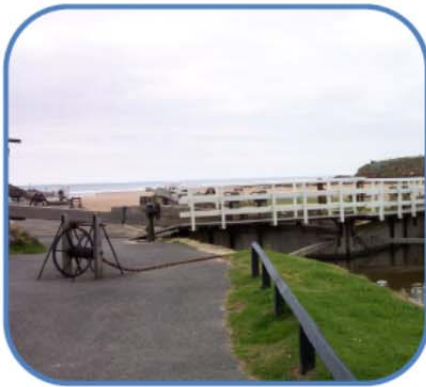
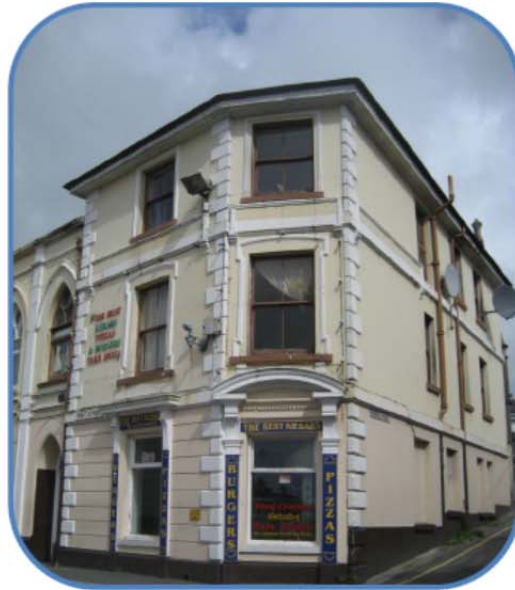
### Examples of the range of issues affecting the condition of listed buildings

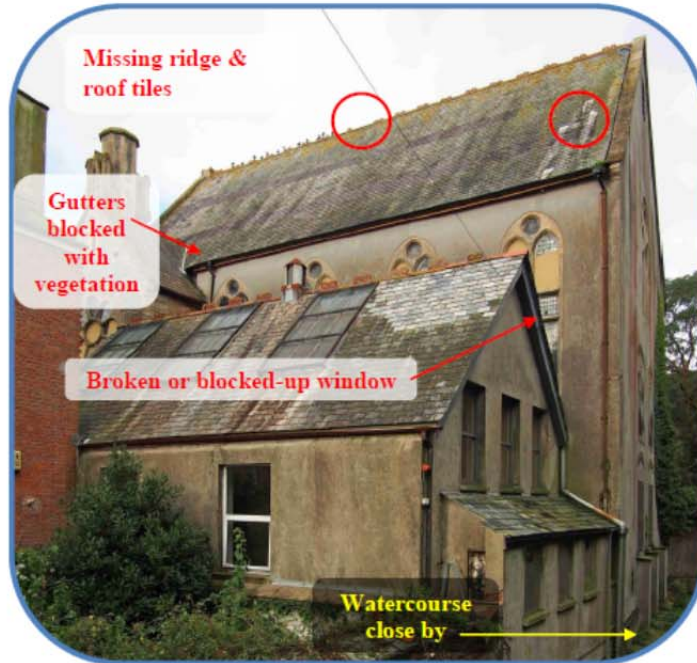
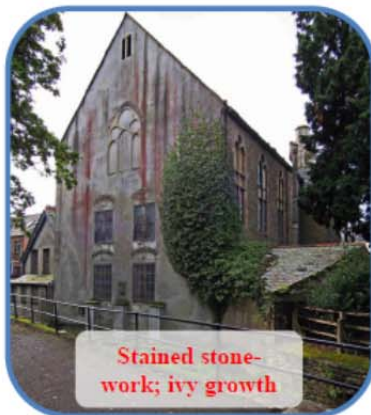
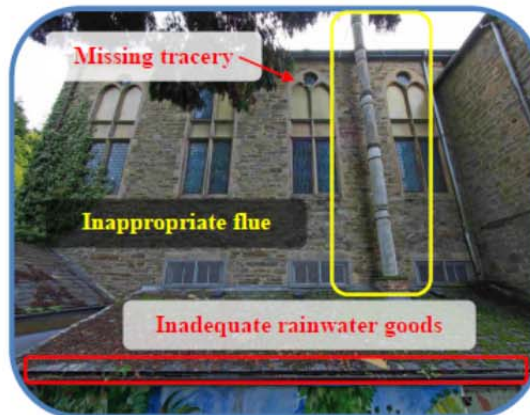
## Technical Guidance

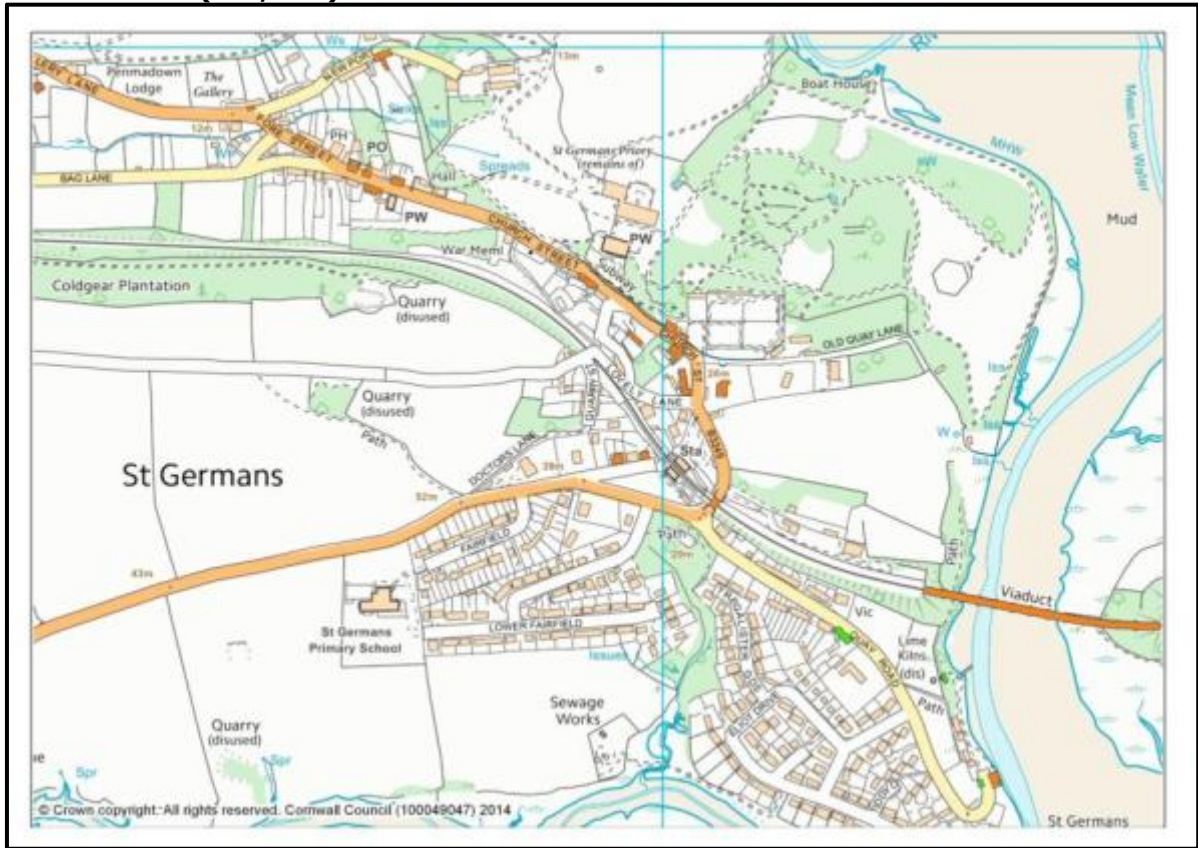
Comparative condition data for those buildings for which records have been updated on the Cornwall HER as of 8<sup>th</sup> August 2014.

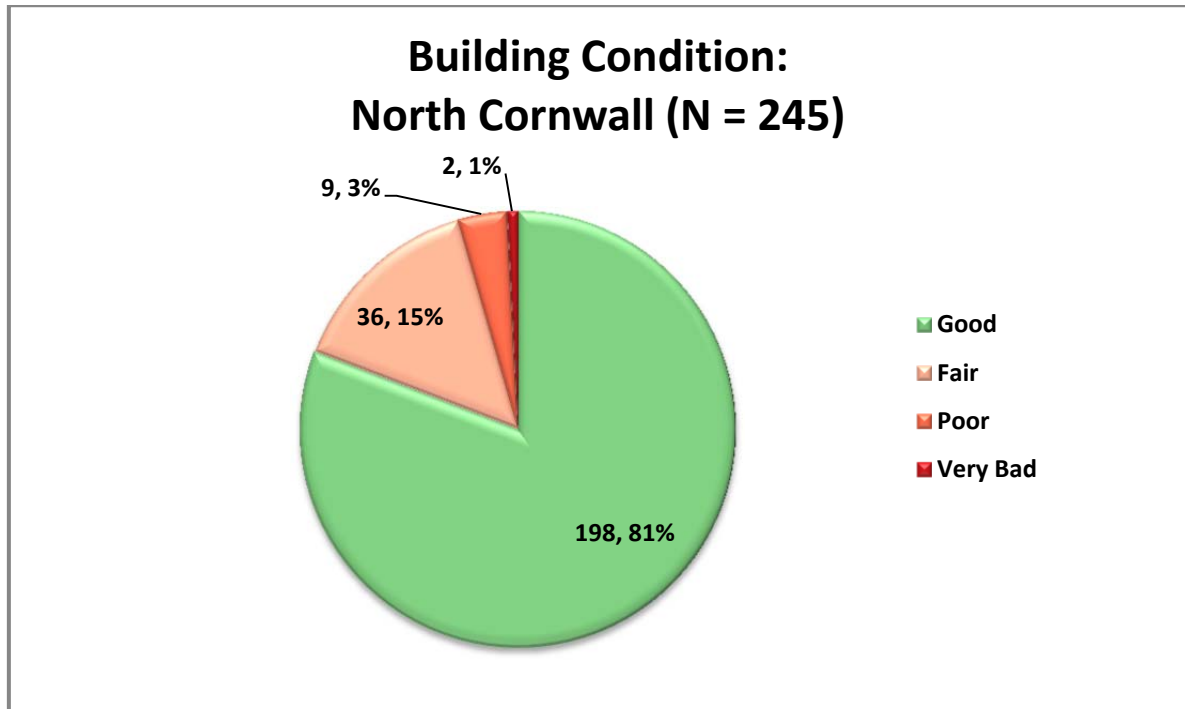
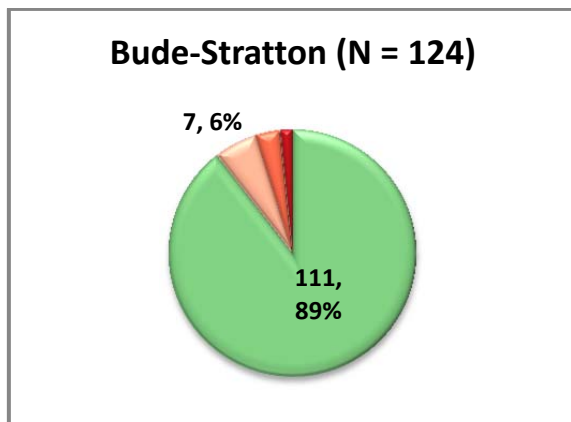
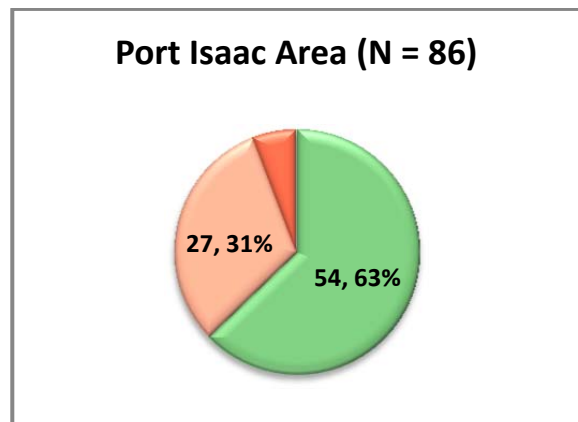
Building condition: South East Cornwall

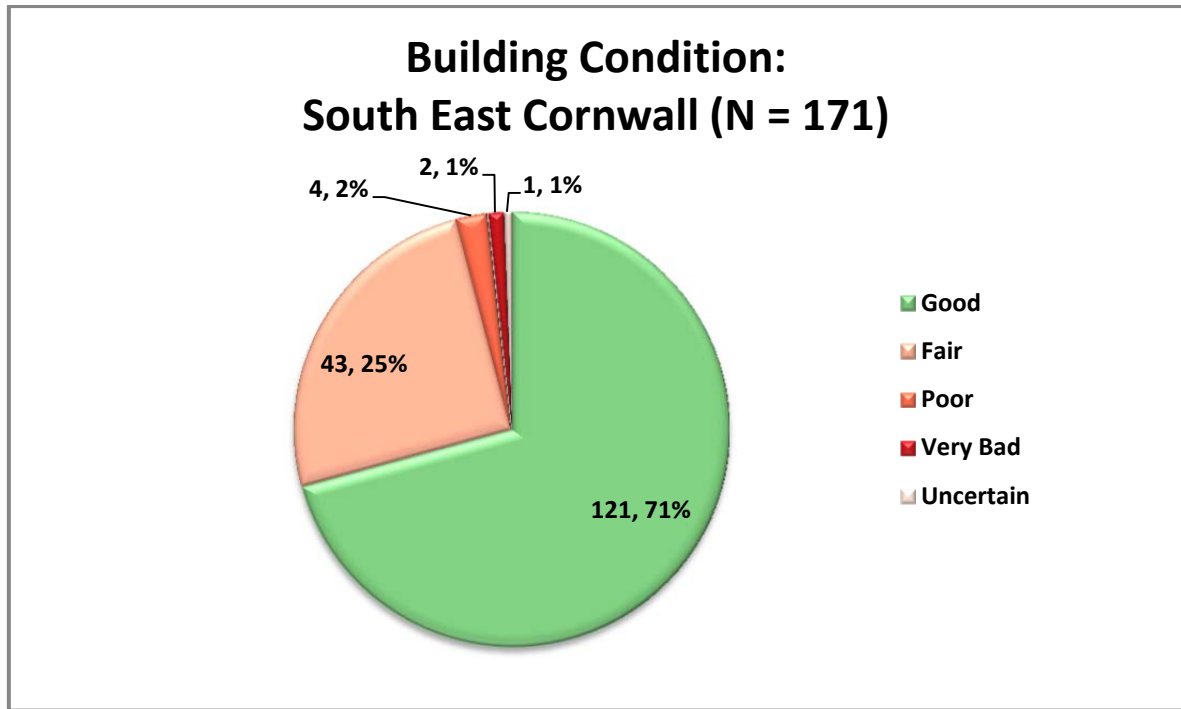
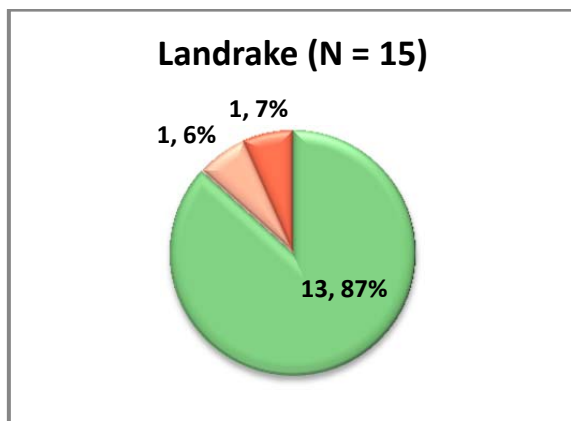
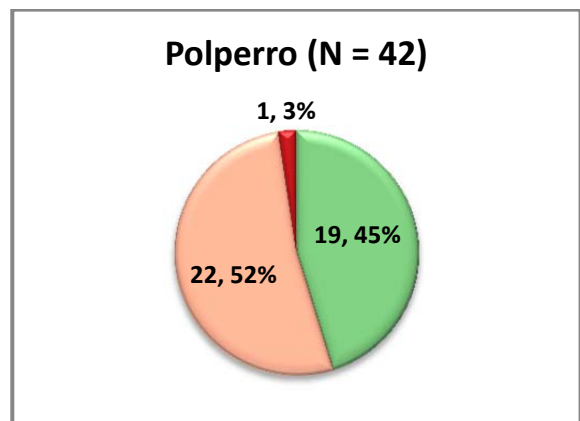
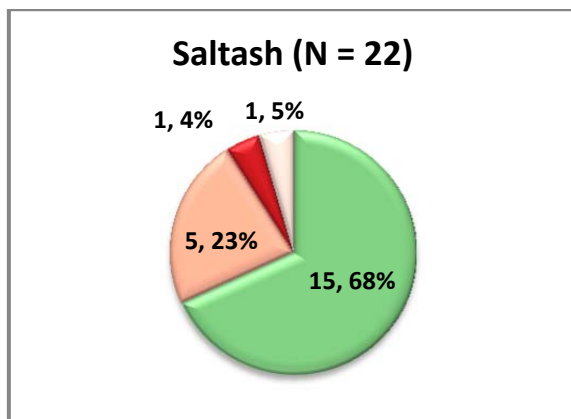
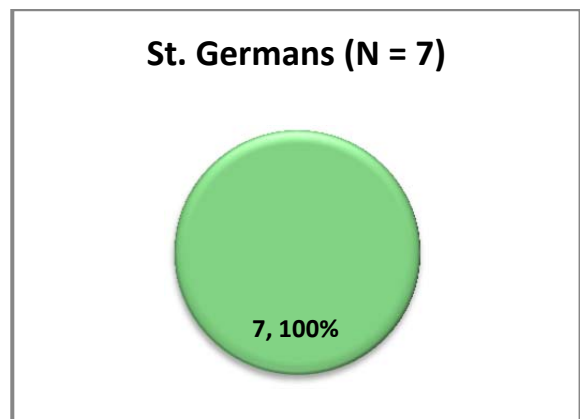
## Appendix 5: Examples of Grade II Listed Buildings surveyed
