# Heritage at Risk: Grade II Listed Buildings Condition Survey, North & South East Cornwall

## Contractor's Report

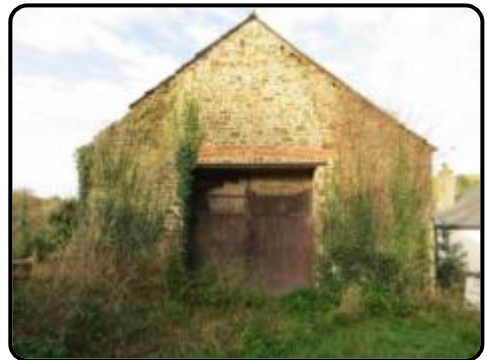
Former mid 19th century iron foundry, Marhamchurch.

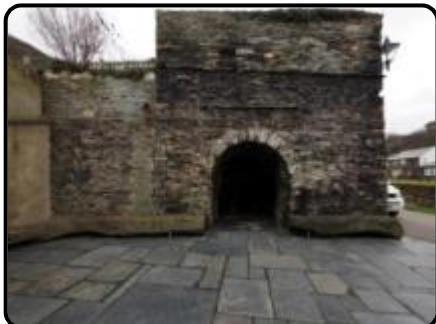
Lime kiln, Boscastle.
