Tregada House, Lawhitton Rural, Cornwall
Heritage Statement and Impact Assessment
Cornwall Archaeological Unit

Report No: 2017R004

Heritage Statement and Impact Assessment

Client	Vince Welch on behalf of Mr. T Lovett
Report Number	2017R004
Date	17 January 2017
Status	Final
Report authors	Eric Berry and Adam Sharpe
Checked by	Adam Sharpe
Approved by	Dr Andy Jones

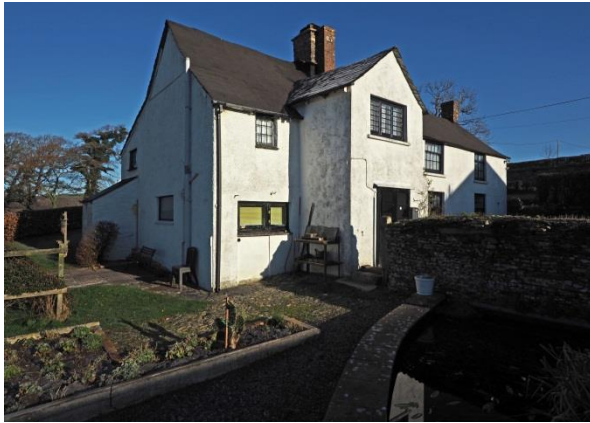
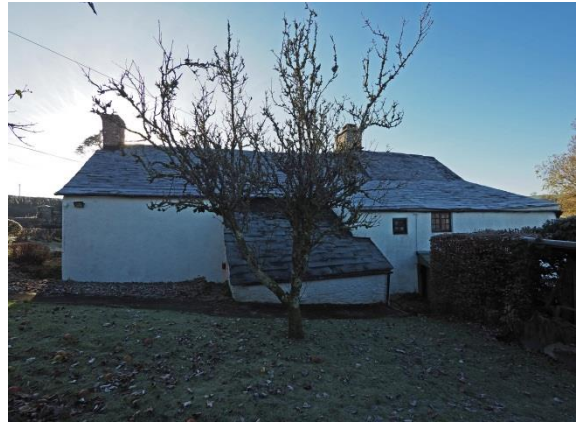
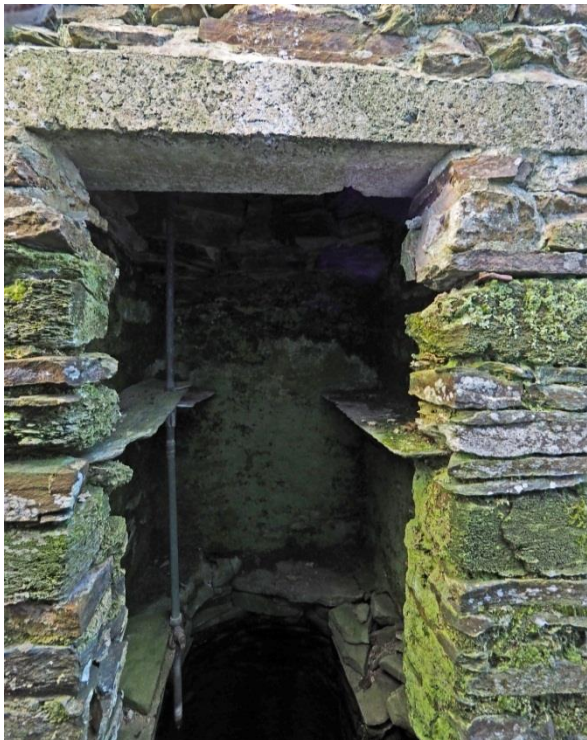
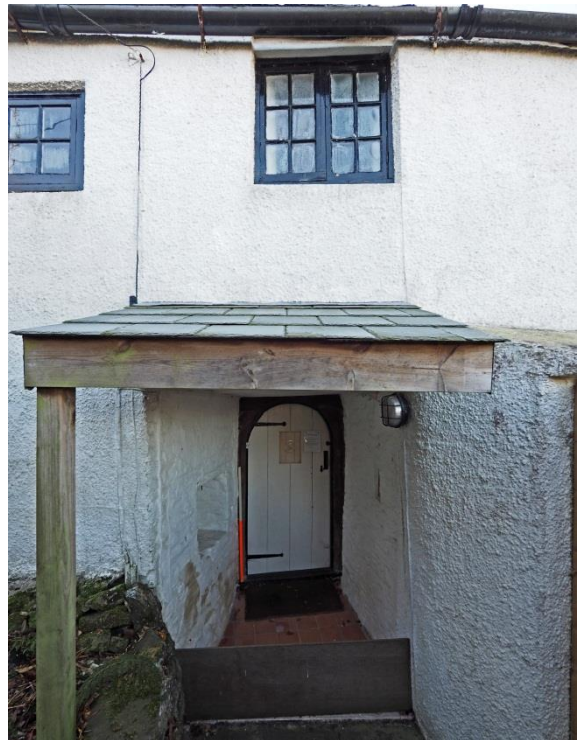
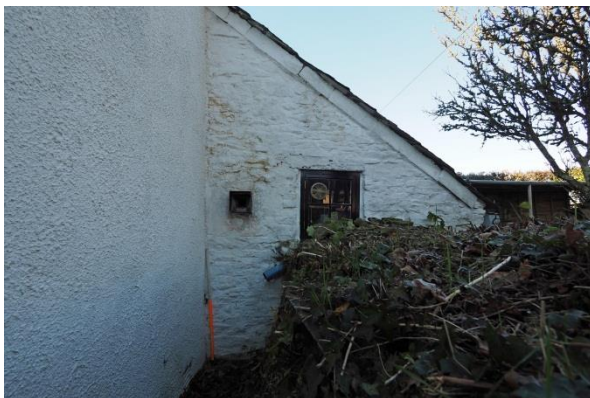
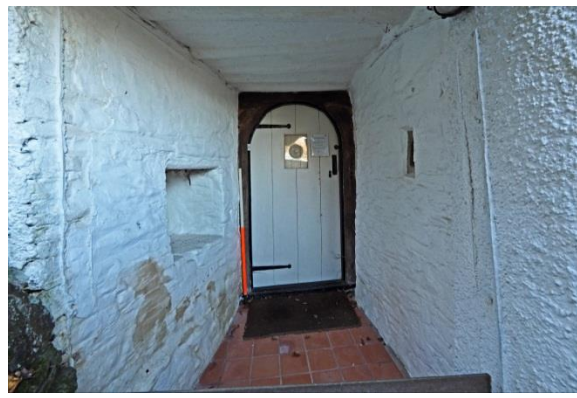
South (front) elevation is a 4-window range. A 17th century 2-storey porch fronts the original through passage towards the left. The porch doorway has modern glazed doors. A wide 3-light mullioned window with 12-pane casements above the doorway is probably a late 20th century replacement of a possible former original window. At

ground-floor level the right-hand (east) side wall of the porch is thicker to the right. This may be the result of some remodelling following the removal of a former probable lateral stack. This alteration blocks a squint window opening in this wall. Fronting the lower end to the left (west) of the porch is a wide modern window in a widened former doorway opening. Above this is a 9-pane casement window. At about 2.5 metres right (east) of the porch lighting the hall is a 19th century 20-pane sash window. Above this is a 15-pane sash (with high meeting rail) of similar date. Towards the right (east), lighting the parlour is another 20-pane sash. Above this is a 20th century cross window with 4 over 4-pane lights.

North (rear) elevation has no windows to the parlour end on the left (east). Central to the rear elevation is a pantry lean-to. This is built into the higher ground adjoining to the north and there are no windows to the north elevation. There is a 4-pane light to each of the return elevations of the pantry.

Right (west) of the pantry there is a low 2-storey projection with its roof joining at a lower pitch the main roof part way up the main rear roof slope. This projection contains an original winder stair drum to the left (east). This originally gave access to the hall chamber but now contains the only stairs. This stair turret has a small window opening with a 4-pane light. The left-hand (east) return wall contains an original pointed (triangular) arched slit window made from a single piece of oak, now only visible within the stair turret and within the pantry, proving that the pantry is a later addition. Right (west) of the hall stair turret at first-floor level is 12-pane casement window. This now lights a bathroom but this part of the north wall was added in the 17th century between the hall stair turret and what was probably originally a further stair turret to the right (west) that originally gave access to the lower end chamber. This turret was extended to the right (west) probably in the 17th century to create a pantry. Set back between the stair turrets there is an original 16th century round-arched oak doorway. Within this recessed area there is a small window opening to each of the stair turrets. The west wall of the hall turret has an enlarged opening, presumably created as hatch access to the under-stair area probably used as fuel storage. The east wall of the other (former) stair turret has a very rare original pointed (triangular) arched slit window made from a single piece of oak like the one to the east wall of the hall stair turret. This feature, plus a doorway similar to the rear doorway set at an angle within the rear end of the through passage and the survival of a 17th century timber-framed partition in the former location of the upper doorway of the stairs, is strong evidence for a second winder stairs in this location. Right (west) of the first-floor window the walling projects slightly and there is an angled weathering between the floor levels. This anomaly is evidence for remodelling and heightening and further supports the interpretation that proposes the former existence of this projection as a winder stair turret similar to the hall turret. There is a small window at ground-floor level.

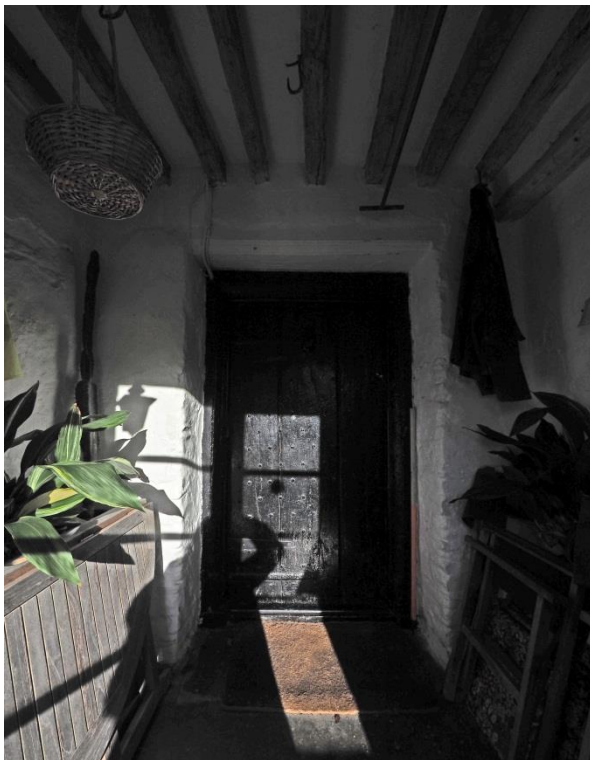
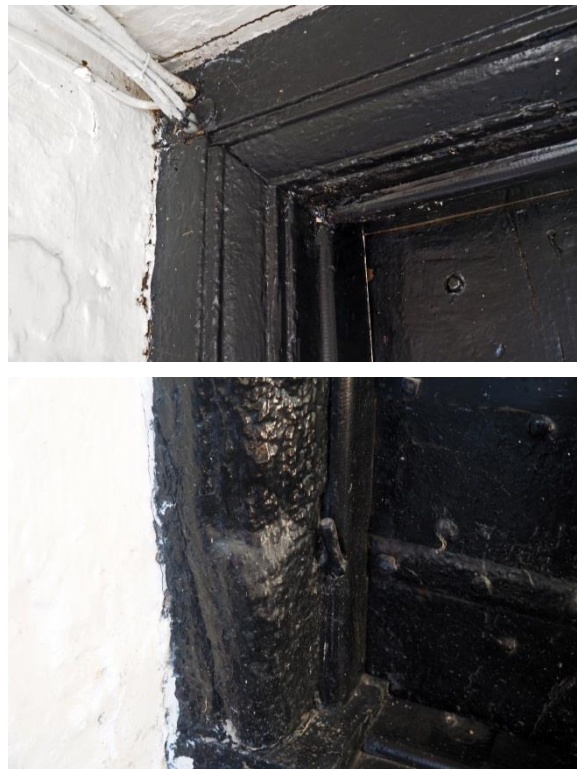
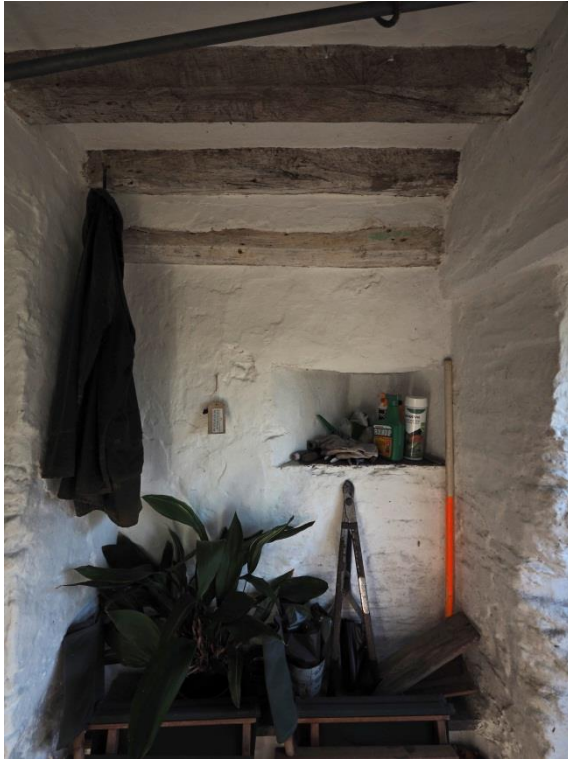
Front porch (Figs 16-18):

- Original early C17 ceiling joists.
- Original squint window opening to east wall, blocked since the wall was thickened externally.
- Rare early C17 moulded and stopped oak doorframe with original double-planked studded door.
- Slate flag floor.

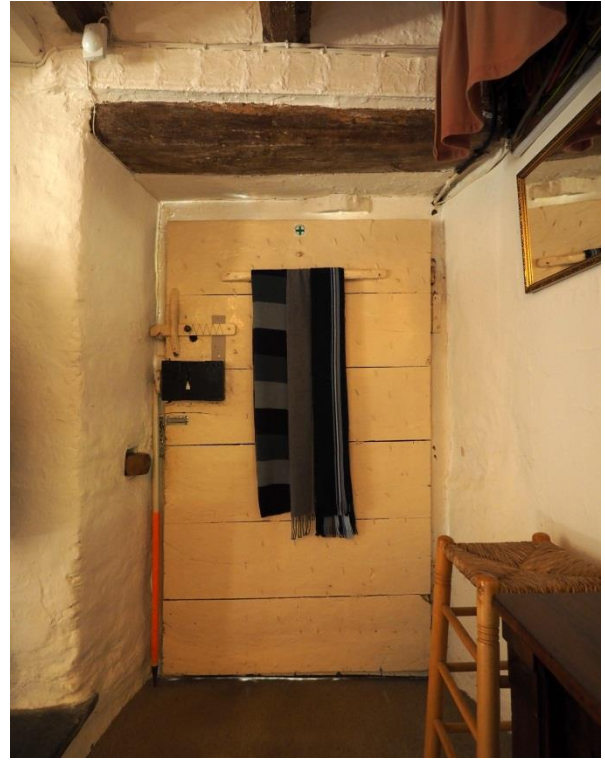
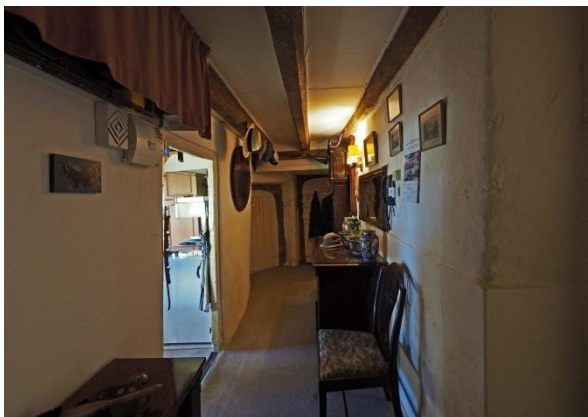
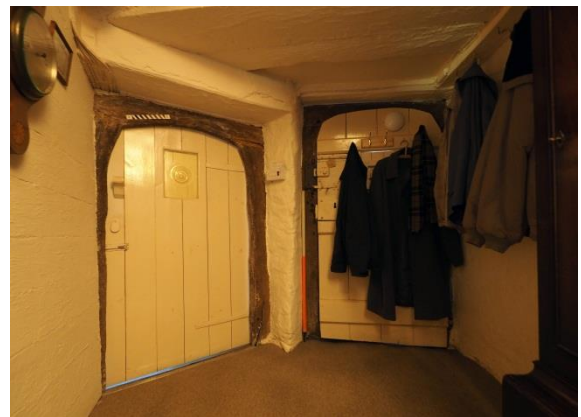
Through passage (Figs 19-21):

- Rear side of front door with horizontal planks and clenched nails of studs.
- Old oak lintel above doorway.
- Very rare draw-bar slot to left (east) of doorway, fitted with modern oak bar.
- Plain probable C17 oak ceiling joists to main front part of passage.
- Rare original C16 round-arched oak doorway to rear of passage.
- Similar rare original C16 round-arched oak doorway set at an angle left (west) of the rear doorway, this doorway the probable original access to a winder stair turret serving the lower end bed chamber, the turret later enlarged to the west and now used as a bathroom.
- Recessed possible blocked doorway to east side of rear end of passage.
- Boarded wall surface to angled partition between rear of passage and kitchen.

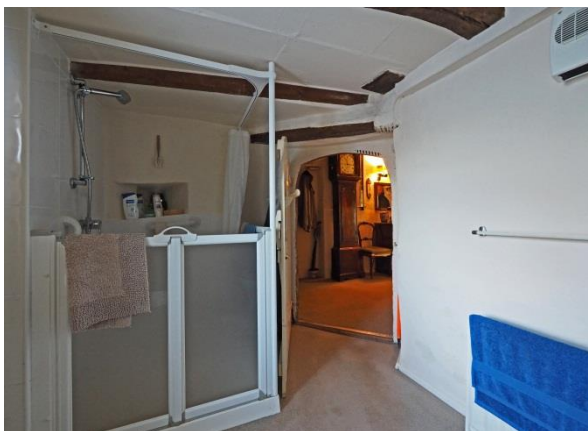
Ground-floor bathroom (Fig 22):

- C17 ceiling joists with angled anomalous spacing at east end.
- Rear side of original C16 doorway from passage.

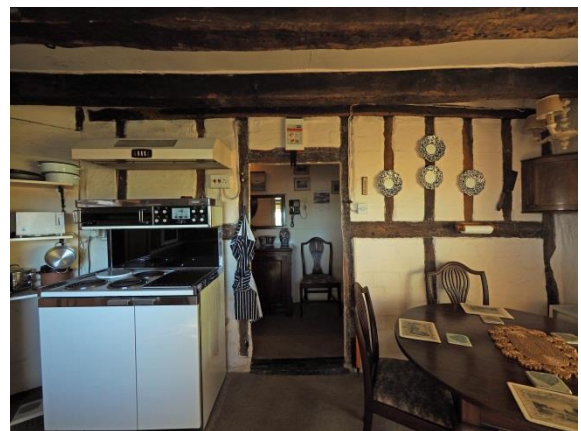
Lower end room (kitchen) (Fig 23):

- Probable C17 rough-hewn ceiling joists with nail evidence for former plaster ceiling.
- Probable C17 brick-nogged oak-frame partition to east side against passage.
- Doorway within oak-frame partition with over-panel.

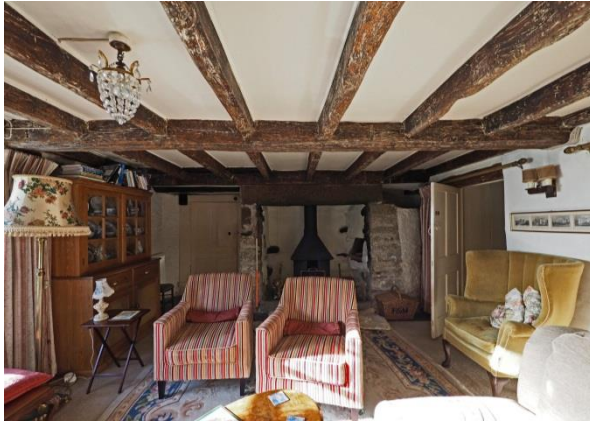
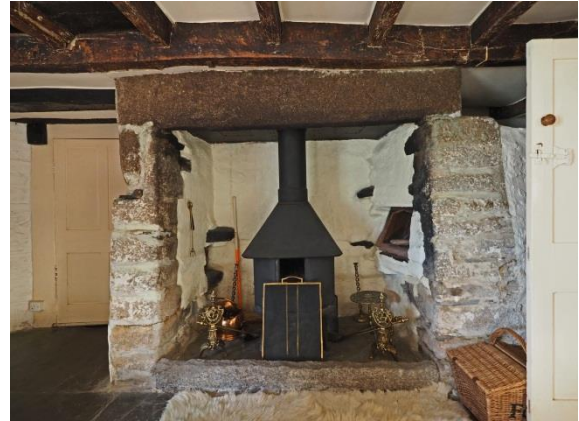
Hall (main living room) (Figs 24-26):

- Probable original C16 oak beam and joist ceiling with chamfered and stopped central cross beam plus plain joists with nail evidence of former plastered ceiling between beams.

- C17 granite fireplace with rare original chamfered corbel over probable original chamfered jamb with added stonework to left-hand (south) side plus original chamfered lintel.

- C17 cross beam over fireplace.
- Small keeping place to left-hand side of fireplace.
- C18 oven added behind rebuilt jamb to right-hand side of fireplace.

- C18 rounded walling enclosing over to right of fireplace.
- Blocked probable lateral fireplace opening spanned by oak lintel to south wall towards the right-hand (west) end.

- Late C18 oak stud partition to east side of hall.
- Late C18 2-panel door to left-hand (north) side of east wall (to parlour).
- Stair doorway fitted with C19 4-panel door to left-hand (west) side of rear (north) wall.

- C19 pantry doorway with C19 4-panel door central to rear wall.
- Storage area under stairs to north west corner of hall.
- Probable C18 or C19 trimmer to left of fireplace, as support to later inserted hall chamber fireplace.

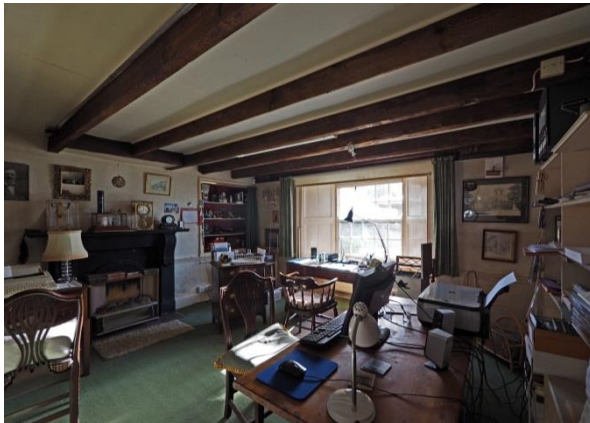
Parlour (east of hall) (Fig 26):

- Late C18 2-panel door from hall.
- Late C18 ceiling with plain joists.
- C19 chimneypiece (within presumed C18 opening) with shelf supported on large consoles central to east end of room.
