Exton Park, Rutland Lidar analysis and archaeological survey

ArcHeritage 2017

# Archaeological Survey and Lidar Analysis

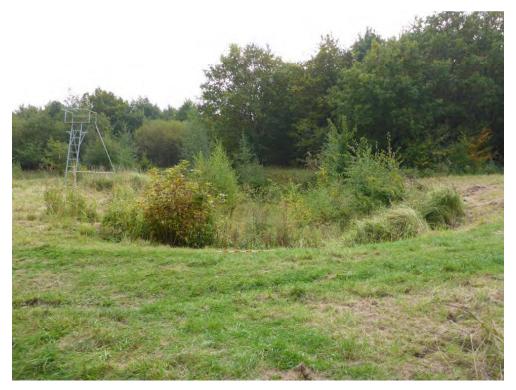
Plate 6: Drainage sump/depression 223 crossing a ride in Tunneley Wood

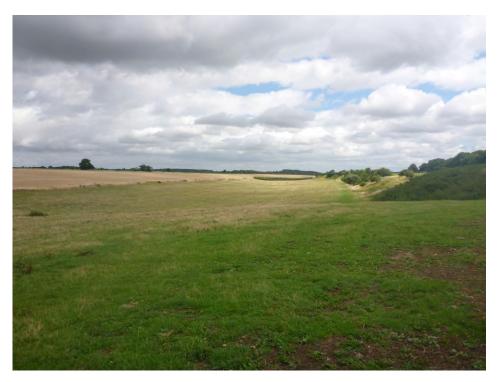
Plate 7: Infilled former ironstone quarry 241, viewed facing east

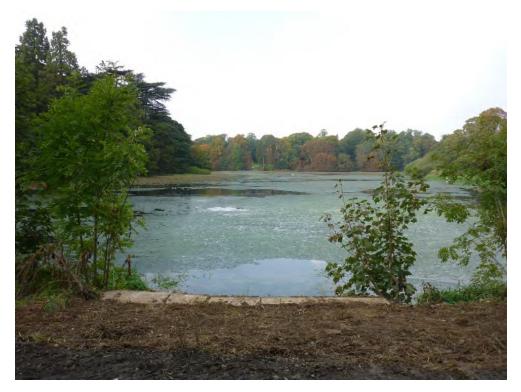
The two ponds or lakes at the eastern side of the park are in varying condition. The Lower Lake is in a good condition, with full water level and a similar extent to that depicted on historic mapping. A modern concrete sill was seen at the southern end in the area of the sluice marked on historic mapping (asset 277). Fort Henry Lake (asset 228) has shrunk considerably since the late 19<sup>th</sup> century, with the water appearing very low and mudflats at the verges. The northeast arm, shown as part of the lake in the 19<sup>th</sup> century (though vegetated in the later decades) is now a narrow brook surrounded by dense vegetation. It is possible that the silting is at least partly deliberate to create habitat for water birds. There is a substantial earthwork dam at the south end of the lake, carrying a track, with an overflow and feeder channel culverted through the bank. The Parks and Gardens Register mentions part of an arch and a cascade in this area, though these were not seen during the survey, possibly due to dense vegetation in the area south of the track. A stone sill was seen in the area of the sluice marked on historic mapping (asset 273).

Plate 10: View north across Fort Henry Lake, with stone sill 273 in foreground

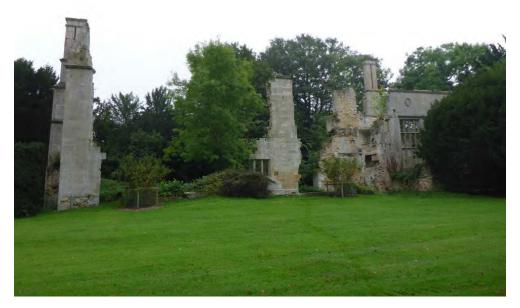
Plate 11: Exton Old Hall ruins (asset 1), viewed facing northeast

Two ruins have been recorded in the survey area, and one in the buffer. The structures are both within the inner park, and comprise the ruins of Exton Old Hall (asset 1), and a nearby stone staircase leading down into a subterranean chamber set into an apparently natural scarp (asset 303). The ruins of the 16<sup>th</sup>- to 17<sup>th</sup>-century Old Hall are quite substantial, and include external walls standing to full height in places, with tall chimneys and large mullioned windows in the south wall. There are a number of fireplaces on the internal sides of the walls, with evidence for different phases, including blocked-in former openings and fireplaces. A hollow in the area of the cross-passage between the kitchen area and the great hall may indicate a partially collapsed cellar or undercroft, and a partially-infilled arched-roof cellar is exposed to the north of the standing walls. The Old Hall is largely screened from the current hall by trees, and the roots of these, and other creeping vegetation, may threaten the surviving walls and cellars. The ruins are listed in Historic England's Heritage at Risk Register as priority category C: in a state of steady decay with no solution agreed. It notes that parts of the ruins are well preserved, though the west gable is vulnerable with cracks, open joints and unsupported masonry (Historic England 2016).

Detailed buildings survey of the ruins of Exton Old Hall would assist in understanding the phasing, layout and character of the building. This could also advise on conservation measures to prevent further decay of the structure and to improve the safety of the site. Further documentary research, including historic images and maps, would also provide more information on the building.

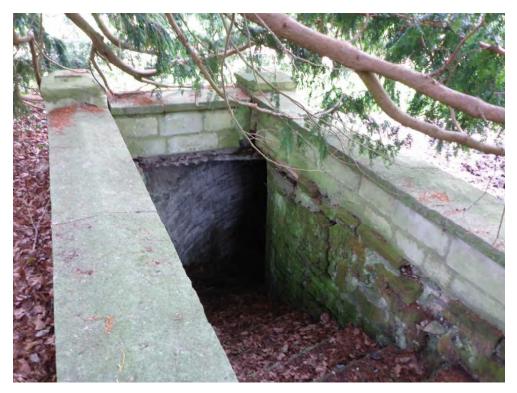
The stone staircase (asset 303) is located c.30m to the north of the Old Hall, and at the top of a north-facing slope. The feature comprises stone steps with a stone parapet wall at the top, the steps leading down to the northeast and curving round to the entrance of a subterranean chamber. The chamber was not accessed due to health and safety concerns. The staircase is

obscured by a large, mature yew tree, the roots of which may potentially threaten any underground features. The purpose and date of the structure is uncertain. The steps are shown on the 1885 OS map, and are roughly in the location of buildings shown north of the Old Hall on the  $18^{th}$ -century to 1826 maps, so could be the remains of an associated underground chamber.

Plate 12: Stone staircase 303, viewed facing northeast

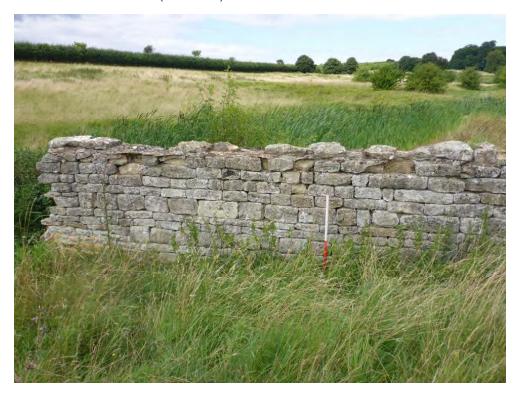
Plate 14: Ruined park boundary wall 292 south of Horn DMV, viewed facing north

Two surviving stone walls form part of the park boundary, one to the southeast of the inner park, the other to the south of Horn DMV. The former is grade II listed, the latter in a relatively poor condition with collapsed stretches. These walls are considered to be of regional importance and considerable significance.

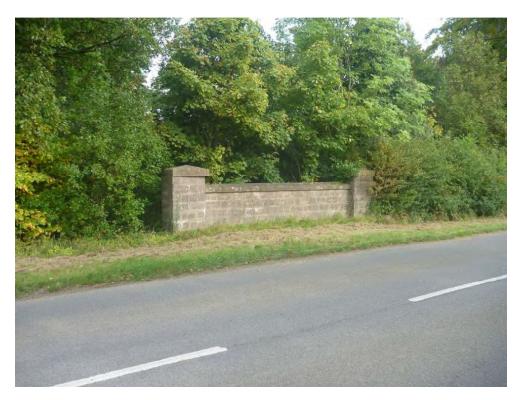
Plate 17: 1950s road bridge 305 over former mineral railway cutting

A road bridge on Cottesmore Road, in the northwest part of the buffer (asset 305) is visible as the stone parapets to either side of the road. This has a flat opening for the bridge. Currently, it covers a very slight hollow below the bridge, though this is actually an infilled cutting for the former mineral railway (asset 27). The bridge presumably dates to the 1950s, and is in a good condition. It is one of the few surviving features associated with the mineral railway.
