Trent & Peak
ARCHAEOLOGY

HISTORIC BUILDING ASSESSMENT OF A CRUCK-FRAMED AGRICULTURAL BUILDING AT HOLYWELL FARM, LOUGHBOROUGH, LEICESTERSHIRE

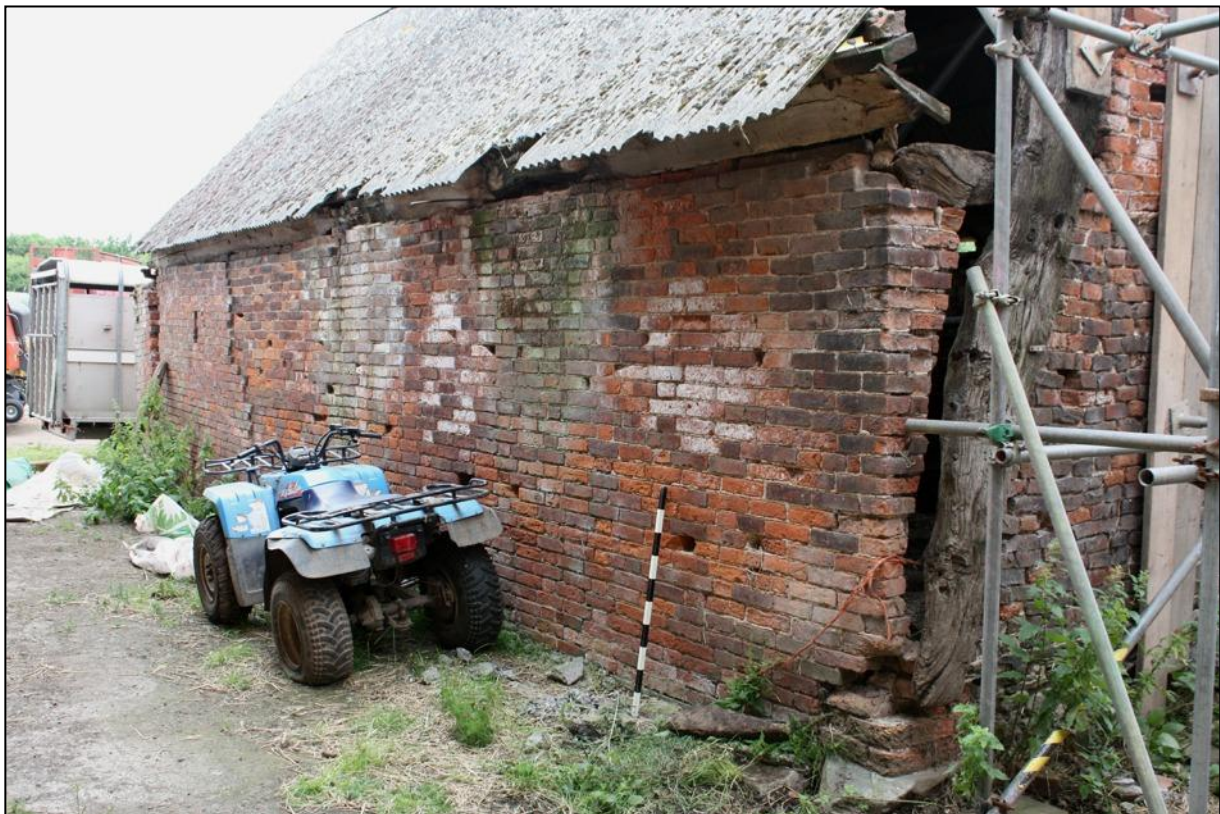
Plate 2: South side of the animal shed at Holywell Farm showing, to left, crack in the walling and, to right, the displaced south blade of the east-end cruck frame. The original wall-plate rests on top of the brick walling.

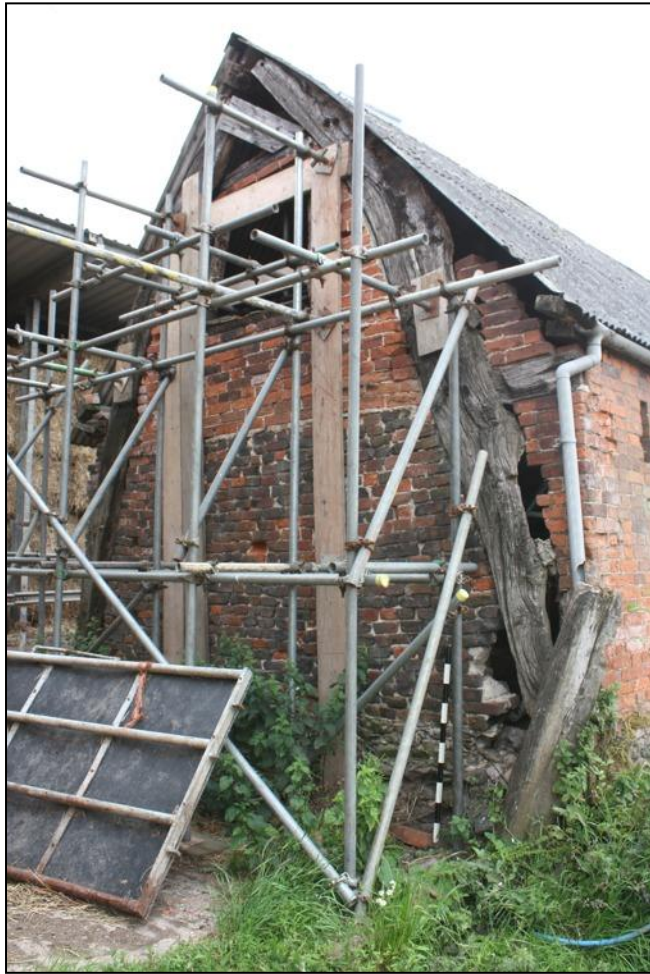
Plate 3: East end cruck frame in the animal shed at Holywell Farm, seen from north-east angle.
