**Midland Metro Centenary Square Extension,
Birmingham City Centre**

**Archaeological monitoring (watching brief) of
Ground Investigation Works**

TPA Report No. 115/2013

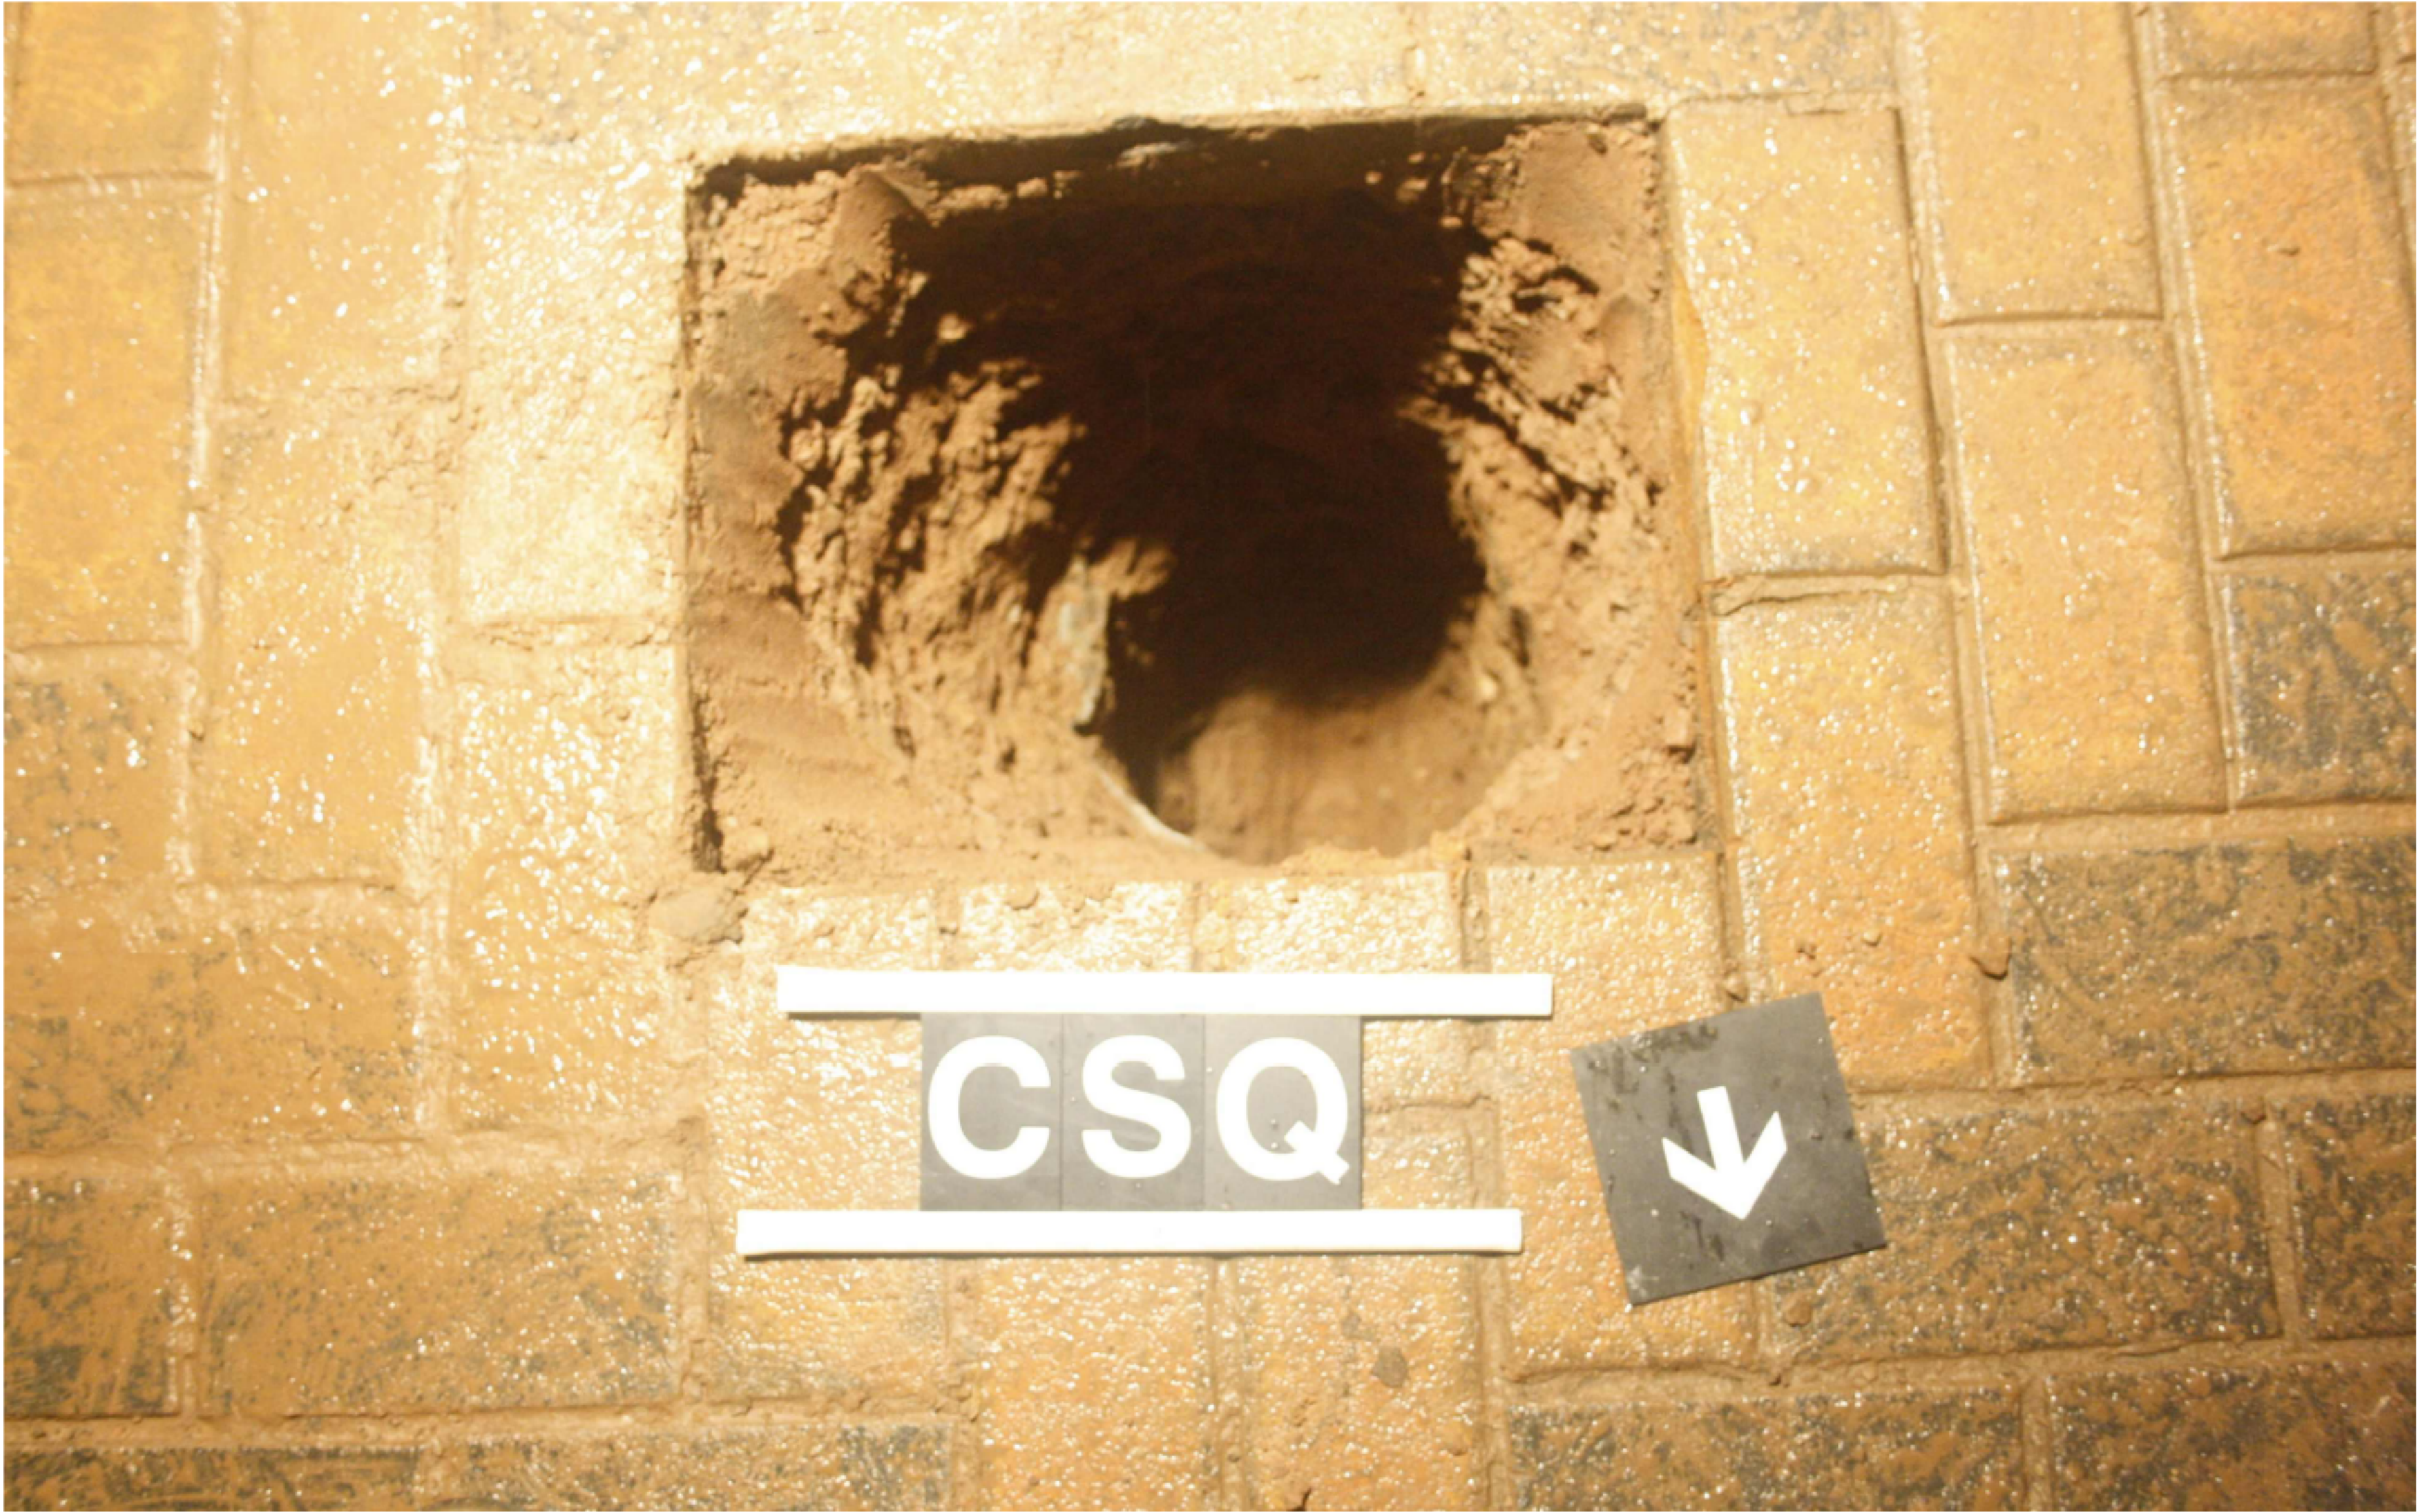
Plate 1: Borehole BH1102

5.2.3 **Borehole BH1102** was located in Centenary Square, removal of the paving (0.1m deep) (0004) and the associated underlying sand bedding (0.04m deep) (0005) revealed a deposit of made ground (0006), comprising a mid-brown sandy silt with brick fragments. Deposit (0006) is probably associated with the construction of Centenary Square and was observed to a depth of 1.2m.

5.2.4 Beyond a depth of 1.2m BGL, data provided by the GI contractors demonstrates that made ground deposits continued to a depth of 3m BGL and comprised at least four deposits of reddish brown gravelly clay and sand. Below these deposits a possible made ground deposit comprising soft reddish brown slightly sandy gravelly clay was observed from 3m to 4.5m BGL. Below this possible made ground two further deposits described as stiff reddish brown sandy clay were observed at 4.5m to 4.7m and 4.7m to 5.15m BGL respectively. The surface of these deposits may represent a theoretical horizon of archaeological potential. From 5.15 m BGL a reddish brown sandstone was observed, with a band of gravelly sand observed at 6.00m to 6.14m BGL. This is the underlying solid geology.

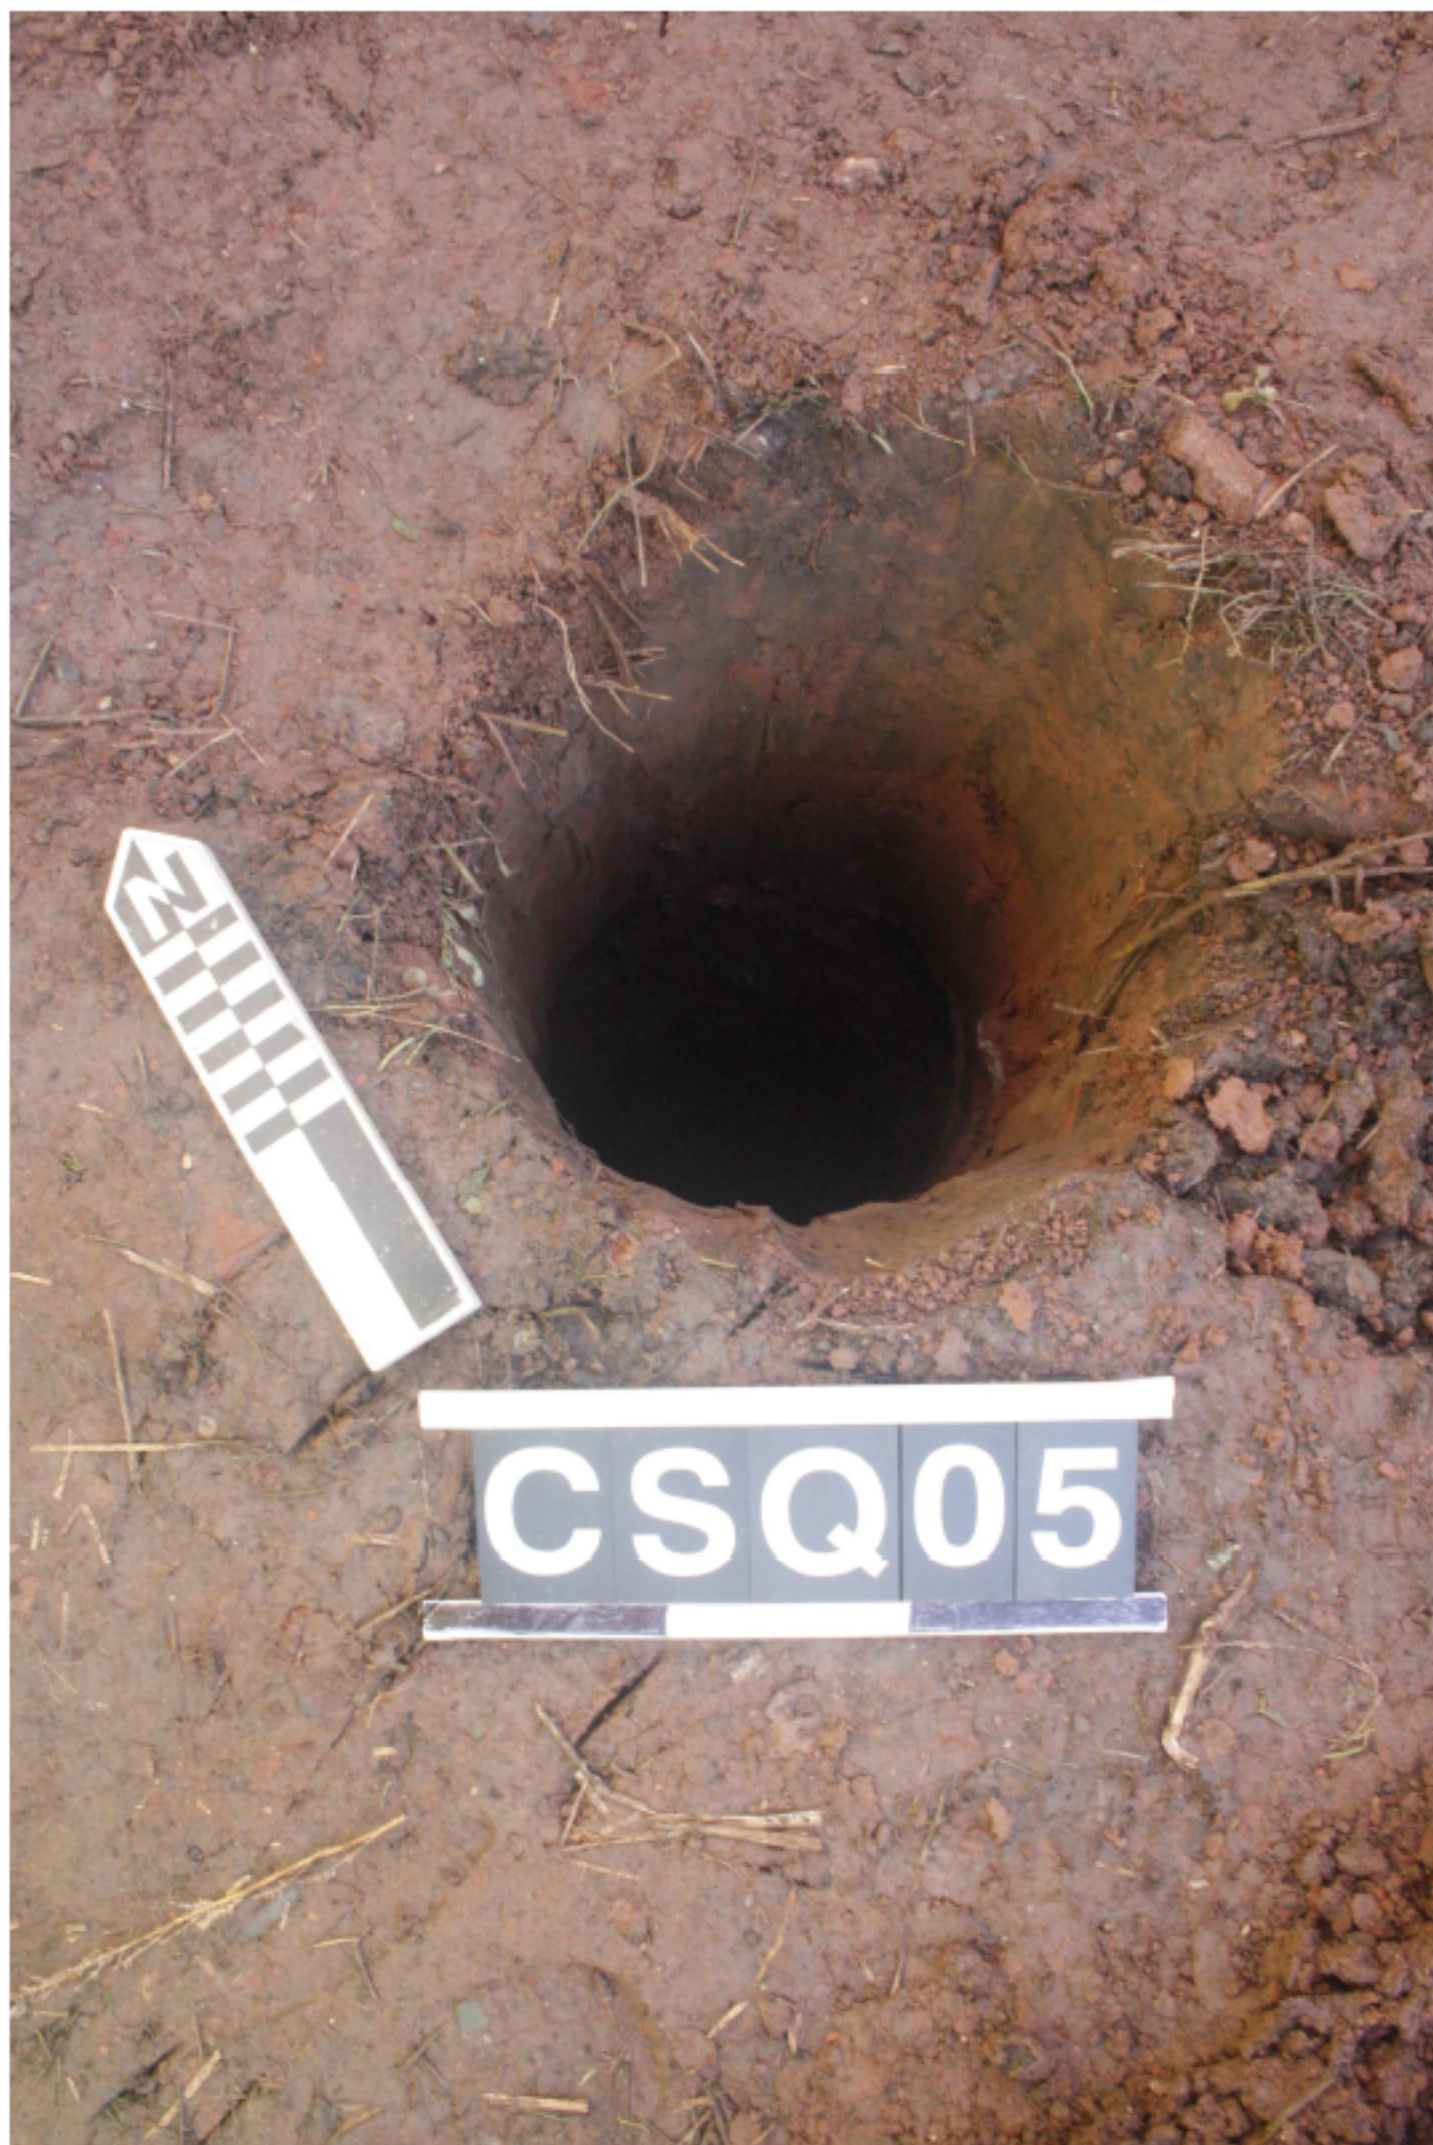
Plate 2: Borehole BH1105

5.2.7 **Borehole BH1105** was located north of Paradise Circus Queensway adjacent to the Easy Row underpass and Fletchers Walk Shopping Centre. After removal of the topsoil (0025), 0.3m in depth, a series of loose red-brown sand made ground deposits (0026) (0.4m deep) ,(0027) (0.1m deep) and (0028) (0.4m deep), were observed which may relate to the construction of the Paradise Circus Queensway.

5.2.9 **Borehole BH1105** (attempt C) was the fourth attempt of Borehole BH1105 and was located north of Paradise Circus Queensway outside the Easy Row underpass. After removal of the Topsoil (0025) (0.3m deep), and a loose red brown sand made ground (0026) (0.2m deep), a deposit of brick and concrete rubble was observed (0029) between 0.5m BGL and 1.2m BGL. This deposit is either made ground or is related to the demolition of 19th century structures, which historic mapping depicts as formerly present in this area.

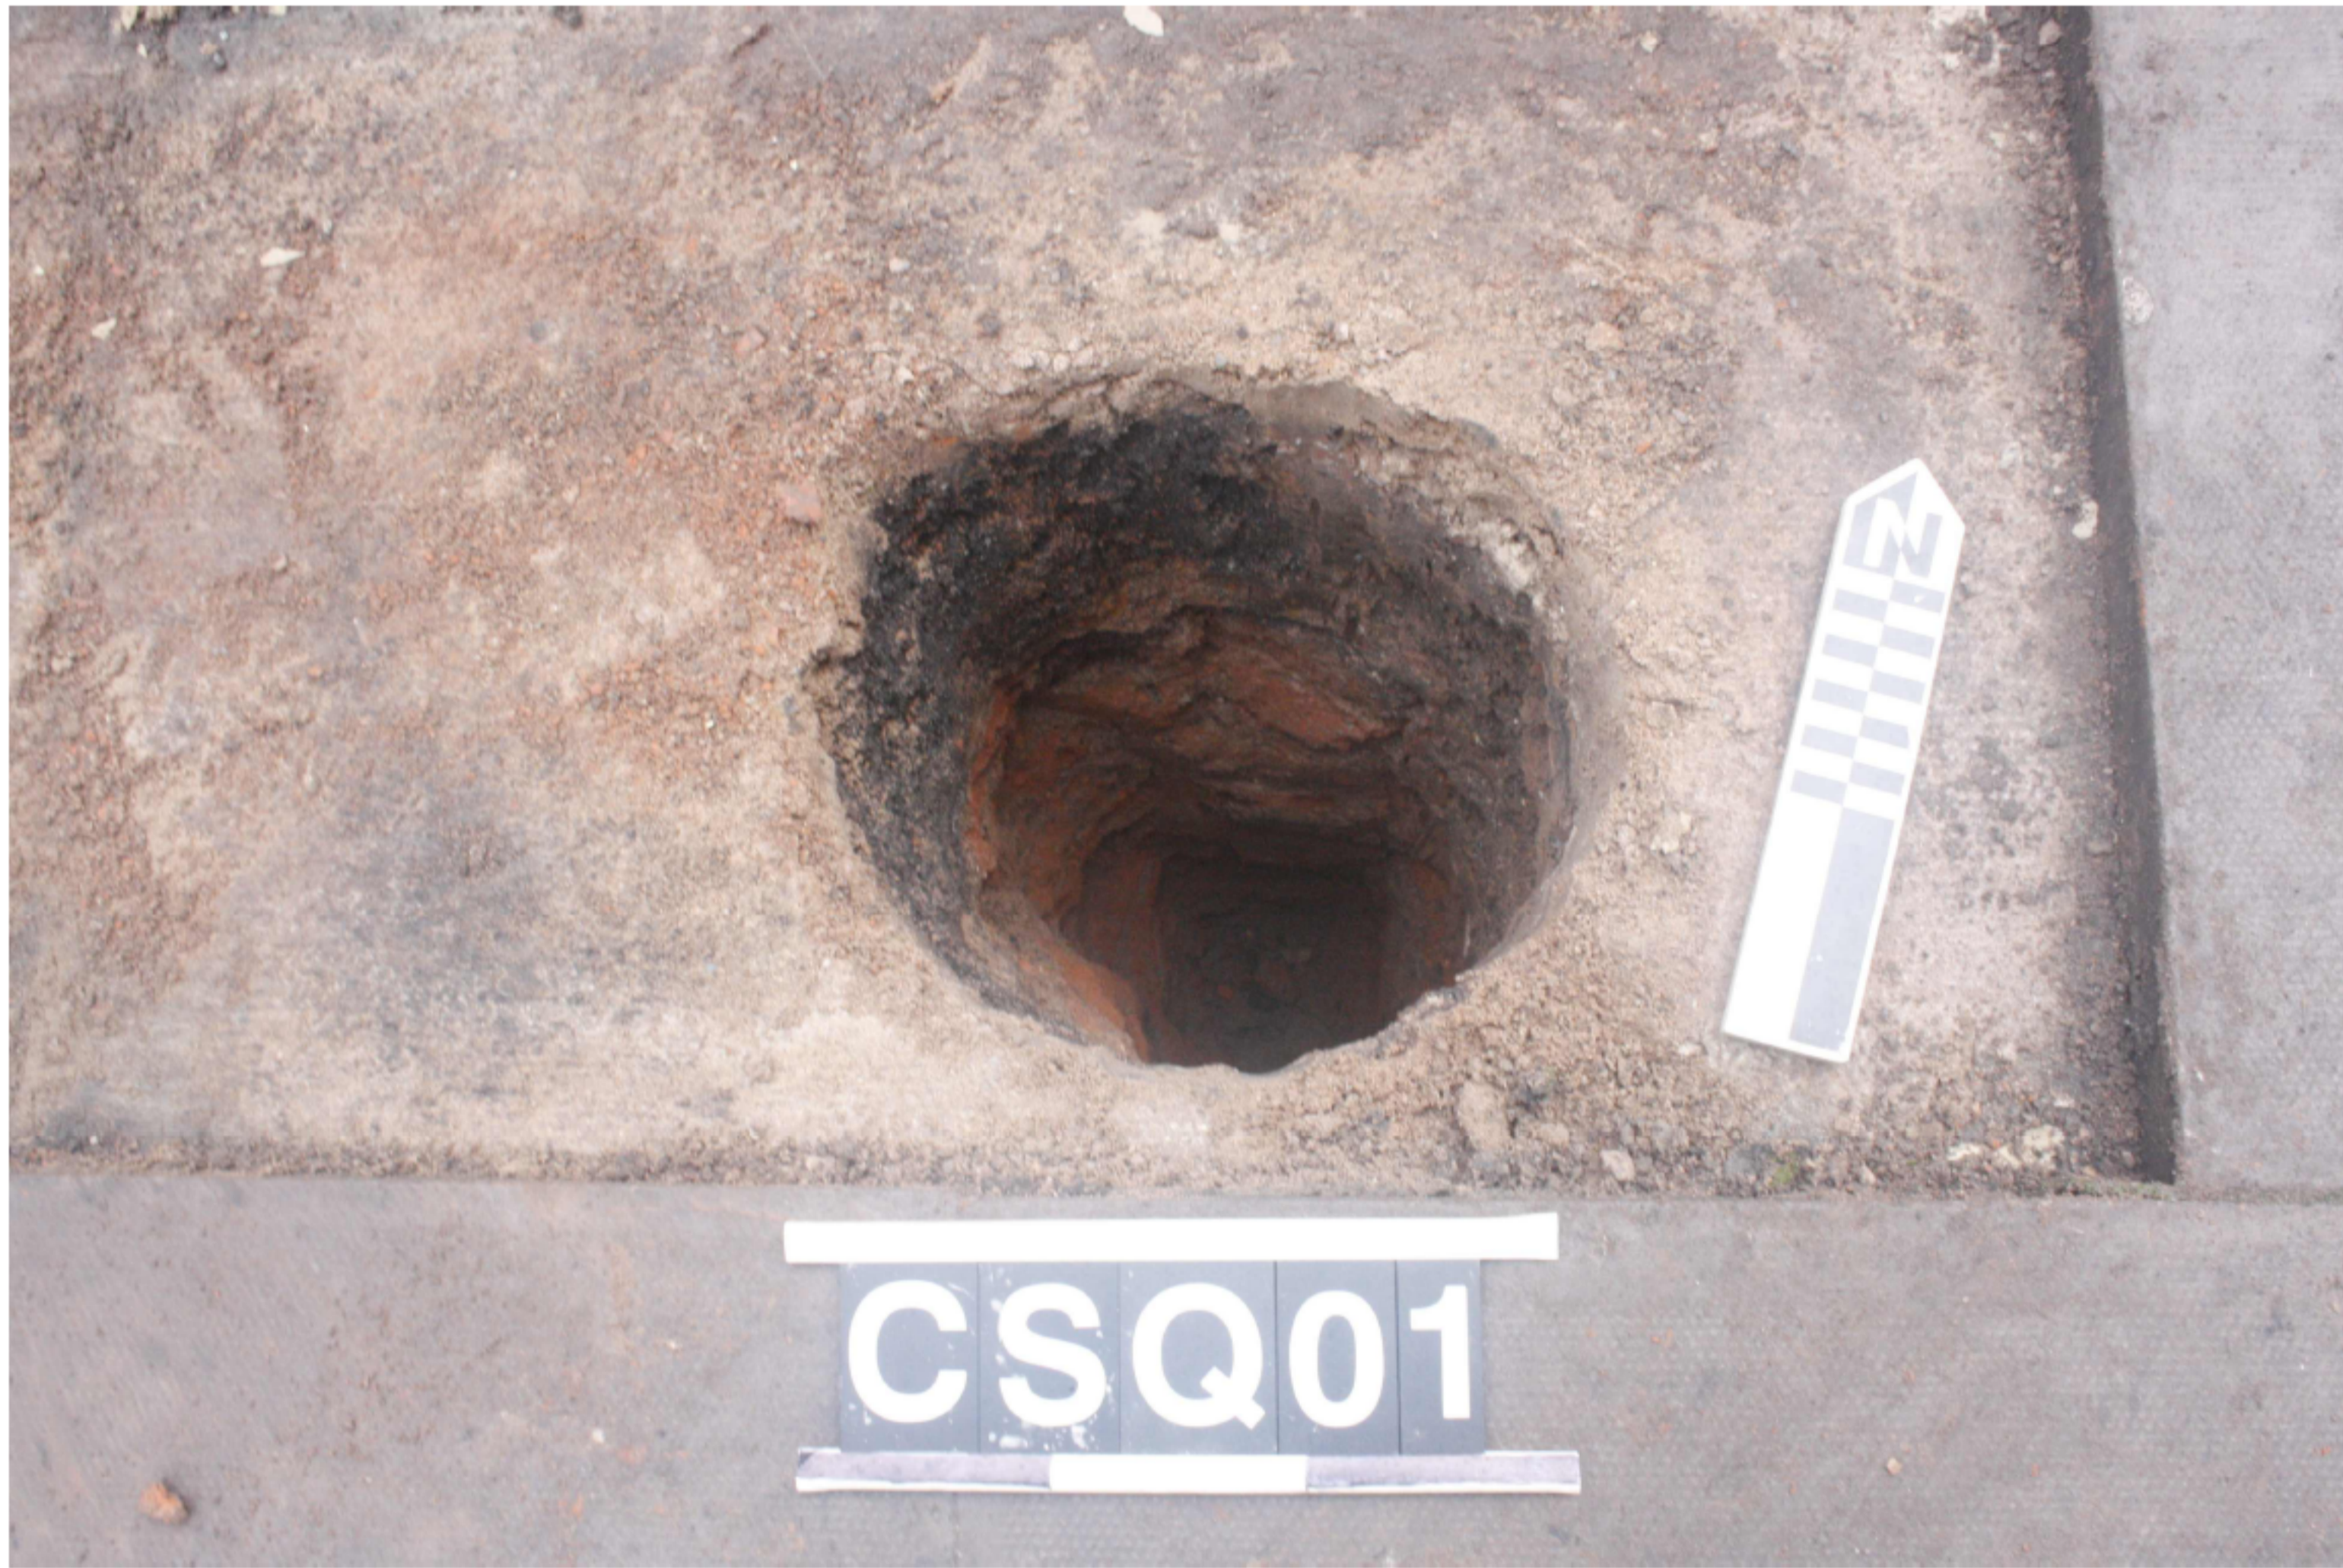
Plate 4: Borehole BH1107, photo is mislabelled

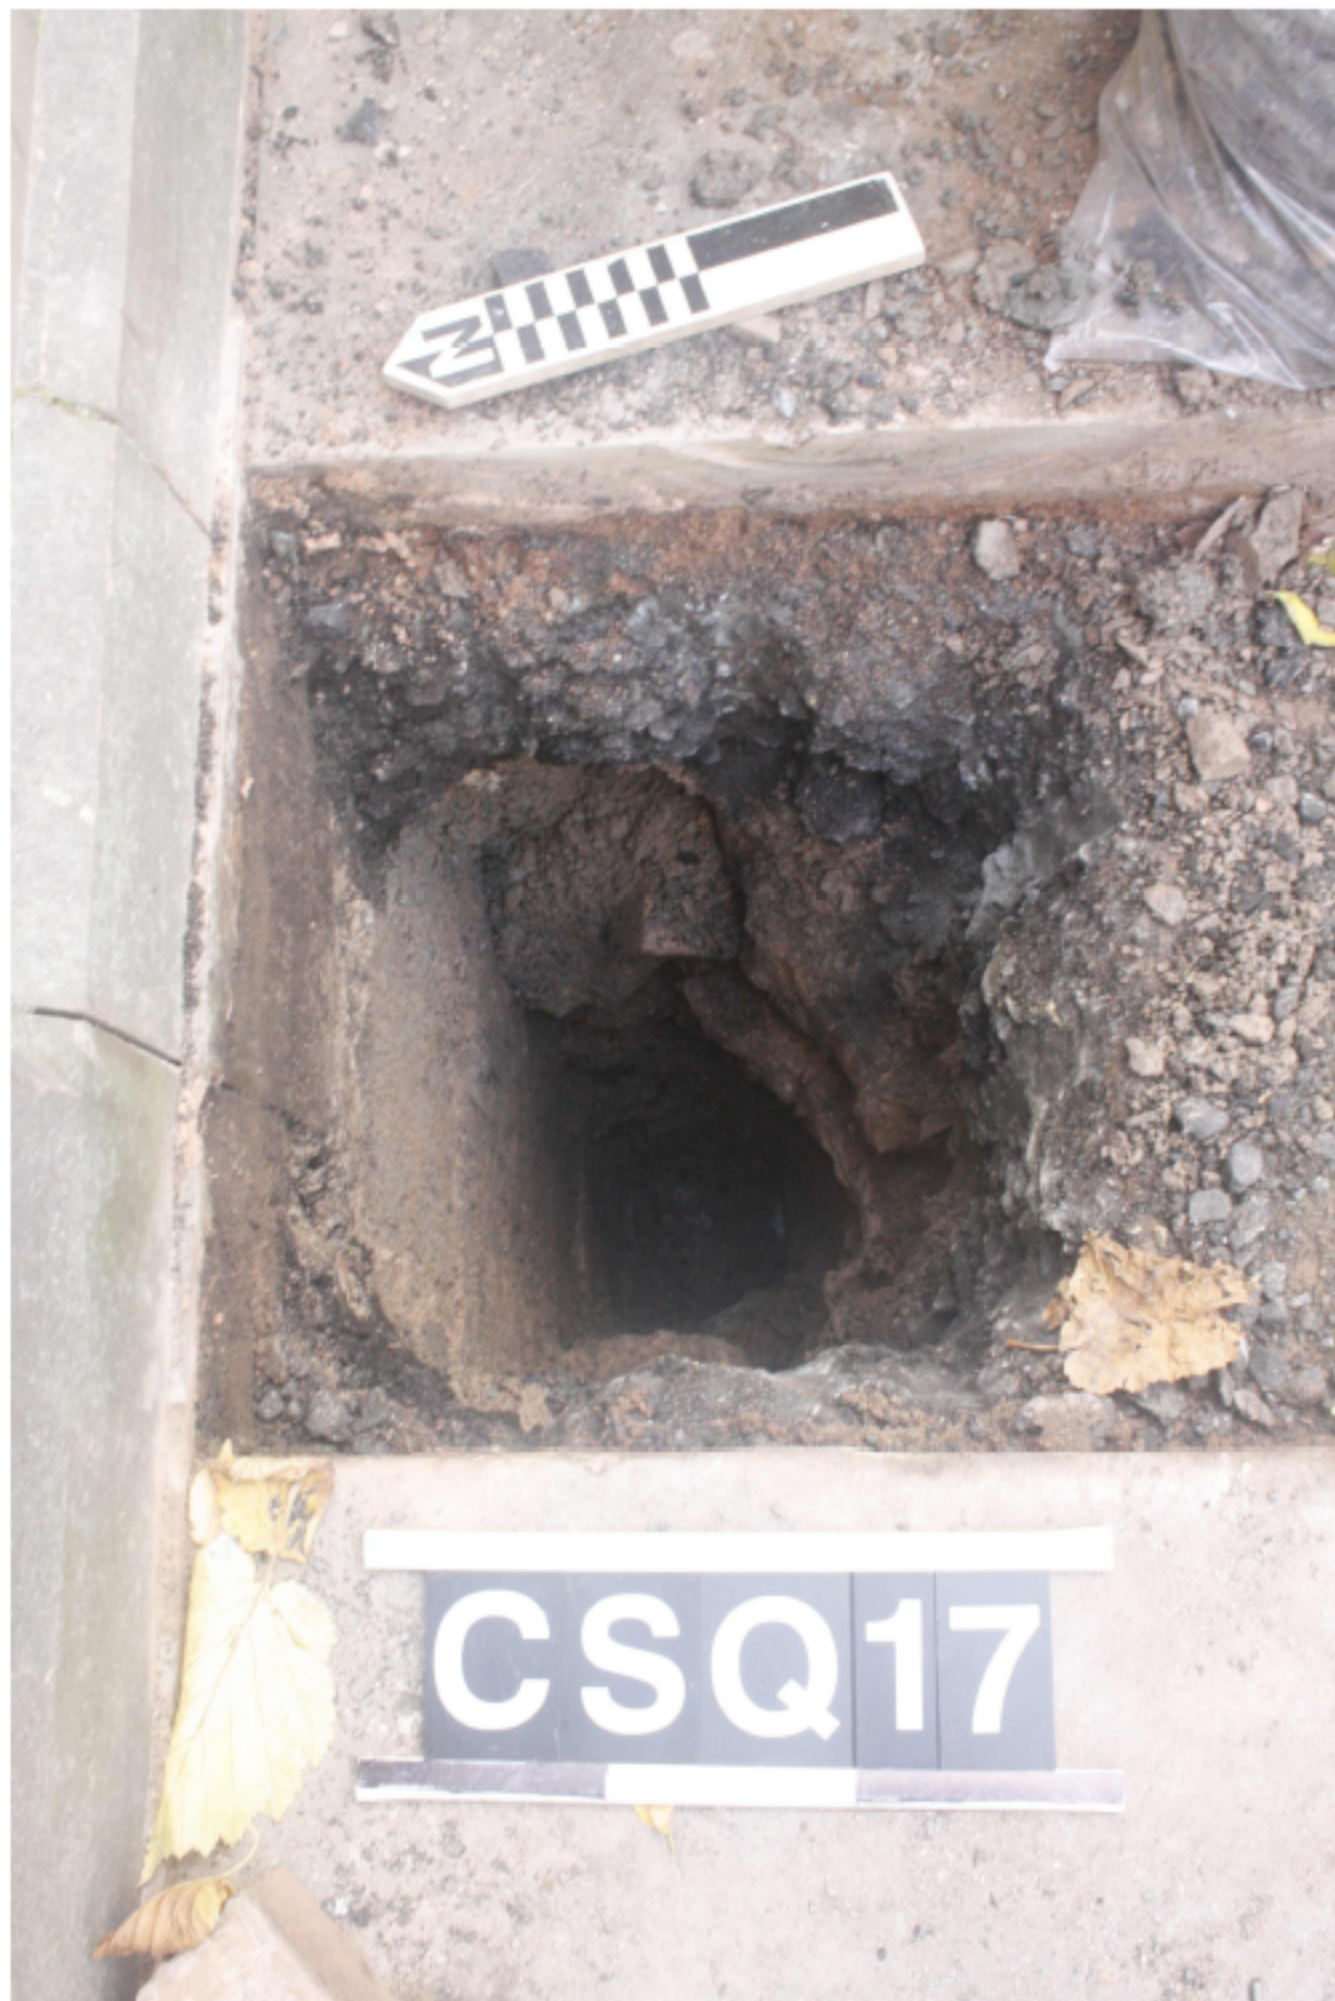
Plate 7: Inspection pit IP5117

5.6.17 **Inspection Pit IP5117** was located in Victoria Square against a wall commemorating the opening of the square by the Princess of Wales. After the removal of paving slabs (0034) (0.1m deep) and related bedding (0038) (0.05m deep) as well as an old road surface (0035) (0.15m deep) a wall (0073) was encountered. Wall (0073) cut through a concrete consolidation (0036) at a depth of 0.3m and 20th century made ground (0072) at a depth of 0.8m. The concrete foundations of the wall (0074) stepped out at a depth of 1.2m and its full depth is unknown.
