St Mary's Church, Chartham, Canterbury, Kent

Archaeological watching and recording brief

Project Code: CC-WB-10
Planning Ref: Faculty No 0096
NGR: 610695 155073
Report No: 2011/130
Archive No: 2854

September 2011

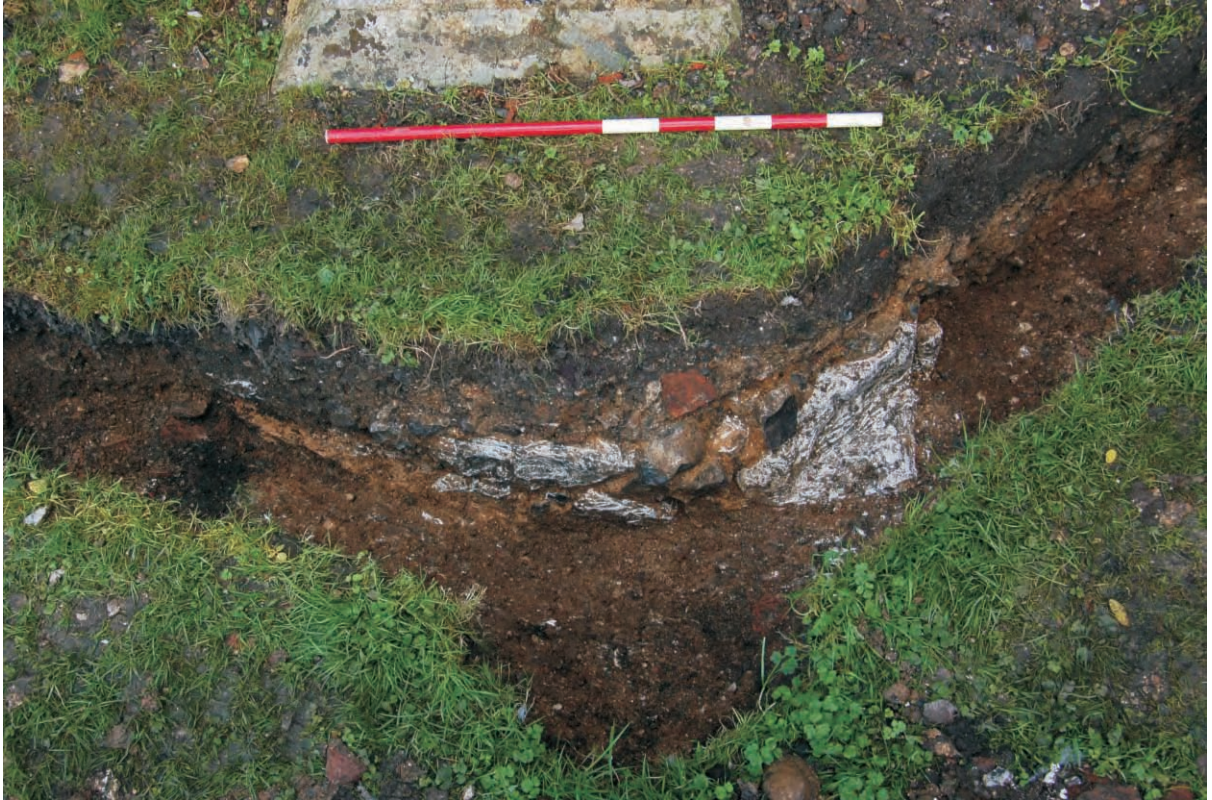
- 3.1.2 The earliest deposits seen in this area were cemetery backfill (1106), revealed at 16.25m OD, 0.52m below the present surface, which appeared from surface cleaning and inspection to contain no post-medieval material. The offset foundation for the chancel buttress (1103; 1107) was observed cutting

these deposits, squared off in line with the buttress and extending some 0.6m from its surface base. It's upper surface lay at 16.52m OD, 0.25m below the modern ground level.

3.1.3 The north-west corner of the chancel foundation had in turn been truncated by the southern edge of the existing flat bottomed pipe trench (1102, filled by 1101). The latter had a moderately steep slope cutting from a maximum depth of 0.51m up to 0.38m below the present surface (16.26–16.39m OD). Topsoil was observed to a depth of 0.25m in this trench.

Plate 2: Chancel buttress foundation in the north-east pipe trench, looking south (scale 1m)

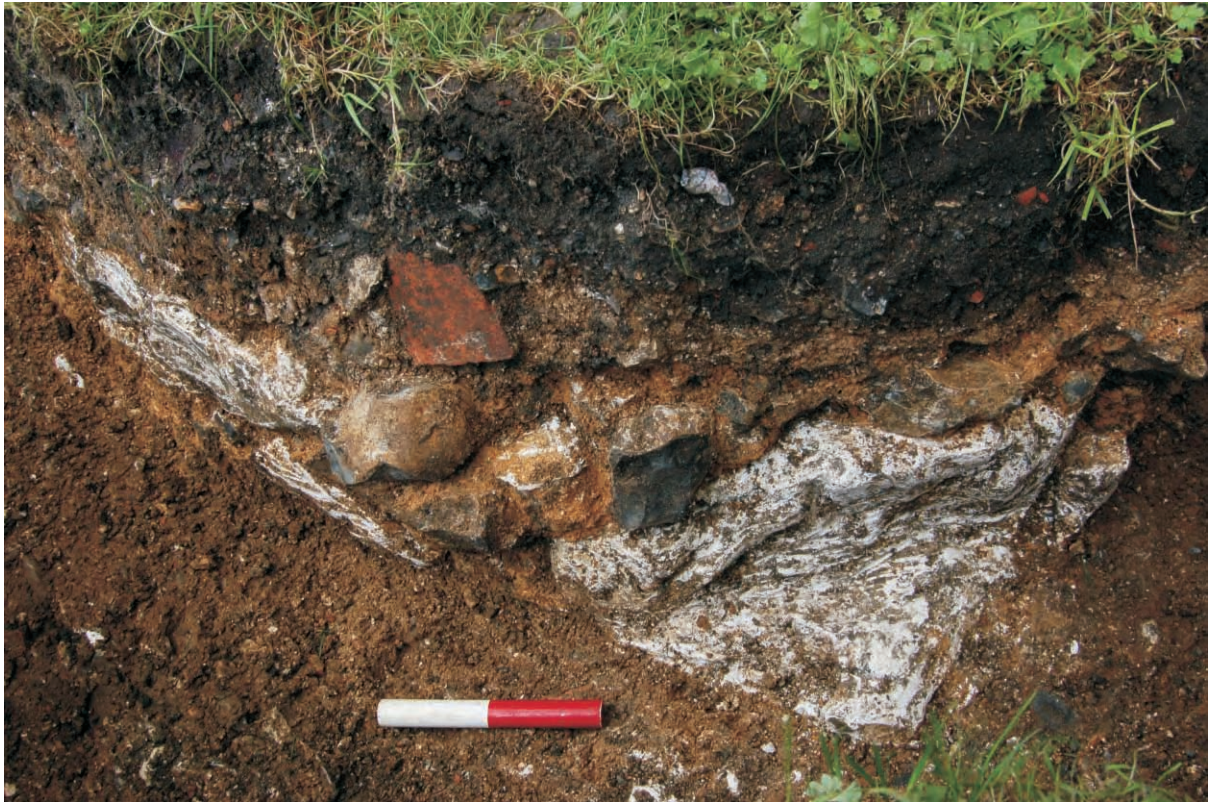
Plate 3: Detail of Chancel buttress foundation, looking south-east (Scale 0.2m)

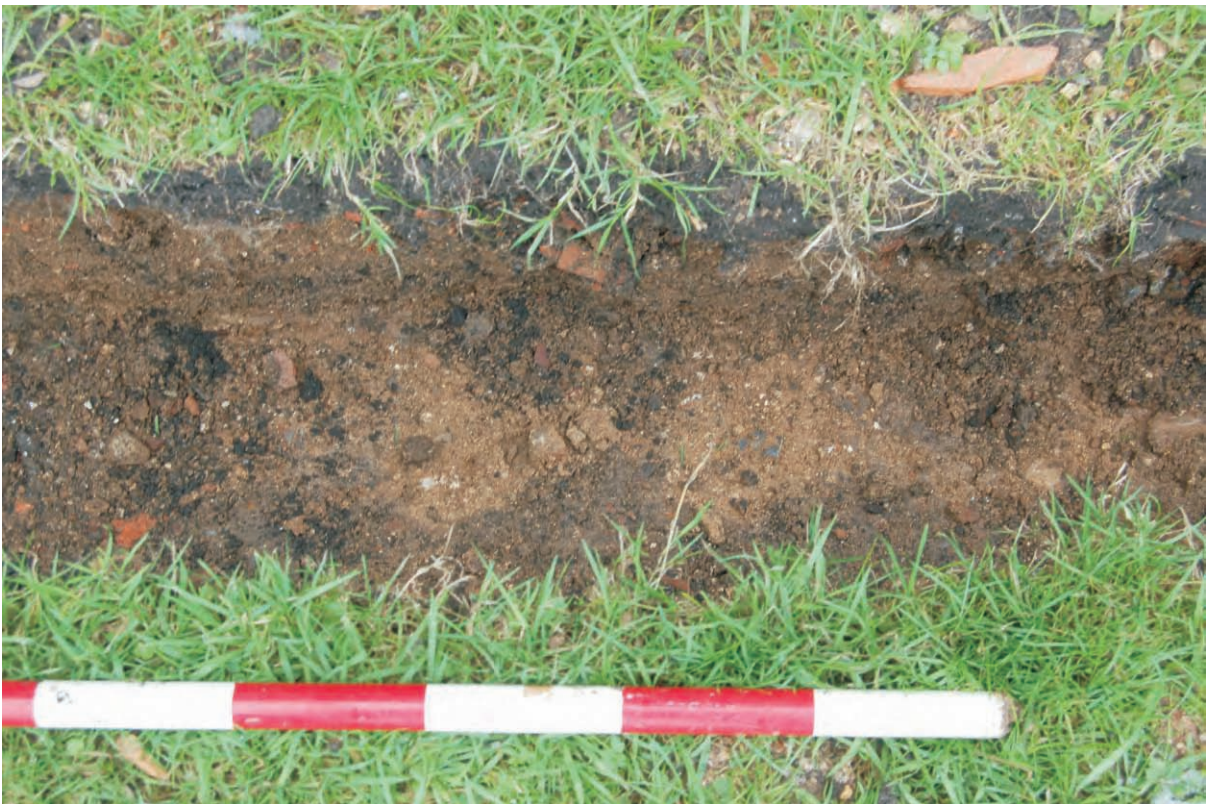
3.2.2 The earliest deposits observed were compact and relatively loam-free cemetery deposits (1204), which appeared from surface inspection to contain no post-medieval material. These had been truncated by the existing pipe trench (1202, filled by 1201) at a maximum depth of 0.5m below the modern ground surface level (at 16.48m OD). Two infant femurs recovered from the backfill (1201) of the existing pipe trench are potentially worthy of note (Fig 1). Topsoil was observed to a depth of 0.2m in this trench.

Plate 4: Northern pipe trench detail, looking south (Scale 0.5m)

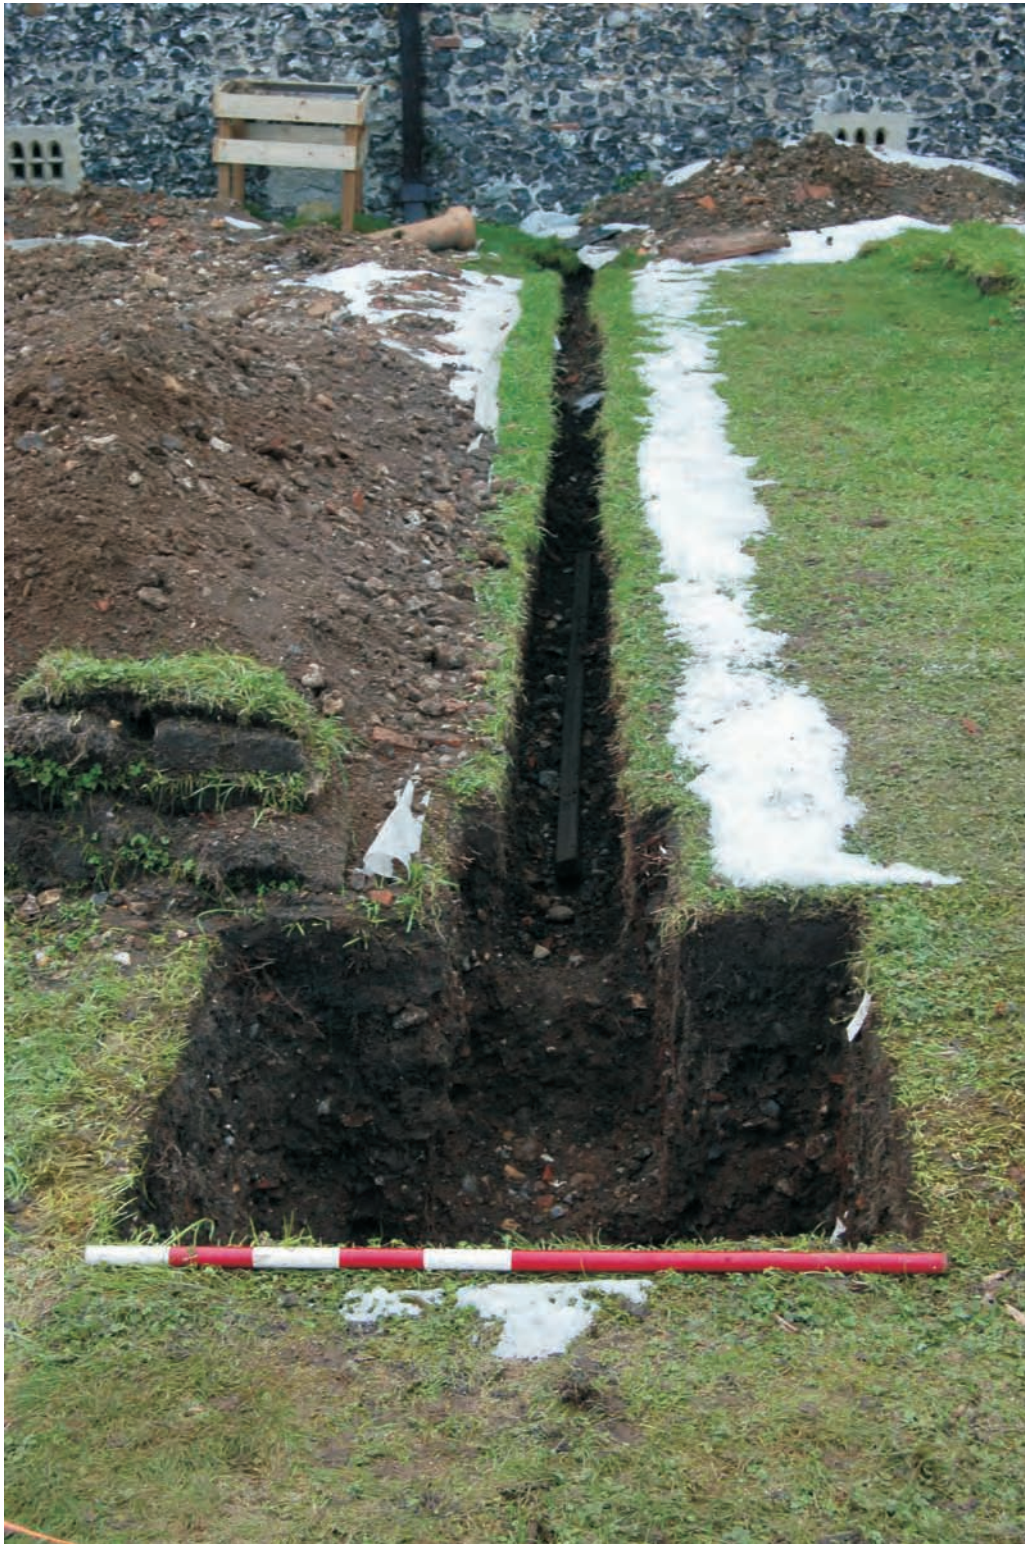
- 3.4.3 The earliest deposits encountered in the pipe extension trench were compact and relatively loam-free cemetery deposits at the southern end (1414, a continuation of deposit 1304, see above); a rim sherd spot-dated to approximately the turn of the fourteenth century was recovered from a surface clean of this deposit, which appeared from this inspection to contain no post-medieval material. The exact relationship between this material and later cemetery soils (1401–7) sealing it could not be established with any certainty, but it is likely that intensive post-medieval burial lay to the north of this approximate boundary.

Plate 5: Northern soakaway and pipe trench extension, looking south (Scale 1m)

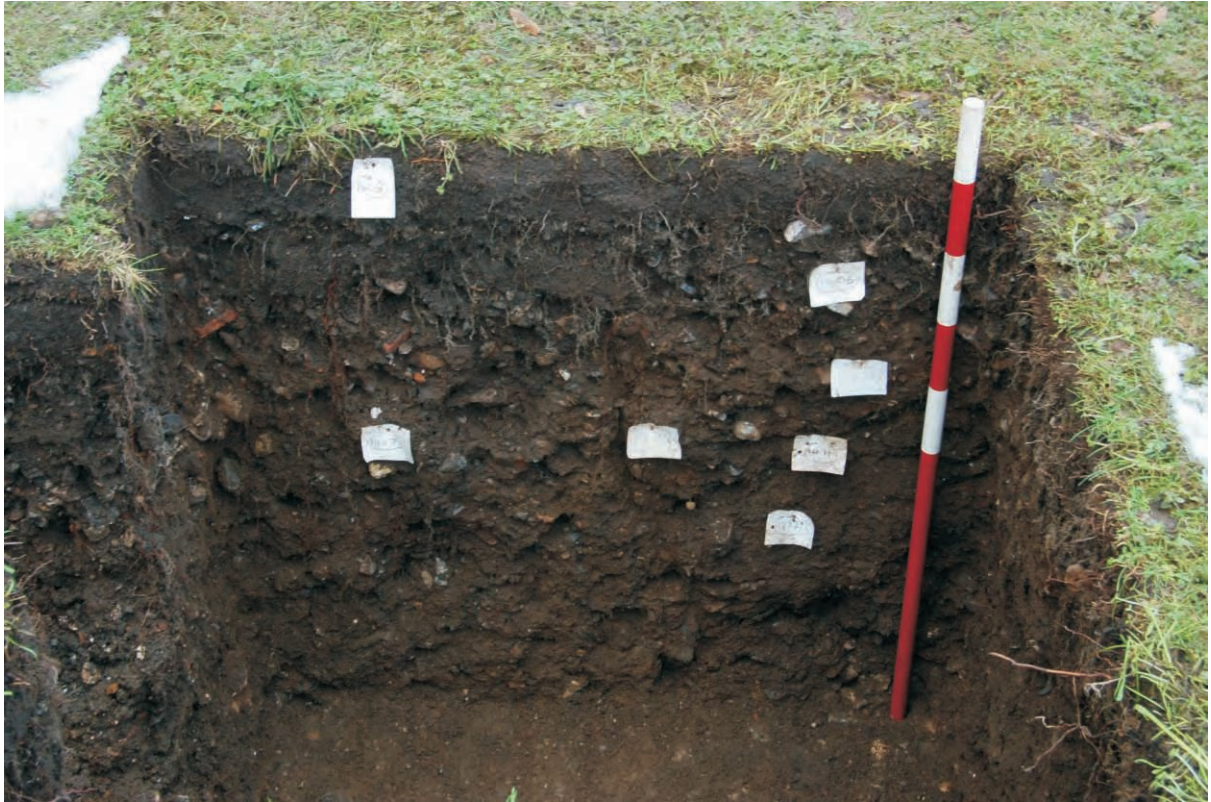
Plate 6: Northern soakaway pit, looking west (Scale 1m)

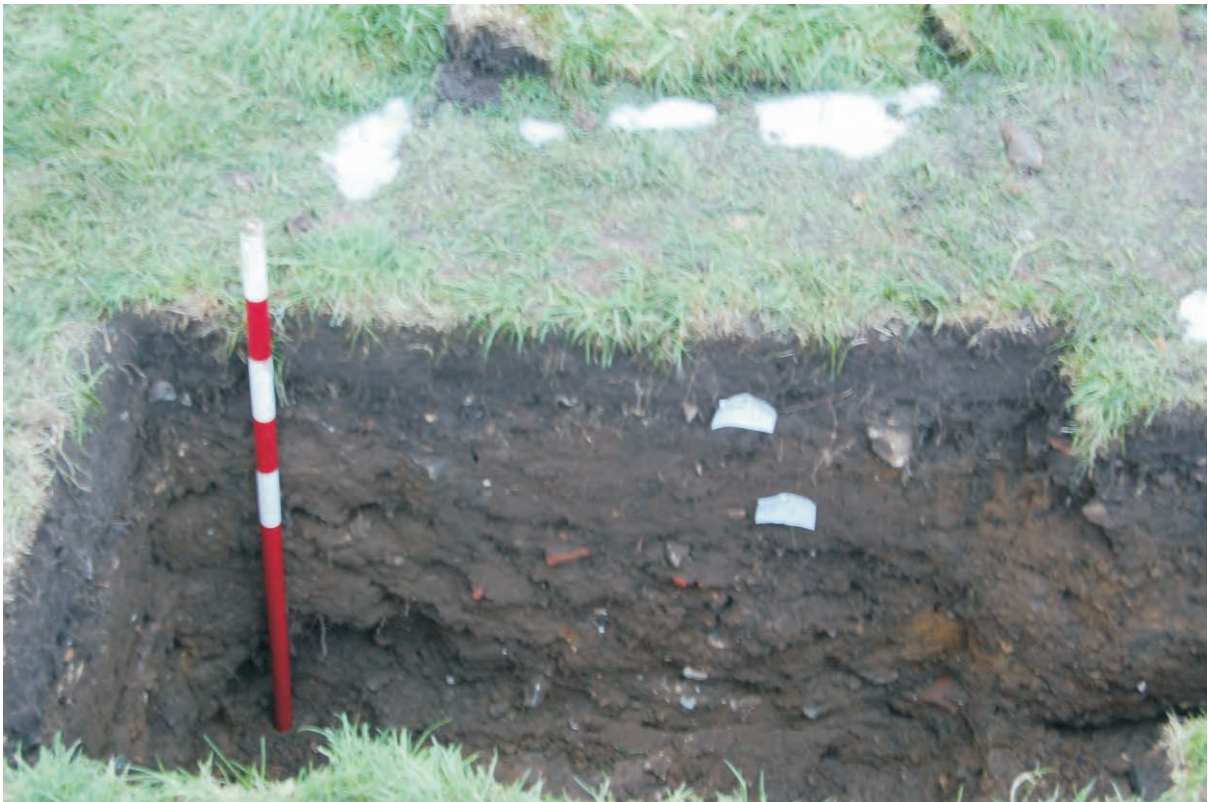
other bones and fragments was observed at approximately 0.7m beneath the surface (at 15.76m OD), along with occasional large nails (possible coffin nails of some antiquity) and occasional fragments of much abraded CBM throughout; a clay pipe stem, dated 1887, was also recovered from this deposit. The upper surface of deposit 1502/1503 lay at 16.01m OD; the topsoil (1501) sealing it to a depth of 0.15m beneath the present surface was also notably free of inclusions.

Plate 7: Southern soakaway pit, looking south-west (Scale 1m)

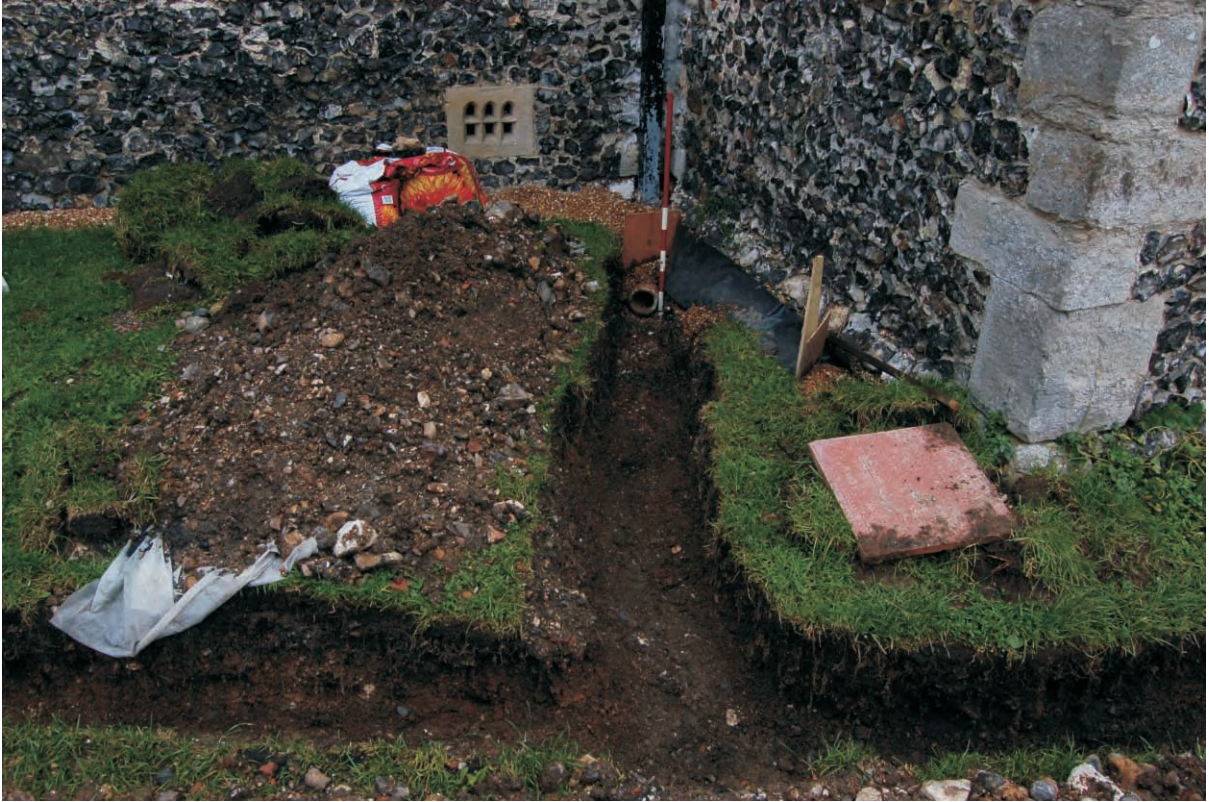
3.6.2 The resulting trench to the west of the south transept was 2.5m in length (aligned north-west–south-east) and a maximum of 0.65m wide (though tapering to just 0.3m wide at the northern end). The earliest deposits observed here were friable to firm, relatively loam-free cemetery deposits (1606), which yielded occasional scraps of medieval or early post-medieval pot. These deposits were cut by the chalk block and mortared flint foundation of the church (1603) and its presumed cut (1604; not clearly seen) which had in turn been truncated by the existing pipe trench (1602, filled by 1601), the latter cutting to a maximum depth of 0.5m (16.32m OD) below the modern ground surface level. Topsoil was observed to a depth of 0.2m in this trench.

Plate 8: South transept downpipe (west), looking north-east (Scale 1m)

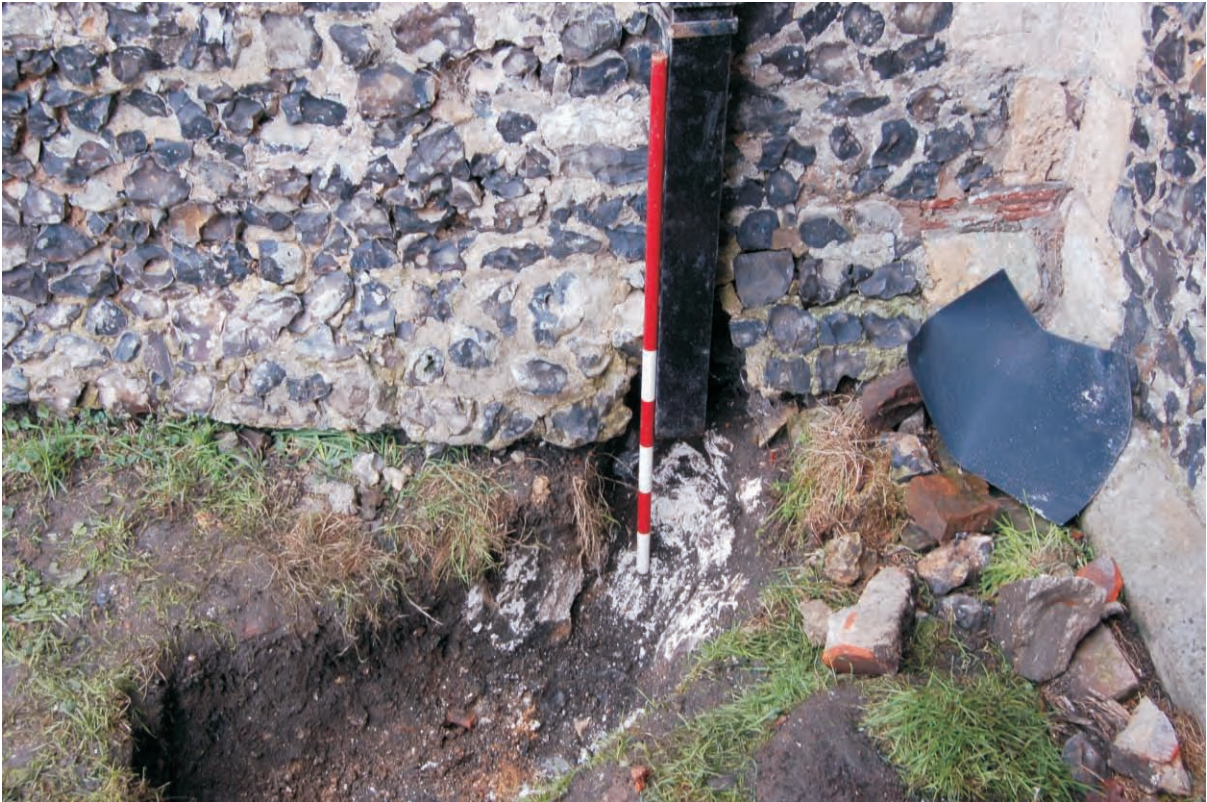
3.6.4 The trench for replacement of pipe work to the east of the transept was just 1m by 0.5m in extent and shallow. The earliest deposit seen here was the truncated chalk block transept foundation (1609), truncated by the existing pipe trench (1608, filled by 1609). In this case only minimal excavation was required, to a depth of *c* 0.35m (approx 16.30m OD) in order for installation of new pipe work. There was little topsoil (= 1600) in the area of the down pipe, but typical depths existed at the south-east end of this small trench (approximately 0.2m).

Plate 9: South transept downpipe (east), looking north-west (Scale 1m)

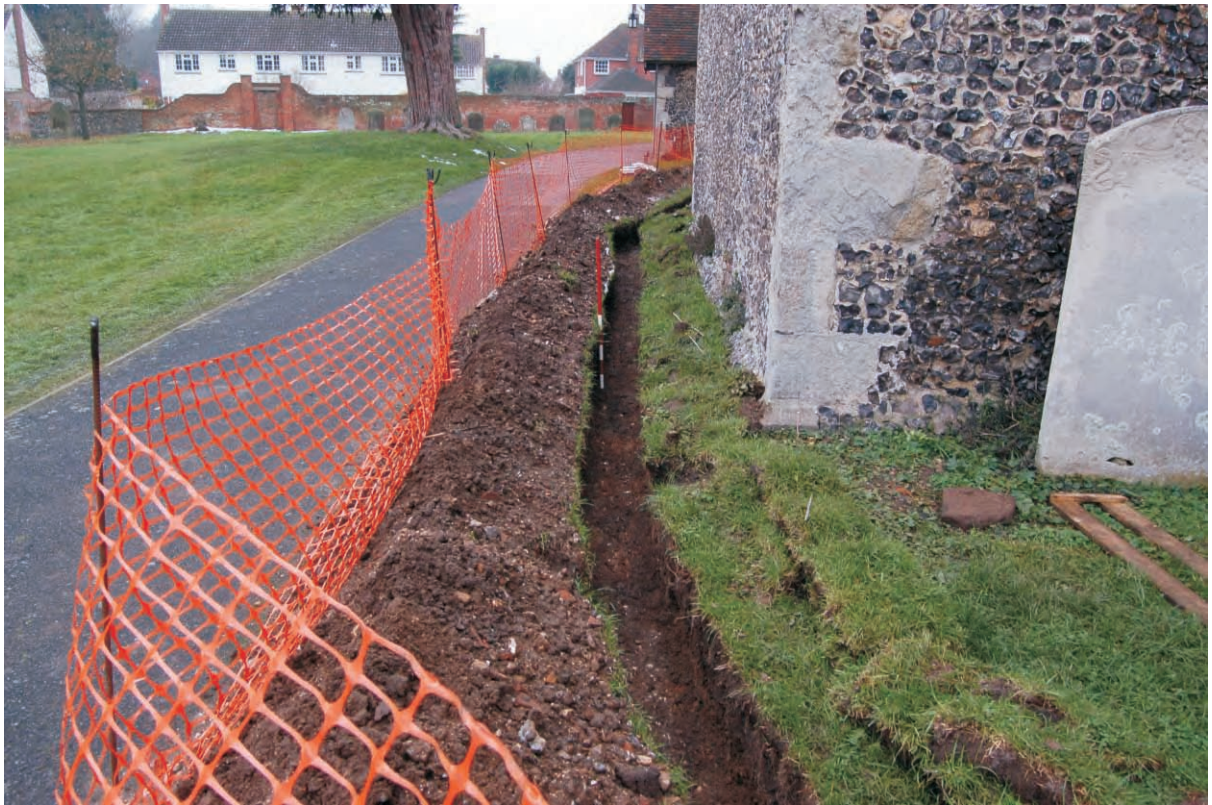
Plate 10: South transept and southern pipe trench, looking west (Scale 1m)

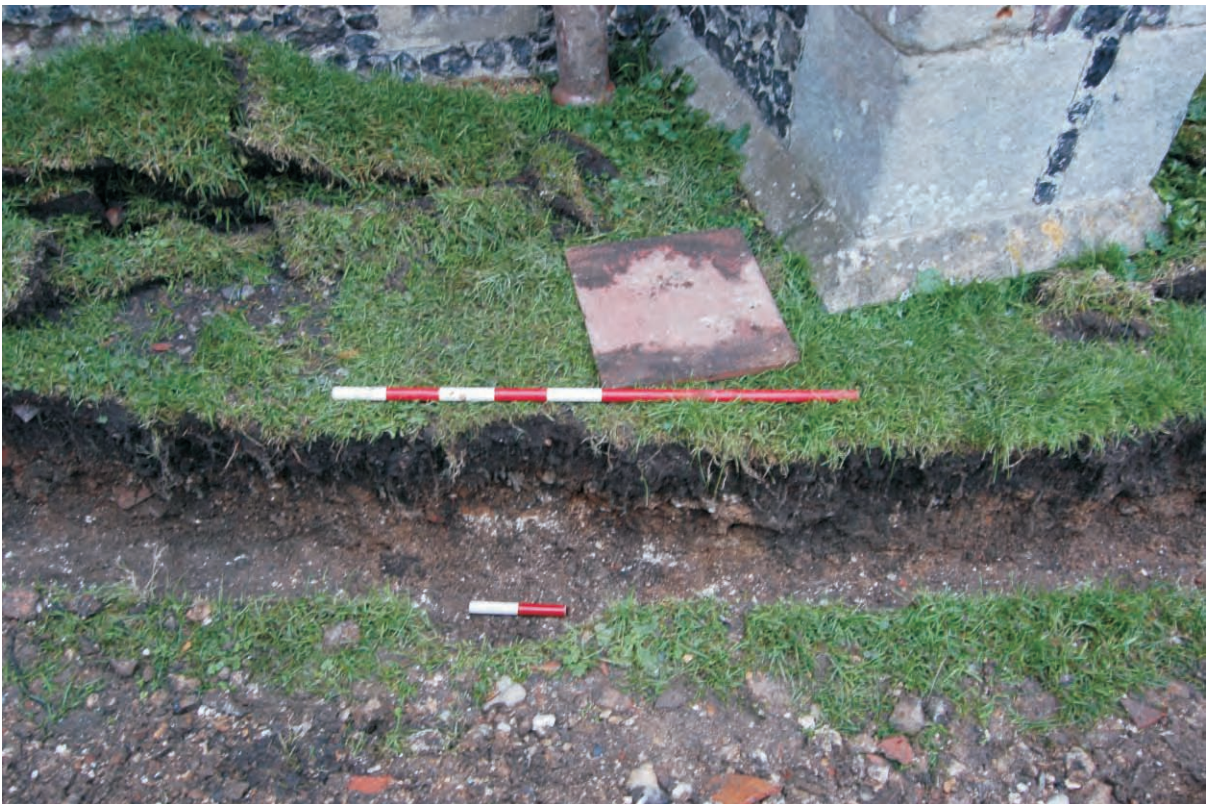
- 3.7.2 The earliest deposits observed here were friable to firm, relatively loam-free cemetery deposits (1710), which yielded occasional scraps of medieval or early post-medieval pot and degraded CBM, the surface truncated to a depth of 0.5m (16.60m OD). Possible grave cuts (noticeably those containing distinctive backfills) were observed cutting this material in the northern (extant) side of the pipe trench (1701 filled by 1702; 1708 filled by 1707: see Plate 12); none of these features could be sufficiently excavated in order to further characterise them. The fill of those on the north side of the trench had been cut by the existing pipe trench (1704 filled by 1703). Modification of the southern edge of the trench revealed another probable burial cut and the southern (1706 filled by 1705). Topsoil was observed to a depth of 0.2m in this trench. Either the backfill of the existing pipe trench ((1703) or cemetery soils encroached upon by widening of the trench during the current project produced some interesting finds, only recovered during backfilling: two large fragments of medieval painted floor tile, one with a distinctive representation of a stylised animal's legs and feet, the other apparently geometric in design.

Plate 11: Southern pipe trench, looking north-east (Scale 1m and 0.5m)

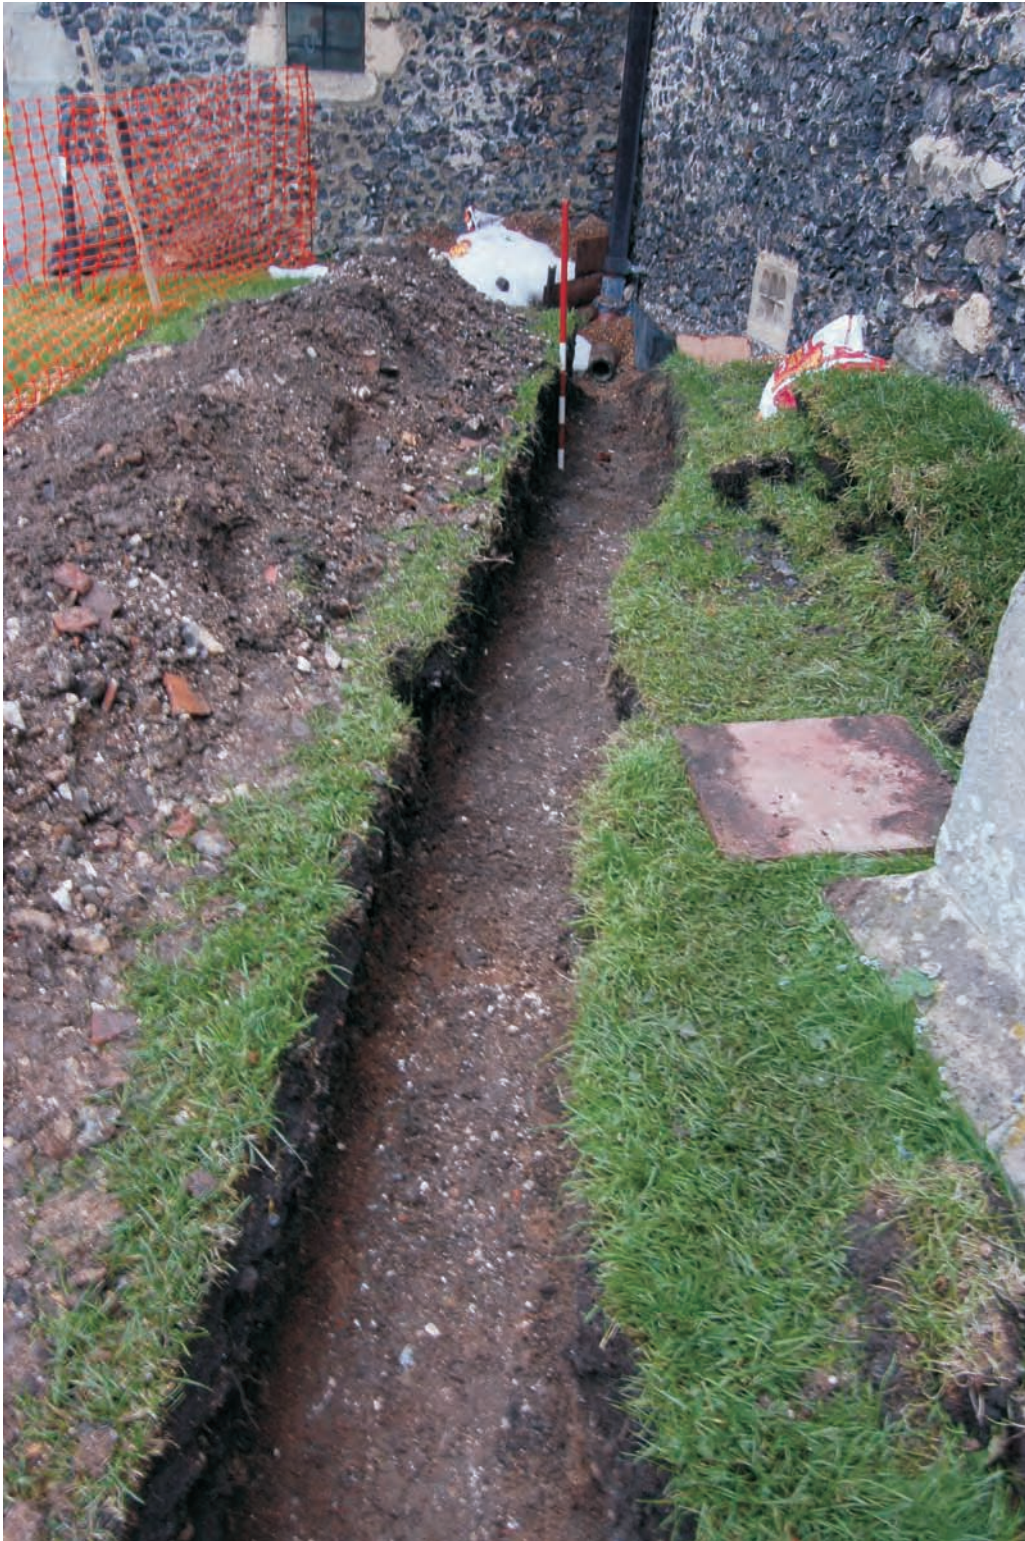
Plate 12: Southern pipe trench near the south porch, the southern edge straightened, looking west (Scale 1m)

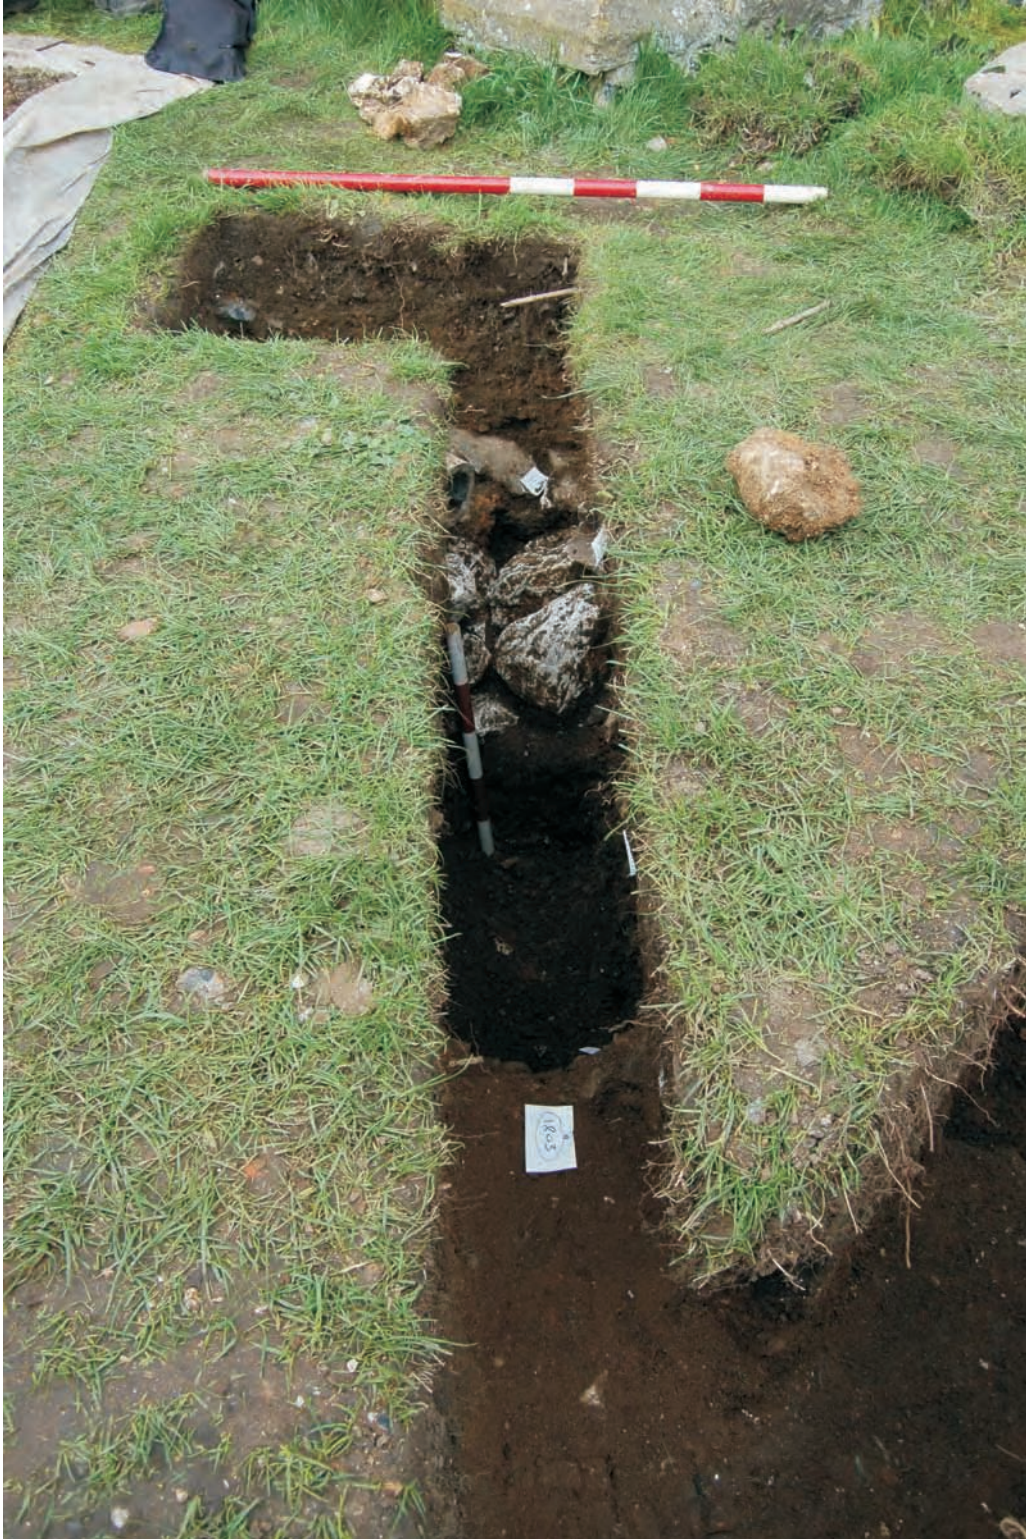
- 3.8.3 Another partially seen grave cut (1802) had probably cut the latter grave backfill immediately to the south-east. The other side of this near vertical cut was also observed within the new pipe trench, indicating the grave to be 0.65m wide at this point, this south-east edge being seen to continue into the existing pipe trench. The grave cut was particularly clear in this case because there was a considerable void and loose material within (1801). This void was excavated prospectively to a depth of 0.9m beneath the present surface (15.54m OD) and was still continuing to plunge vertically beyond that depth. Loose cemetery loam backfill within the grave (1801) also produced redeposited fragments of mortar, mortared flint and chalk disturbed from the fill of adjacent feature 1808. Two clay pipe stems were also recovered from near the south-eastern edge of the grave cut.

- 3.8.4 The void within feature 1802 had no doubt been discovered previously during excavation of the existing pipe trench, which cut to a depth of 0.4m below the ground surface in this area and seen in section to have steep sides and a confined sump to house the pipe. Clearly localised conditions had affected the morphology of the pipe trench in this area.

Plate 13: South-eastern pipe trench extension and void, looking north-west
(Scale 1m and 0.5m)

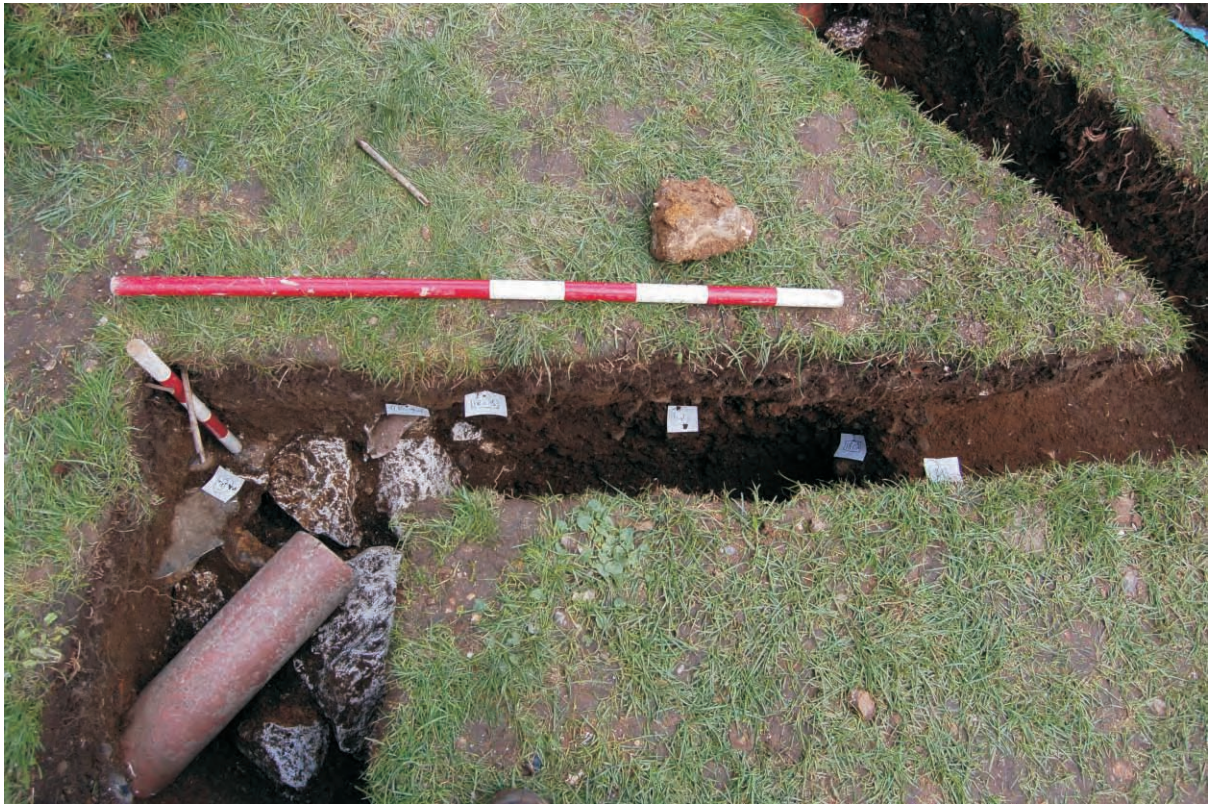
Plate 14: South-east pipe trench extension and void, looking east (Scale 1m and 0.5m)

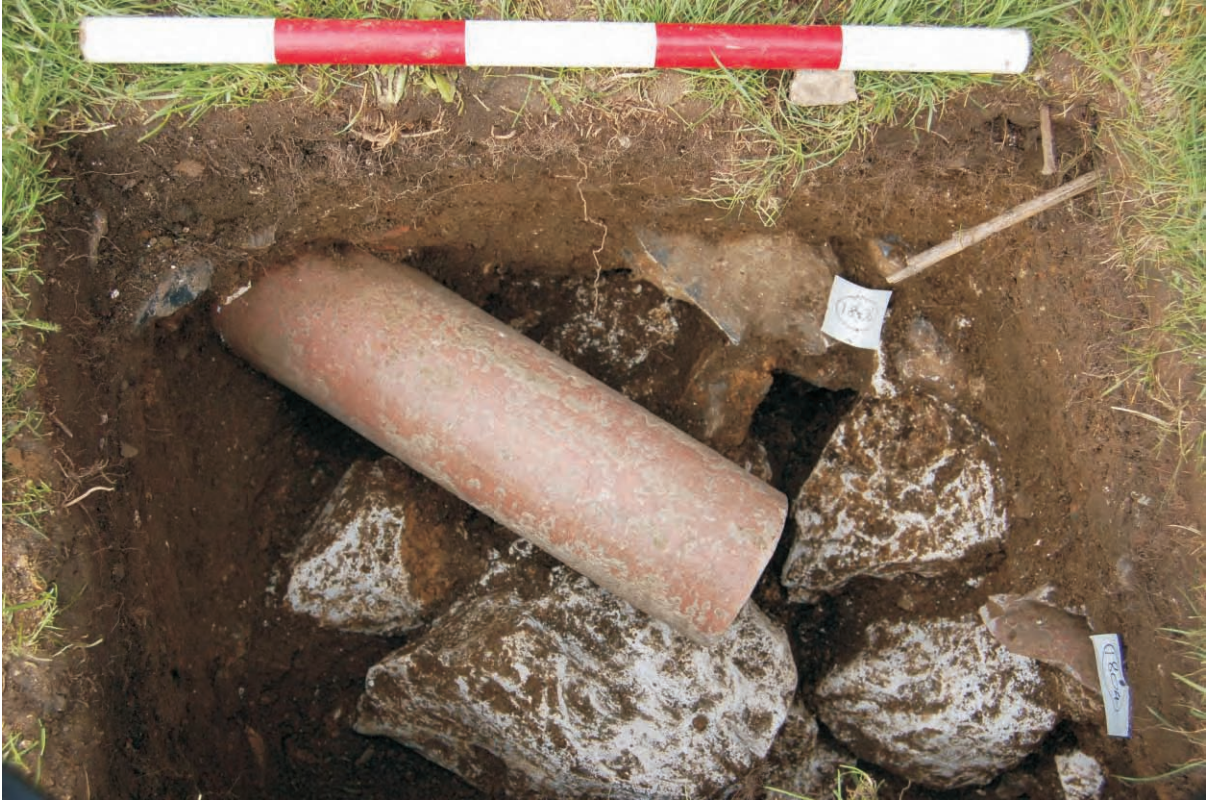
- 4.1.3 The back-filling in a probable burial next to the southern wall of the chancel with what was clearly medieval foundation material (1806) is interesting in that this material presumably derives from either the current or a previous incarnation of the church building. While it is possible that the chalk block seen in the south-east pipe trench (next to the path; Plate 16) was part of a foundation of another, hitherto unknown building, it may equally have been part of another burial backfill or possibly had been re-used as a foundation of the cemetery path. The void within another burial (1802) seen in this trench suggested a particular taphonomic process, perhaps due to several coffins having been interred either at once or in quick succession and then disintegrating following burial.

Plate 15: Close up of chalk backfill 1806 (Scale 0.5m)

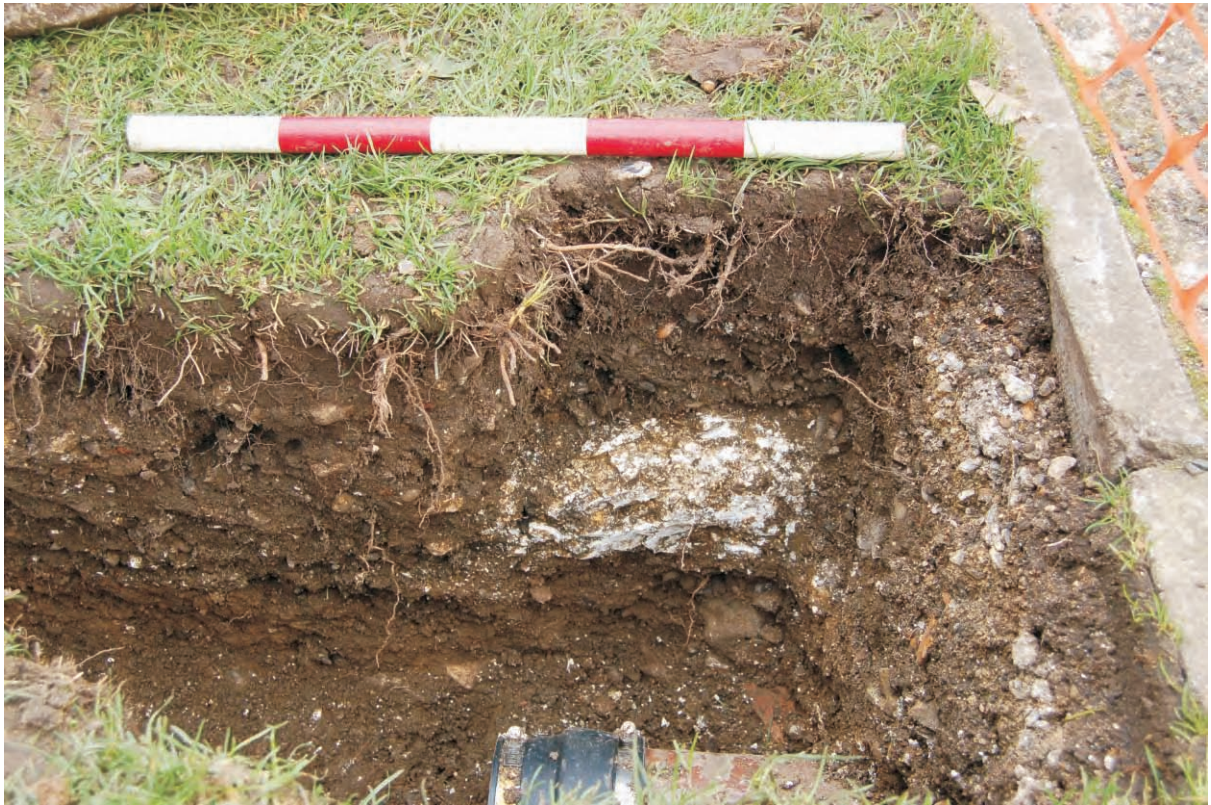
- 3.8.5 A further chalk block (again no doubt redeposited foundation material) was observed in the section at the southern end of the existing pipe trench (Plate 16). Topsoil was observed to a depth of 0.2m in this trench.

Plate 16: Chalk block seen in section near path, looking east (Scale 0.5m)

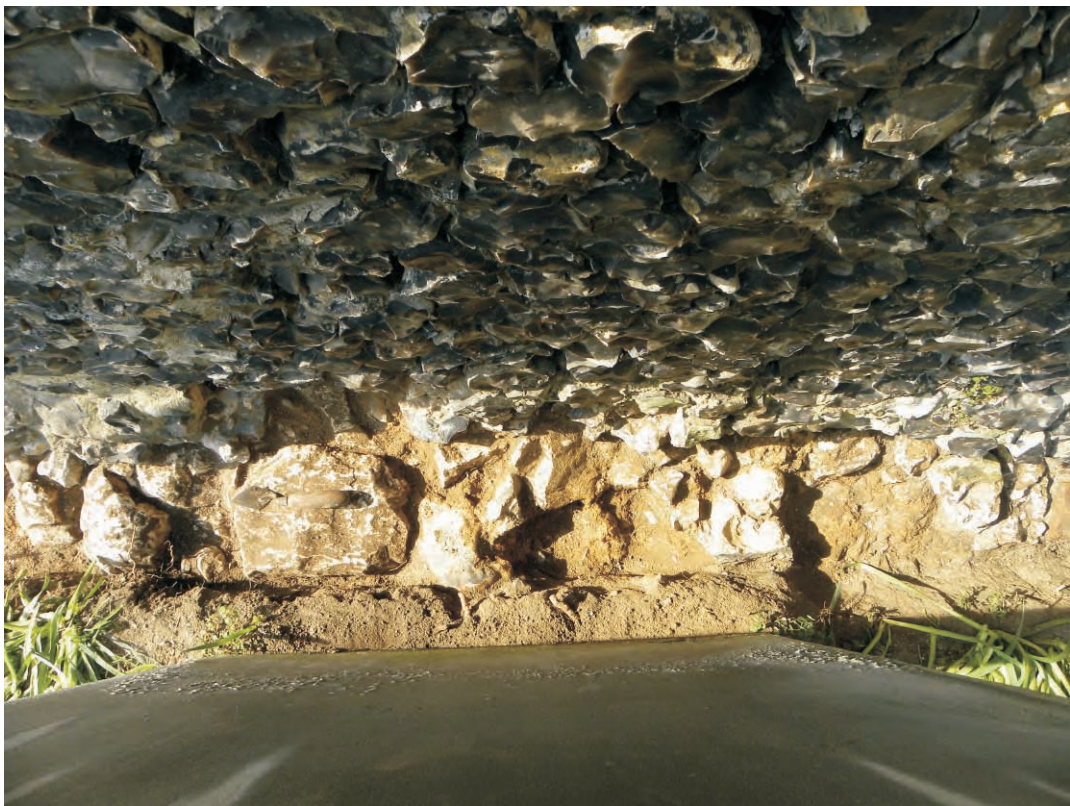
- 3.9.1 Topsoil was removed alongside the east wall of the south transept in order to install pea-shingle drainage, revealing the foundation and packing for a large gravestone.
- 3.9.2 The earliest exposed deposit was the truncated transept foundation (1903), with typical chalk block surmounted by mortared flint construction. This had been evidently disturbed (1902) by arrangements to erect a large grave stone and re-packing of foundation material for its support (1901). The latter also included two post-medieval bricks set carefully at the edge of the existing pipe trench in this area (1607), their purpose unknown.
- 3.9.3 A summary of recorded contexts from this intervention is shown in Table 9.

Plate 17: South transept foundation disturbed by gravestone foundation

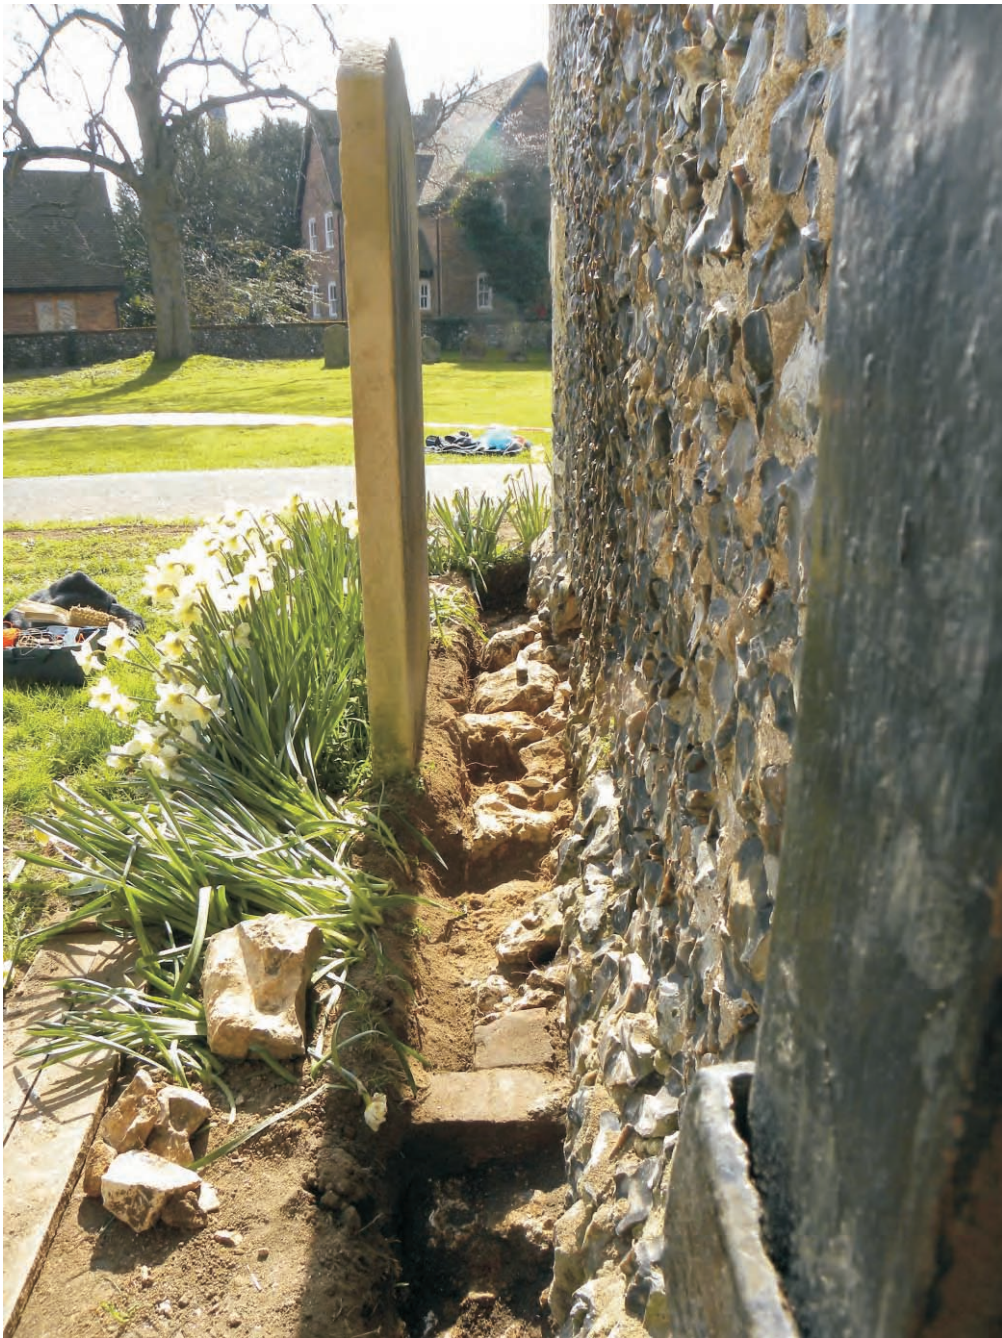
Plate 18: General shot of pea-shingle trench, looking south
