# Historic Building Survey

**BERRYNARBOR MANOR HALL,  
BIRDSWELL LANE,  
BERRYNARBOR, DEVON**

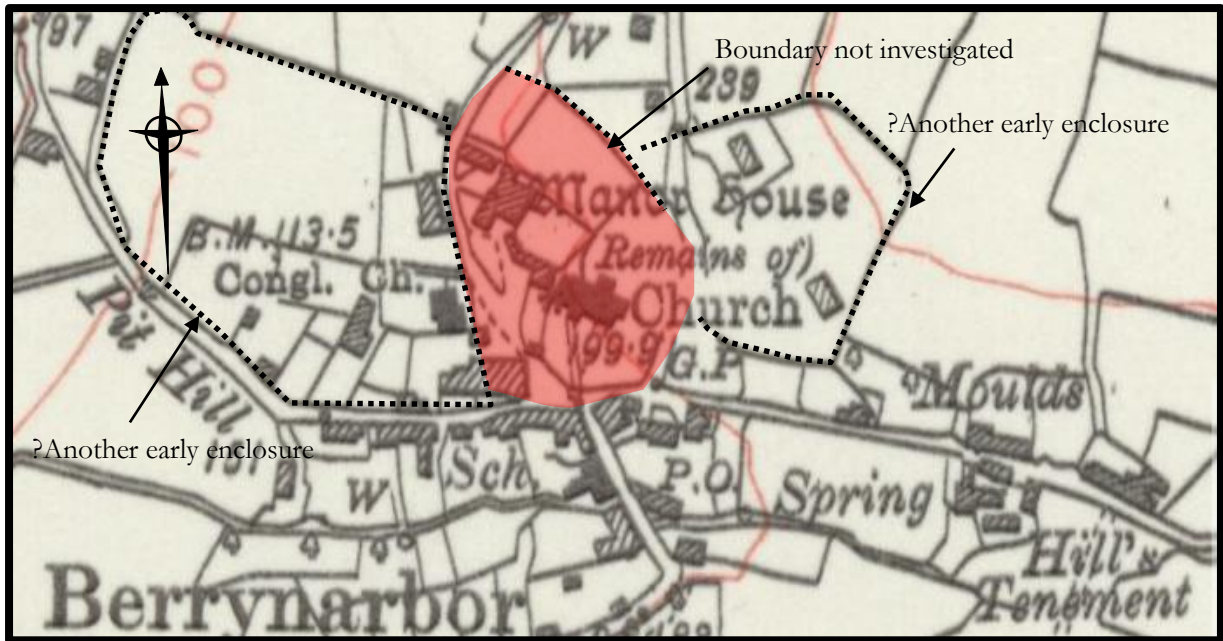
Fig. 2 Suggested early manorial enclosures at Berrynarbor (shown in pink or with dashed lines).

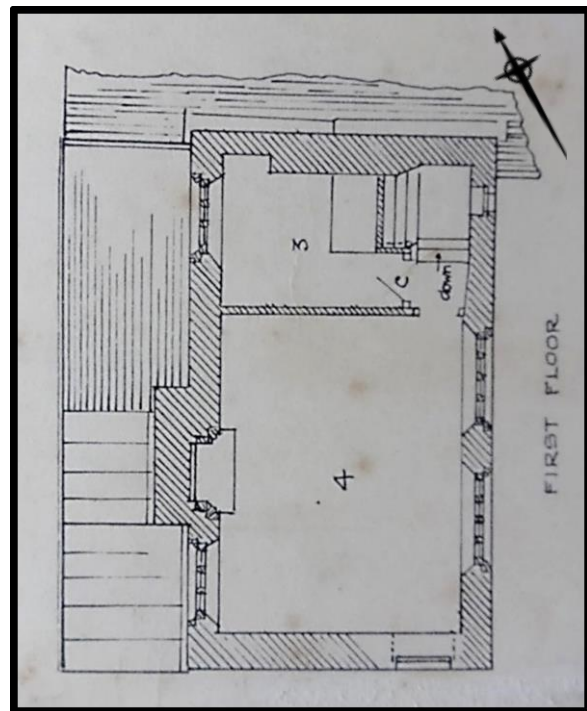
Fig.12 Extract from the drawing showing the first-floor plan in 1941.

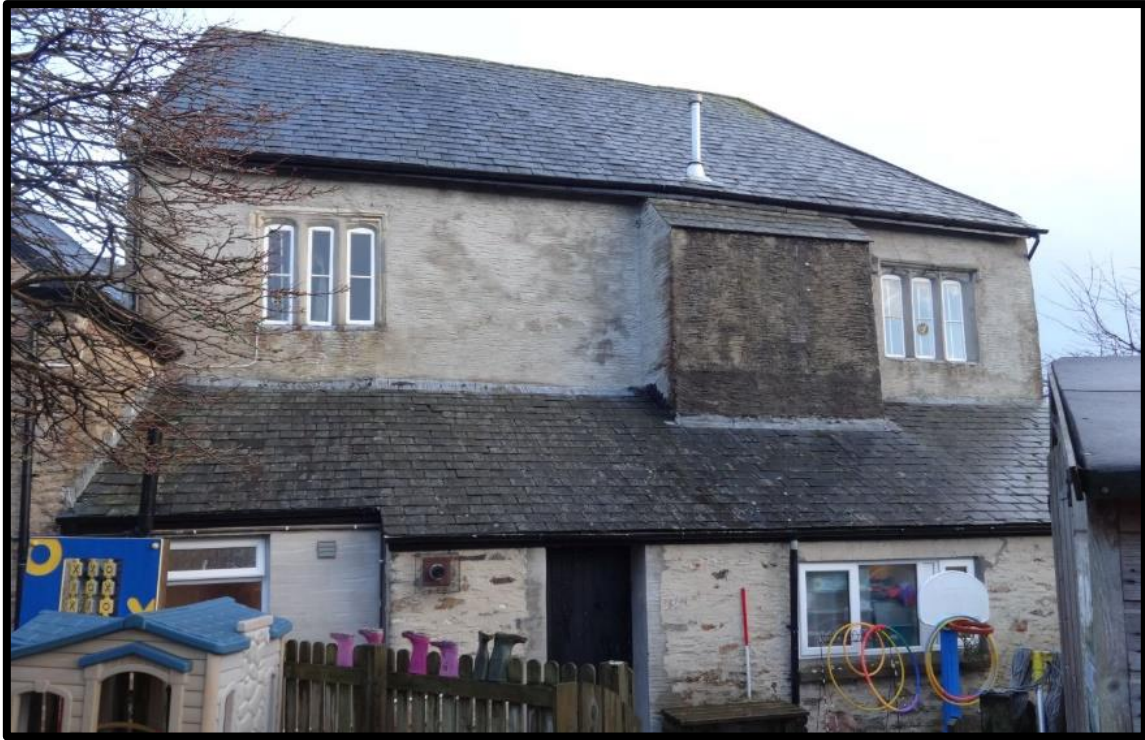
Fig. 19 West elevation of the west range showing the two three-light windows at first-floor level and the large chimney breast serving the fireplaces at ground- and first-floor level. The lean-to probably dates from the 19th century.

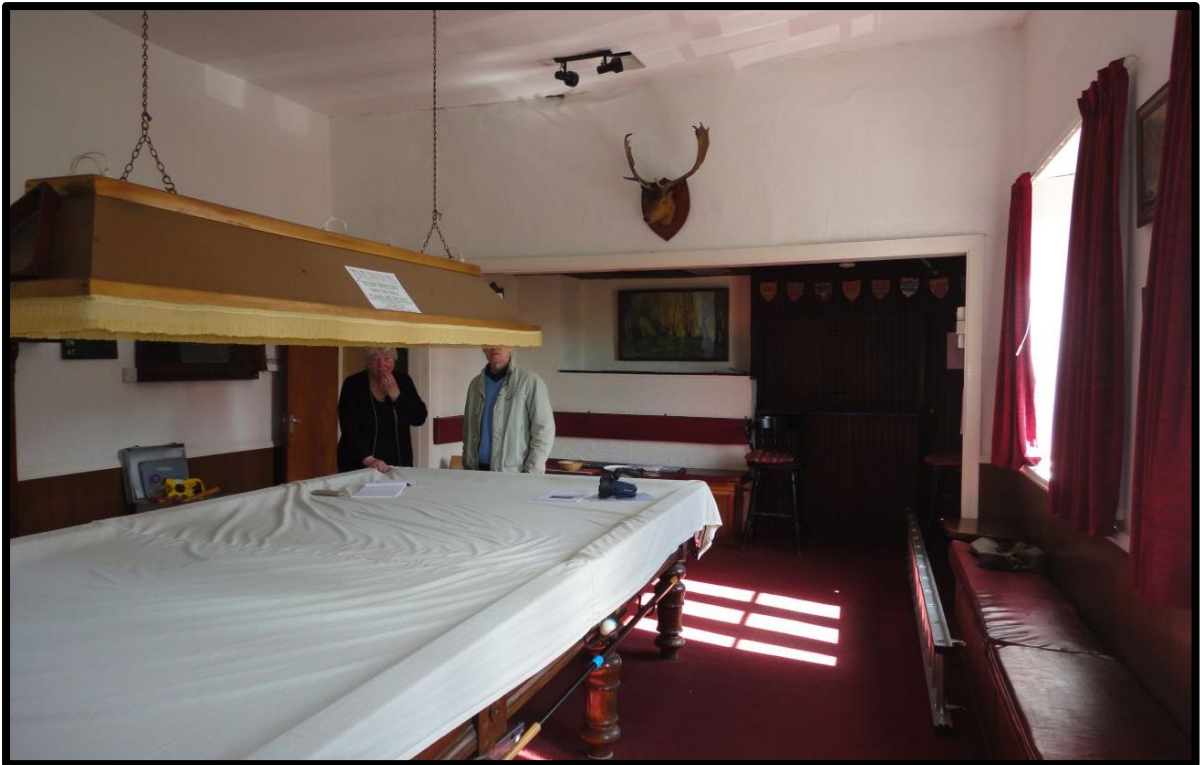
Fig. 23 View of the Billiard Room on the first floor, looking north, showing the lower ceiling in the bar area beyond the 'arch'. The upper part of the wall above the arch retains early fabric and evidence of historic plaster.

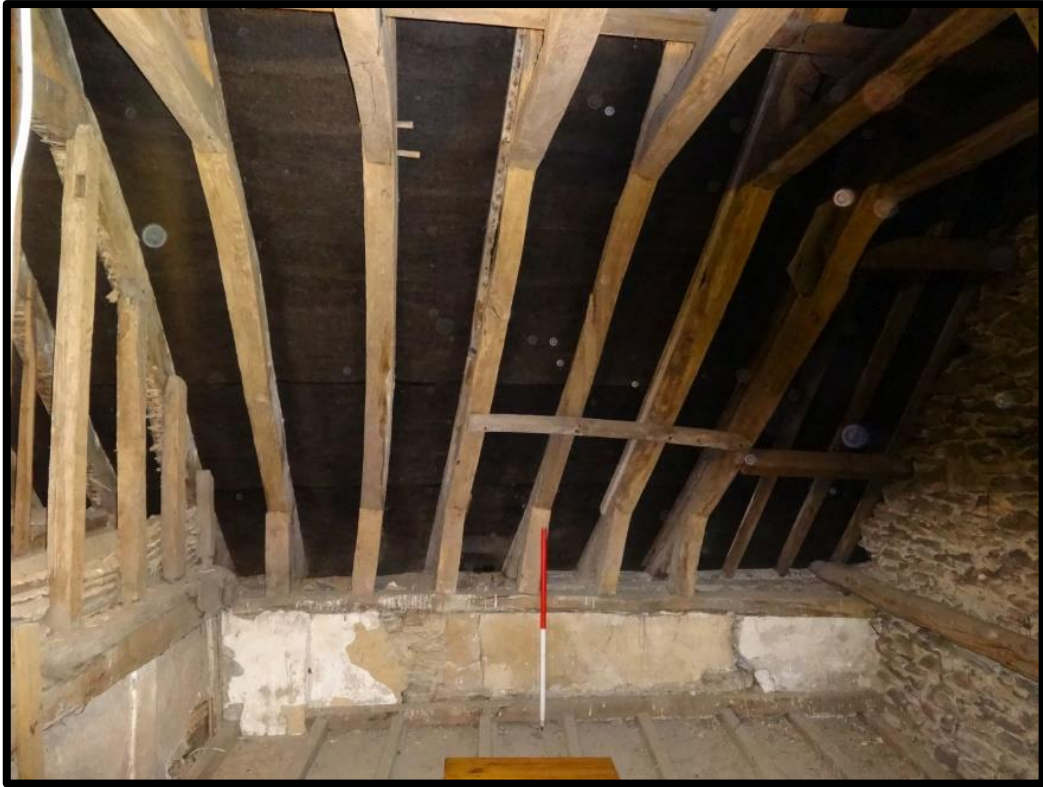
Fig. 24 View of the roof structure, looking west, showing the evidence for historic partitions and plaster finishes to the smaller first-floor room; also the complete rebuilding of the northern gable above this level.

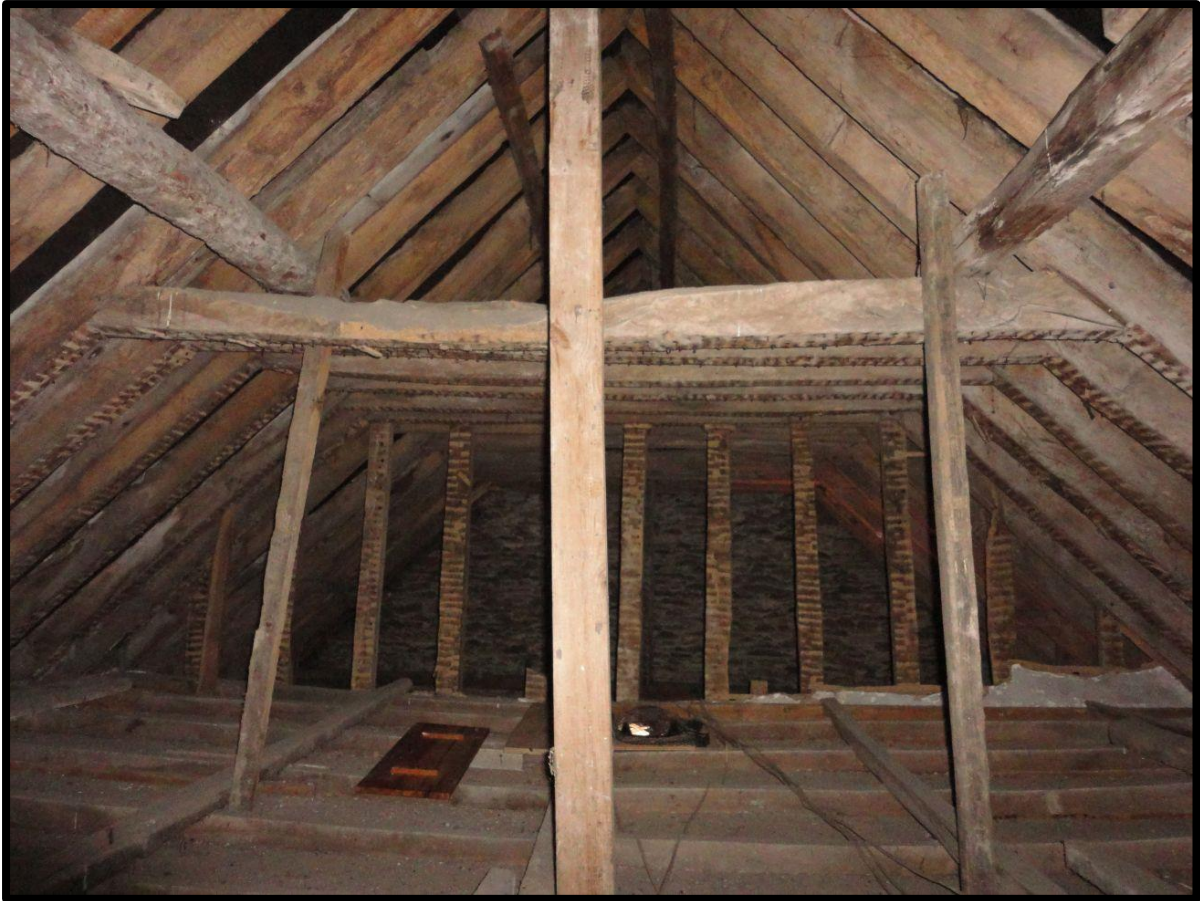
Fig. 26 View of the roof structure over the west wing showing the inserted flat ceiling in the southern part of the first floor and the evidence for lath and plaster forming a high, canted ceiling. The 'purlins' on either side are modern insertions.

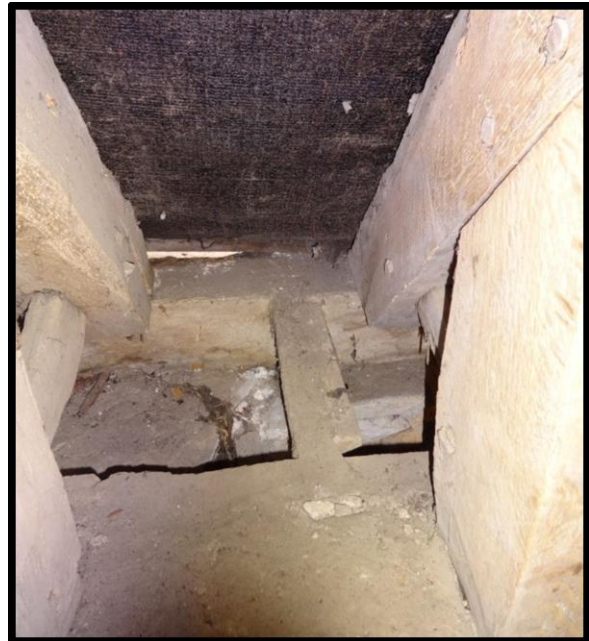
Fig. 28 Detail of the short dovetail ties linking the wall and eaves plates across the wall tops. Note the apparently good condition of these members.

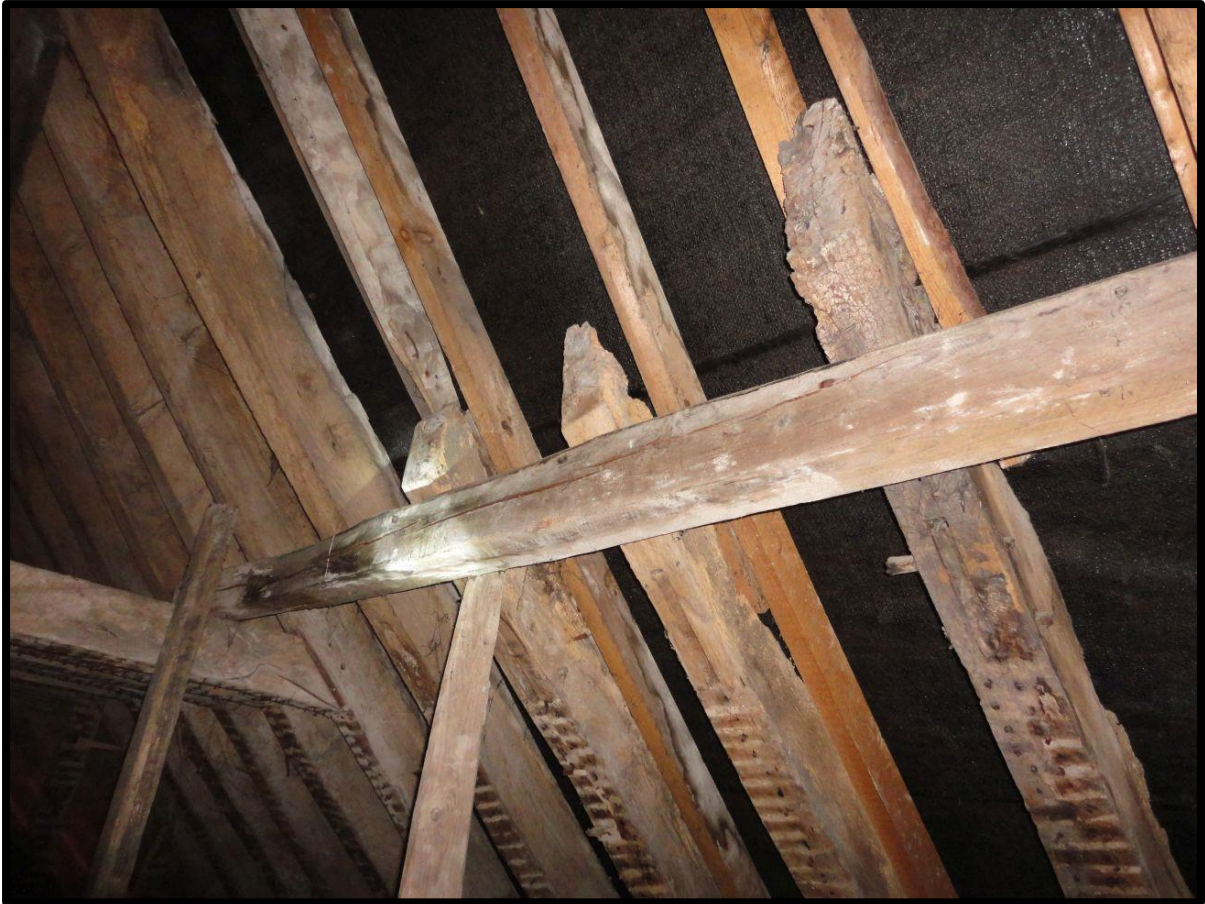
Fig. 29 Detail of the truncated rafters at the centre of the roof showing sockets for the collars, now sawn short, inserted purlins and re-shaped ends to each rafter allowing them to rest against the chimney.

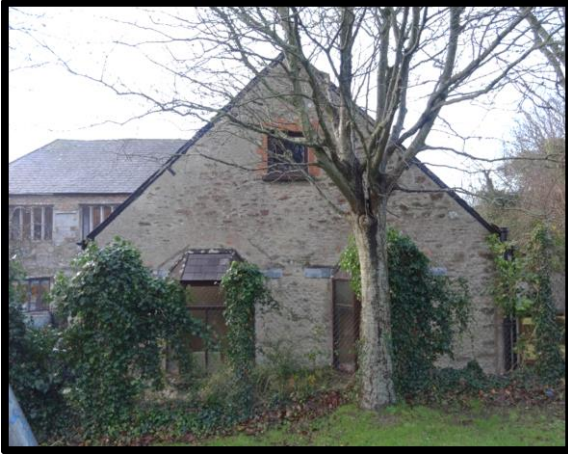
Fig. 31 View of the eastern gable of the hall, showing red brick dressings to the windows.
