Lady Well Dumfries House, South Ayrshire

Excavation: June 2017

Report date: August 2017

Job number AA: 2196

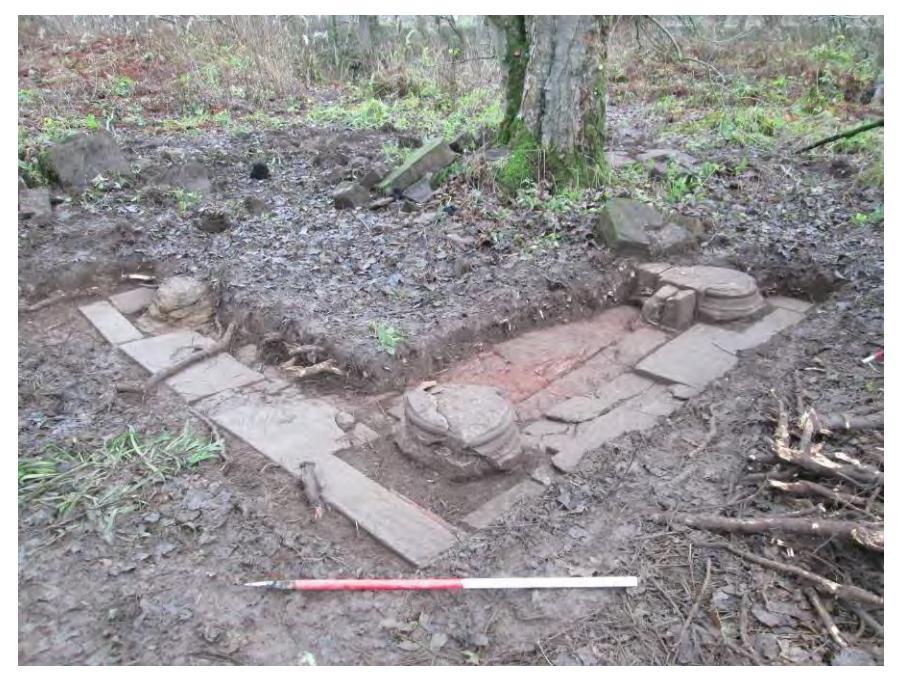
Plate 4 South and East footings of the Lady Well, looking north-west (042)

The evaluation revealed that the area under the arches and within the interior of the superstructure was surfaced with cut blocks and flags of red sandstone (*plate 4*). Large slabs of a fine-grained pale grey polished sandstone formed the outer edging of the structure, this extending beyond and around the column bases.

The red sandstone slabs were considerably fractured and delaminated; it was thought possible that this damage was caused in part by the explosives used to destroy the building. Some of the outer slabs were also heavily damaged; however, it was not possible to tell whether this was the result of an explosion or the slower process of damage by ground water and penetrating tree roots causing delamination along bedding planes.

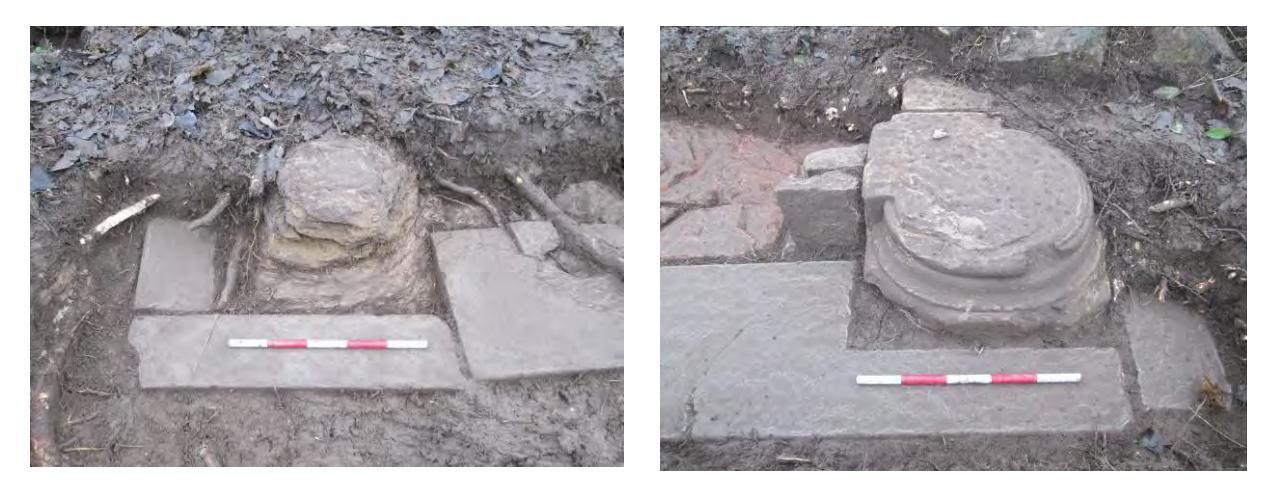
Three of the superstructure's column bases were exposed; these were laid out within a square of about 3.3m (*plates 5 and 6*). The bases were integral to the underlying platform structure. The south-west base was in very poor condition, much eroded. The southeast base was in somewhat better condition, retaining most of the moulded detail around its base, but with some significant structural cracking. The northeast base was in good condition retaining its original form and moulded detail. These moulded bases are not visible on any of the historic photographs and it is notable that their profile is at variance to that shown in the 1944 drawn survey.

Plate 5 South-west column base

Plate 6 North-east column base

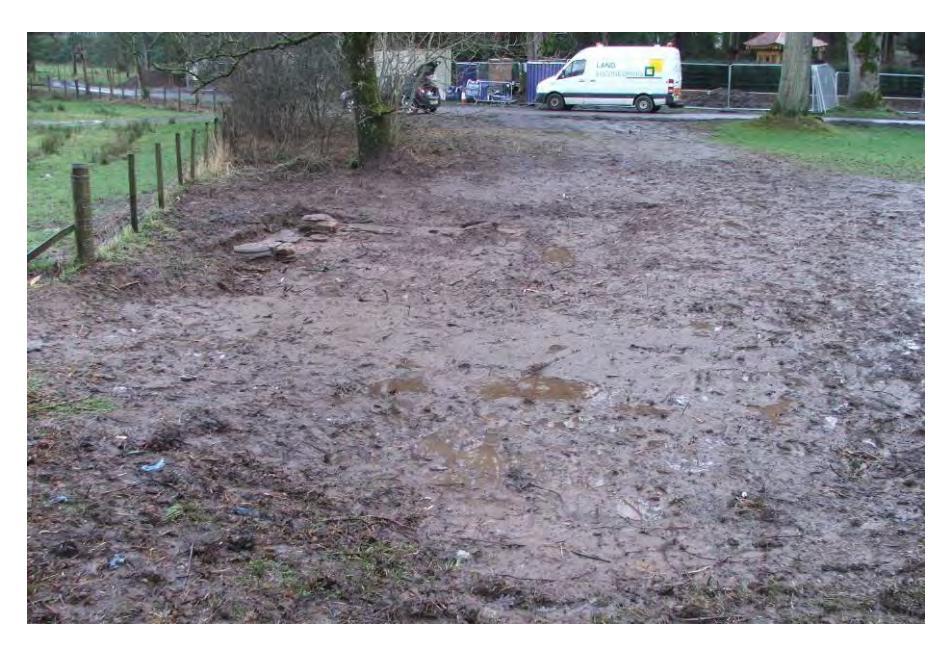
Following the initial evaluation, the Estate tidied up the surrounding area. This tidying involved machine removal of trees, stumps, roots and a general grading of the site down to the top of the surviving masonry. This was followed by a period of flooding which left the site under a depth of sticky machine disturbed soils (*plate 7*).

Plate 7 state of site left by machined groundworks (site mid left)

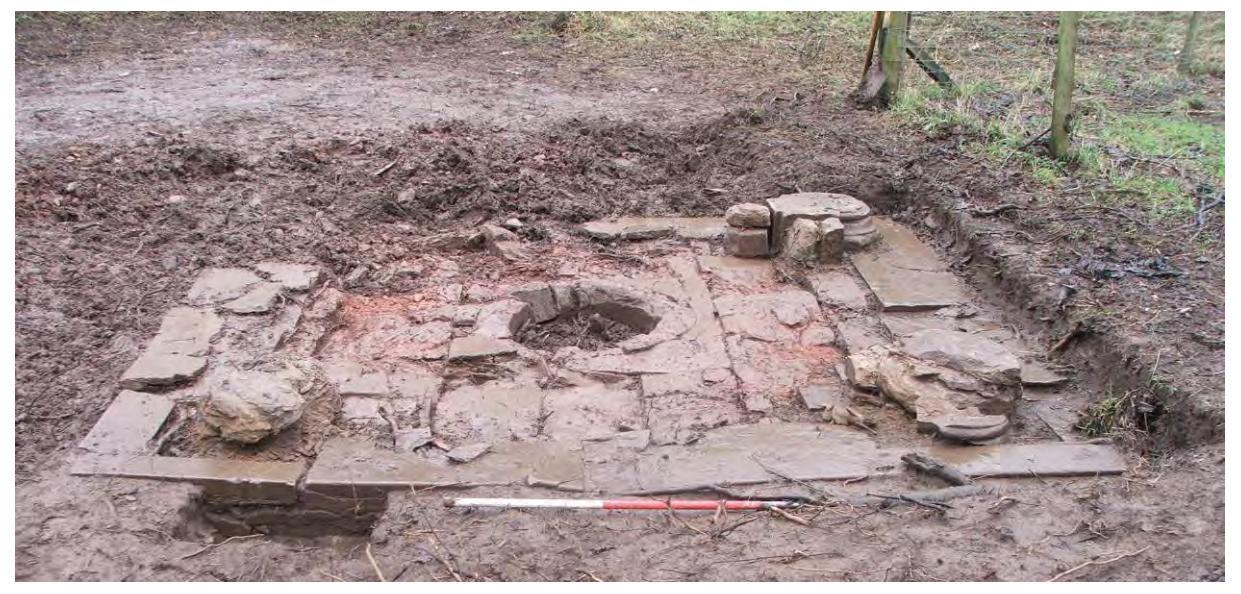
With limited time, the masonry was cleaned up as much as possible. This uncovered the round wellhead for the first time. This was 0.70 m in diameter internally and formed in red sandstone the same as the surrounding flagstones; the damage to the western corner from grubbing out the large tree stump was noticeable. The general degraded condition of much of the masonry was also clear.

Plate 8 Lady Well as exposed

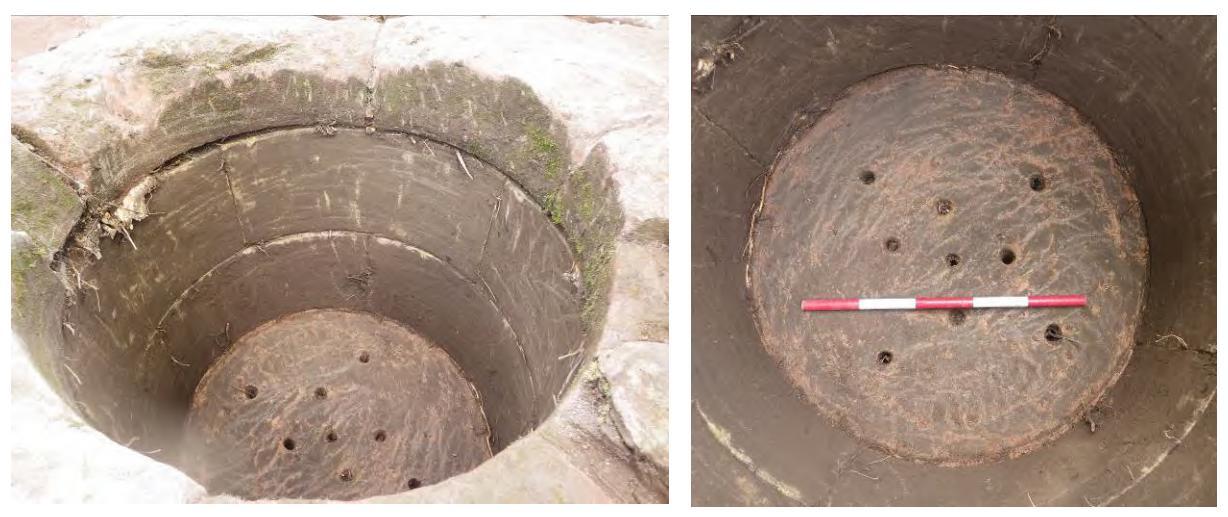
The first element to be constructed was likely to be the well shaft 002; this was very neatly formed from blond ashlar sides forming a 0.70m diameter shaft. These sides were built up from a red sandstone base, which sat at 0.76m (30 inches) below the finished floor of the structure and underlay the masonry of the sides. This base was of a single slab of sandstone polished smooth, with a shallow circular depression in the centre. Nine small 25mm diameter holes were evenly spaced drilled through the base, five within the depression area and four around (*plates 9 and 10*).

Plate 9 sides of well shaft

Plate 10 base of well shaft showing drilled holes

As the masonry of the well base was in good condition and left intact, what lies beneath was not discovered; probes pushed through the holes in the base indicated a compact silty soil but no structure was encountered for the 0.3m of the probe.

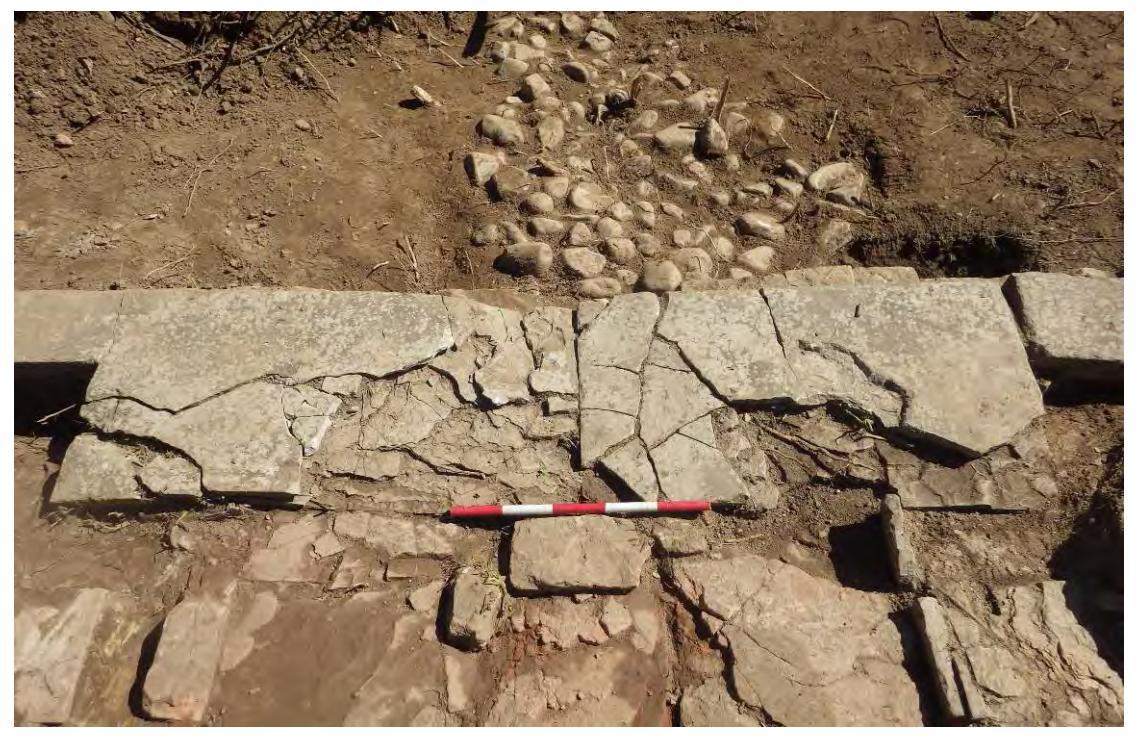
The main access into the structure appears to have been unsurprisingly from the southeast along the cobble path 013. The kerbing 006 in this area is heavily worn and damaged at this point as is the lower kerbing 005 of the upper foundation (*plate 14*); elsewhere these stones are damaged but noticeably unworn.

Plate 14 wear on kerbing showing main access point at SE

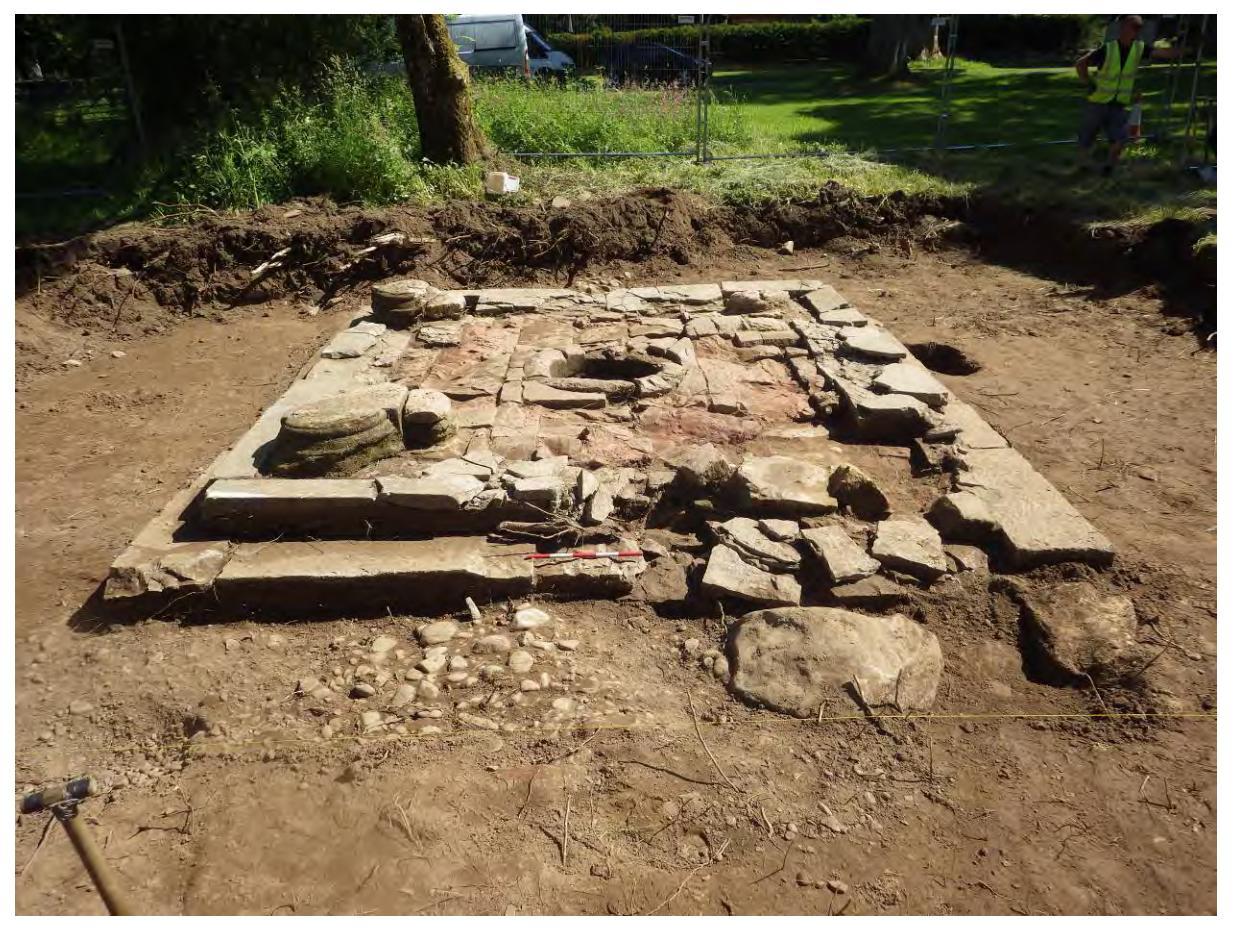
Plate 15 NW side showing metalling/cobbling 014 and damage left by grubbing out tree to right

The northwest side of the structure was heavily affected by the removal of a tree. This also destroyed the western half of the metalling 014, but the eastern half-survived and a strip along the base of the structure was cleaned up and recorded prior to digging a trench to fully expose the foundations.

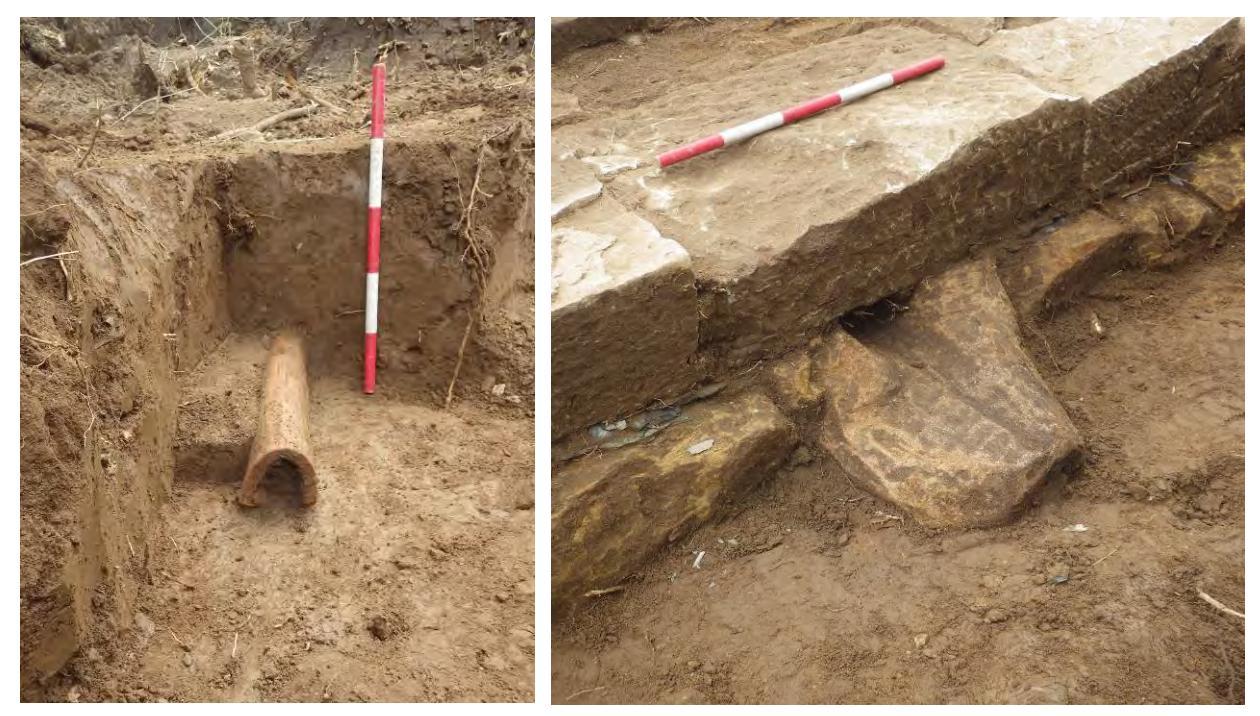
Plate 17 clay horseshoe shaped overflow 011 running to the SW

plate 18 cut stone "spout"012 built as part of 003 foundation running into the clay drain 011 to the bottom left (removed)

This field drain 011 (sample 3) was positioned directly on the soil with no base and ran up to/from a sandstone "spout" 012 built within the foundations and with a channel cut in its surface. Where the drain joined the spouts opening it was packed around with broken drainage tiles and capped at the junction with an offcut from the polished grey kerbing 006 (sample 4).

The spout 012 was clearly integral to the foundations and the drain was capped with construction offcuts from the structure's original build, which demonstrates that this was an original built feature rather than a secondary insertion (*plates 17 and 18*).

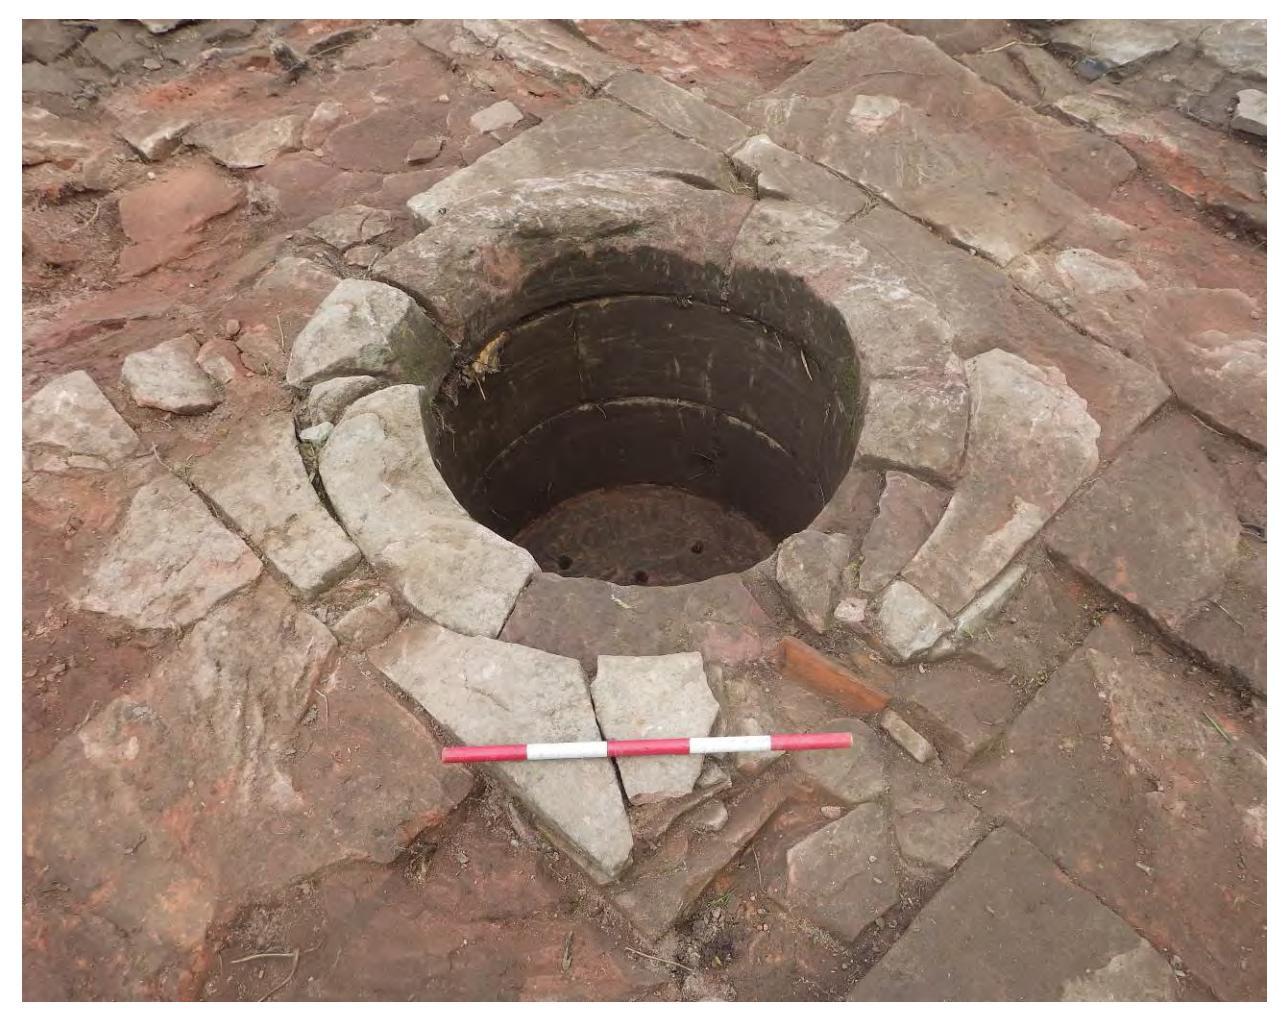
The upper course of the well shaft forming the rim was removed down to the next course as it was badly damaged (*plates 19, 20, 21*). This allowed further investigation of the construction of the

Plate 19 upper rim of well shaft 012 as first exposed shows overflow drain 011 and cut 010 in relation to original (worn) floor level (above right end of scale)

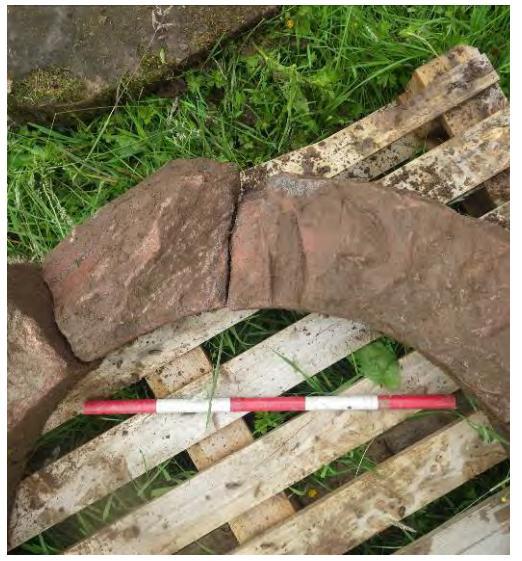
Plate 20 removed upper course of well shaft showing overflow cut 010

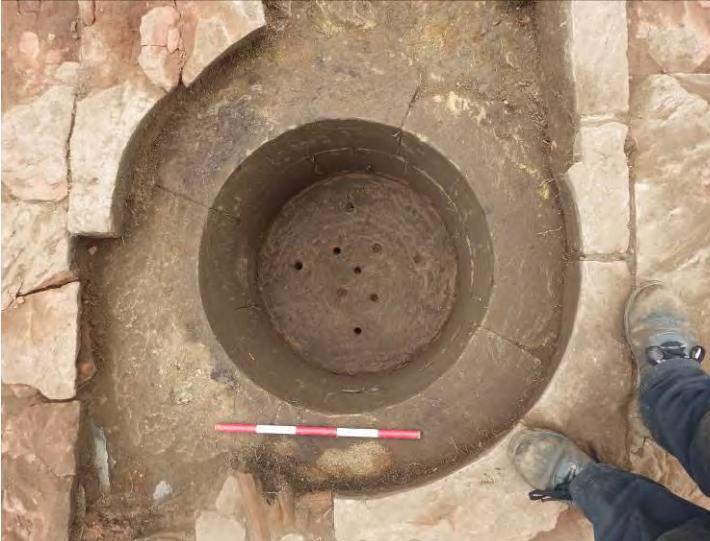
Plate 21 upper course of well shaft 002 removed showing construction, overflow at bottom

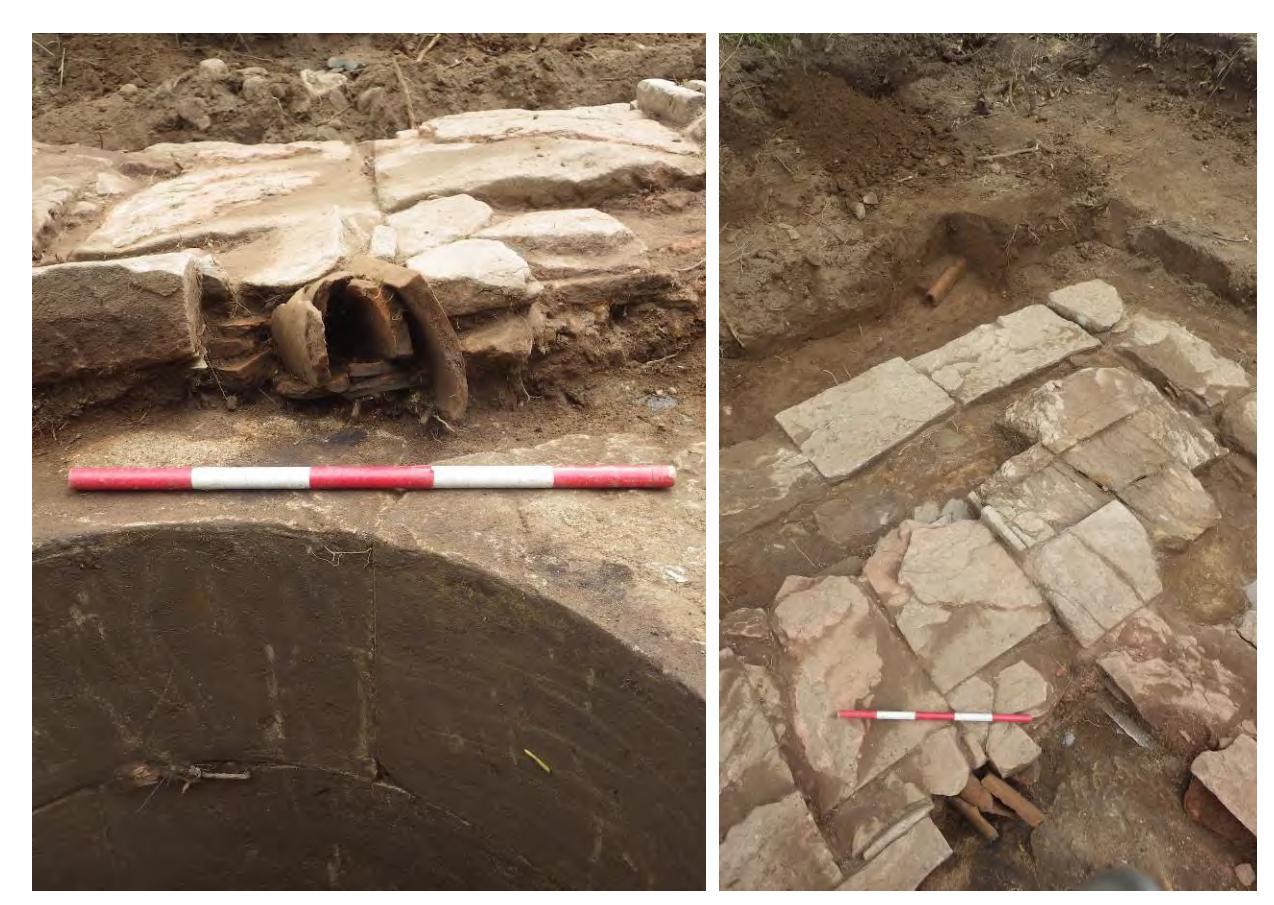
overflow. The horseshoe drain 011 was seen to utilise the side of a larger broken drain tile as a base, at least at the upper part, but also likely to be the same as it sloped down through the masonry. The drain was also packed around with broken drain fragments (*plates 22, 23*).

Plate 22 overflow drain 011 revealed (packed around with broken drain fragments) once upper course of well shaft removed

Plate 23 overflow drain system 011, well overflow mid bottom, and drain running away to the SE mid top

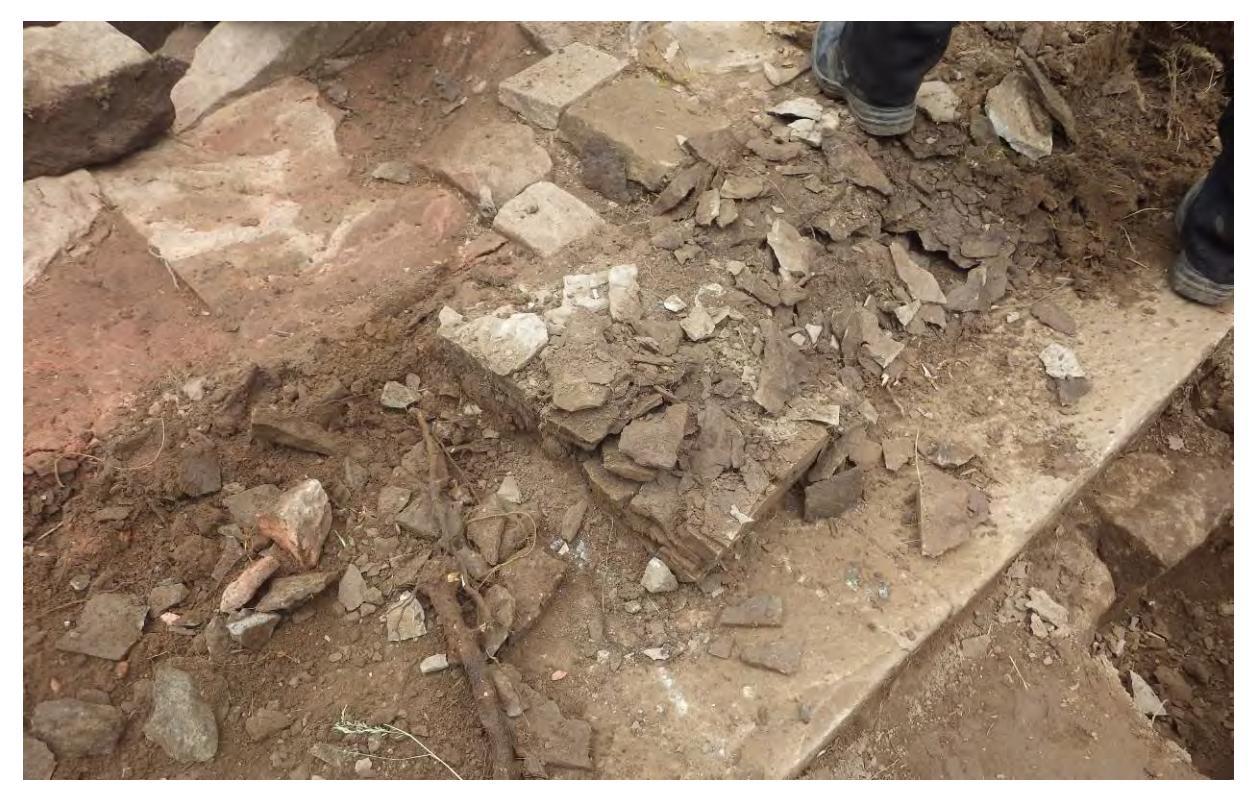
Following the recording of the exposed structure, some of the most degraded masonry was removed to provide a secure foundation for the rebuild. The kerb 006 made up the majority of the removed masonry. With the action of frost and roots this had completely shattered and delaminated so much that a shovel was the easiest way to lift the remnants of the stone (*plates 24, 25, 26*).

Plate 24 006 kerbing showing disintegration of stonework during removal

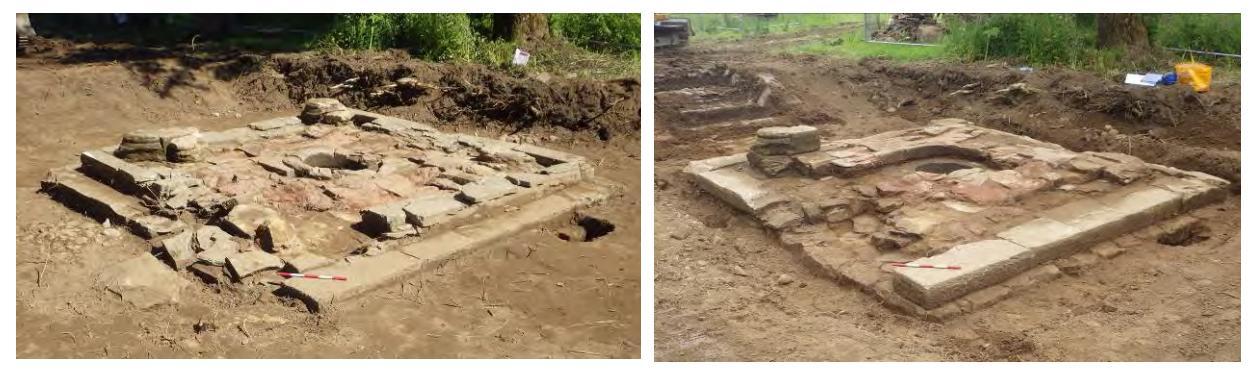
Plate 25 site pre stone reduction

Plate 26 site post stone reduction

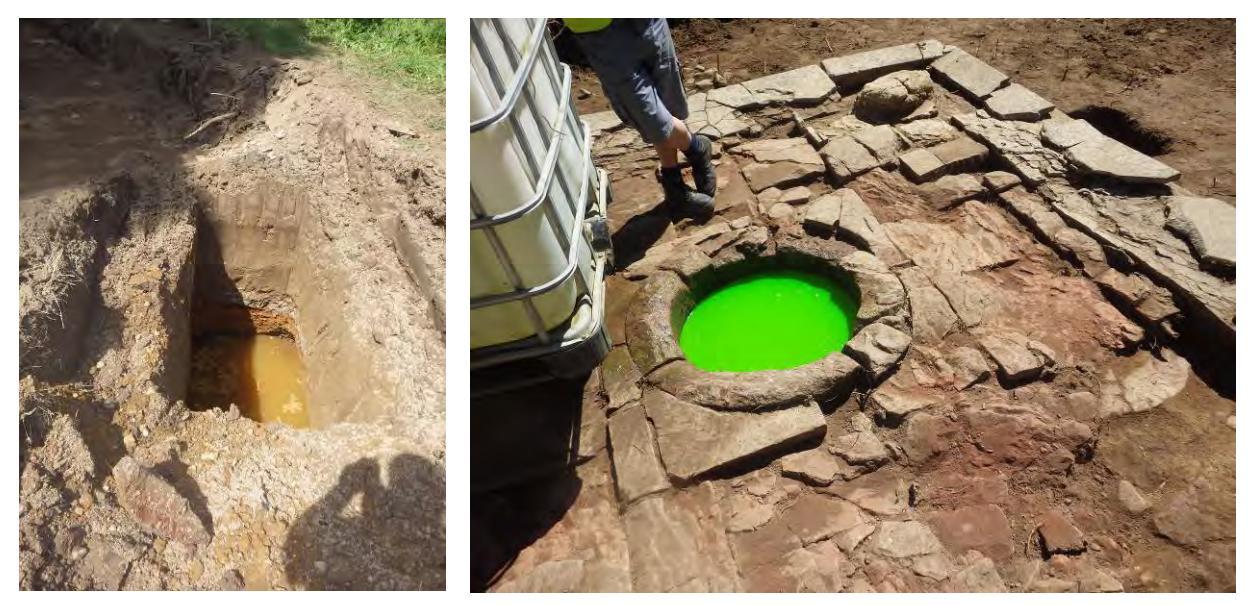
Plate 27 engineers test pit exposing the water table

Plate 28 dye testing the well

The water table was reached at some depth; this was noticeably deeper than the base of the well shaft within Lady's Well. The deposits noted were 1.30m of silty soils overlying a thin band of grey soil/gravel on top of 1m of rusty reddish gravels; these in turn overlay greyish sand and gravel to beyond the limit of excavation (LOE) at 2.70m (*plate 27*).
