# Newhailes House and Estate

## *Musselburgh, East Lothian*

*Flower Garden: Historic Building Record and Assessment*

### Historic Building Record and Assessment

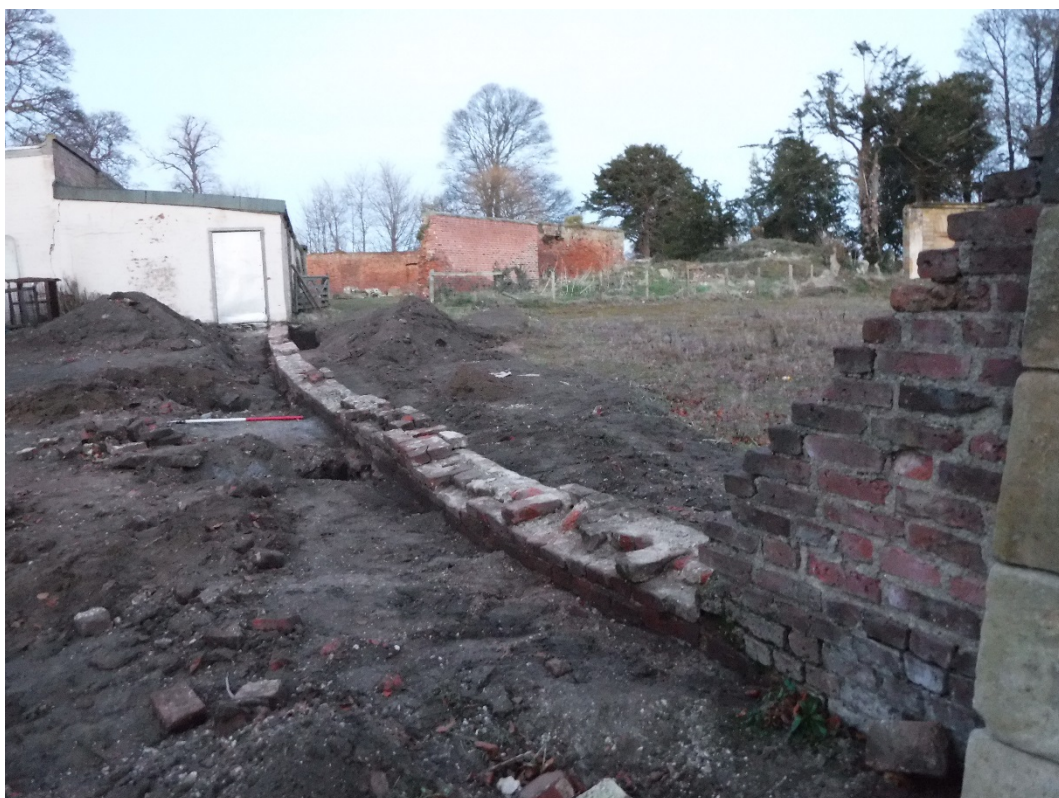
The exposed footing for the Flower Garden wall **(103)** extended between an existing storage shed in the Flower Garden Yard to the north-east (incorporating elements of the original wall) and a surviving element of the curved boundary wall to the south-west. The wall footing observed a gentle curve for a length of approximately 18 metres. It was constructed of 18<sup>th</sup>-century hand-moulded bricks, arranged in English Garden Wall bond, secured with a light-grey lime mortar. In the inspection pit it was revealed that the seven lowest courses stepped out, in order to provide a firm foundation for the upper reaches of the wall. The lowest courses of the stepped-out section were crudely pointed, with excess mortar filling gaps between irregularly arranged bricks. There were on average up to four surviving courses of brickwork above the projecting lower courses, commencing with a neatly arranged, well pointed stretcher course. Alongside the reduction of the wall height to the present ground level, it had evidently been cut by a service trench to the north-east, with cabling still intact. There was no clear evidence of multiple phases or distinct zones of repair in the section of wall inspected.

*Plate 1 exposed wall footing, looking north-east*

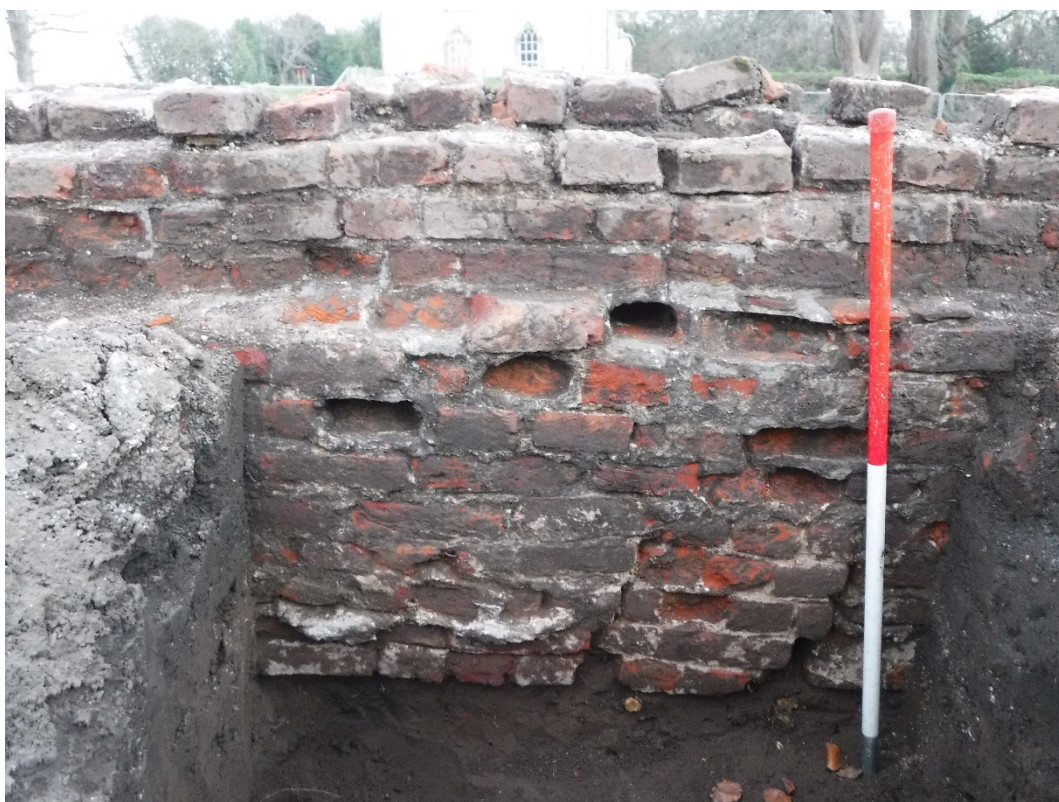
*Plate 2 elevation of external face of wall footing, looking south-east*

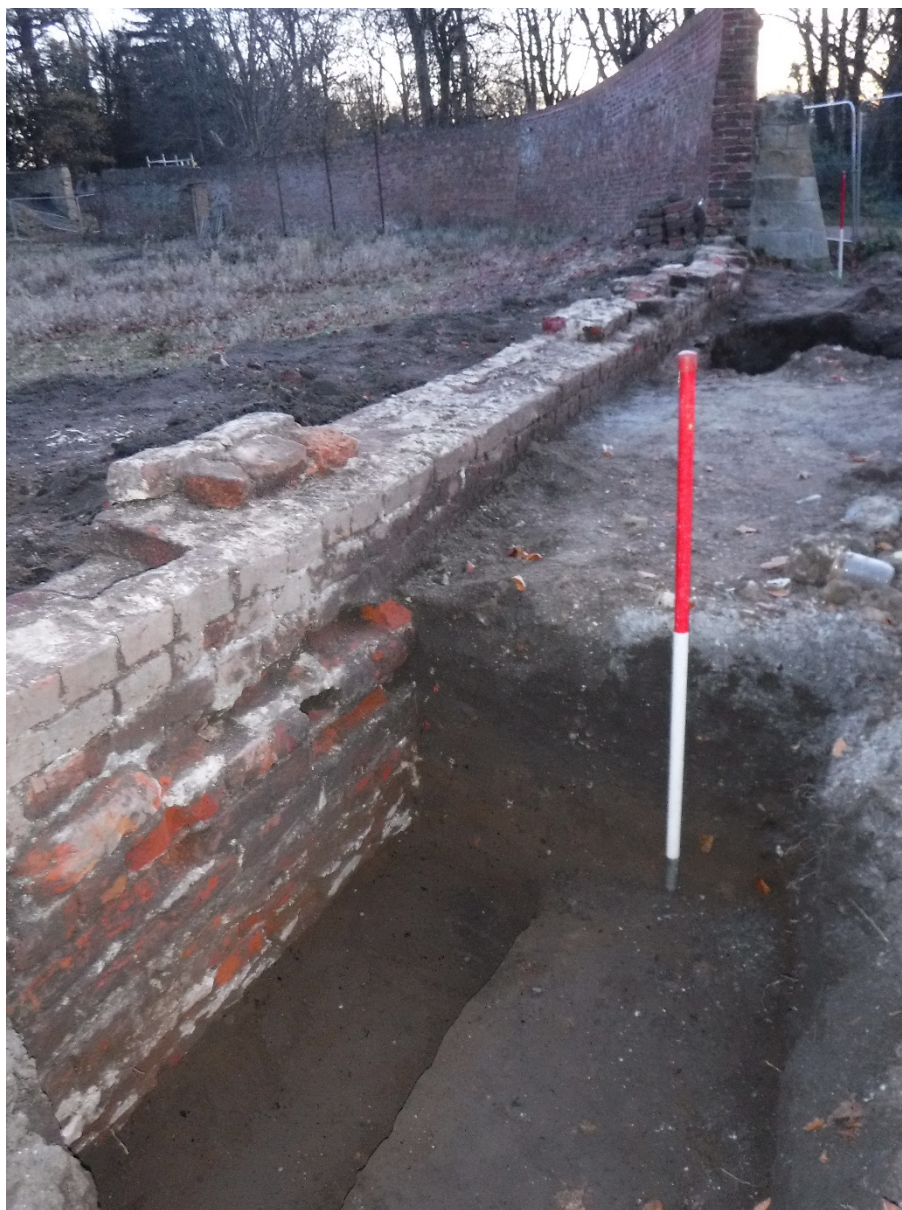
In cross-section, no foundation cut was observed in association with the brick wall. On either side of the wall, a mid orangey-brown silty sand, interpreted as a buried garden soil, was observed banked against the wall **(102)**, overlain by the present topsoil, which comprised a dark brownish-grey silty sand **(101)**. The upper horizon of the buried garden soil was noticeably higher within the Flower Garden itself. A demolition layer of friable ash and well-sorted sub-angular rubble and gravel overlay the topsoil against the external face of the wall.

*Plate 3 Oblique view of soils banked against the external face of the wall footing, looking south-west*

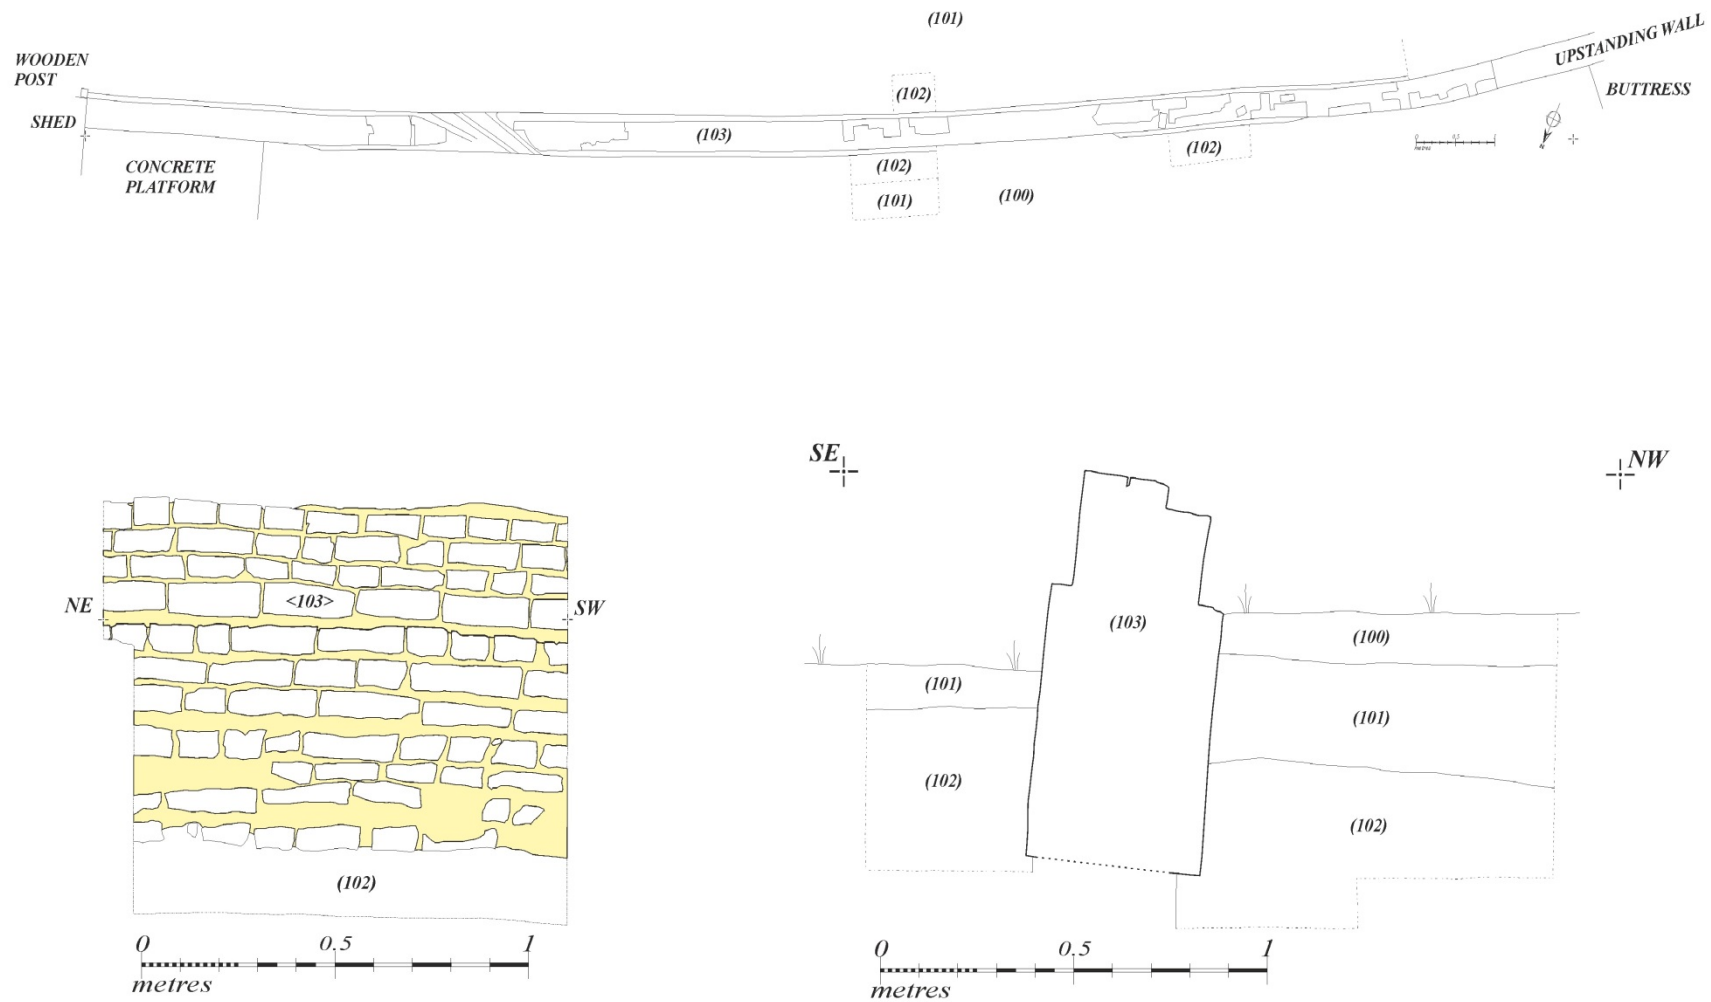
Figure 8 Plan, elevation and cross-section of wall footing, Flower Garden, Newhailes House and Estate

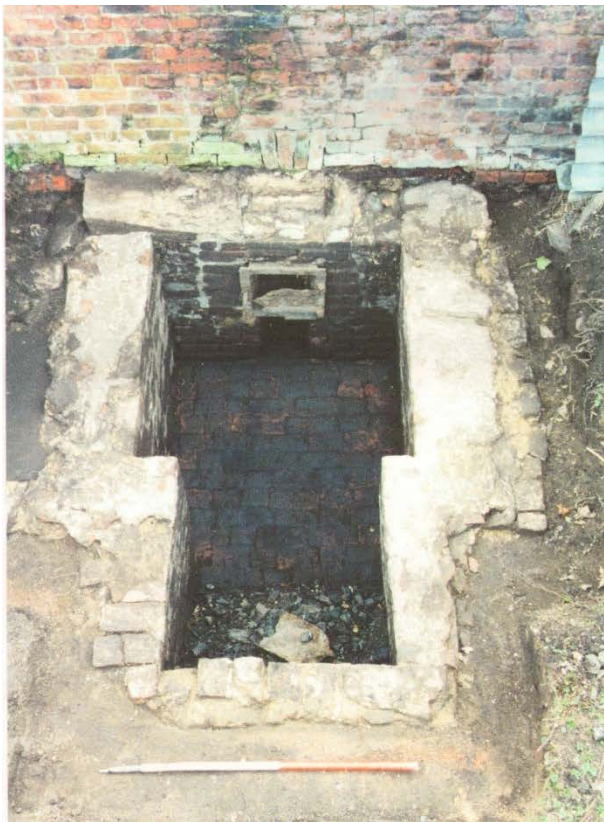
The firebox was located within a sunken brick-lined pit, about 1m deep. This structure was almost square in plan (1.24m wide by 1.20m), with a further smaller square projection from its N wall of 0.90m by 0.90m. The pit floor was formed of bricks lain flat, this continued into the ash pit below the firebox.

*Plate 2.10 Trench 38, sunken firepit fully excavated*

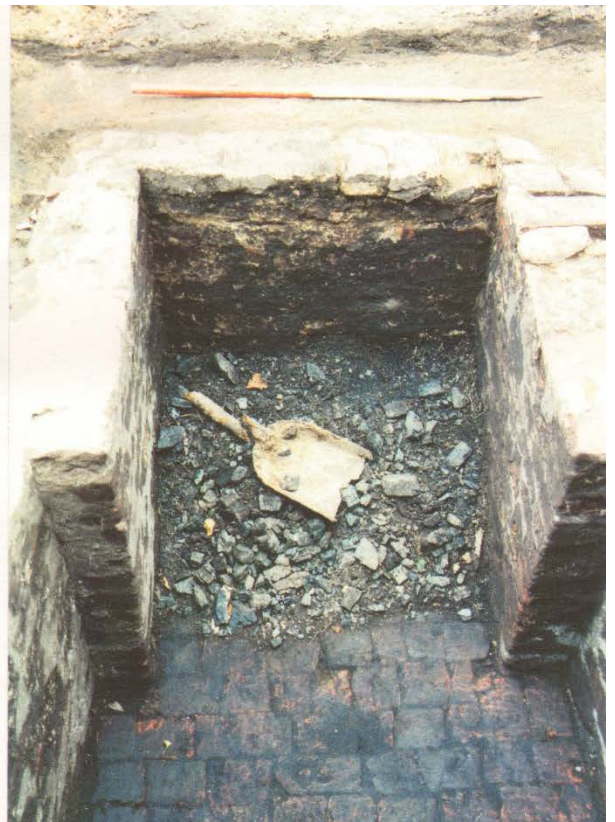
The purpose of the N projection became clear by its contents upon excavation, for within remained *in situ* a pile of coal with its attendant stoke shovel. The shovel was of iron with a wooden handle that had survived. This hand shovel neatly fitted both the stoke hole and ash pit.

*Plate 2.11 Trench 38, shows coal and shovel in situ*

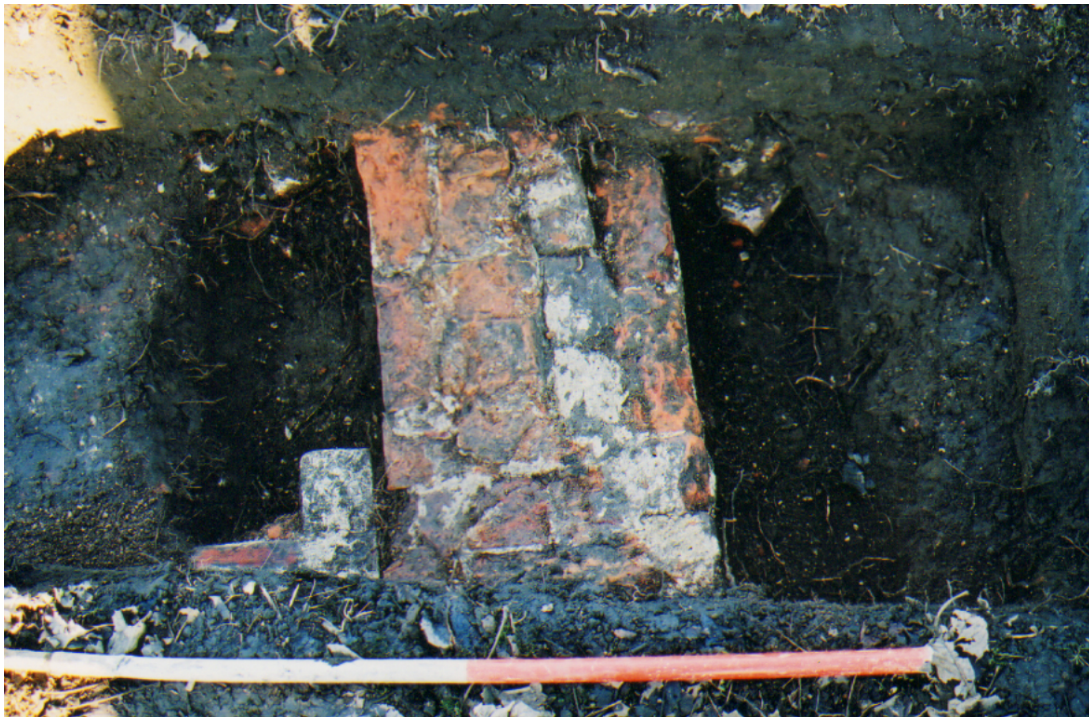
*Plate 2.13 Trench 25, masonry of former boundary wall within trench*

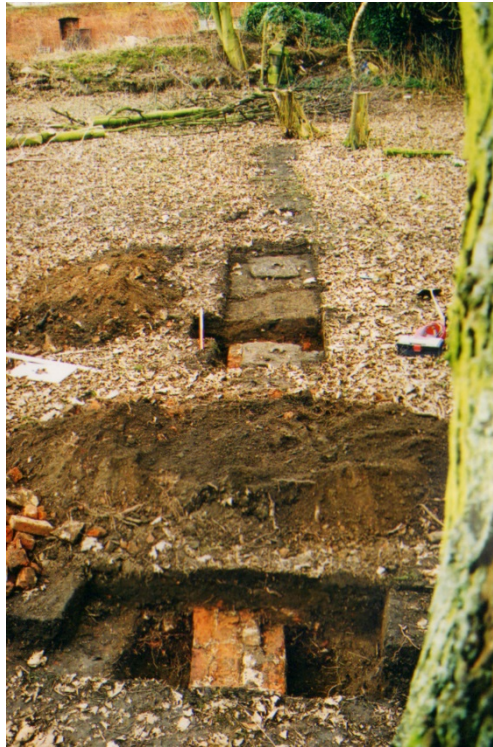
Within the trench, the wall survives to a height of 4 courses; the top-surviving course is about 20-30cm below current ground level. This sat within a cut extending 0.4m to either side of the wall (2505.F), which contained a brick rubble and loamy soil fill 2504. This fill was thought to relate to the demolition of the wall rather than its construction. Its date of demolition is not clear as the boundary line is shown on maps at least up to 1938 Ordinance Survey, whether this marked boundary refers to this wall or the iron fence line that superseded it is not obvious.

*Plate 2.14 Trenches 25 and 26 shows line of excavated boundary wall*

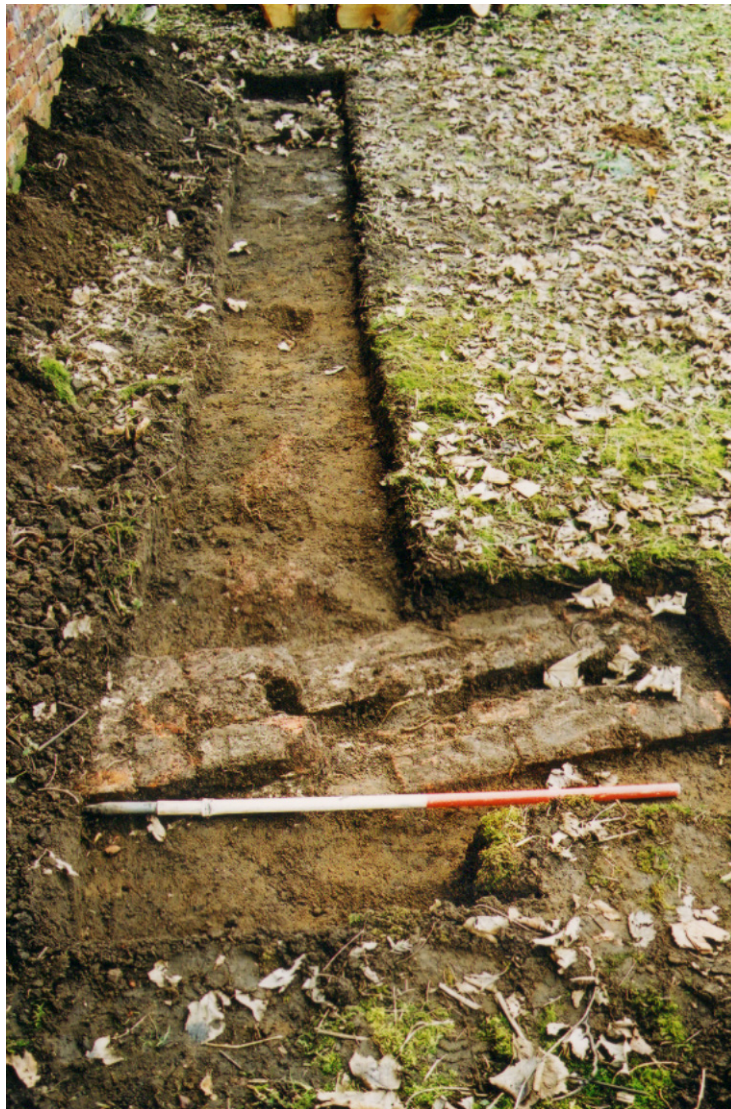
Directly below the silhouette under a shallow covering of soil, the curved wall end was identified, displaying a similar build to the other brick boundary walls on site. This wall butts against the boundary wall, not bonded in. And so may represent two phases with the curved wall inserted into an earlier rectangular garden.

*Plate 2.16 Trench 32, curved wall foundations exposed*
