EAST TULLOS BURN RESTORATION ST FITTICK'S COMMUNITY PARK ABERDEEN

- Archaeological Watching Brief -

Carried out 10th March – 1st April 2014

Report No: MAS 2014-16

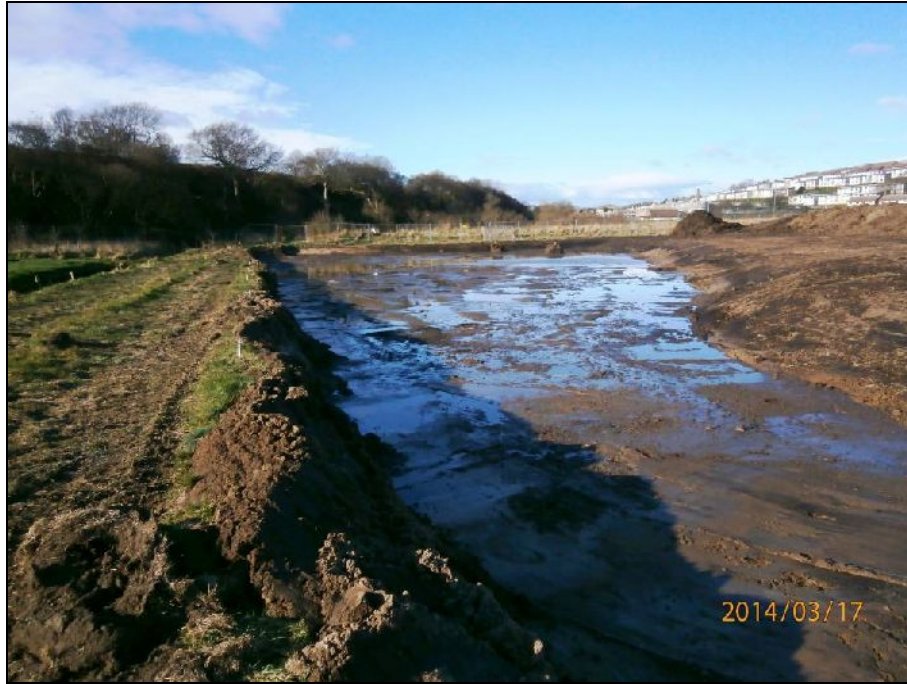
Removal of the topsoil at the Inline Pond revealed clean, smooth, compact fine grey-brown sands with patches of clay c.700mm down. This level was further reduced by 300-400mm with no change being evident.

Tile and stone drains were observed in this area and were removed during excavation works. The remnants of a modern gravel path foundation were observed at the W end but this also was excavated out.

Illus 4: View of Inline Pond, looking W

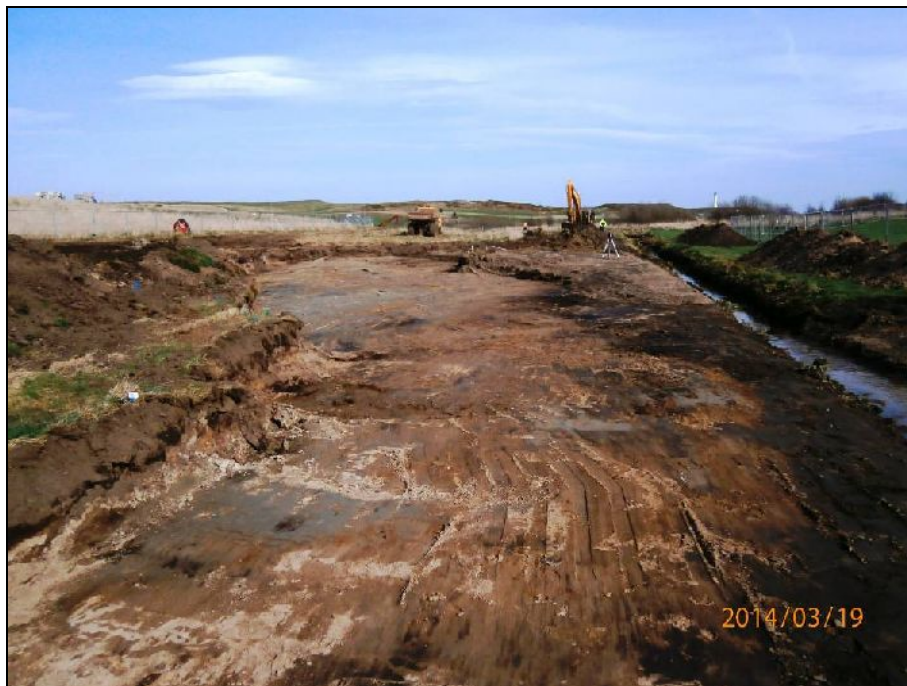
- 3.2 Excavation of the floodplain bench was observed from XS3 at the E end of the Inline Pond to XS23 at the mid point, mainly on the N side of the burn (see Illus.2). Topsoil depths on the N side of c.400mm and c.250mm on the S side, overlay clean, compact sandy natural.

Illus 5: New floodplain bench showing natural sands, looking E from XS5.

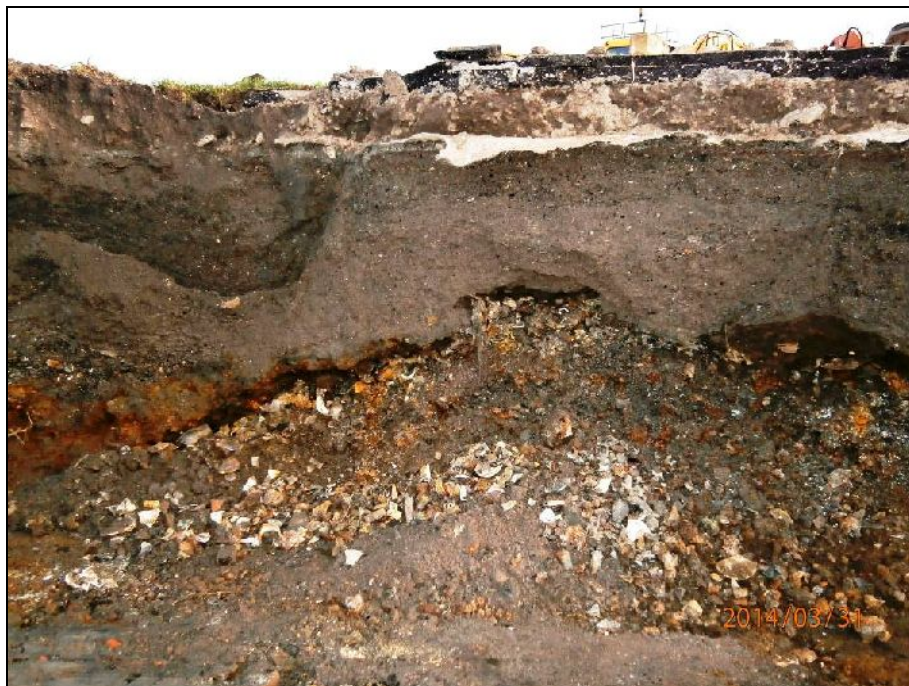
- 3.3 From XS24 to approximately XS46 (see Illus.3), excavation on the N side went through tip material, characterized by an area of raised ground levels. The tip surface, below topsoil, was a layer of cinders over a mixture of glass bottles and clay and stoneware pots and bottles, dating to the c.late 19th/early 20th century. A series of five small ponds were excavated into this material on the N side of the burn (red on E side of Illus.2 and W end of Illus.3).

Illus 6: Tip profile at XS33, looking N.

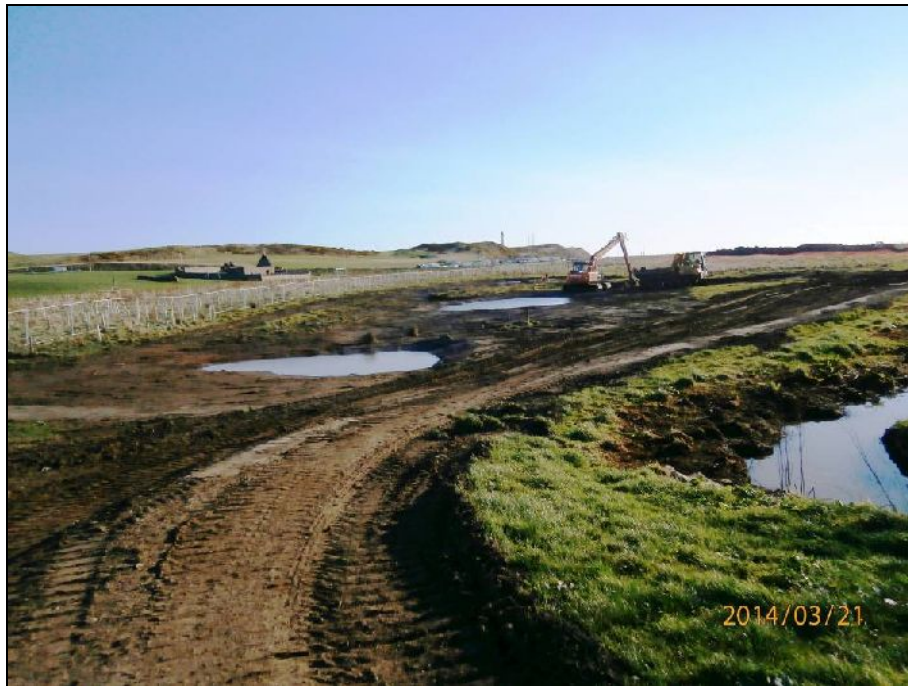
The five small ponds on the N side of the burn were dug into the tip cinder covering but not into the underlying tip material.

Illus 7: The two most westerly small ponds, looking NE.

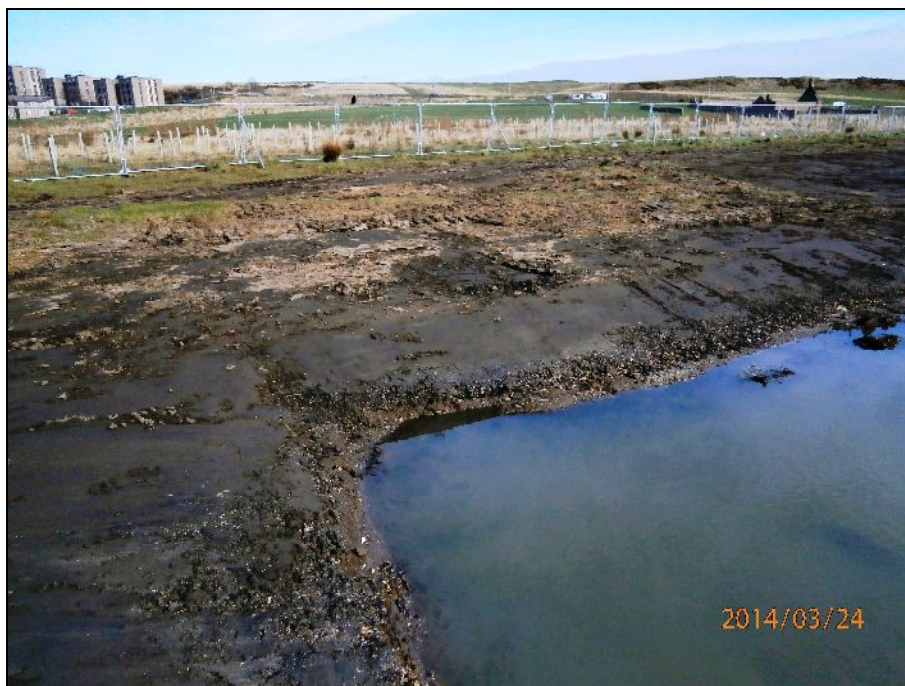
Illus 8: Small pond cut into cinder layer.
