**PATHWAY  
DRUM CASTLE  
ABERDEENSHIRE**

**Archaeological Watching Brief**  
Carried out 7<sup>th</sup> March 2016  
by  
**Murray Archaeological Services Ltd**

**Report No: MAS 2016-11**  
by  
J C Murray

**-Archaeological watching brief-**

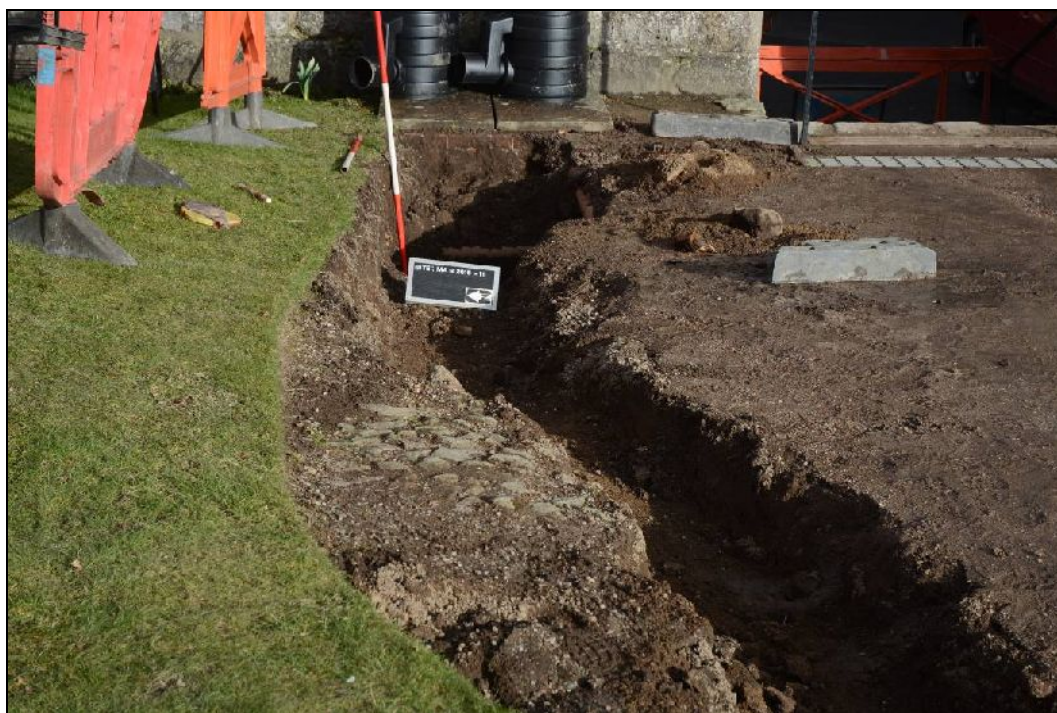
- 4.1 A new Whin dished channel was excavated along the N side of the pathway leading from the car park located to the W of the Castle, E to the castle courtyard. It was 61m long, 500mm wide, with an average depth of 300-400mm. For c.12m W of the entrance to the courtyard, the fill of the trench consisted of soil mixed with stone rubble. The trench was angled to avoid disturbance to a patch of cobbles visible on the N side of the path which may represent an earlier old pathway running SE to NW (Illus: 6, A, GPS 379596 800508), identified on the geophysical survey carried out in 2014 (Ovenden, 2014, fig.4, no.6, Illus.7).

**Illus 1: Cobbles of possible pathway (6), looking E**

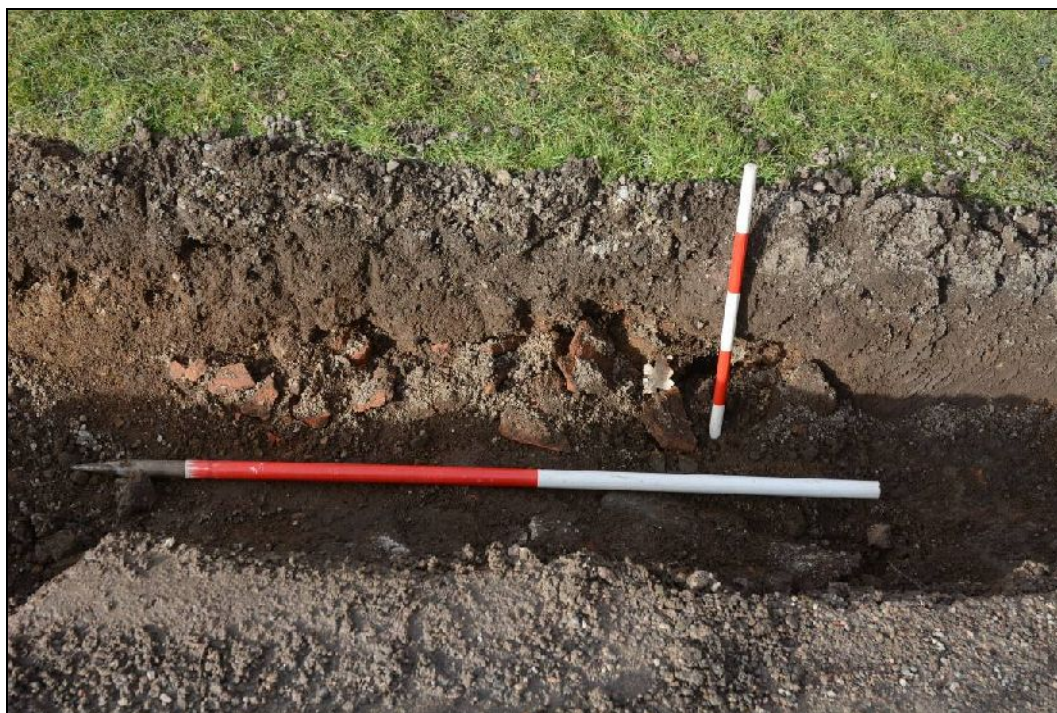
Between 12.7m – 13.5m W of the E end of the path (Illus: 6, B, GPS 379588 800506), a concentration of stone and broken field drain may represent a disturbed earlier field drain, possible running N-S across it.

**Illus 2: Possible earlier field drain, looking N**

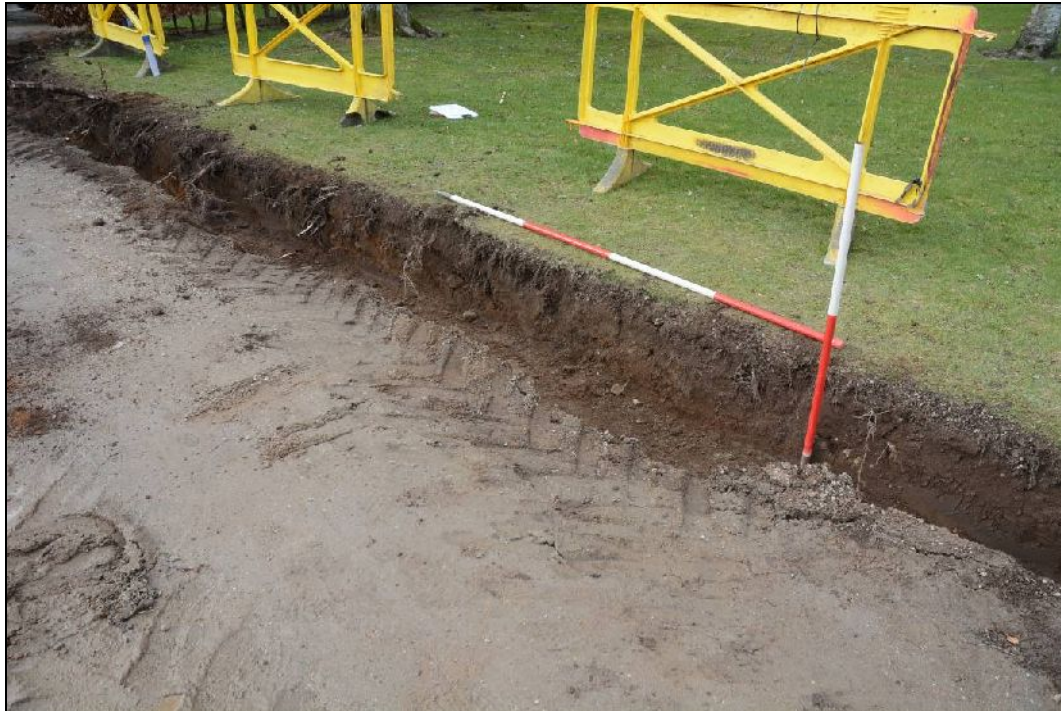
From 34.5m W of the E end of the path (Illus: 6, C, GPS 379568 800504) and continuing W to the car park entrance, the trench fill consisted of c.100mm of brown soil with some tree root overlying hard beige/yellow sandy natural with some rock outcrop visible. At c.3m SE of the W end of the channel, an electrical cable which provides light for the display on the NW side the path was located.

**Illus 3: Soil and tree root overlying natural, looking NW**

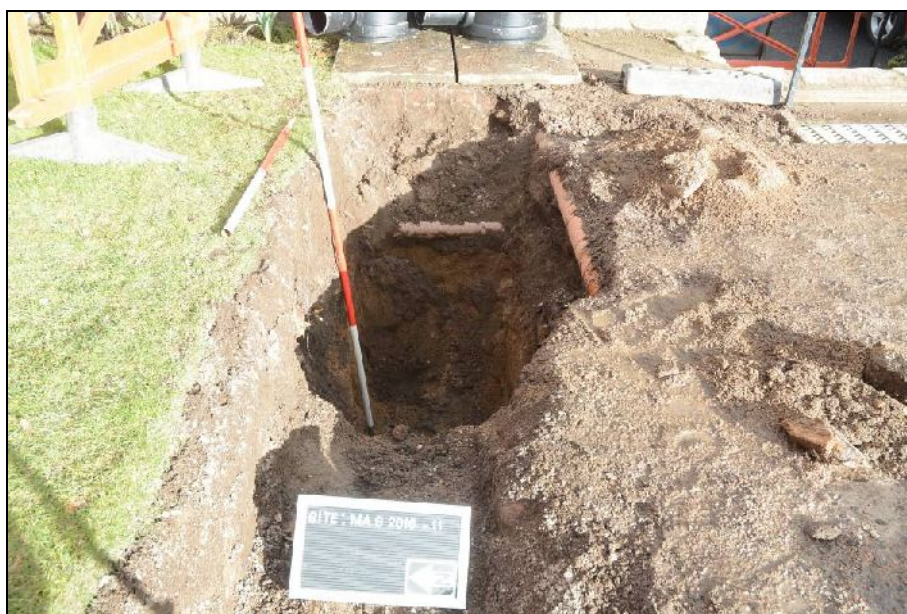
- 4.2 At the E end of the drainage channel, on the W side of the courtyard entrance, a trench 1.9m E-W x 900mm wide and 1.1m deep was excavated for a double gully pot to replace an existing brick-built drain butting up the W side of the courtyard entrance wall. This area had been heavily disturbed by earlier drainage work with plastic drainage pipes visible in the sides of the trench.

**Illus 4: Trench for gully pots, looking E**

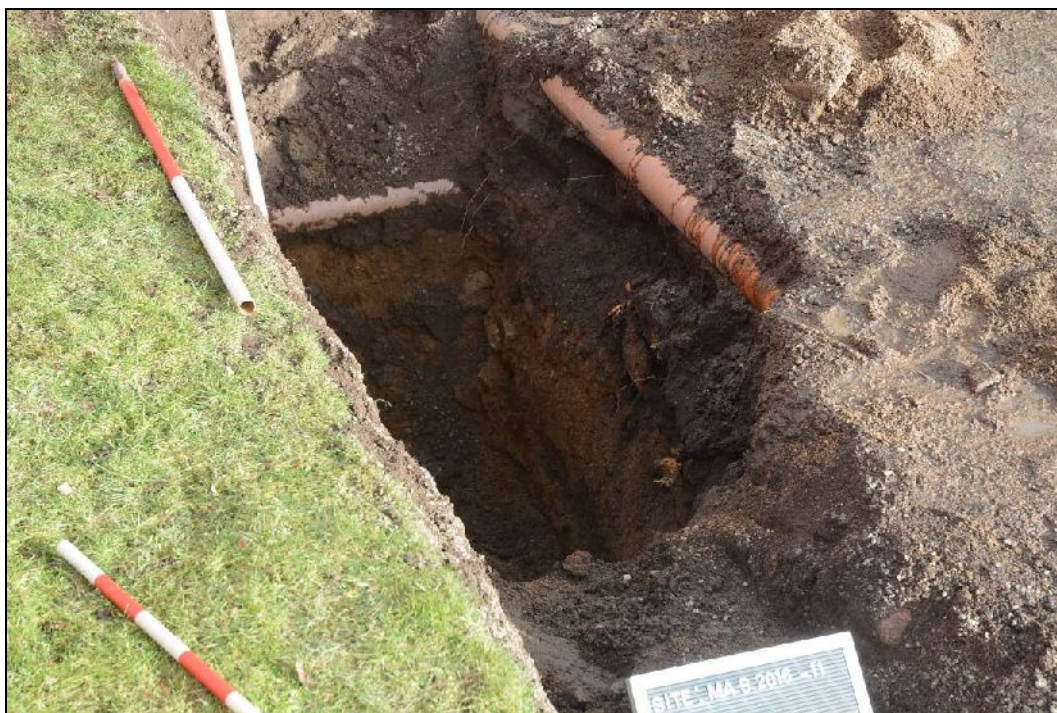
**Illus 5: Gully pot trench, looking SE**

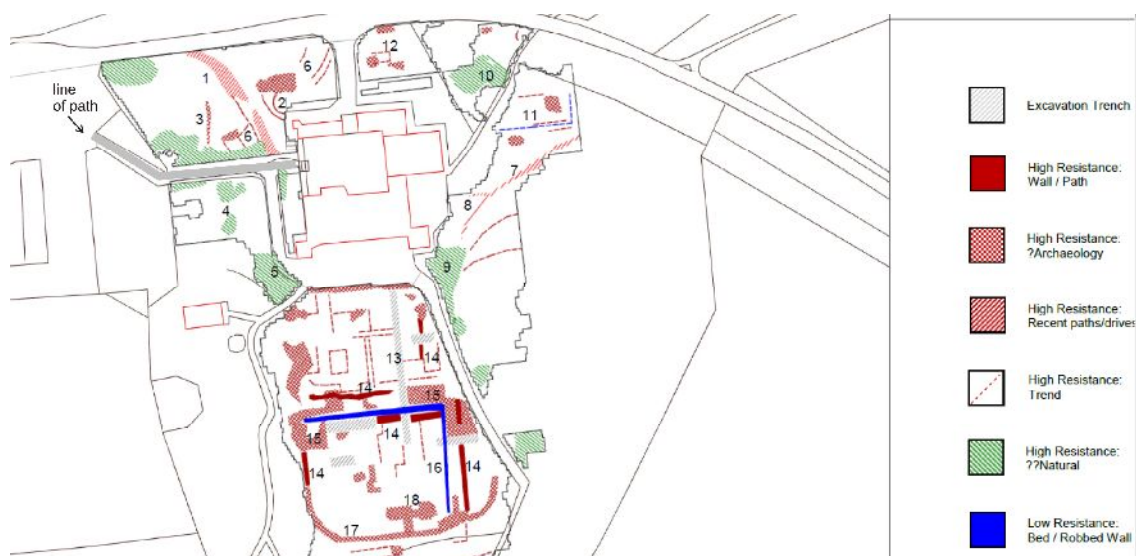
**Illus 7: Plan showing geophysical features in relation to the Pathway**

- 5.1 With the exception of the cobbles that may represent an earlier path running SE-NW, nothing of archaeological importance was visible in the excavated drainage channel. The green areas shown on the N side of the pathway, and identified in the geophysical survey as areas of high resistance, are probably a combination of rubble stone and very hard sandy granitic natural.
