**Malvern Museum:
Archaeological investigation and recording of
historic timberwork.**

**Report prepared by
Tim Hoverd**

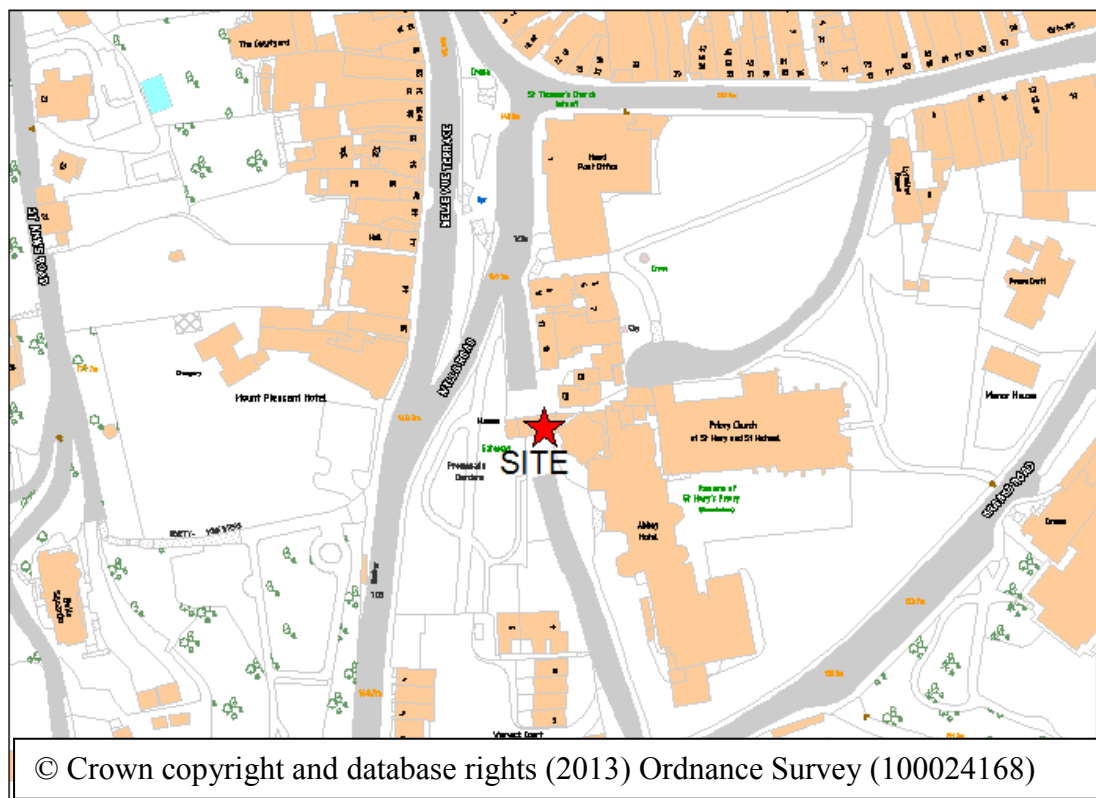
Figure 1: Site location of the gatehouse in relation to the modern streetscape.

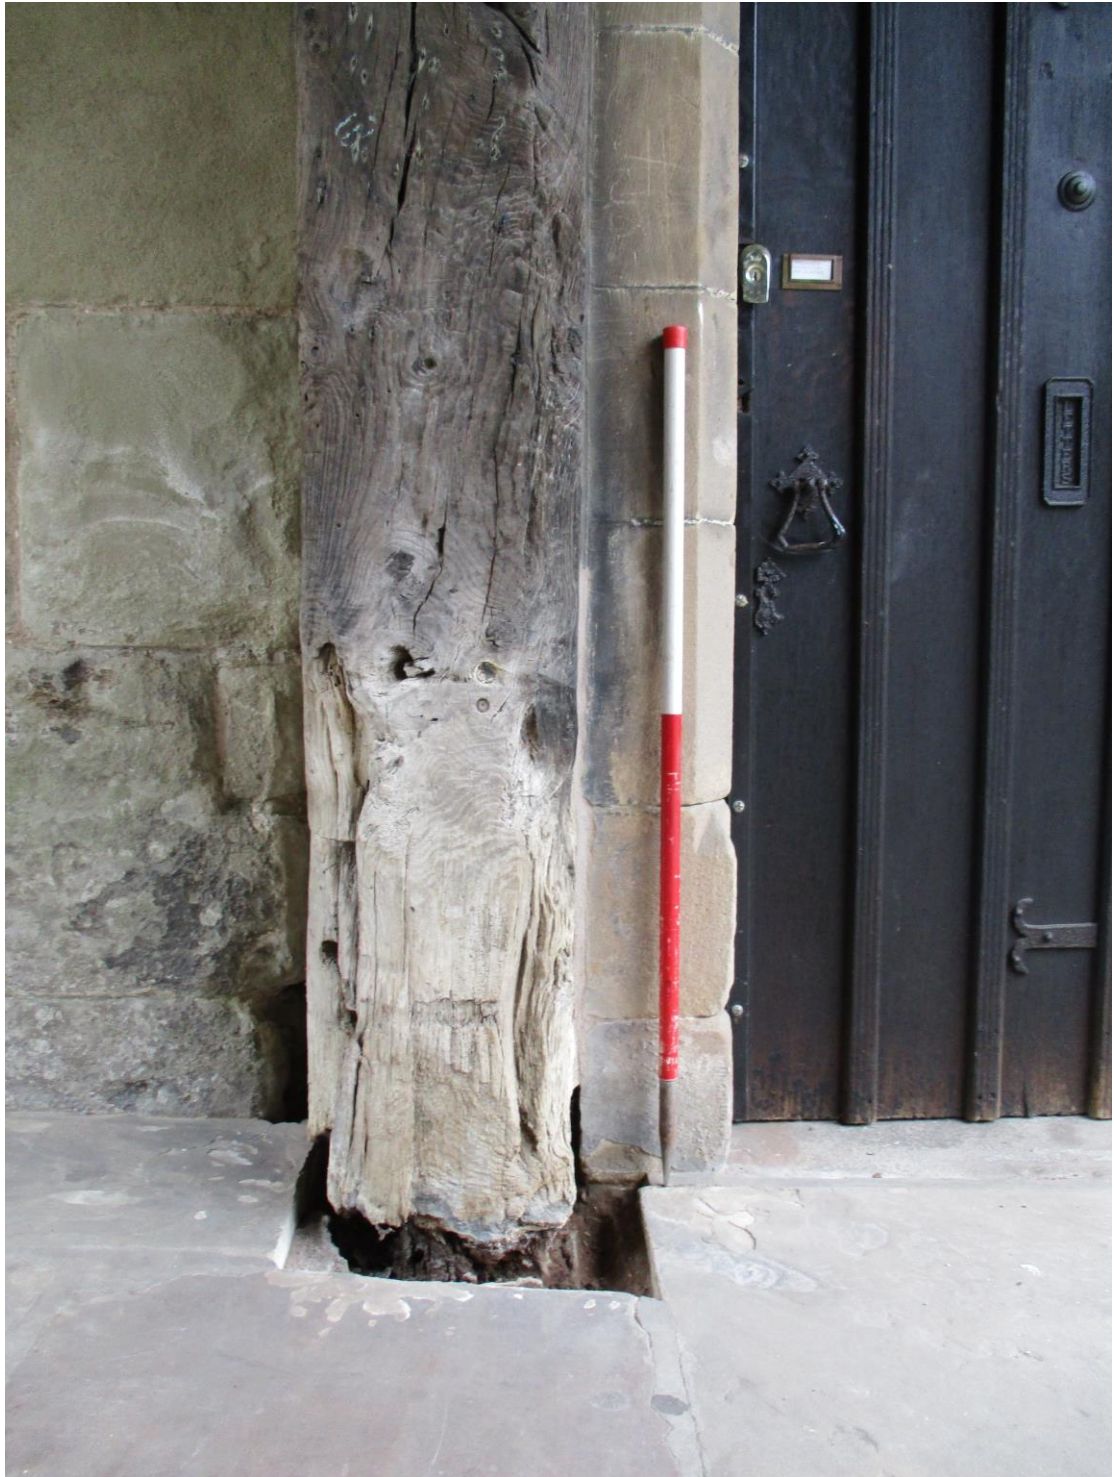
Plate 1: Timber jamb looking east, showing the extent of the damage and rot.

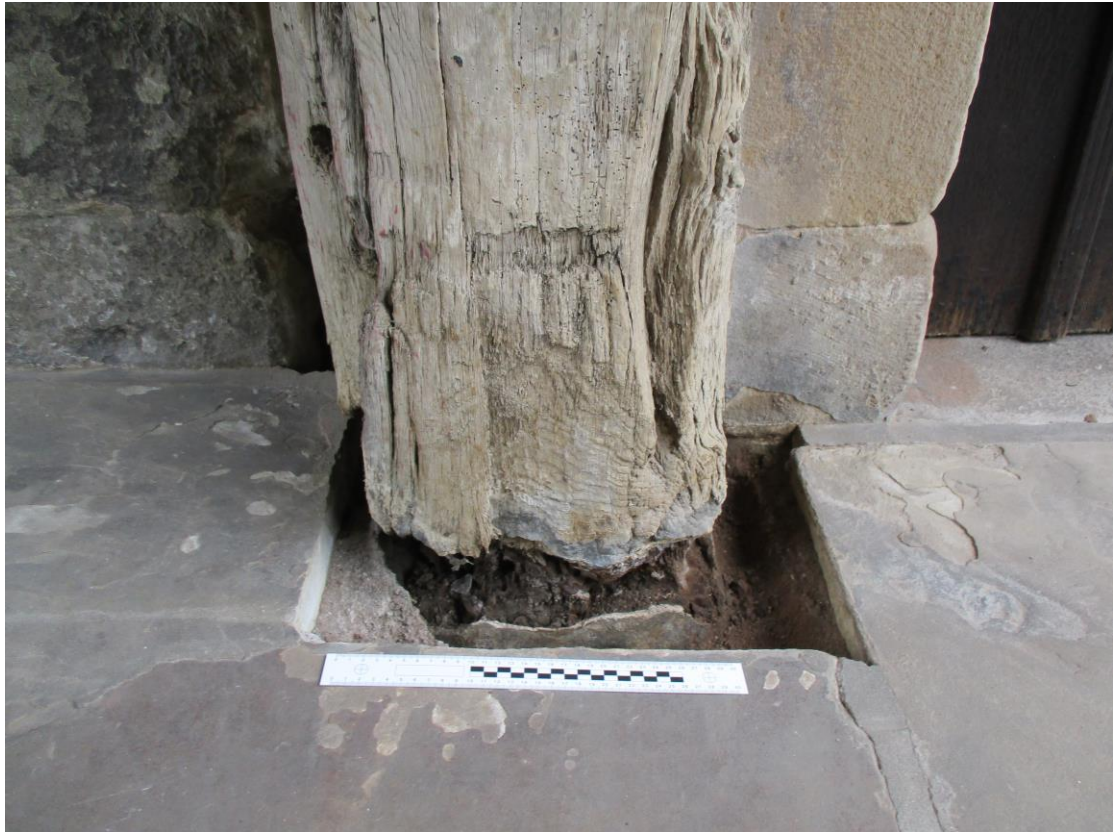
Plate 2: Detail showing splintering and abrasion to the jamb.

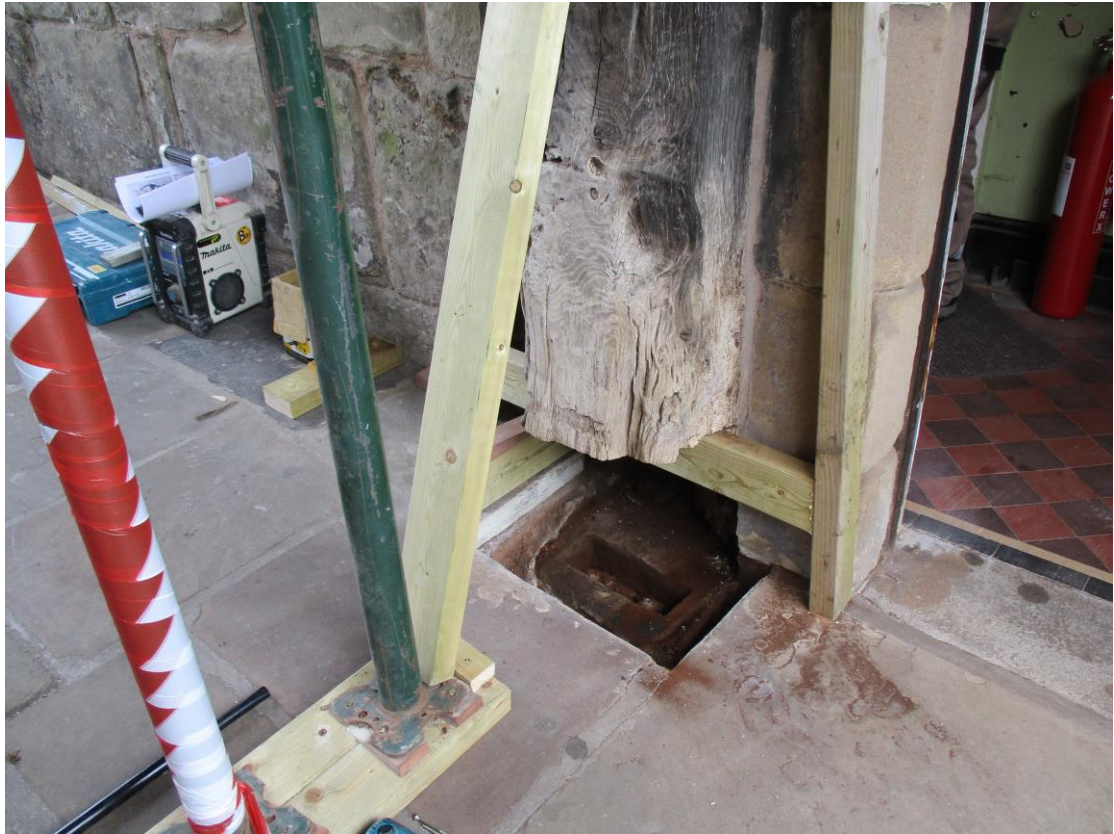
Plate 3: The Jamb after removal of its base and excavation of loose material.

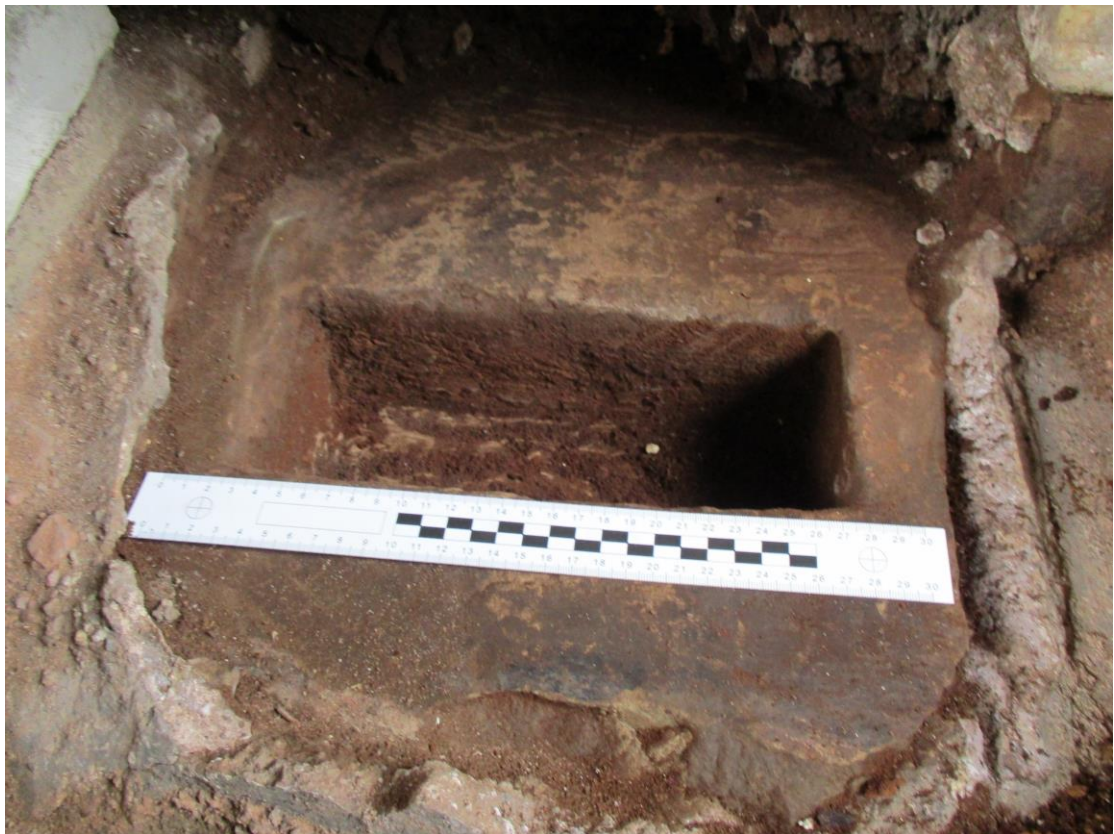
Plate 4: Foundation / pad stone with cut mortice in it
