Cow Tag 17 Type possible structural post

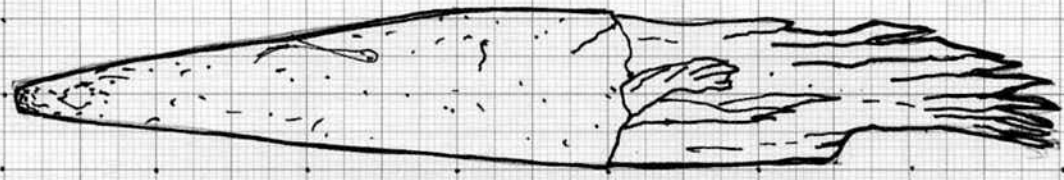
Surface A

Description 70cm in length. Tapers to a point at 'end A'. Badly damaged at 'end B'. 8cm wide x 8cm thick (varies). No fasteners. It is in a dried out and extremely brittle state. Surfaces are cracked and covered in a orange/yellow staining or growth. May have been part of a riverfront structure however it can not be said for certain.
