Oak radial, disc 11/5/10, org 258a

Cow Tag 19	Type Timber fragment.	DB 19/5/2010
----------------------	---------------------------------	--------------

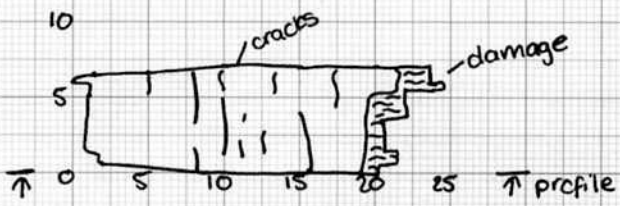
Description
length 24.5cm width 7cm depth 6cm
The surfaces of the timber is very cracked with damage at both ends.
Side B appears to have more damage than side A.
Side A has patches of rust colour. Also some sections of the timber has started peeling back.
