DB 20/2/8

Cow Tag 303	Function Code S31.6 S21.6.
----------------	--

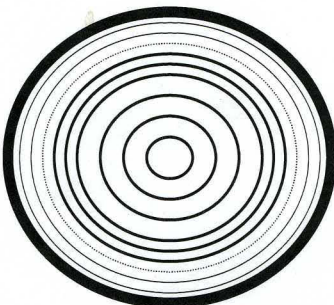
Brief Description: [timber element, p/s, condition, fragments]
long plank, somewhat damaged on edge

*OB : inscribed lines, no particular type
 wedged and shaped treenail,*

*IB : type 1 + poss. toolmark next to F45
 4 treenail forward, several inscribed lines
 Numerous clamp marks*

*c 85H Radial, P. Amerton
 ARW = 198/85.*
