Cow Tag 306

Function Code 521.5

Brief Description: [timber element, p/s, condition, fragments]  
complete plank good condition

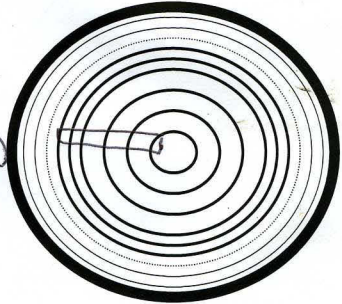
c 90H Intermediate Pith beyond lower edge or growth? ARW = 207/90
