Cow Tag 38	Type Timber fragment
----------------------	-----------------------------

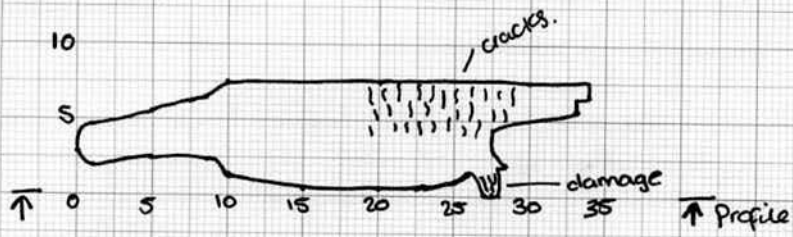
Side a

Description
length 34cm width 7cm depth 4cm
The surface of this timber is very dry and cracked and damaged.
Side A is very cracked with no features.
Side B is very cracked with one large crack. Also contains some modern damage on one end.
