2B 21/05/2010

Cow Tag **57** Type **Possible stringer**

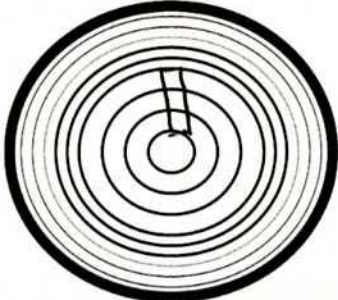
Description Dried timber possible stringer or plank. 67cm in length 15cm wide and 3.5cm thick. Two complete treenail holes and two partial treenail holes. Treenails no longer in situ. Diameter of treenails is 2.5cm. One metal fastener - no longer in situ. Shaft measured 1cm x 1cm. No head or clench plate impression visible due to damage. End B (see drawing) has a deliberate cut - appears to be a **Rebate** for another piece. It is 2cm deep. The base of the rebate has evidence of caulking - animal hair. Surface B has toolmarks covering entire surface - possibly caused during the splitting of the timber from the tree. Second fastener in the centre of the plank appears to have had its point hammered down. (impression remains)
 See 46 - same timber as 57. Rebate continues onto 46

Wood Science: Radially split

Recommended action: [samples, additional photos, moulding, queries and problems]
 Sample # taken - animal hair caulking?
 dendro sample taken # 3013
