Cow Tag 60 Type POST

Description 1.05m in length, 11cm in diameter (roughly circular) tapering to a point. Extremely dry and cracked most likely part of a river front structure possibly part of the wharf. No rootmarks or fasteners.

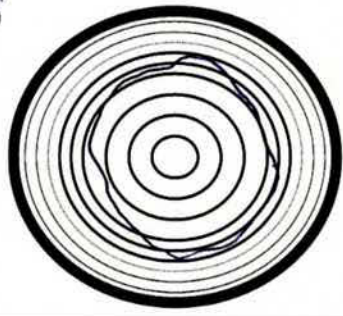
large crack run along grain

Discarded
