Cow Tag 62 Type purpose unknown Possible frame fragment

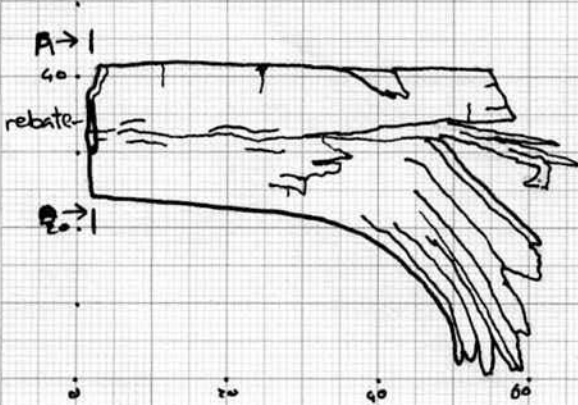
SURFACE C

Description Dry timber. Severely damaged at one end possibly due to machine on site. No evidence of fasteners. Measures 60cm in length. 20cm x 15cm in section. Function of this timber is unclear may have been a frame fragment or possibly part of a substantial river-front structure. There is a possible rebate visible on surface c (see drawing) It may also be a partial nail hole. It measures 5.5cm in length and 1cm deep.
