Cow Tag **70**

Type *Part of riverfront wall.*

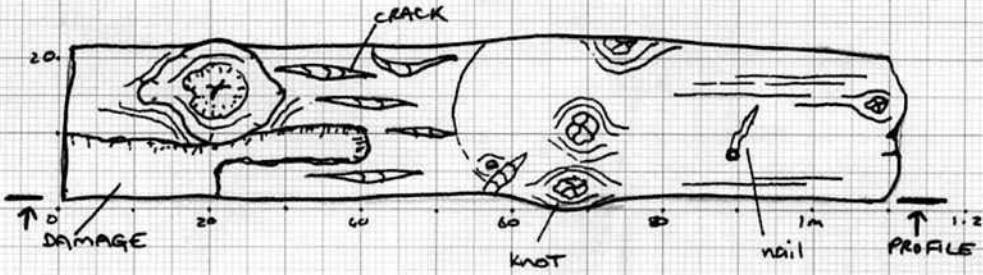
SURFACE A

Description *1.14m in length, 22cm wide x 13cm thick. One iron nail, shaft is badly corroded. Head is 2.7cm in diameter. No toolmarks present. Quite good condition except for some surfaces dry and cracked. Most likely function of this piece is part of a bank wall or riverfront structure. The one and only iron nail protrudes 1cm out of the timber.*
