**Historic Building Recording
at
Veryards, 4 Fore Street
Cullompton, Devon
in 2017**

**by
Stuart Blaylock**

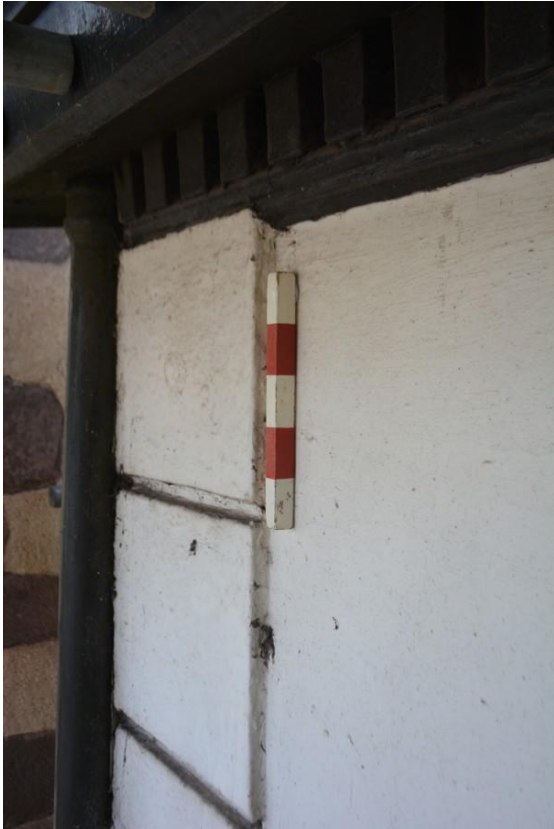
Fig. 22 Southern quoin, detail of rusticated quoins and cornice at wall top (photo ref: 6872).

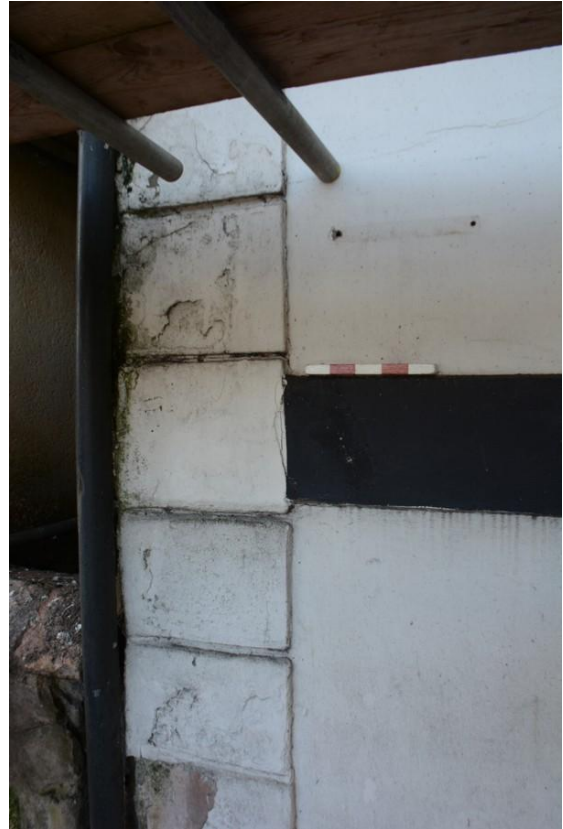
Fig. 23 Southern quoin, detail of rusticated quoins and plat band, looking south west (photo ref: 6908).

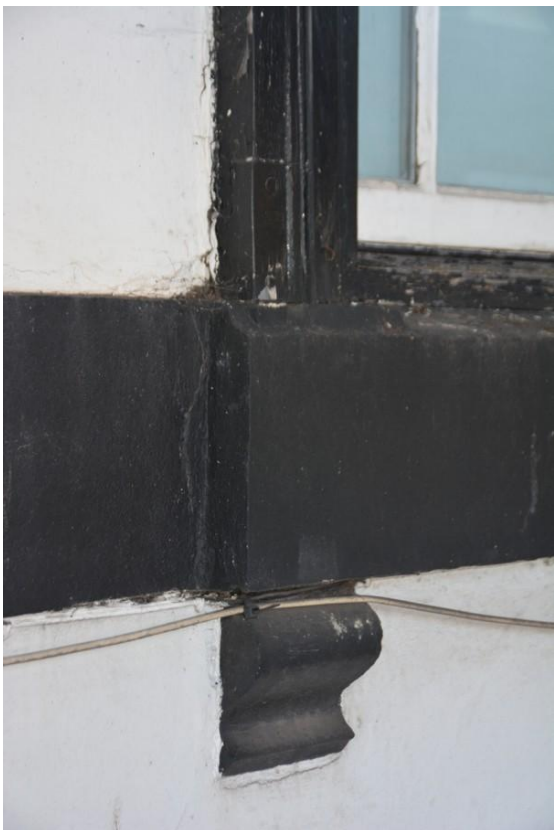
Fig. 24 Detail of plat band stepping out beneath windows and bracket beneath (photo ref: 6916).

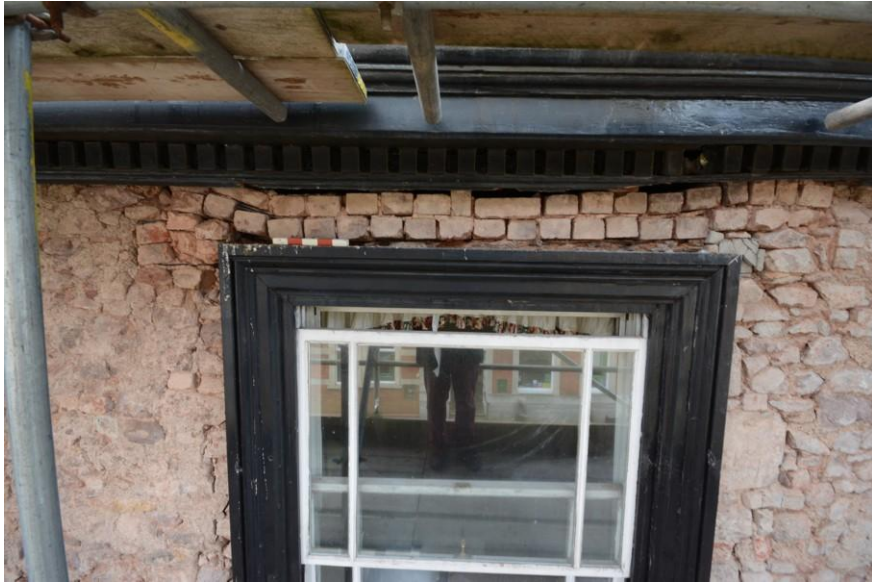
Fig. 26 Northern first floor window, showing improvised 1980s brick repair of decayed lintel (photo ref: 6997).

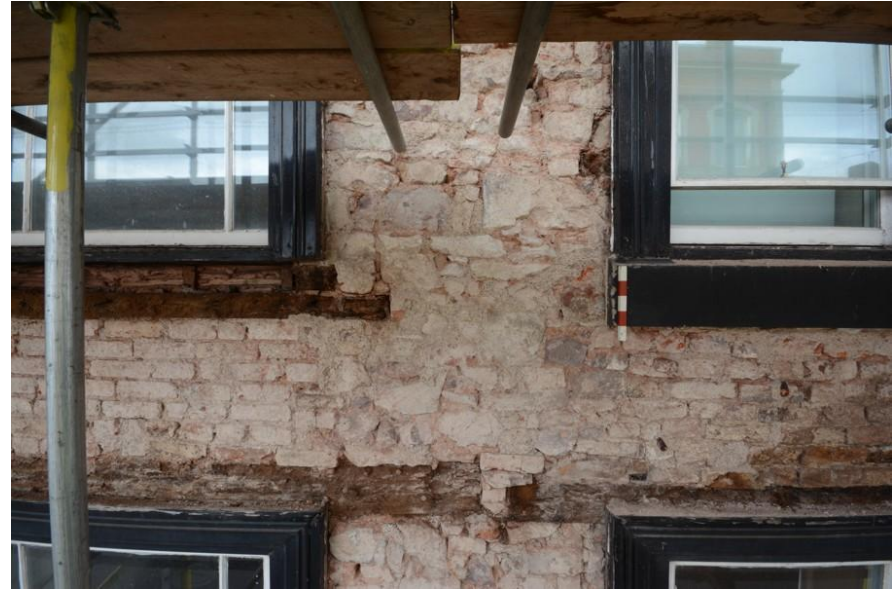
Fig. 27 Southern and central first-floor windows, showing brick aprons beneath and original lintels to ground-floor windows below (photo ref: 7028).

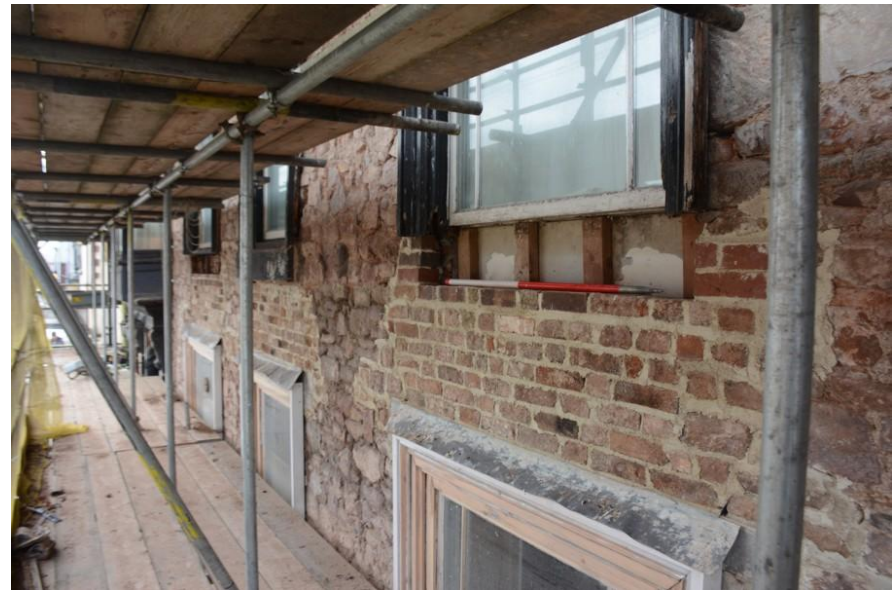
Fig. 29 Oblique view along first floor at window sill level, showing repairs in progress after inserted of new concrete lintels (photo ref: 7522).

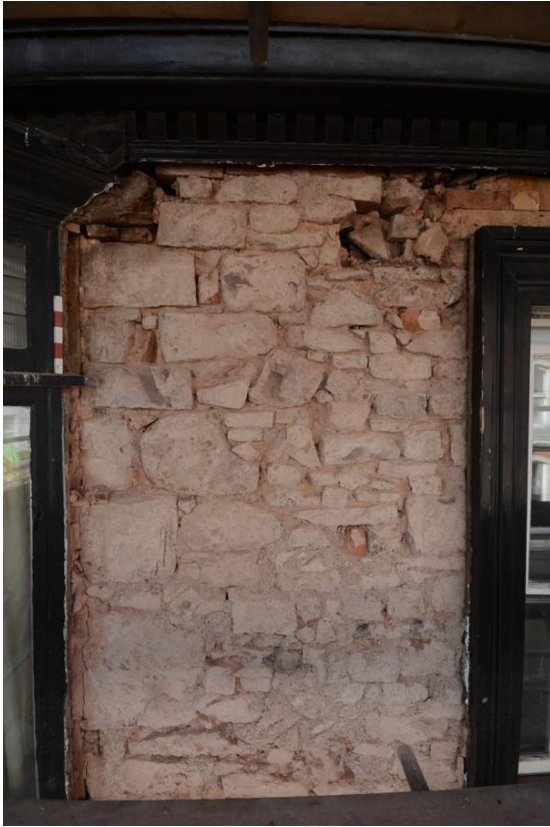
Fig. 30 Masonry walling north of the oriel window, showing the SE quoin of the 17th century building, upper stage (photo ref: 6984).

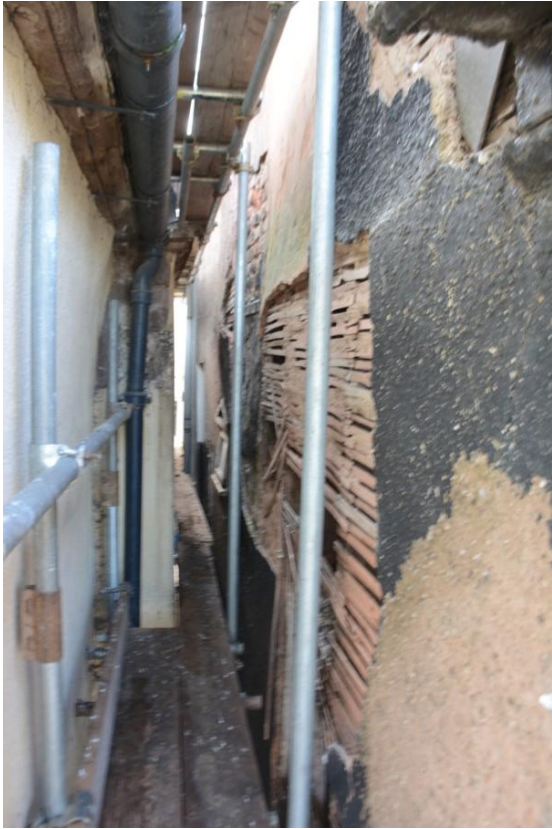
Fig. 34 South elevation, oblique view looking west along the wall in the narrow gap between Veryards (left) and The Walronds (right), showing condition before stripping in September 2017 (photo ref: 6868).

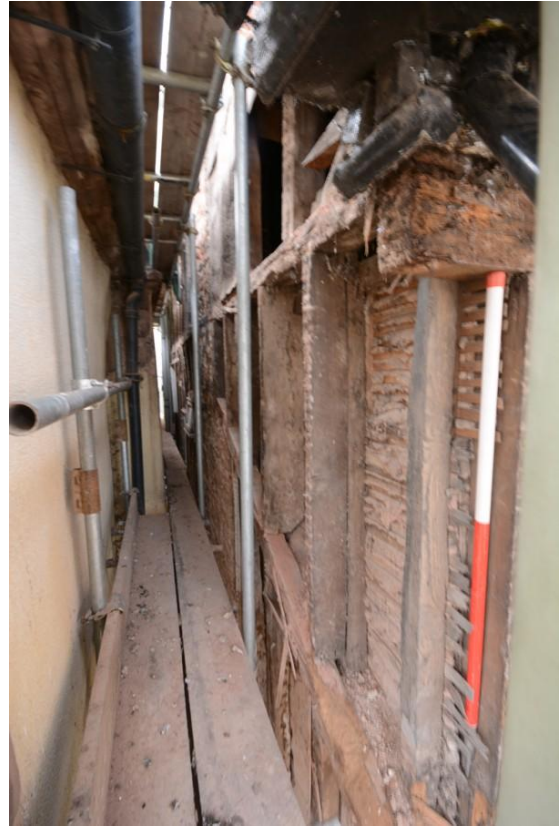
Fig. 35 The same, once lath and plaster had been removed in October 2017 (photo ref: 6979).

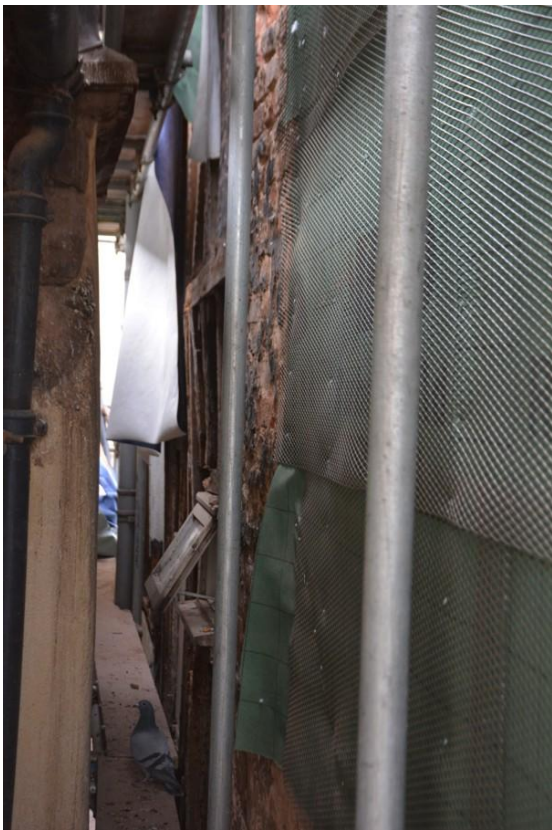
Fig. 36 Same, during repair in December 2017 (photo ref: 7545).

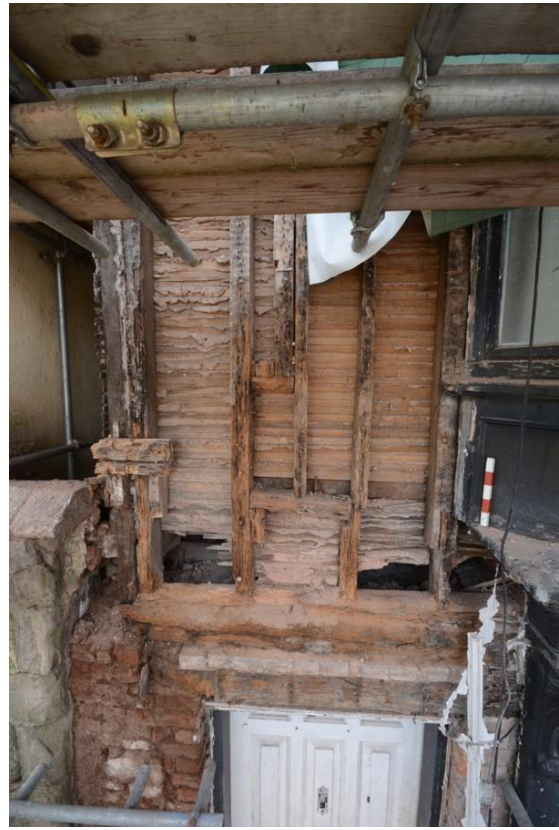
Fig. 37 South end of the south elevation, between the corner and the oriel window, showing original mid.-19th century framing (left) and blocking of a first-floor window (centre), note two phases of lath and plaster (photo ref: 7016).

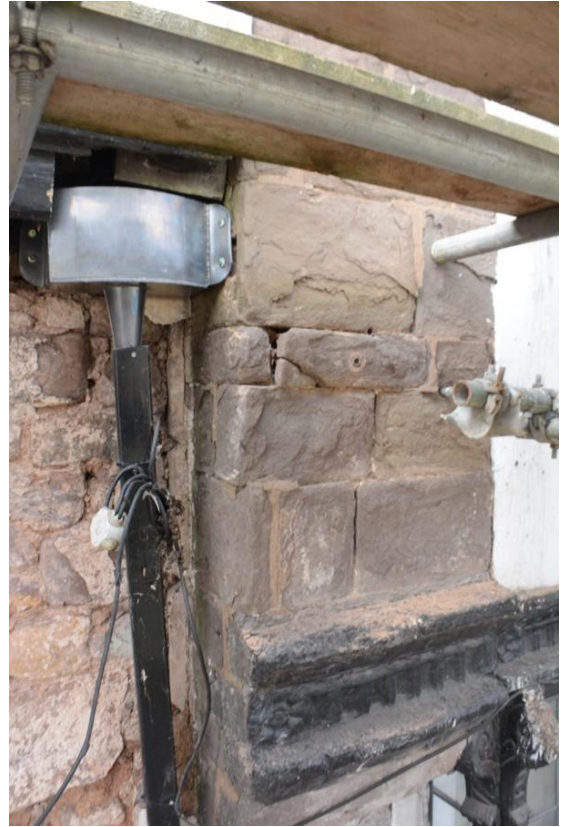
Fig. 47 South wall showing plaster rusticated quoins in section against the south face and abutted by the masonry of No. 4 (left) (photo ref: 7533).

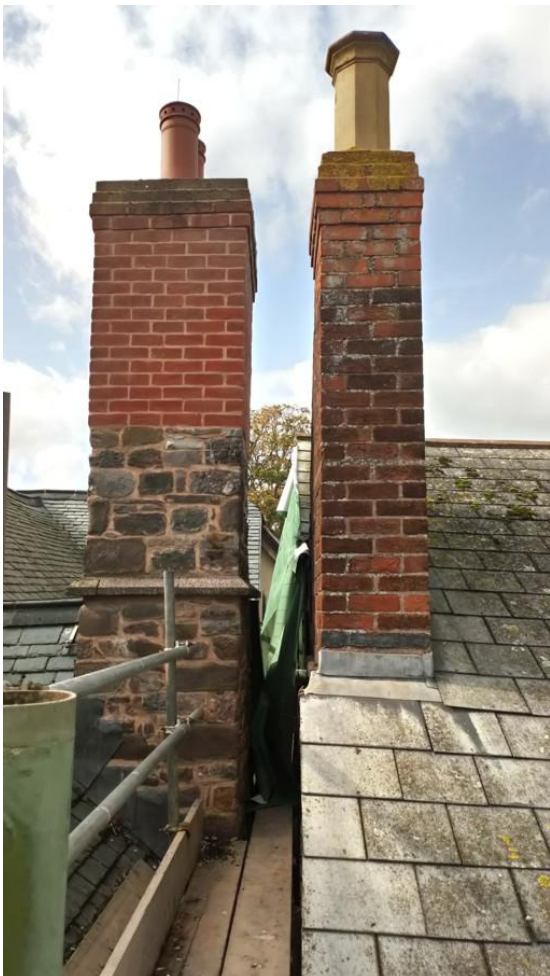
Fig. 48 Chimney of south gable, note brick repair of upper nine courses, with chimney of The Walronds to the south (photo ref: 0064).

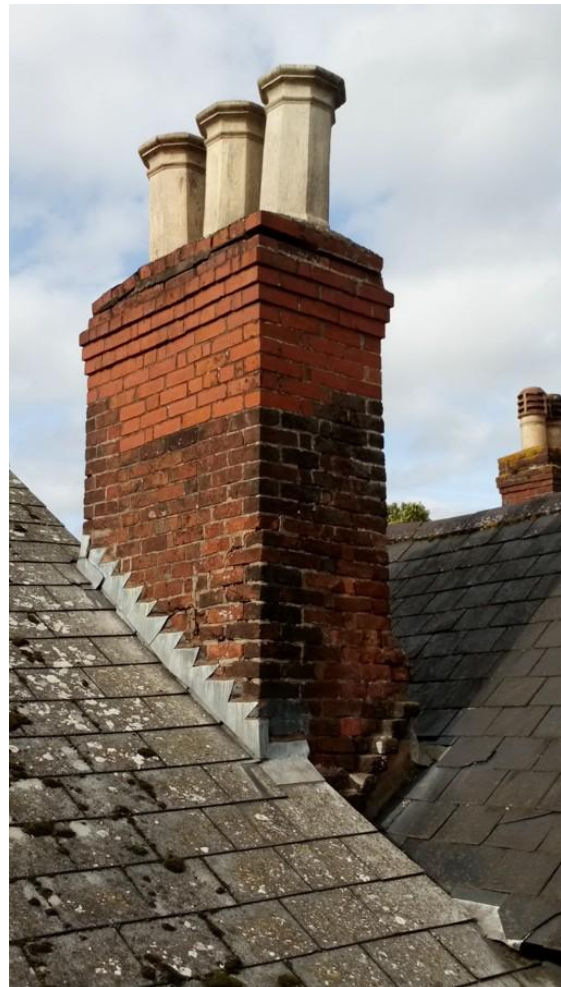
Fig. 49 Chimney of north gable, showing top eleven course rebuilt (photo ref: 0062).
