A66 - Package A: Greta Bridge to Scotch Corner - Archive Report

## APPENDIX 1: PETROGRAPHIC ANALYSIS OF LATE IRON AGE POTTERY

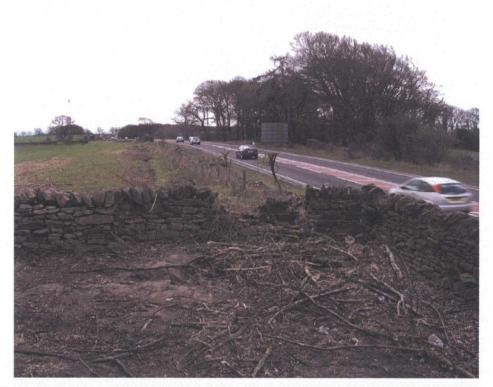
Plate 64: Site 001, the eastern end of Gatherley Moor Quarry, from the north of the carriageway, looking south-east. Wall in state of disrepair, large sections missing

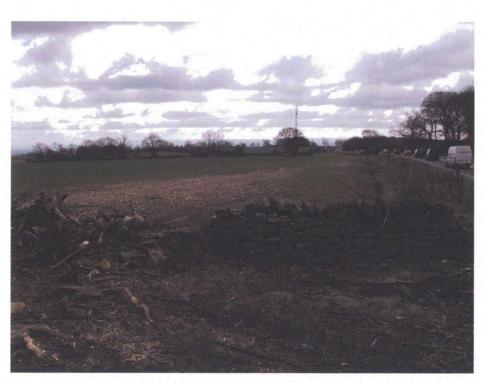
Plate 65: Site 002, the eastern end of Gatherley Moor Quarry, from the north of the carriageway, looking east. Substantial damage can be seen

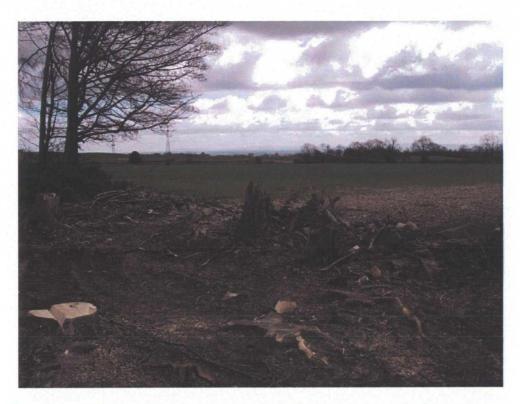
Plate 66: Site 003, the eastern end of Gatherley Moor Quarry, from the north of the carriageway, looking north. Substantial damage is evident and the majority of the wall does not survive

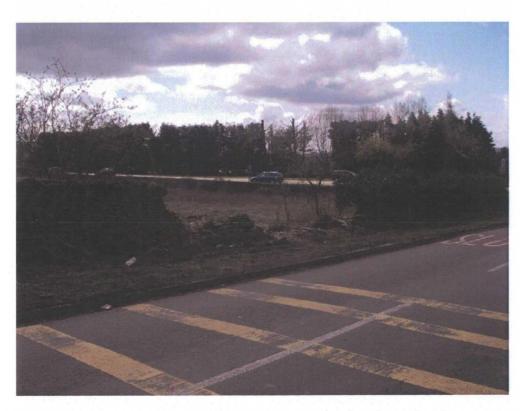
Plate 67: Site 004, western end of Gatherley Moor Quarry, taken from the north of the carriageway, looking south. Note the removal of a section of the wall at this location

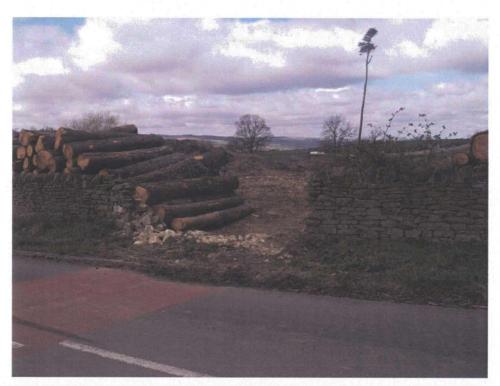
Plate 68: Site 005, western end of Gatherley Moor Quarry, taken from the north of the carriageway, looking north-west towards Carkin Moor. Note the removal of a substantial section of the wall at this location

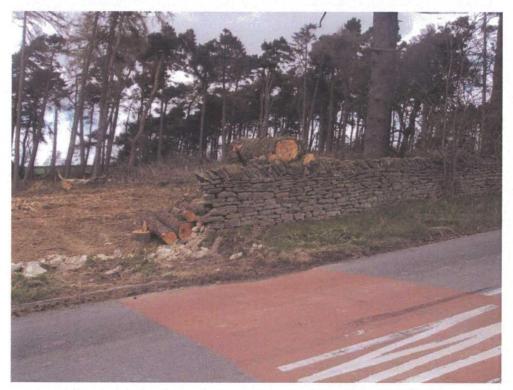
Plate 69: Site 006, western end of Gatherley Moor Quarry, taken from the north of the carriageway, looking north. Note the removal of a section of the wall at this location

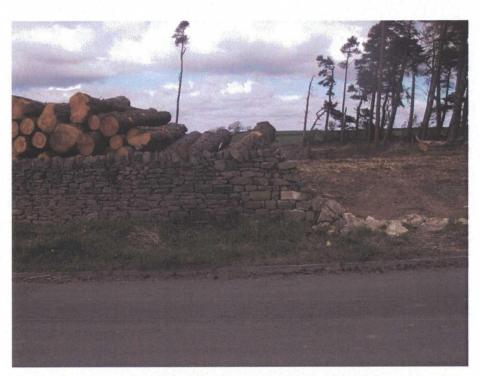
Plate 70: Site 007, western end of Gatherley Moor Quarry, taken from the north of the carriageway, looking north-west. Note the removal of a section of the wall at this location

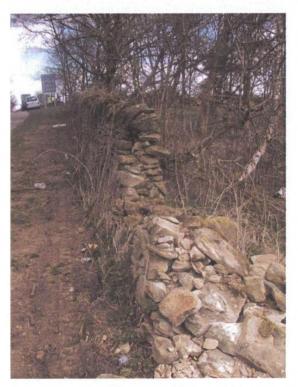
Plate 71: Site 008, field wall to the north of the A66 on the corner of Forcett Lane, looking north-west towards Carkin Moor. Note the similar construction style to the walls at Gatherley Moor Quarry, and substantial damage

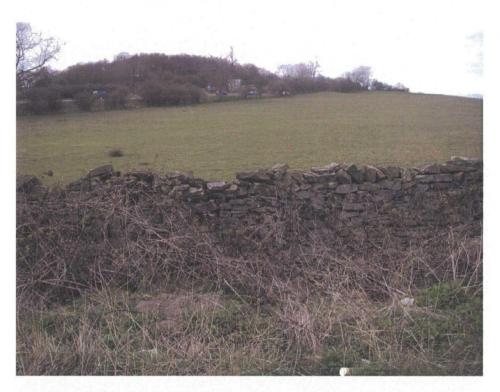
Plate 72: Site 009, field wall to the south of the carriageway taken on Forcett Lane, looking north-east. It appears to have been poorly rebuilt and shows signs of deterioration. Note the lack of quality in its construction compared to examples at Gatherley Moor Quarry

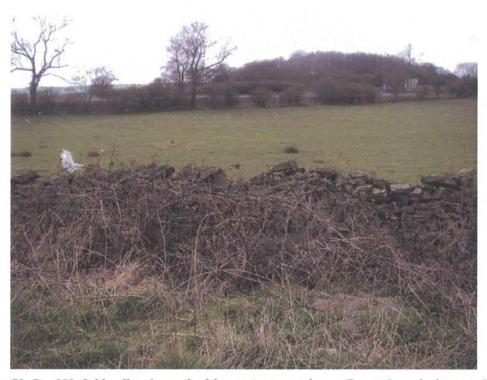
Plate 73: Site 010, field wall to the south of the carriageway taken on Forcett Lane, looking south. As with 009, it appears to have been poorly rebuilt and shows signs of deterioration. Note the lack in quality of its construction compared to examples at Gatherley Moor Quarry

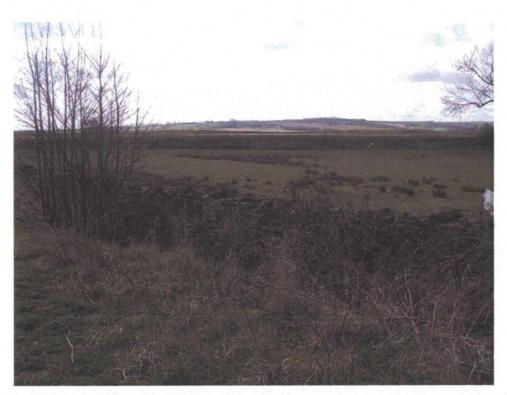
Plate 74: Site 011, field wall to the south of the carriageway on the access road to Browson Bank Farm, looking north-east. Its constituent stones appear to be slightly larger than those at Gatherley Moor Quarry

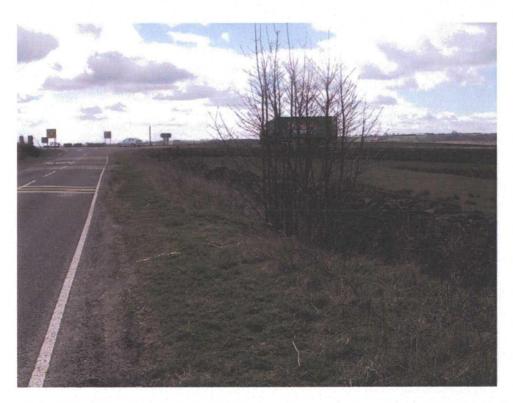
Plate 75: Site 012, field wall to the north of the carriageway opposite the access road to Browson Bank Farm, looking south. Slightly lower than the wall seen at 011, but of identical form

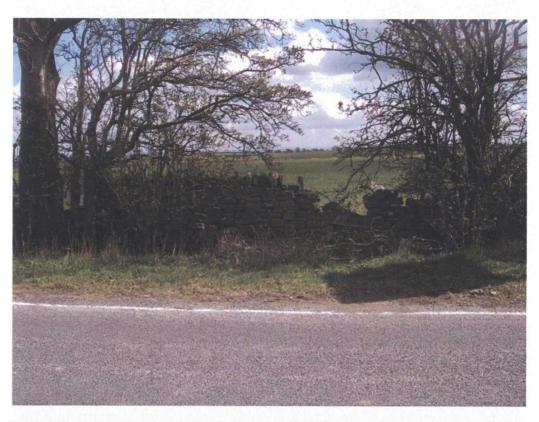
Plate 76: Site 013, field wall at Stephen Bank, to the north of the carriageway on New Road, looking south-west. Similar construction to walls at 011 and 012, but in a very poor state of repair

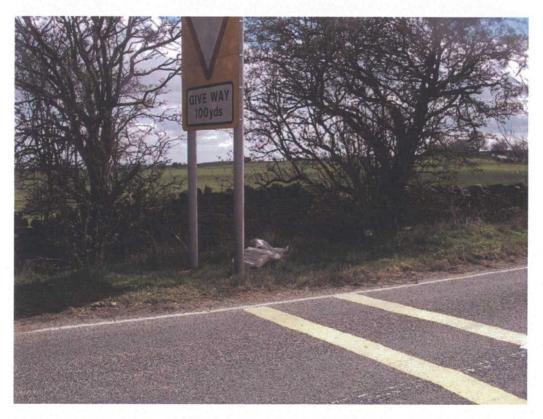
Plate 77: Site 014, wall on Lanehead Lane, to the north of the carriageway, looking south. The wall is in very degraded state

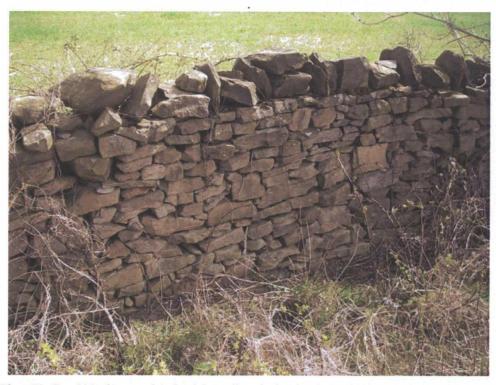
Plate 78: Site 015, showing details of the wall at the lay-by on Stephen Bank, to the south of the existing carriageway. Its construction is similar to that at Gatherley Moor Quarry. The wall has been extensively rebuilt in places

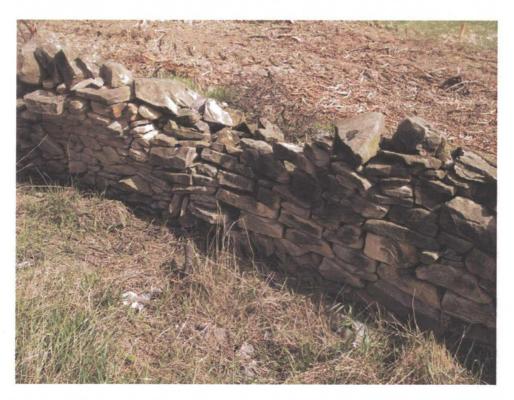
Plate 79: Site 016, showing details of the wall at the lay-by on Stephen Bank, to the south of the existing carriageway. Its construction is similar to that at Gatherley Moor Quarry. The wall has been extensively rebuilt in places, and has areas of collapse

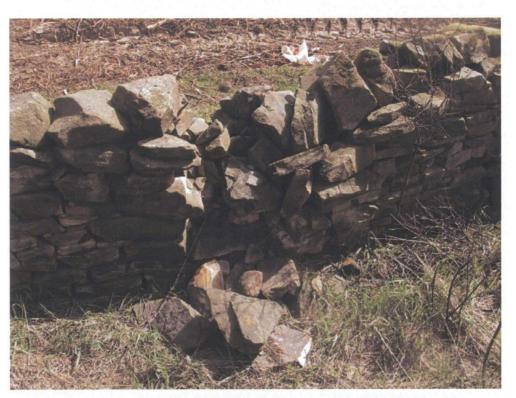
Plate 80: Site 017, showing details of wall collapse at the lay-by on Stephen Bank

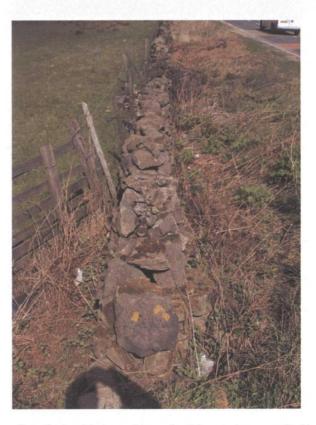
Plate 81: Site 018, wall at Carkin Moor, to the south of the carriageway, looking north-west. This displays evidence of stone removal and deterioration common to most of the field walls in the vicinity of the A66

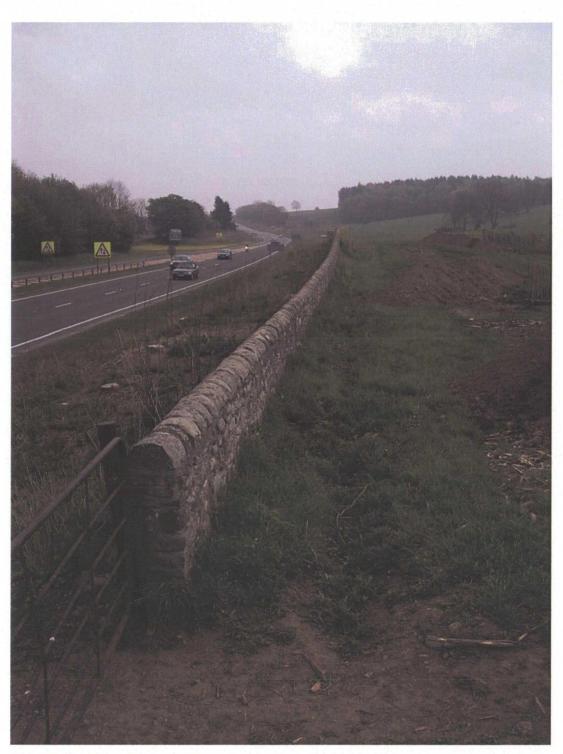
Plate 82: Site 019, wall opposite Thorpe Farm to the south of the carriageway, looking south-east. The wall is mortared and of a different style from the drystone walls, but of a similar style to the culvert headwalls, and is probably late twentieth-century in date

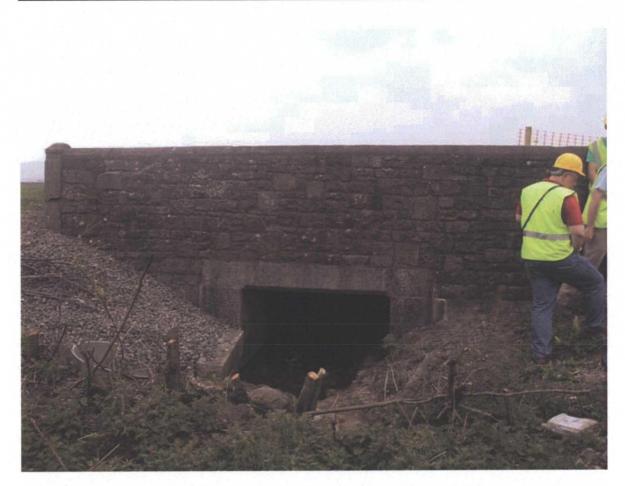
Plate 84: Site 021, stone headwall for a culvert at the south of the carriageway to the south-east of Carkin Moor Roman fort. The structure is roughly 2.5m in height, and is likely to be of late twentiethcentury construction
