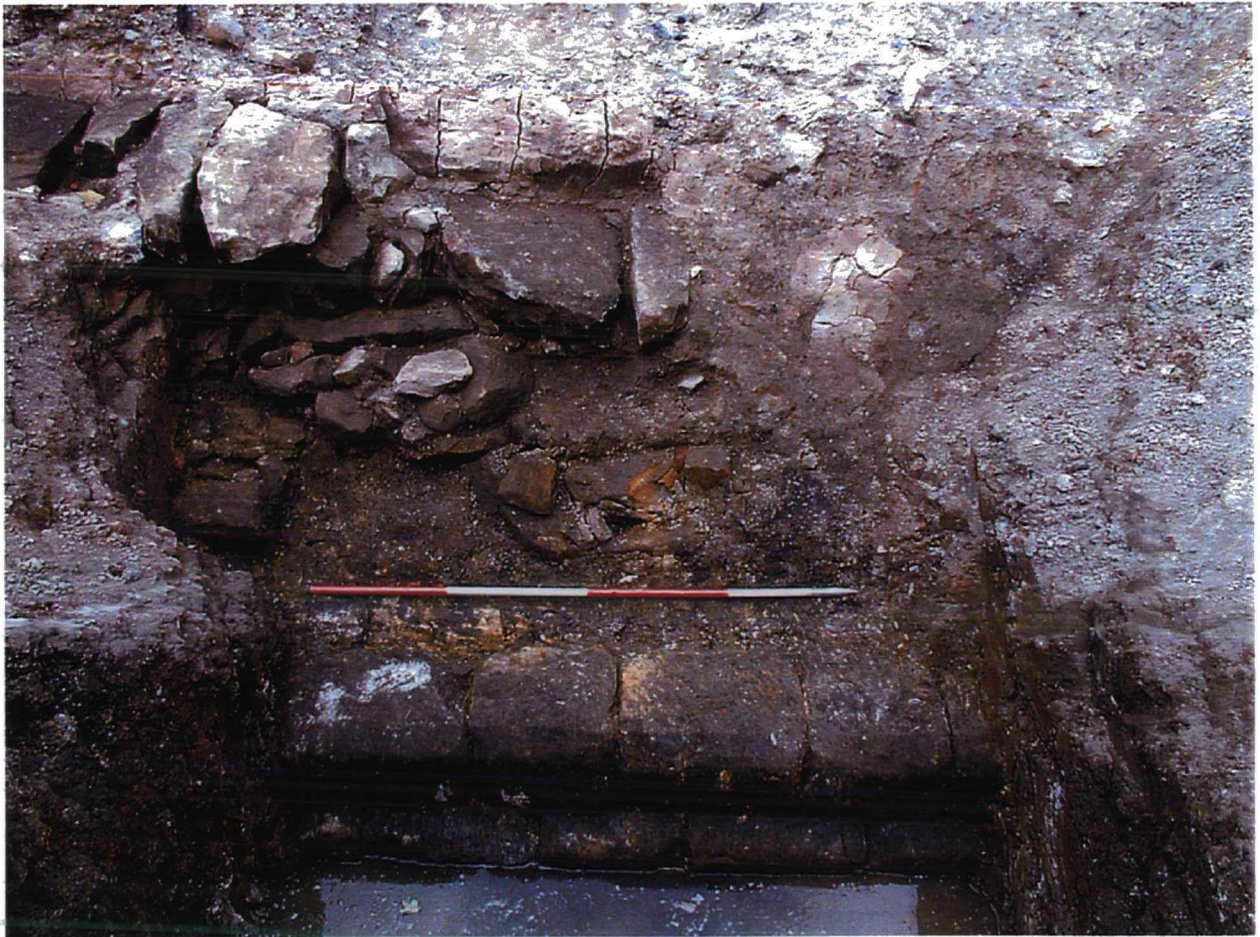
It is clear that collectively contexts 3007, 3004, 3005 and 3010 represent the remnants of a dry dock. 3007 can be seen as a construction cut sliced through the earlier deposited land reclamation fill 3003. The fine stonework of 3010 represents the well built interior walling of the dock whilst behind this the rubble 3005 forms infill between the construction cut and the inner facing. The function of the thin ribbon of clay 3004 may have been to form a watertight lining between the dry-dock and surrounding ground. Given that the full depth of the dock was likely to have been quite considerable and that construction took some time it is probable that the key constructional elements, 3004, 3005 and 3010 were each laid at the same time in sequences or stages as the work progressed.

The demise of the dry-dock was represented by contexts 3009, 3008 and 3006. The former of these formed an irregular profiled robbing cut that had facilitated the removal of the uppermost of the fine blocks of the interior facing 3010. These reclaimed blocks presumably being put to some other structural use in the locality. By necessity this robbing had also involved the removal of an amount of the infilling stone rubble 3005, though to a higher level. That 3005 was not robbed to the same depth is likely to reflect its comparative lack of worth and indeed whether this rubble was actually removed from the dock or merely cast down into the base is not known. The process of robbing also caused some disturbance to the dock construction cut 3007 which resulted in a slightly irregular profile. Some of this was due to slumping, context 3008, of this cut and the material through which it had originally been cut. The final component in the demise of the dock was represented by its backfilling. The material used in this process, context 3006, was essentially a mid to dark reddish brown, silty clay that contained occasional fragments of sandstone up to 0.20m in size. Occasional lenses of darker silt, together with a small quantity of artefactual material, namely nails of iron and copper, an iron bar and a fragment of lead sheet, were also present within 3006. The clean appearance of the bulk of this material however, suggests the likelihood of its having been re-deposited "natural". Quite why such a material was used is uncertain though it may relate to an absence of other waste materials, to the presence of contemporary on-going ground works in the locality or to a requirement for compact, solid backfilling. A precise date for the infilling of the dry dock has not been ascertained, but is likely to have been soon after the shipyard closed in 1902, and was before 1908 (see section 3). The 1913 Ordnance Survey map (Figure 10) shows the dock area filled in.

Plate 8. Trench 3, looking north-east, showing dry dock facing stone 3010, rubble backing 3005 behind with clay lining 3004 (cracked). Robbing slumping 3008 to right, dry dock infill 3006 to left and right foreground

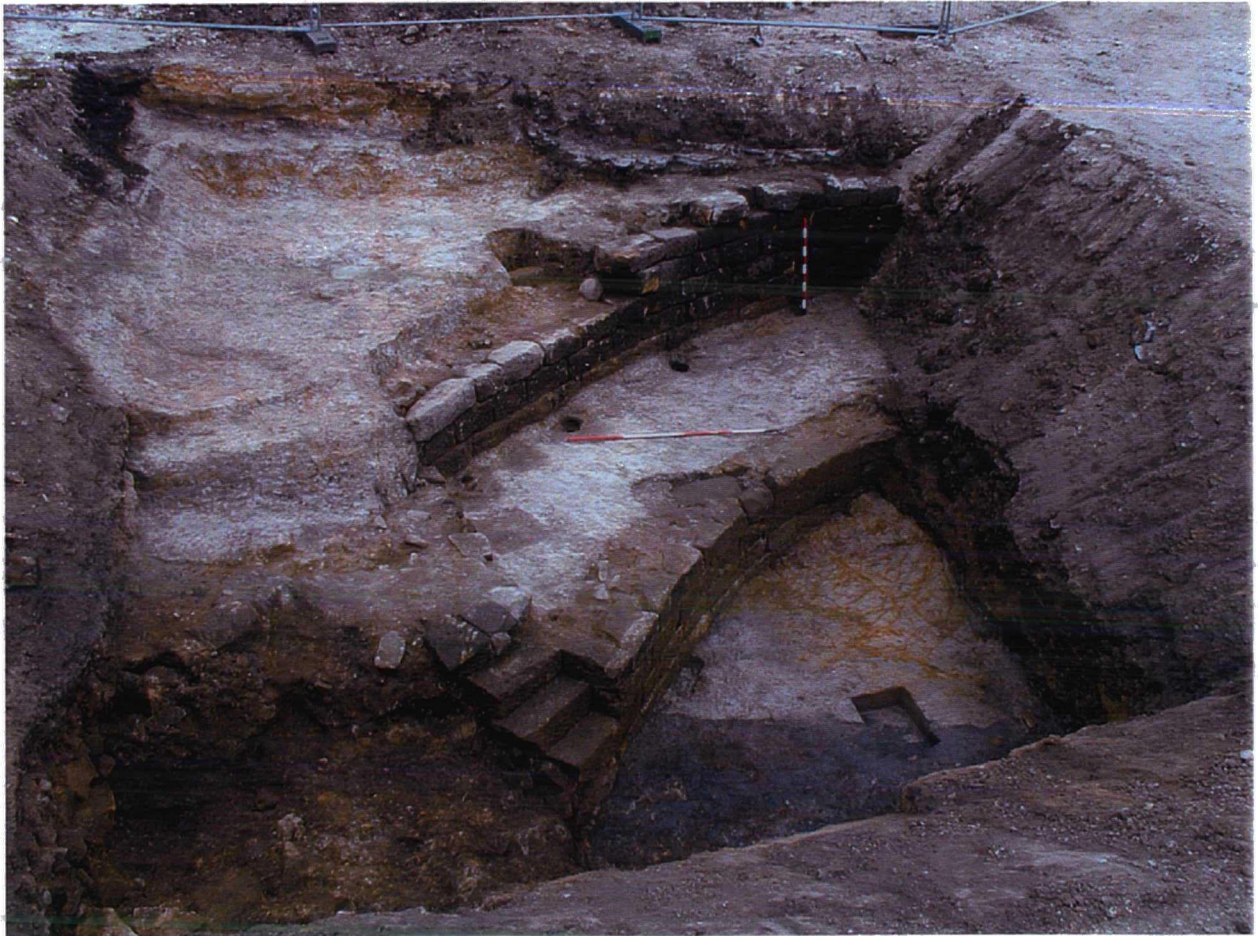
Parts of a well preserved structure terraced into natural 4012 and comprised of a number of component parts overlay feature 4026. The major of these components consisted of upper and lower curvilinear walls connected at their western ends by a series of stone steps. The upper wall occupied cut 4008 that terraced into natural 4012. The wall itself, context 4006, was built of well and tightly coursed blocks of sandstone (maximum block size 0.82m x 0.23m x 0.32m) bonded only with a dark clayey silt that stood three courses tall at the north-west and for six courses at the south. Apparently only one block wide the stonework was heavily coarse picked, with just two blocks being tooled in herringbone pattern. A yellowish brown, silty clay

Plate 9. Trench 4 looking south-east, showing walls 4006 and 4009, steps 4013. Infill 4021 to left foreground, natural 4012 at base of trench elsewhere. Early fill 4025 visible in lower right foreground

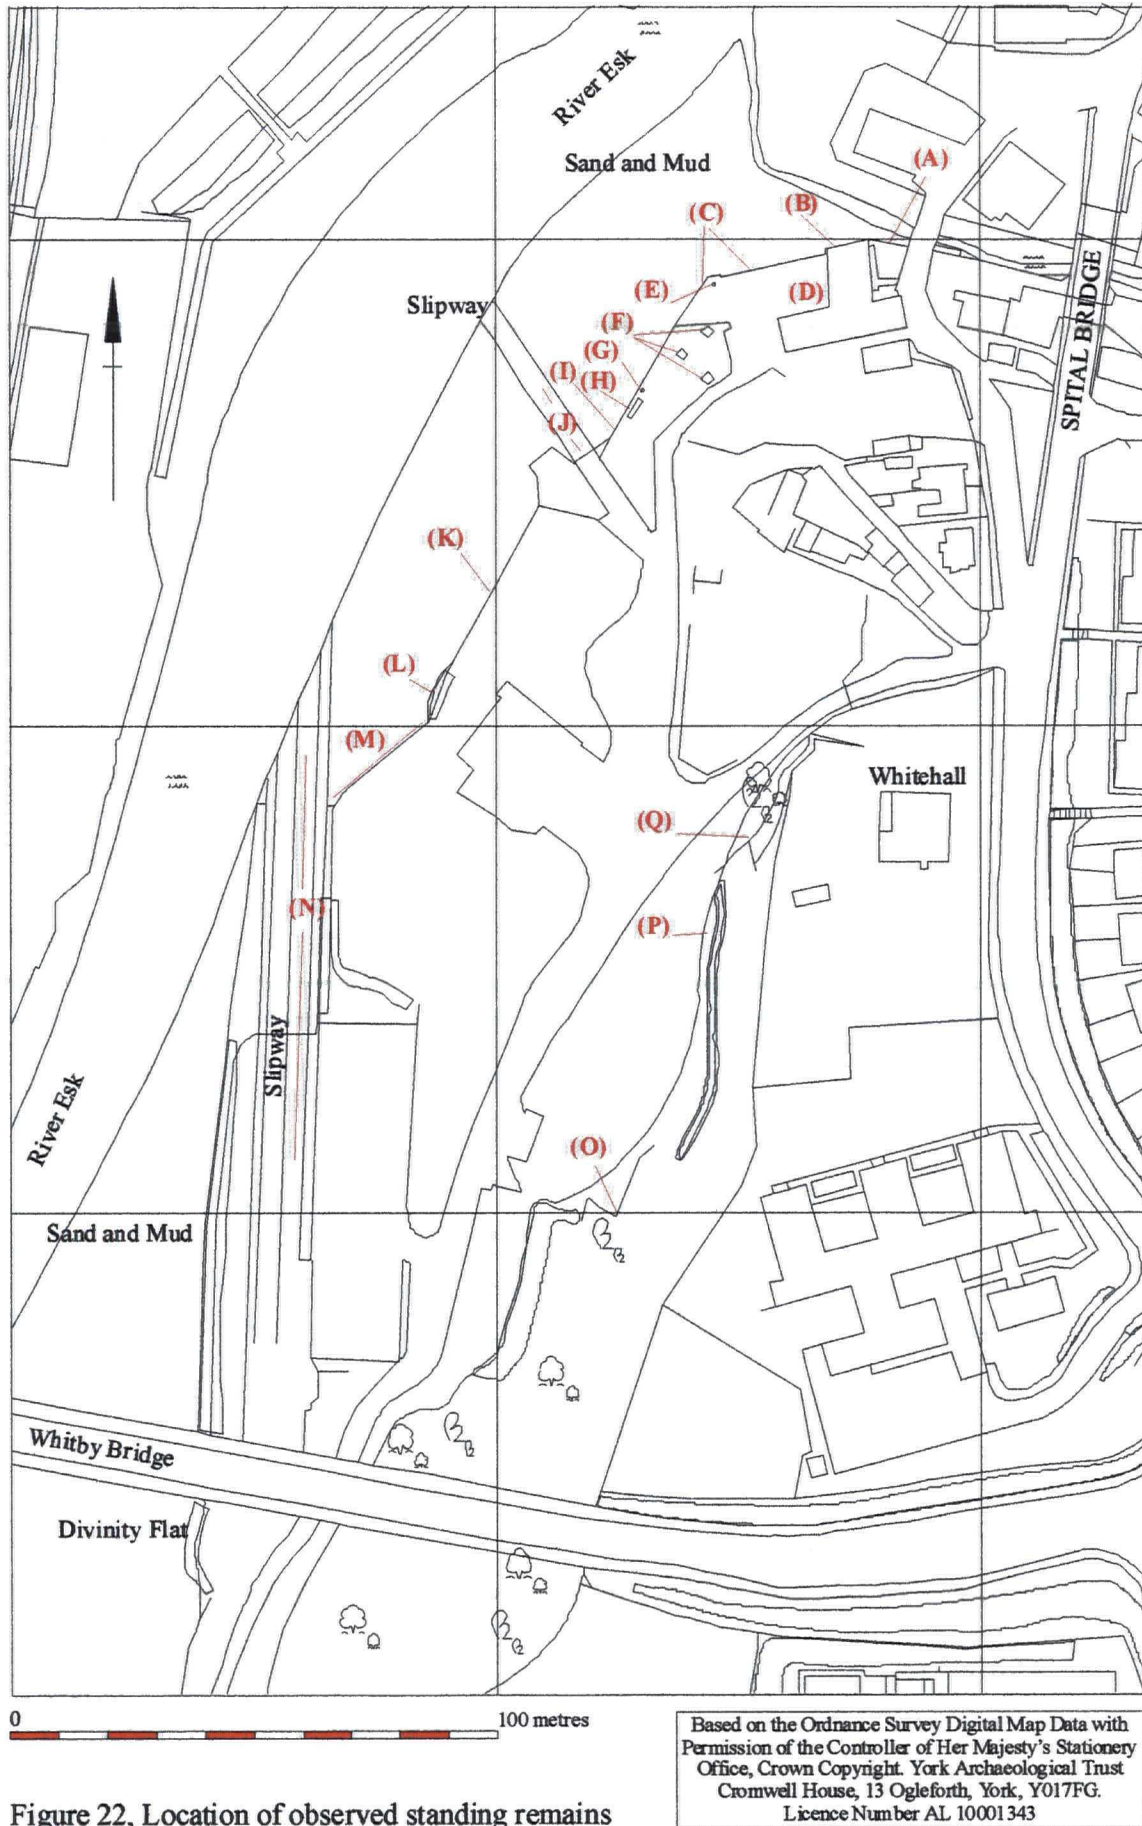
Figure 22, Location of observed standing remains

(C) Immediately west of the sail loft an area of well constructed quay is present. This extends westwards for a distance of 25m before turning sharply to the south-west for a further 34m. Visible for heights of between 2.50m-3.65m, this wall is constructed of large tightly jointed sandstone blocks of a size similar to those in the lower courses of the sail loft (B), many of which again display coarse picked tooling. The sequential relationship of this wall to the lower parts of the sail loft is not certain. Although the courses of both walls are at variance they have nonetheless been keyed into one another. At the south-western extremity of this quay the walling turns abruptly to the east, a course presently occupied by a sewer. Later concrete blockwork continues the line of the old quay further to the south-west. The eastwards return of the old stone quay is of some note as it corresponds with a narrow inlet shown on 19th century maps that extended as far as the western end of Dog Lane. Whilst the precise reason for this slipway being infilled is not known it may relate to a rearrangement of facilities at the site or merely to the reclamation of land. It is possible that the old slipway survives intact below the later infilling materials. The entirety of this quay is in good overall condition though immediately south-west of its north-west corner the walling has been lowered by two courses; this relating to 20th century works in the vicinity. This quay was known as Chapmans Quay in the 1840's and throughout the 1850's - 1870's (at least) is marked on maps as a timber yard. The old quay is clearly of some antiquity and may well be that depicted on Wooler's map of 1740. As such, this quay should be considered a monument of some significance.

(I) Between the south-western end of the old quay and existing slipway a short stretch of modern concrete block river wall is present. This is badly eroded below the high water mark.

(K) A small area of mud and shingle is present immediately south-west of the slipway and a further area of concrete block walling beyond this. This walling extends for a distance of over 40m and in places is in such poor condition that large areas of collapse have taken place. Materials visible in the land behind the slumped wall were seen to be of 19th and 20th century date. Suggestions of an eastwards return of this wall could be seen below overgrown scrub. In places well preserved stonework, presumably from an earlier frontage wall, were visible beneath the modern concrete blockwork. This section of walling covers the entrance location of the former entrance to the dry dock.

(M) Extending from (L) to the large concrete slipway and along the eastern side of this was a continuous stretch of driven interlocking steel shoring sheets. Water action had corroded many of these and modern rubble fill was visible to their rear in many places. By comparing the present riverside with that shown on 19th century maps it appears that between 13m and 18 m of ground have been reclaimed here in the 20th century.
